Caerus Piceance LLC
K33NW
Location # 334632

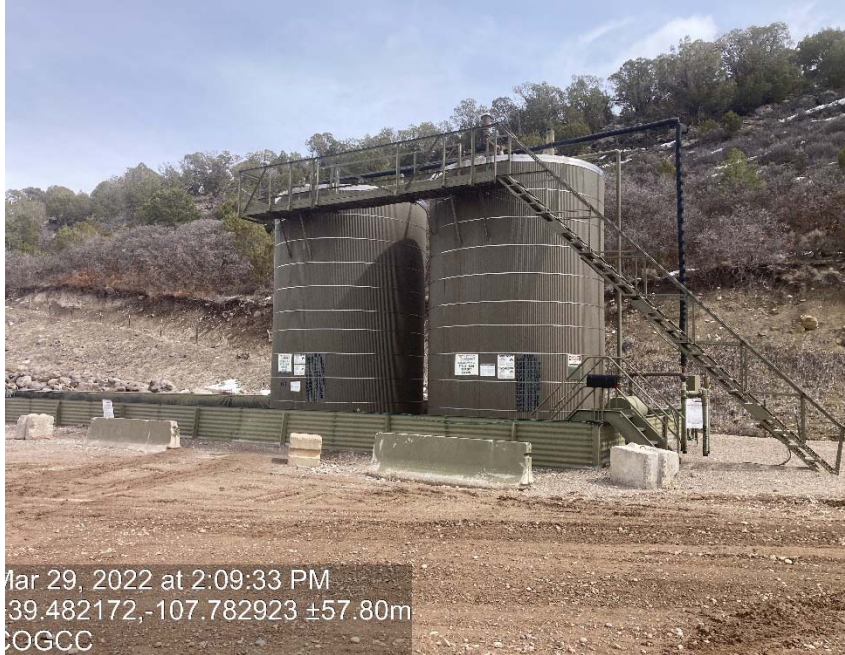
Location/ lack of battery signage

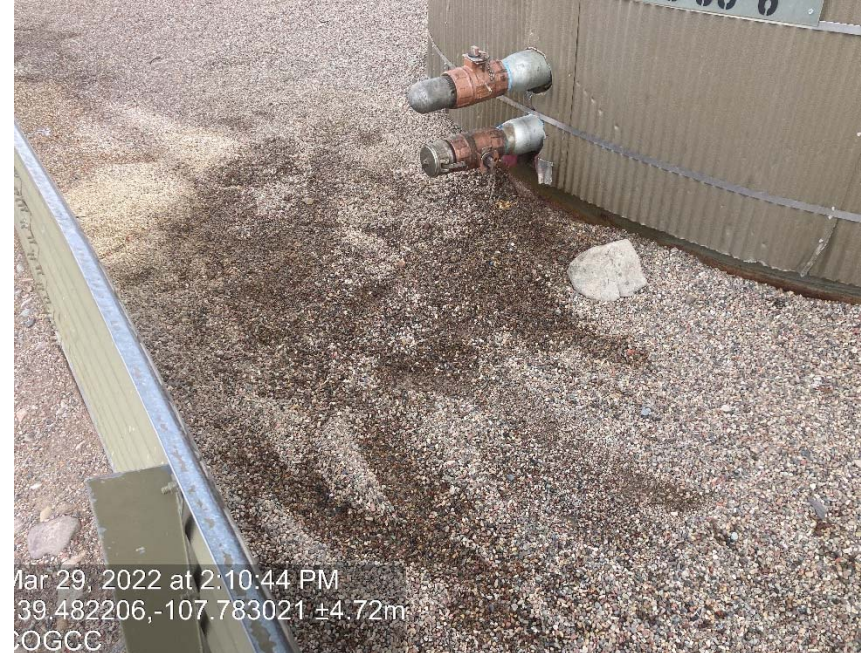
Staining

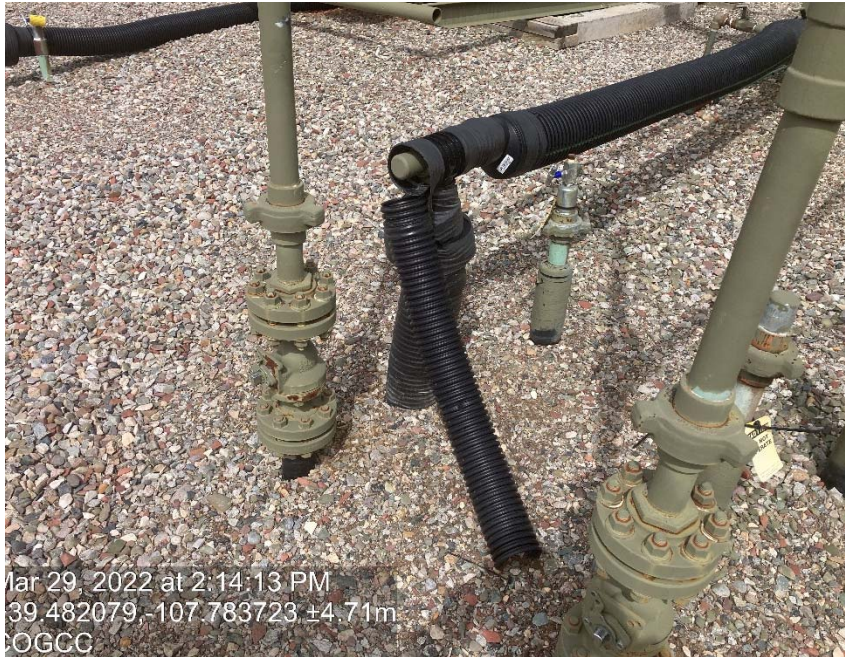
Open ended pipe

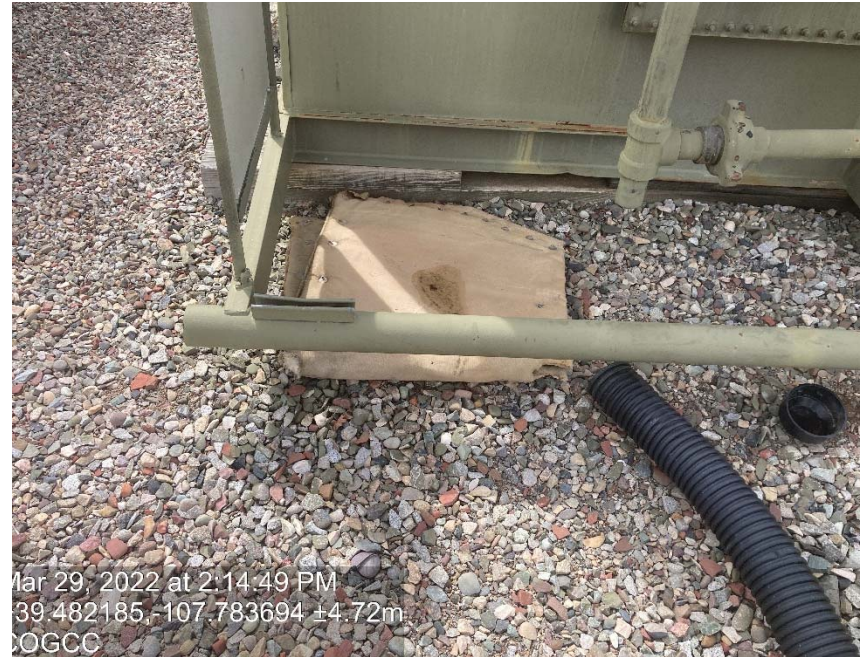
Open ended pipe and debris

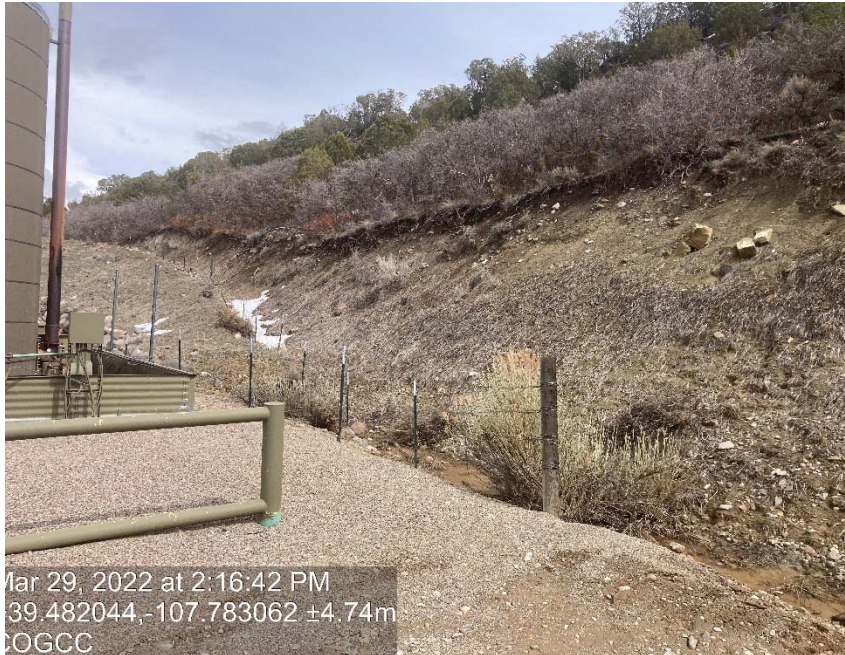
Cut slope show some areas of erosion

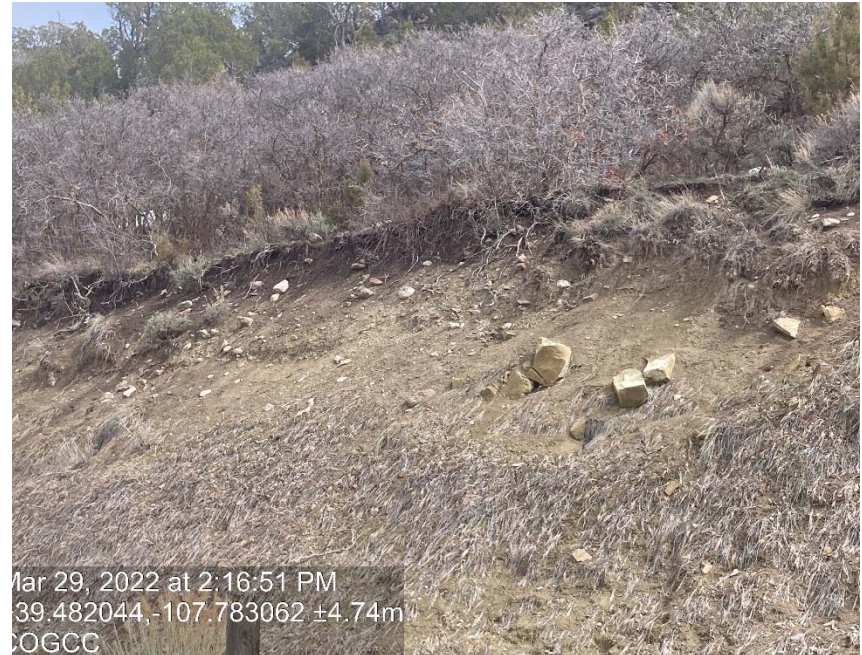
Cut slope show some areas of erosion

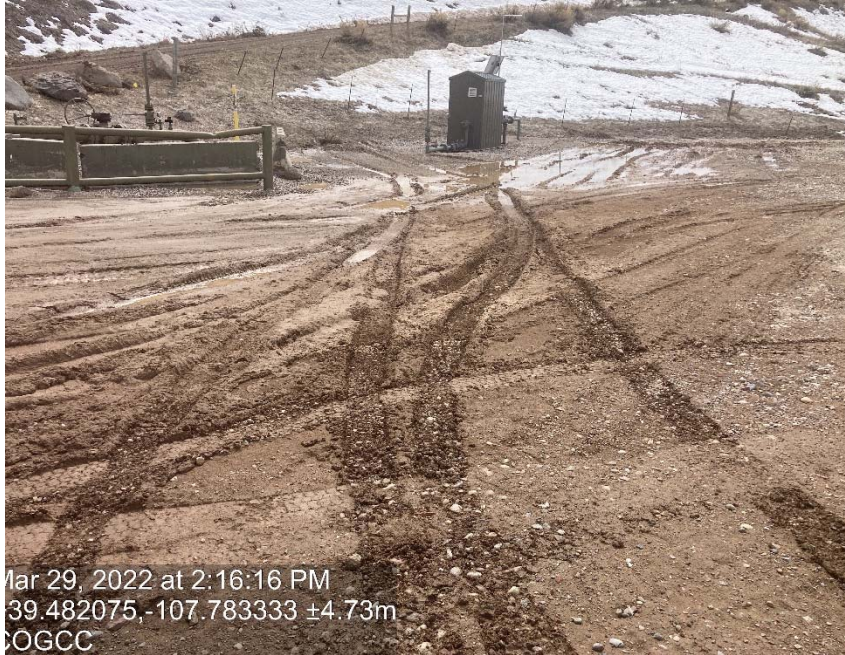
Lack of stabilization/compaction

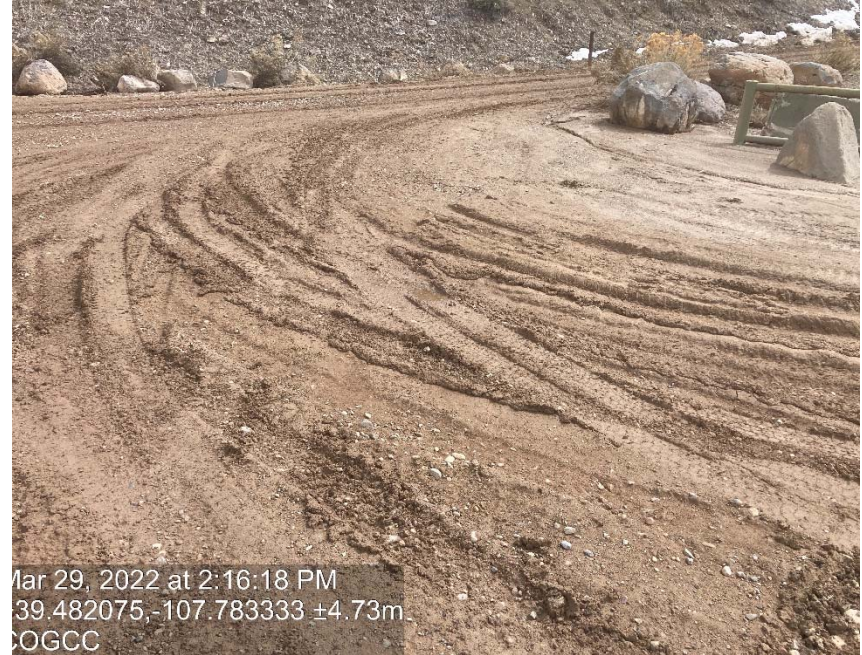
Lack of stabilization/compaction
