TEP
KP 32-17
Location # 335239

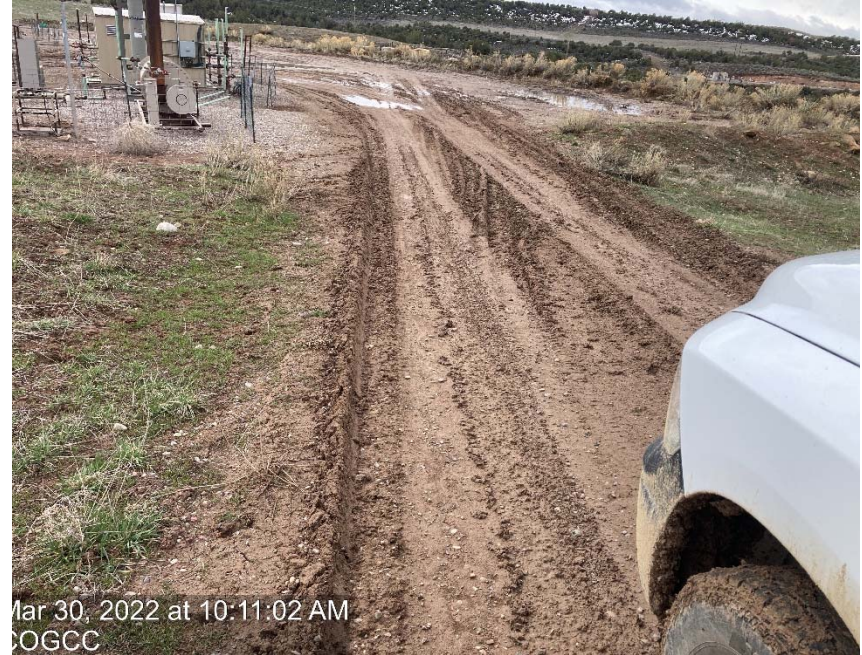
Lack of stabilization/ compaction/ degradation

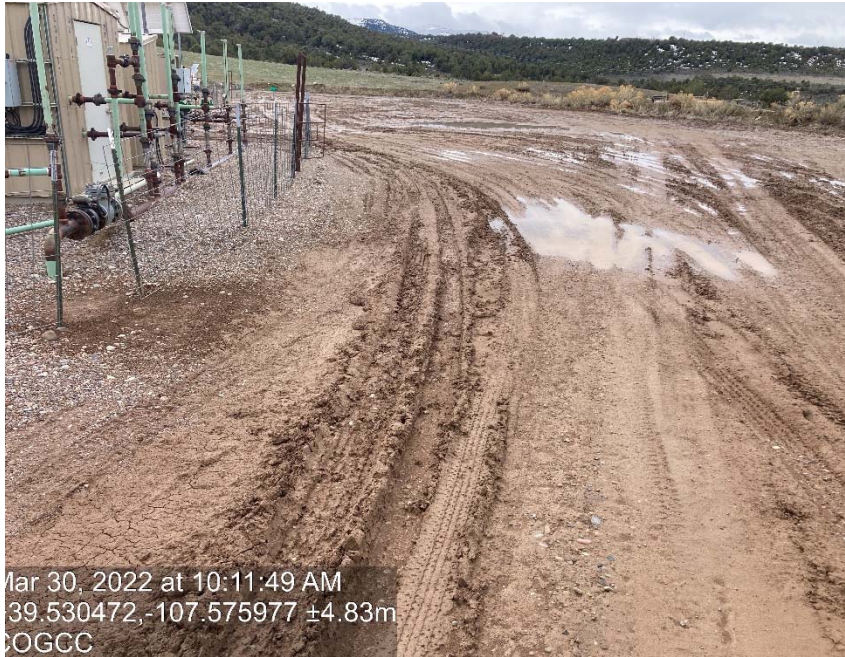
Lack of stabilization/ compaction/ degradation

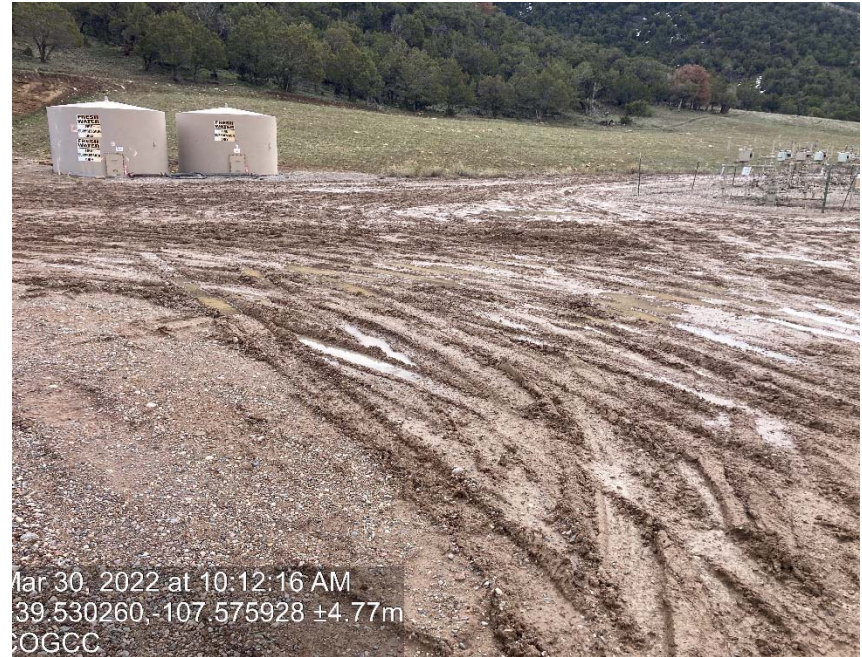
Lack of stabilization/ compaction/ degradation

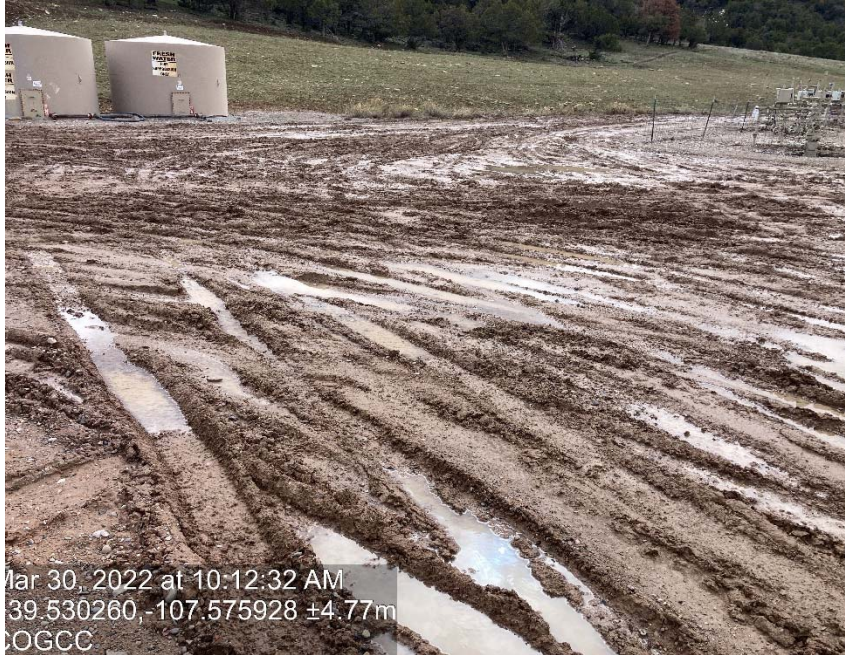
Lack of stabilization/ compaction/ degradation

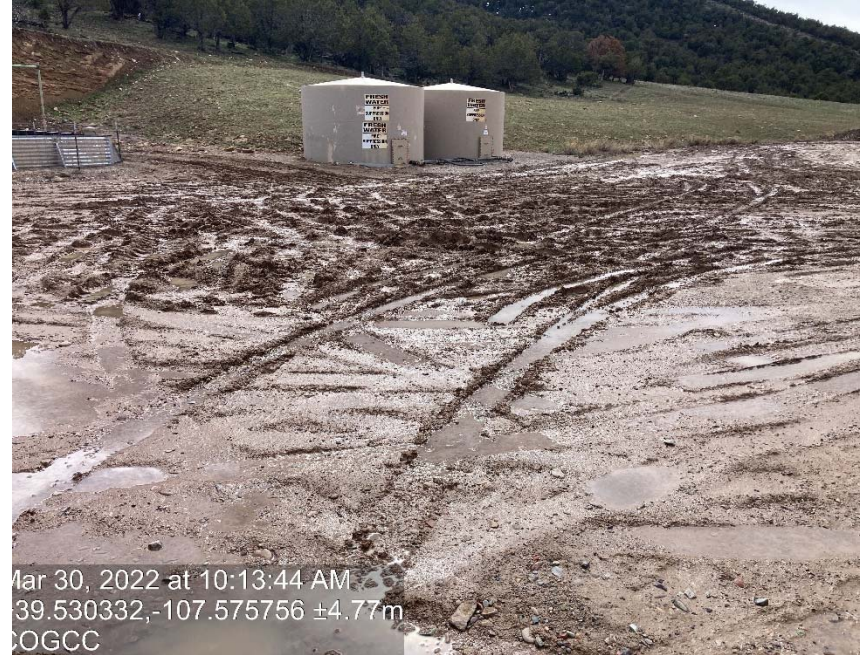
Lack of stabilization/ compaction/ degradation

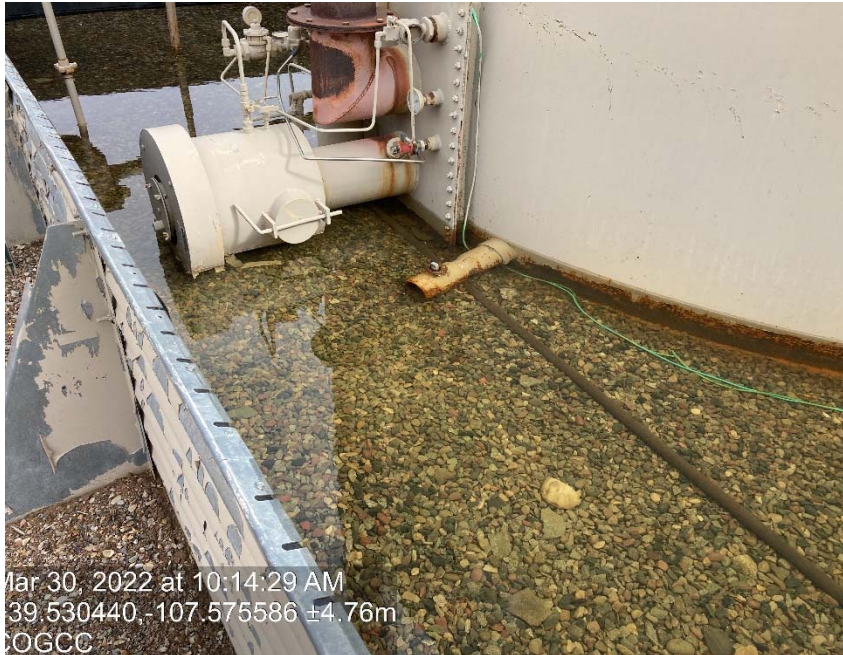
Valve missing cap/plug under water

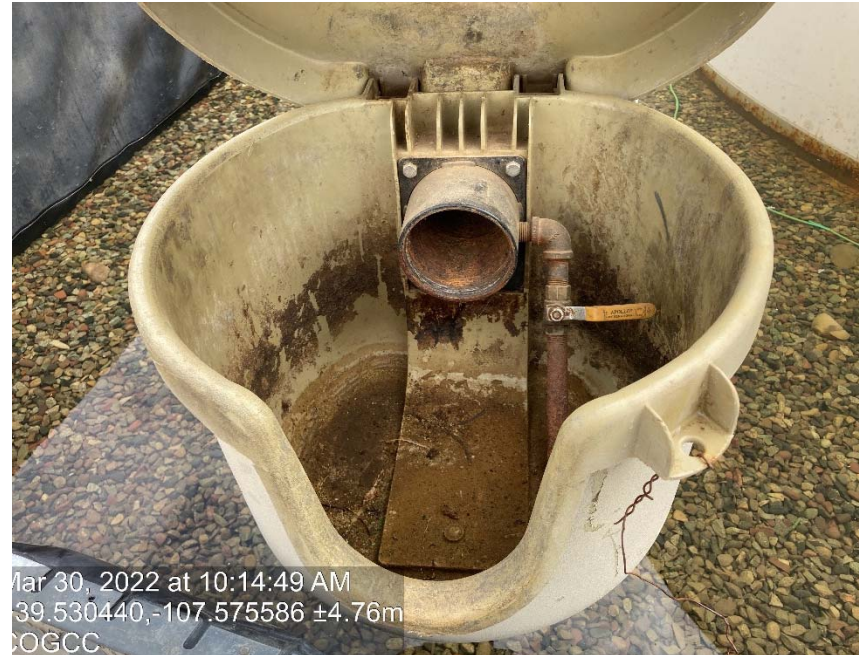
Valve missing cap/plug

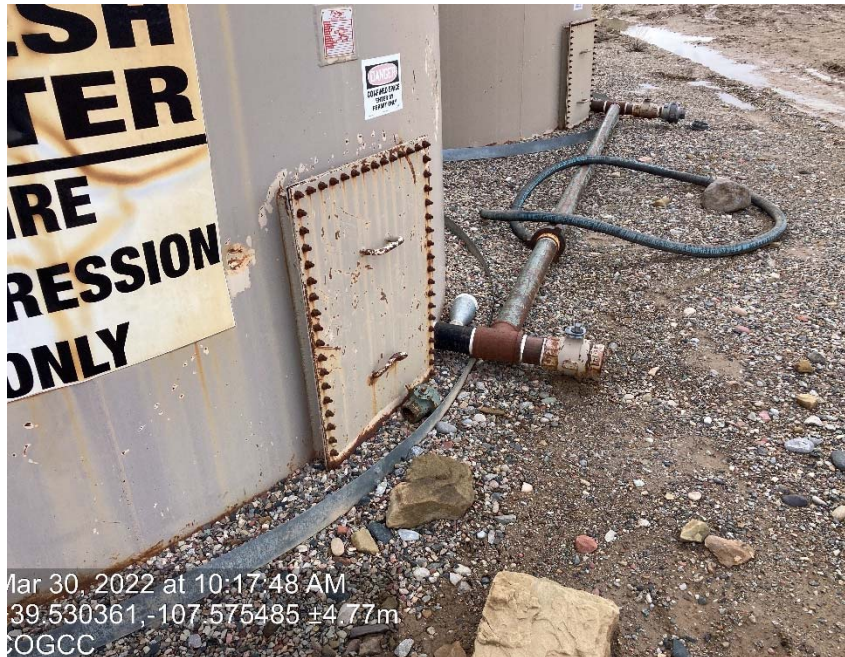
Debris

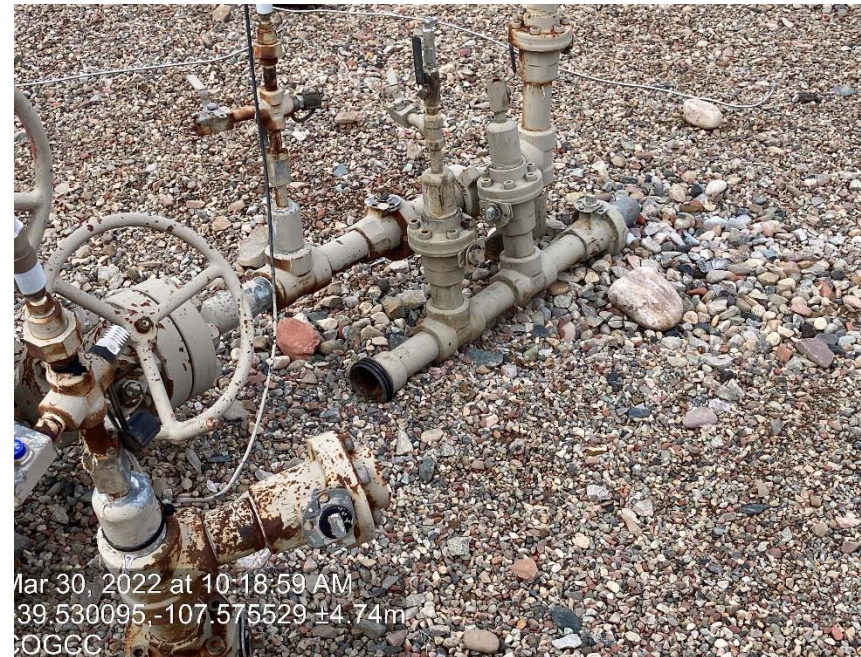
Debris

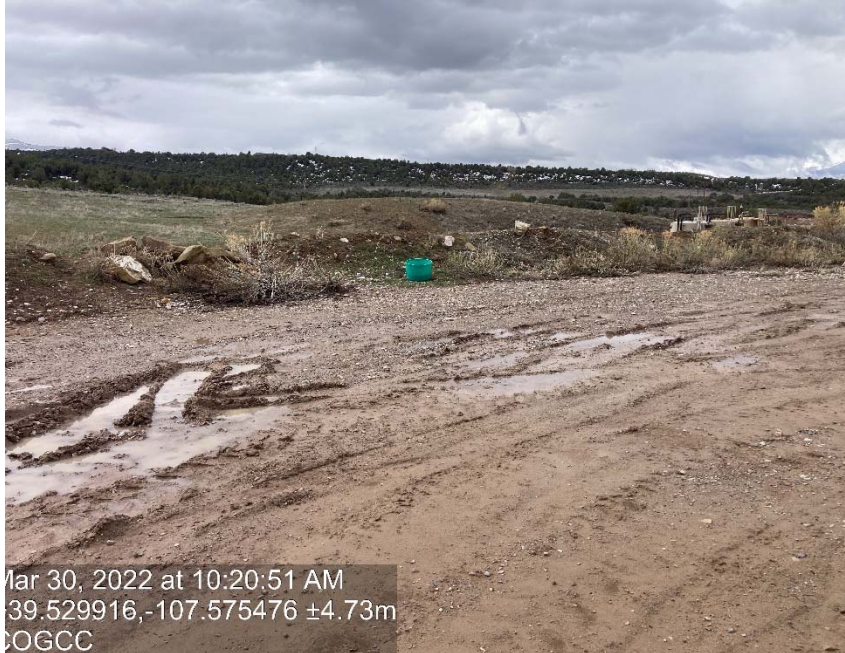
Debris

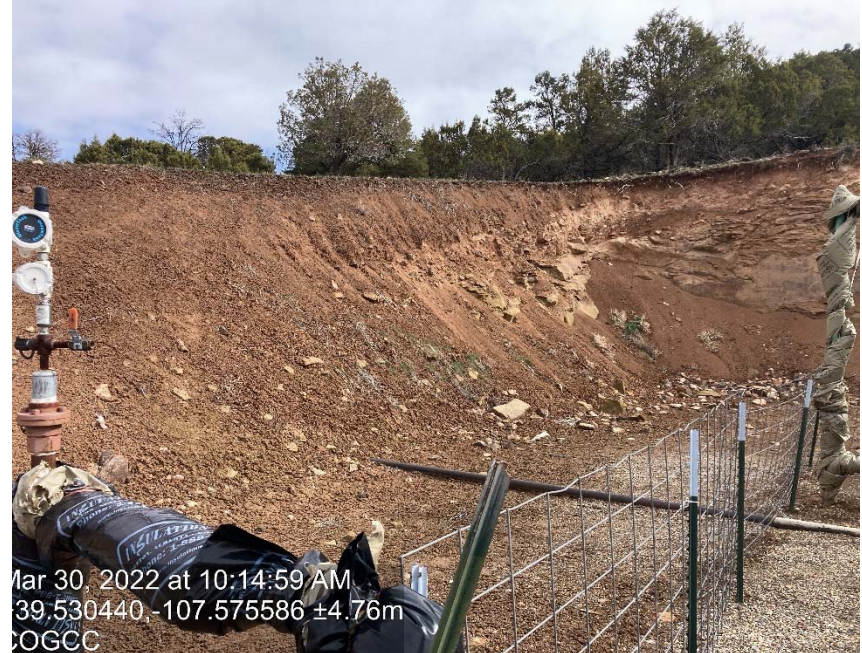
Cut slope erosion/ lack of stabilization

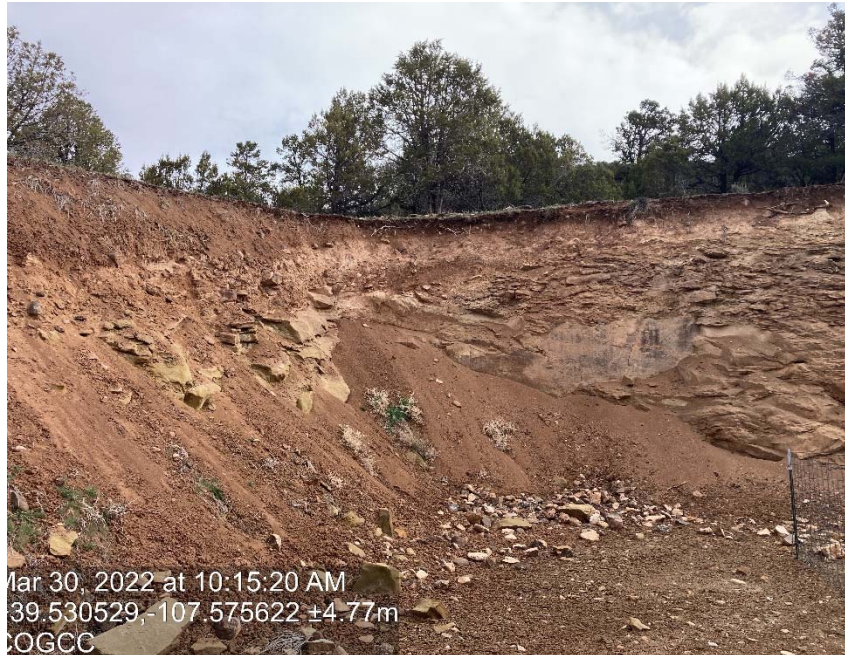
Cut slope erosion/ lack of stabilization

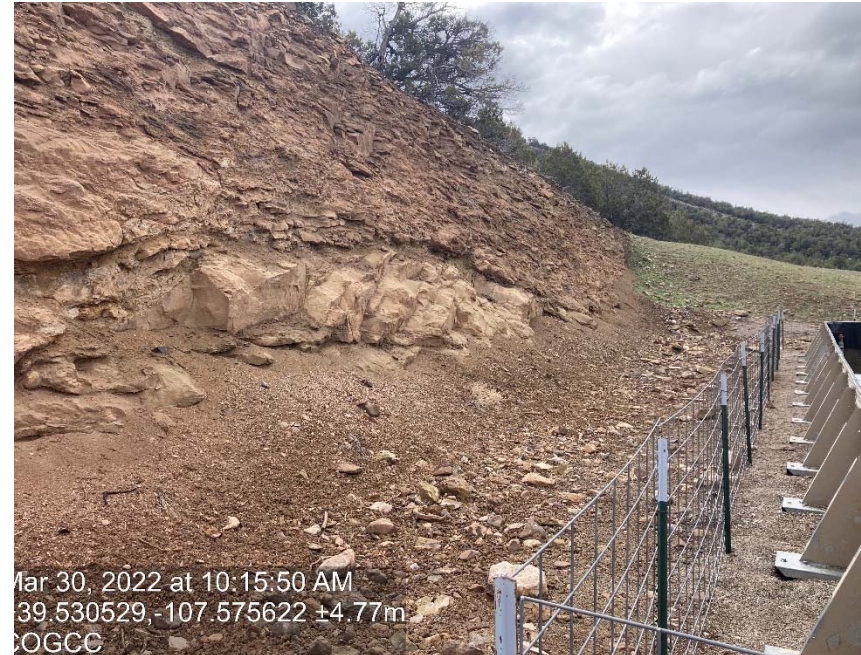
Cut slope erosion/ lack of stabilization

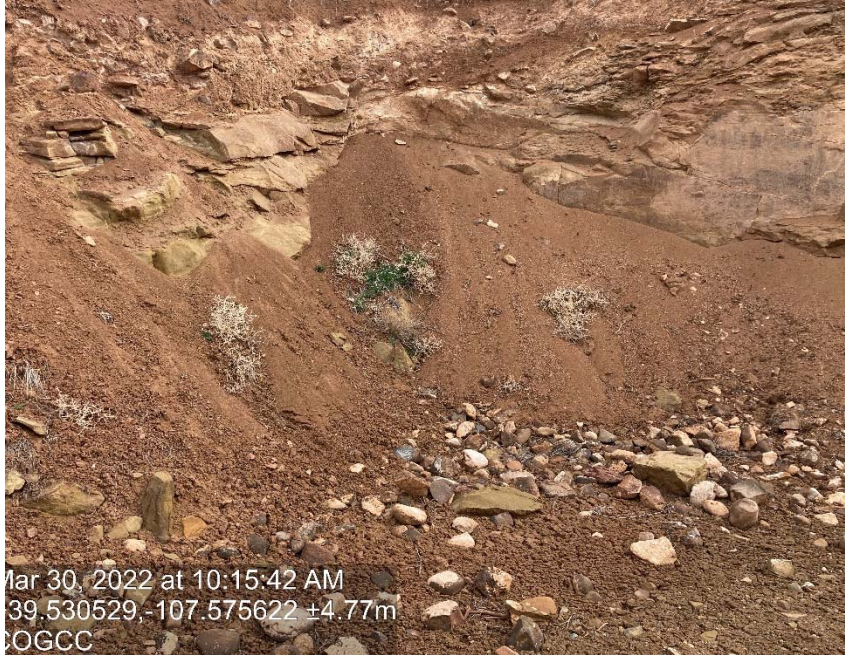
Cut slope erosion

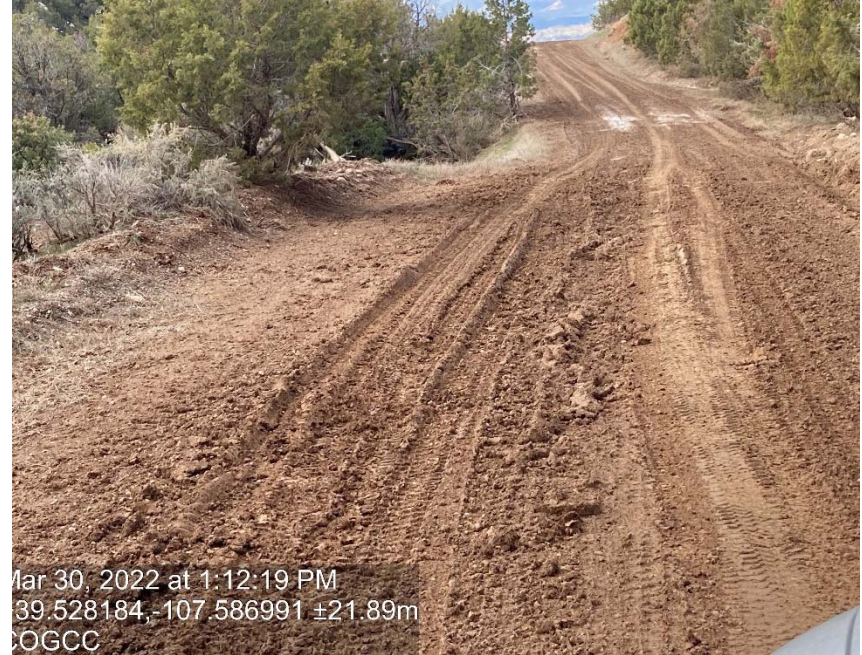
Main access road shows signs of degradation
