Inspection Photos

API: 071-06723

Operator: EVERGREEN NATURAL RESOURCES

Inspection Date: 4/4/2022

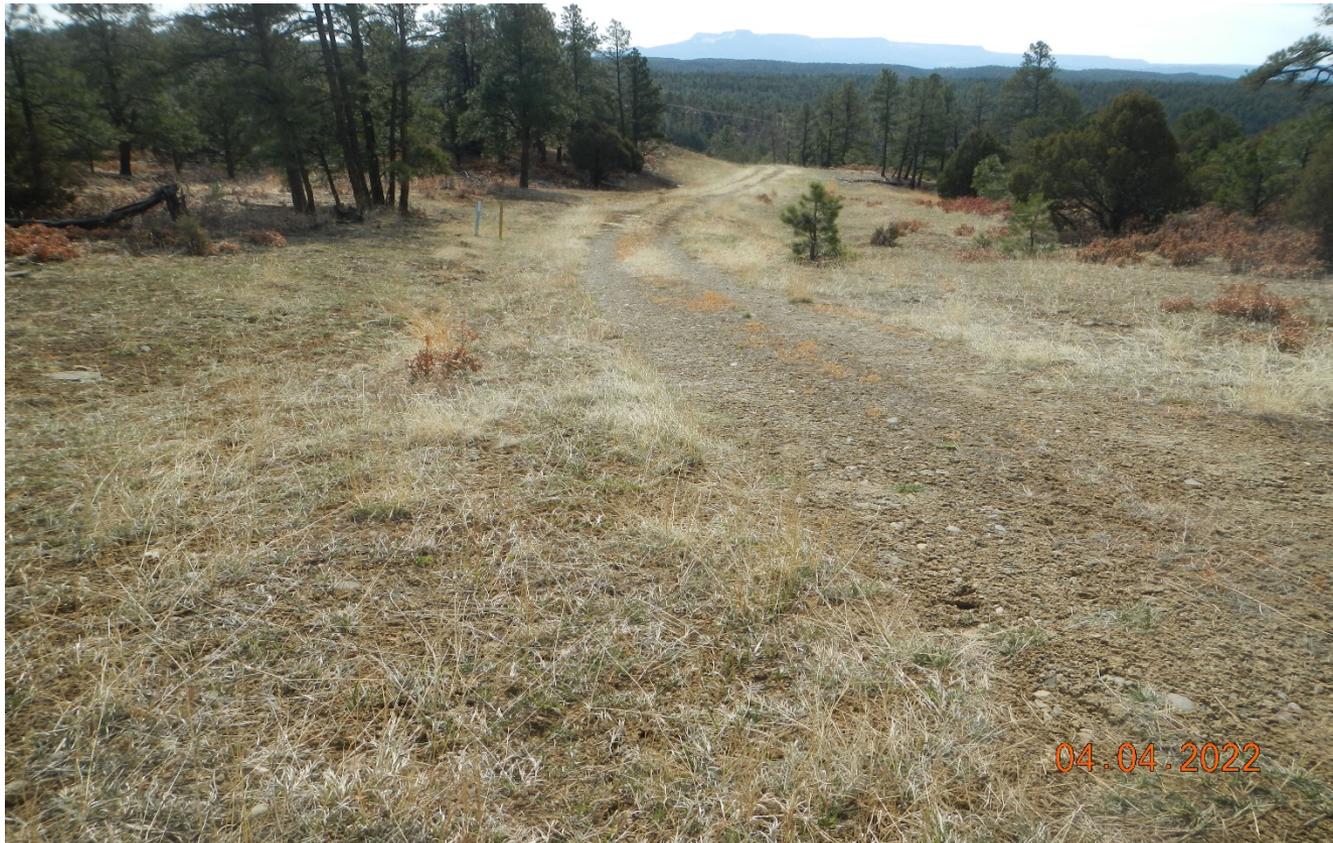
Photo 1. Facing southeast at the beginning of the access road.

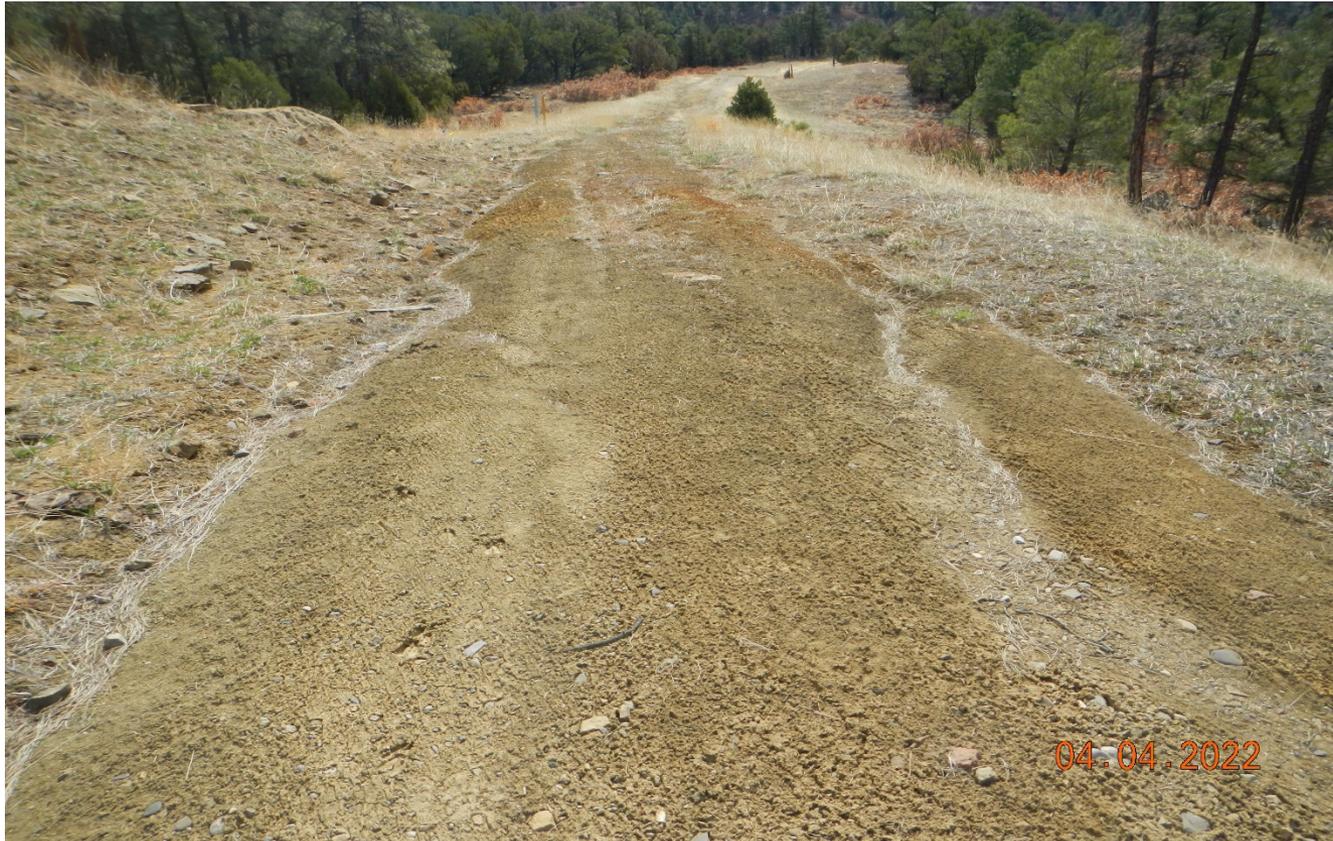
Photo 2. Facing southeast along the road. There are signs of erosion in this area of the road.

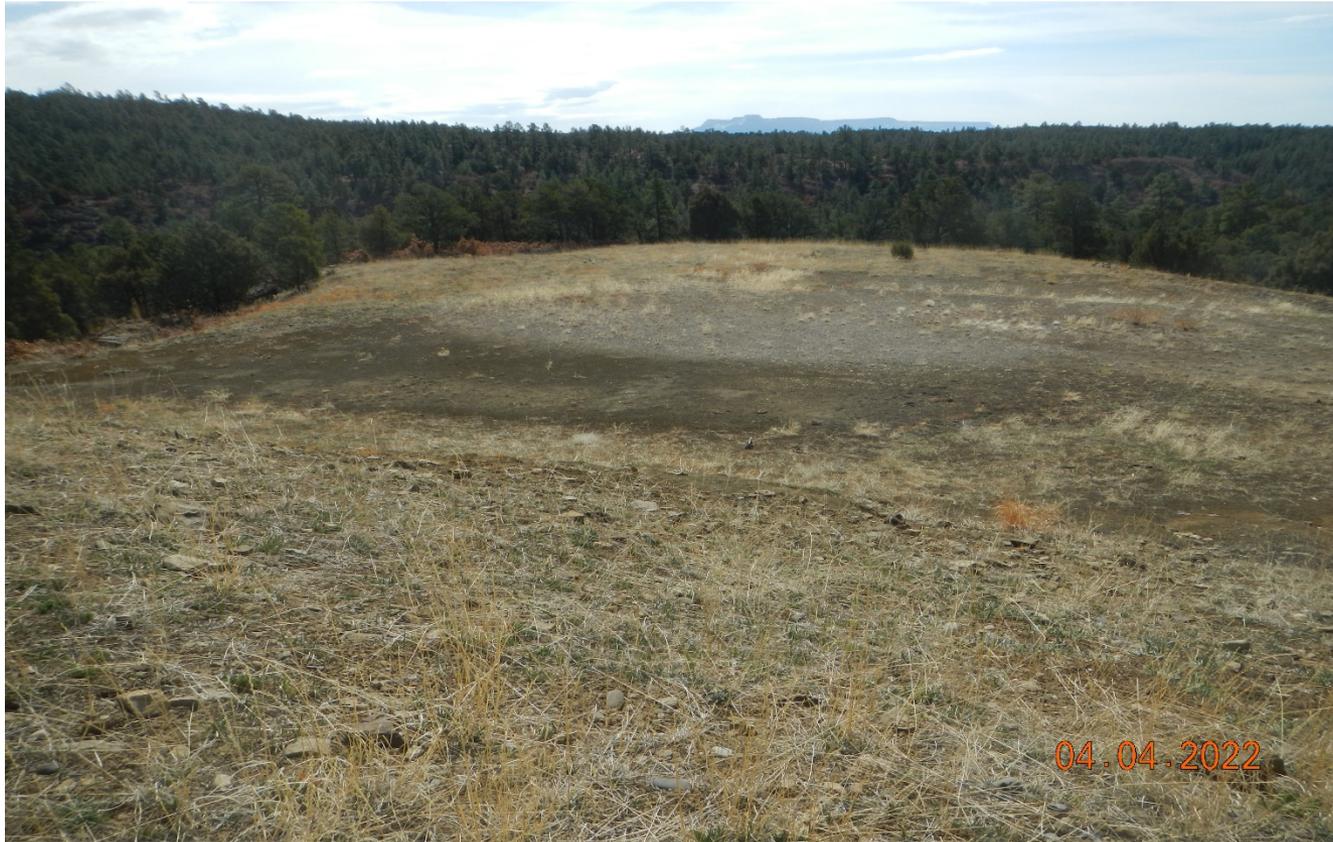
Photo 3. Facing southeast toward the location standing above the cut slope.

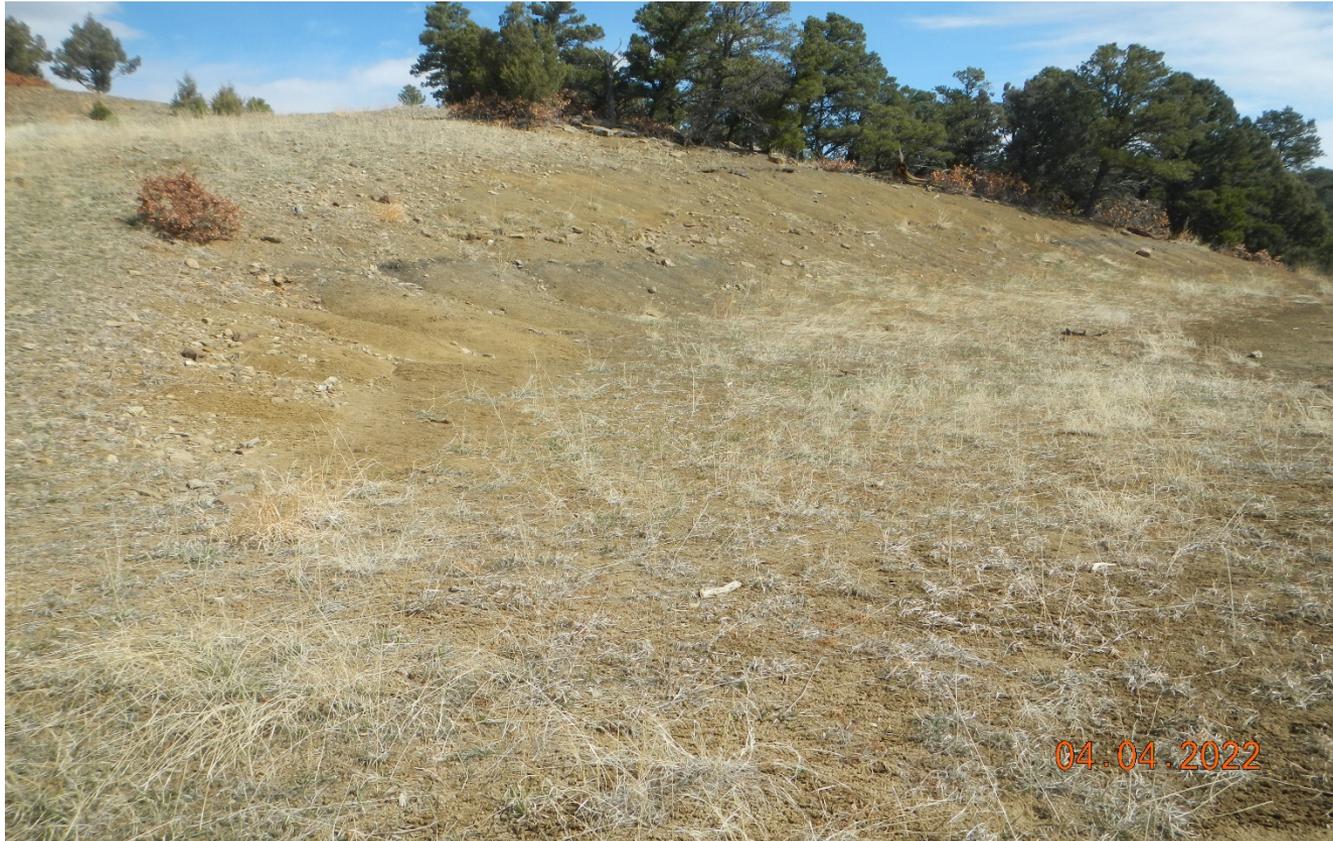
Photo 4. Facing toward the cut slope. There are signs of erosion along the cut slope which is not stabilized.

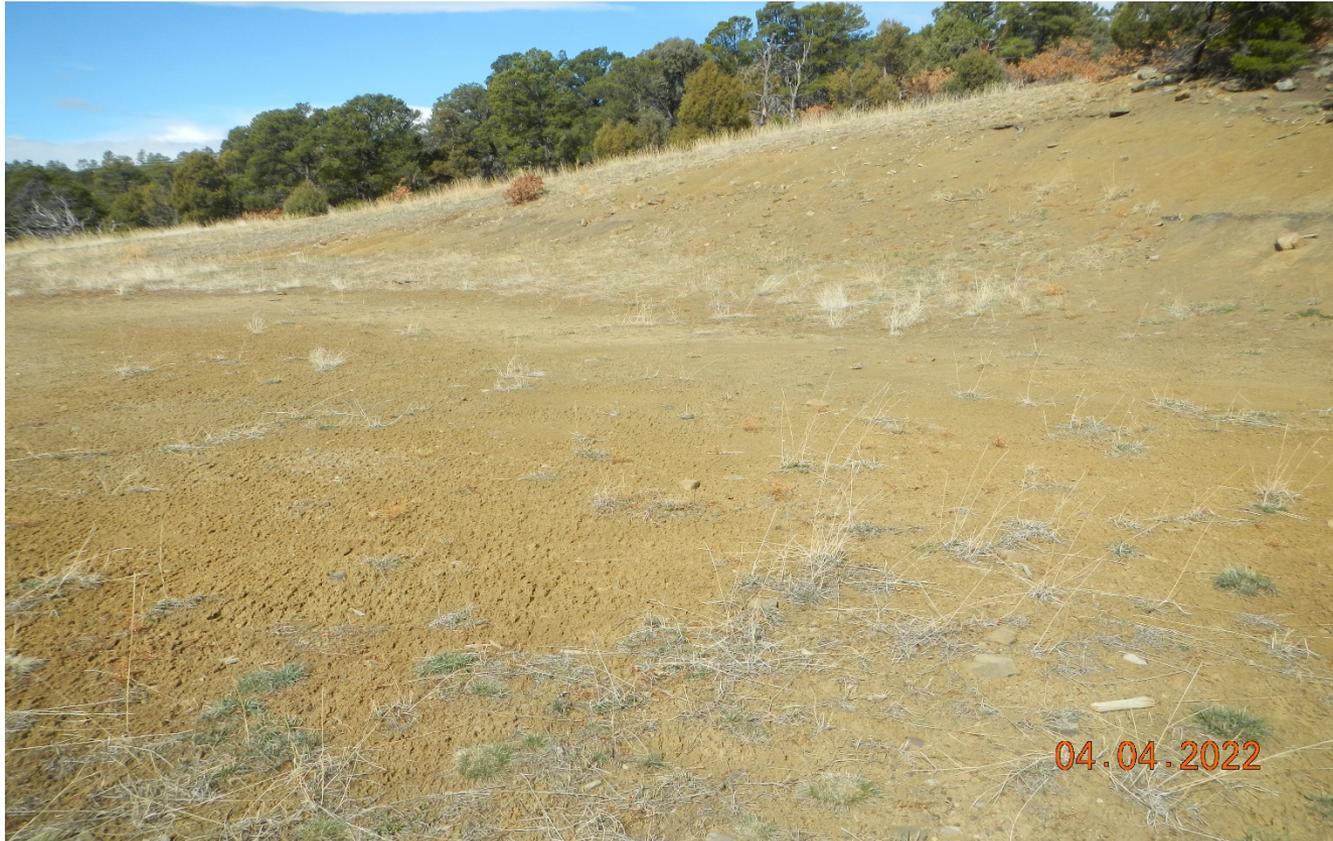
Photo 5. Facing west at the location. The location has not been recontoured and vegetation has not established in areas.

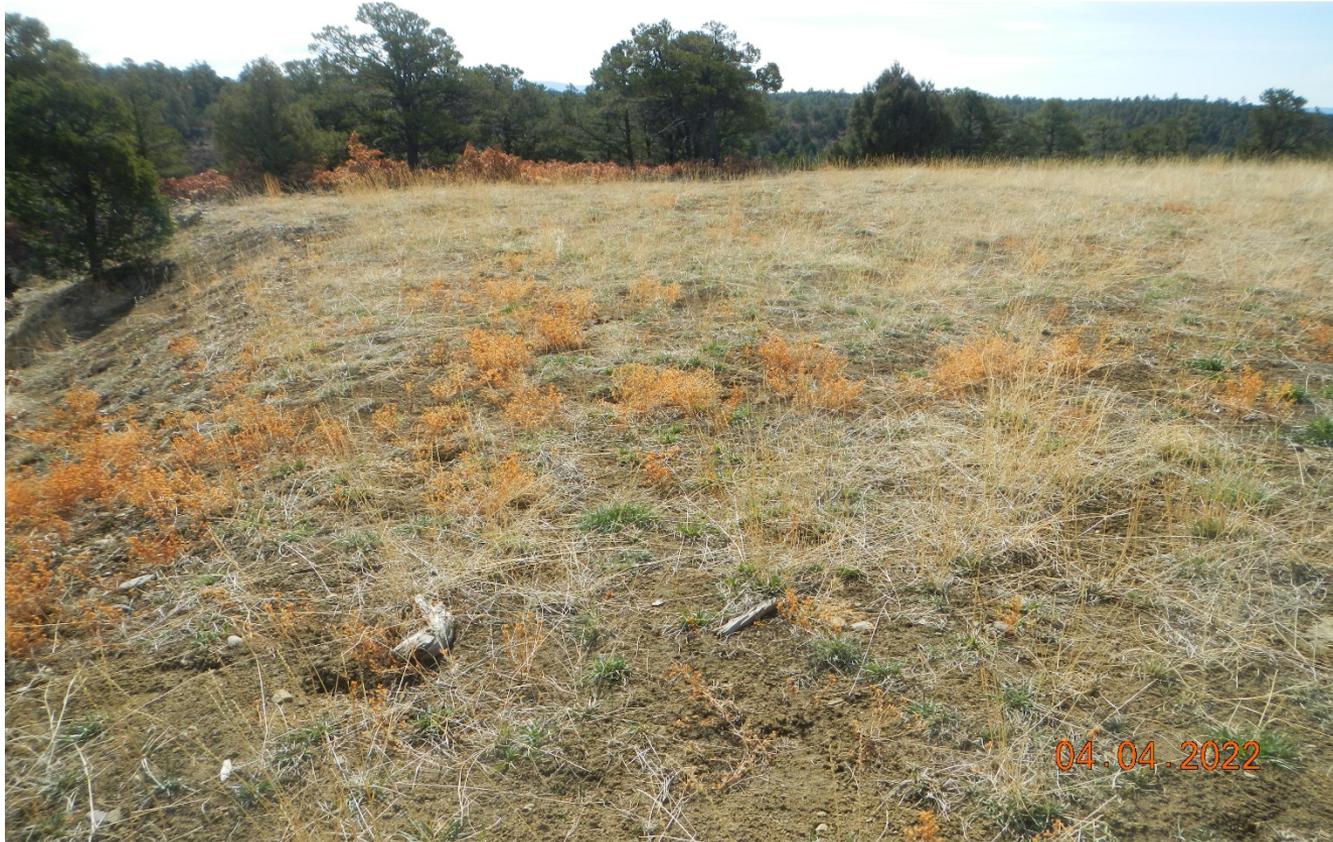
Photo 6. Facing south at the location.

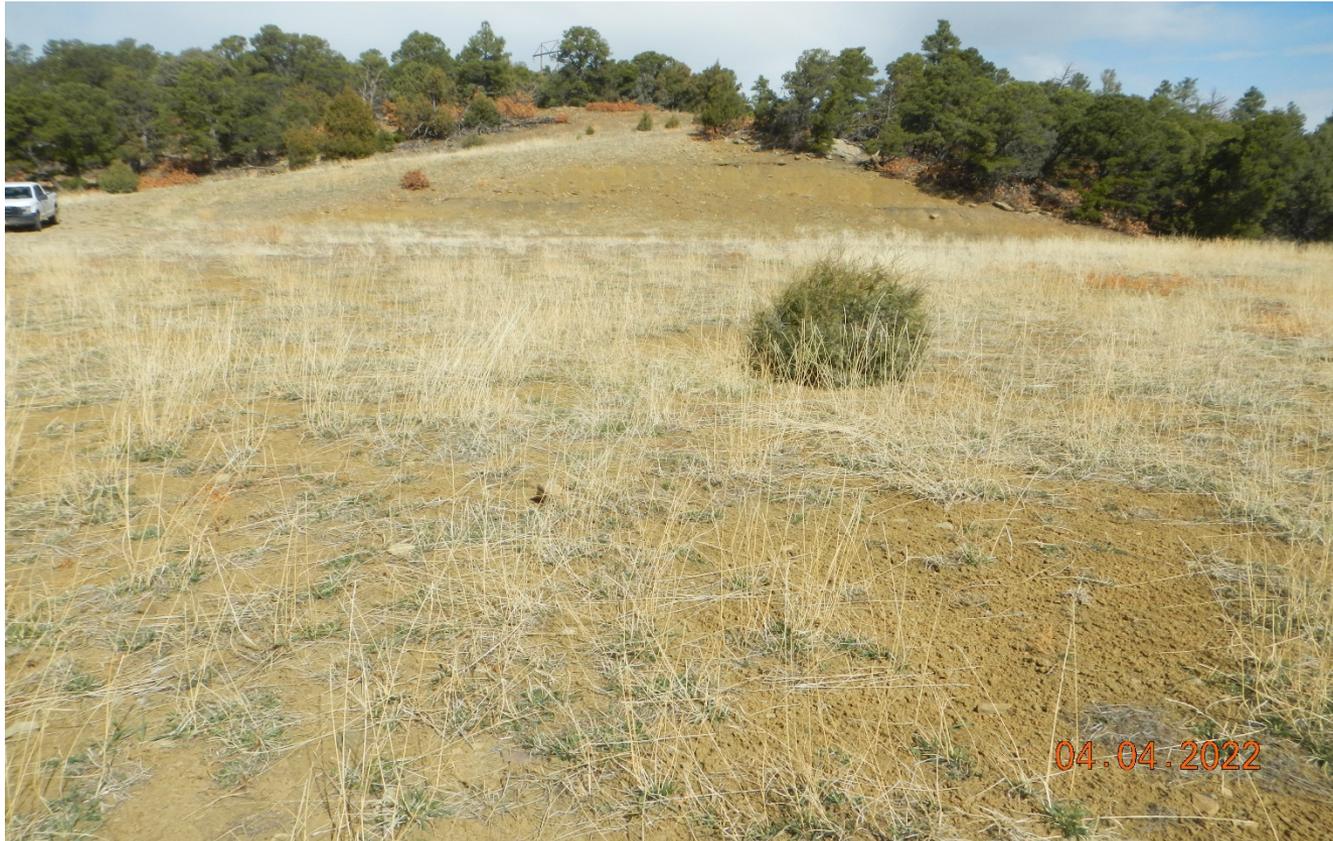
Photo 7. Facing northwest at the location.

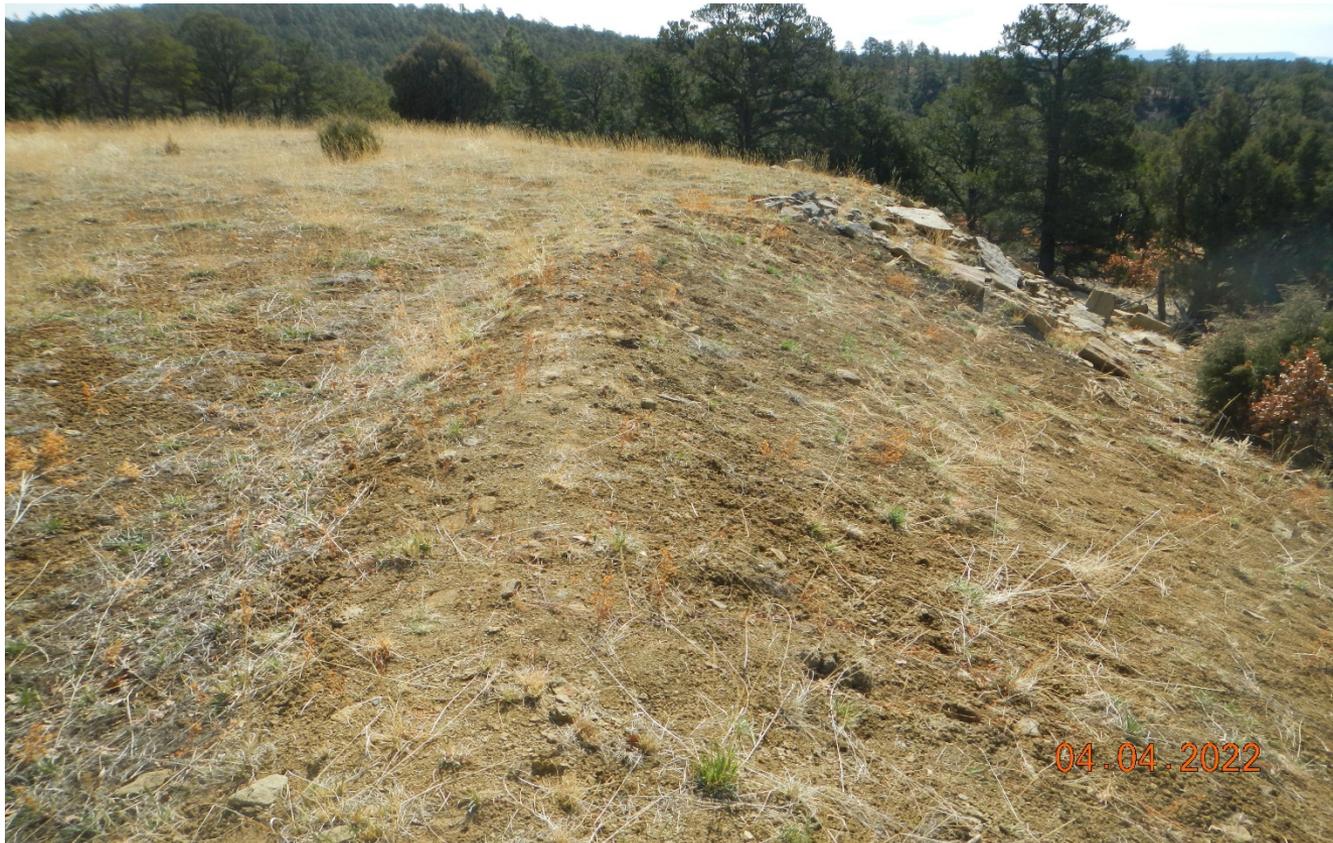
Photo 8. Facing southeast toward the fill slope.

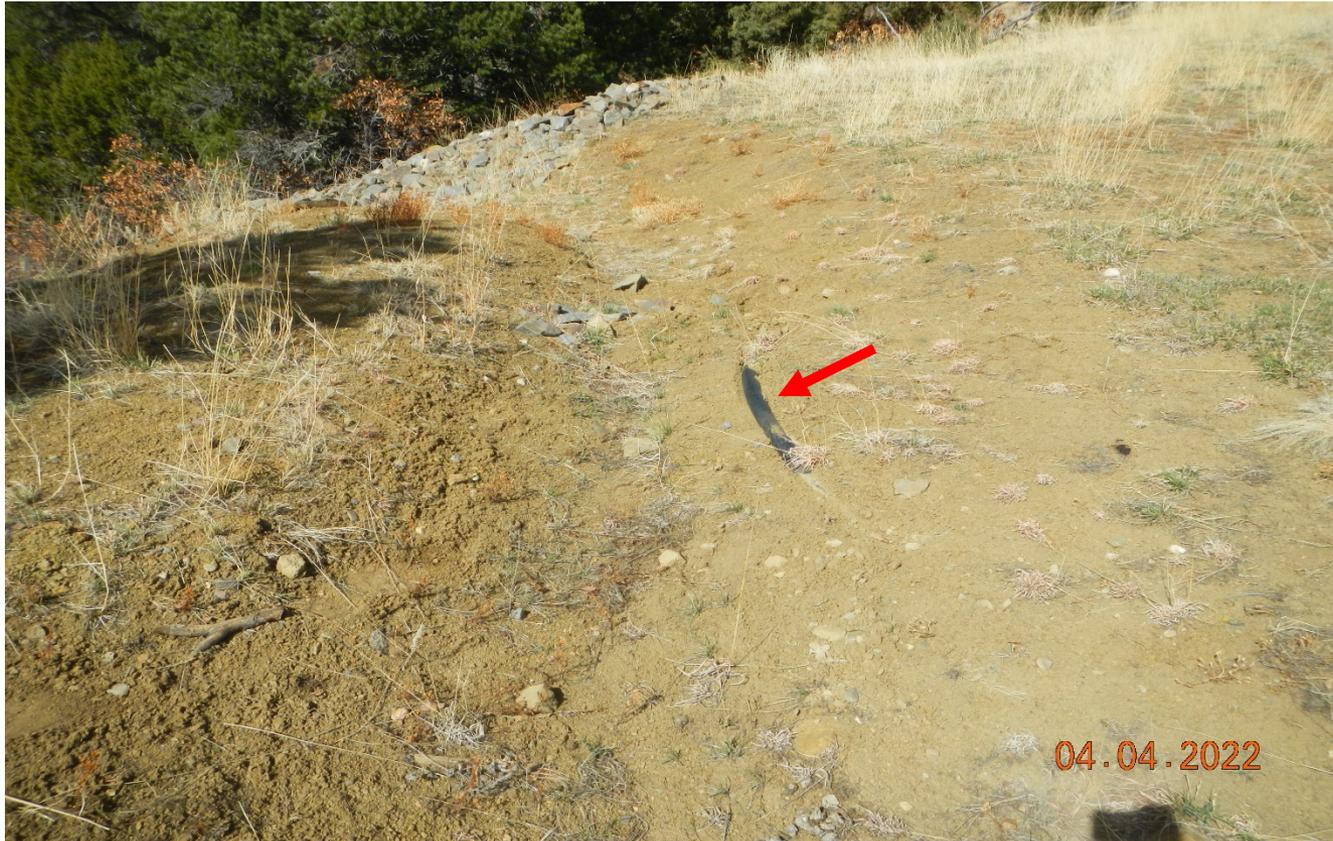
Photo 9. There is a exposed black poly line at the southwest side of the location.
