Inspection Photos
E. Stieber Consolidation
Facility IDs: 480275 & 481906

COLORADO
Oil & Gas Conservation
Commission
Department of Natural Resources

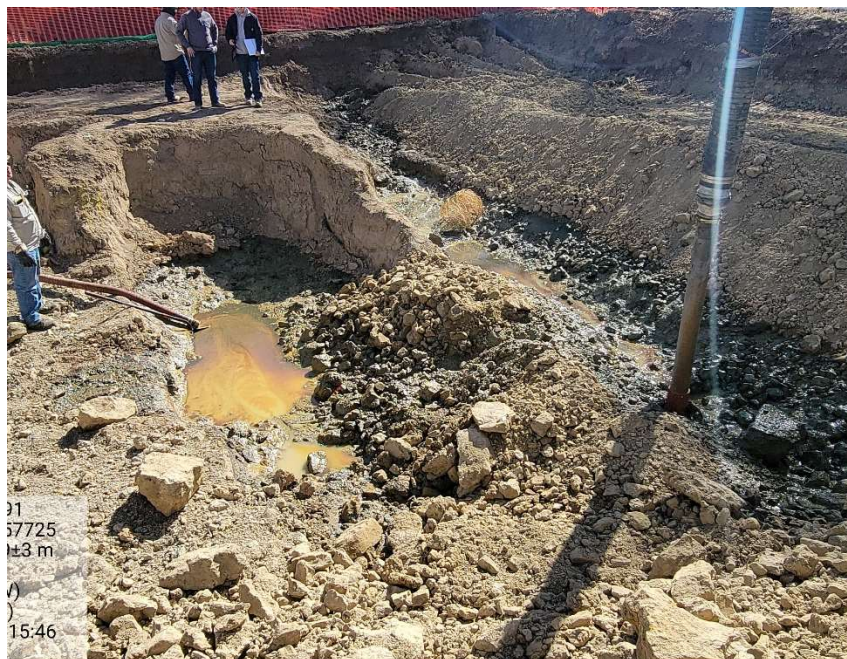
Photo 1 – April 5, 2022 – Initial spill response to new spill; liquids removal

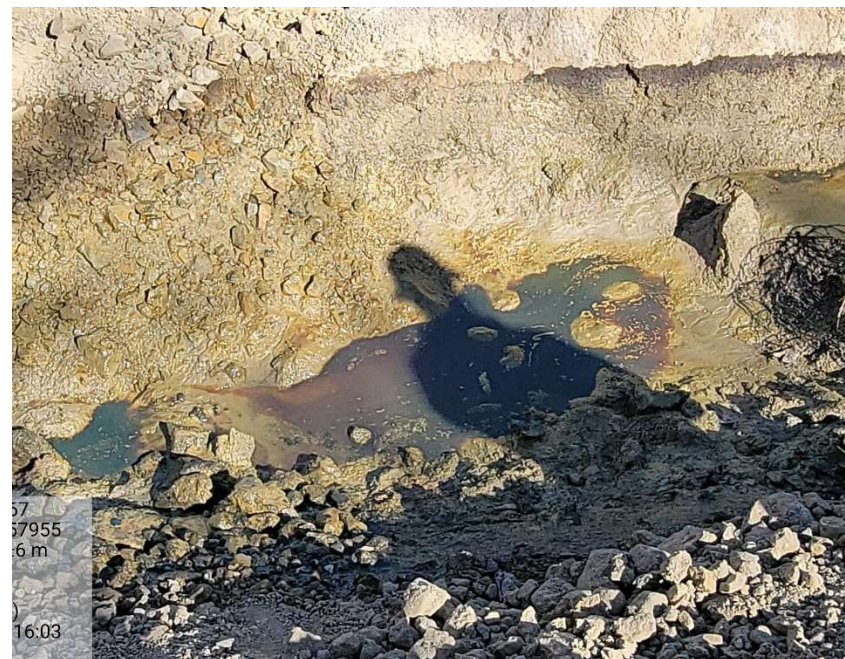
Photo 2 – April 5, 2022 – New spill

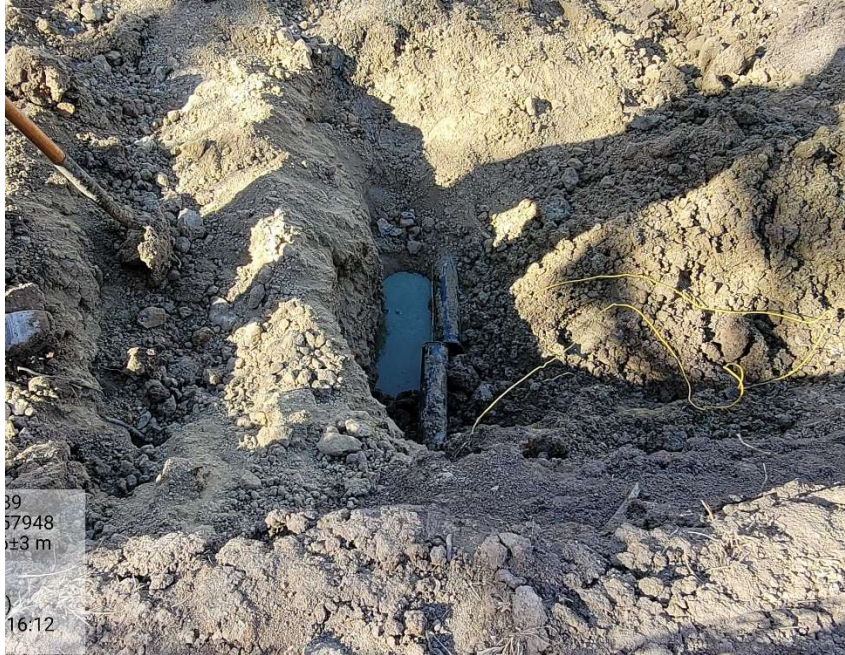
Photo 3 – April 5, 2022 – Initial spill response to new spill: Exposed damaged flowline

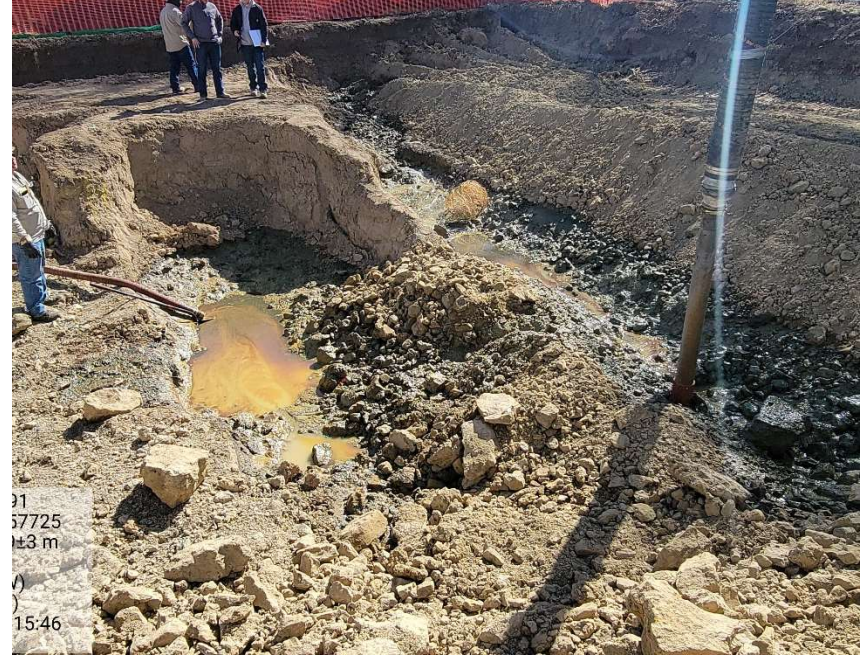
Photo 4 – April 5, 2022 – Initial spill response to new spill: Hydrovac

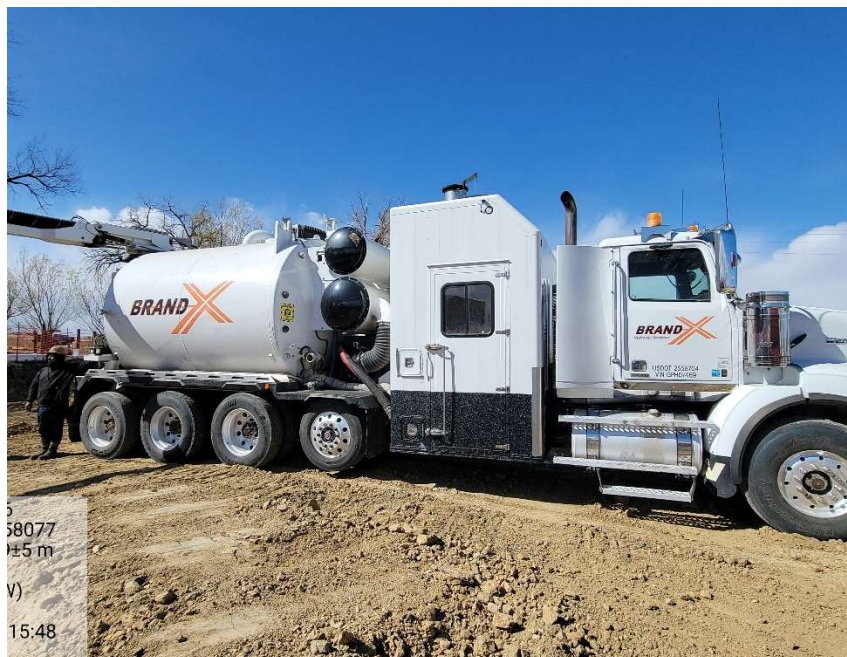
Photo 5 – April 5, 2022 – Initial spill response to new spill

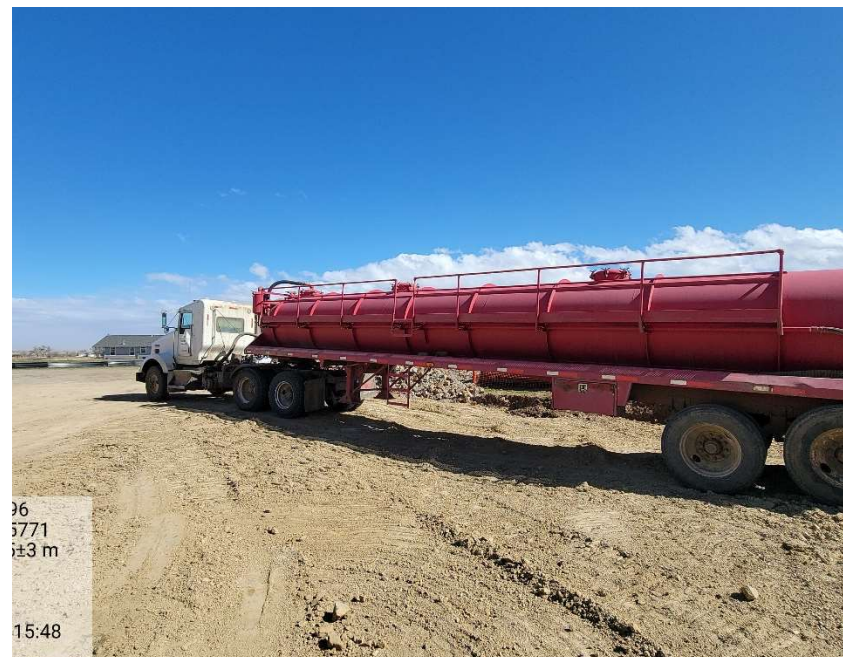
Photo 6 – April 5, 2022 – Initial spill response to new spill

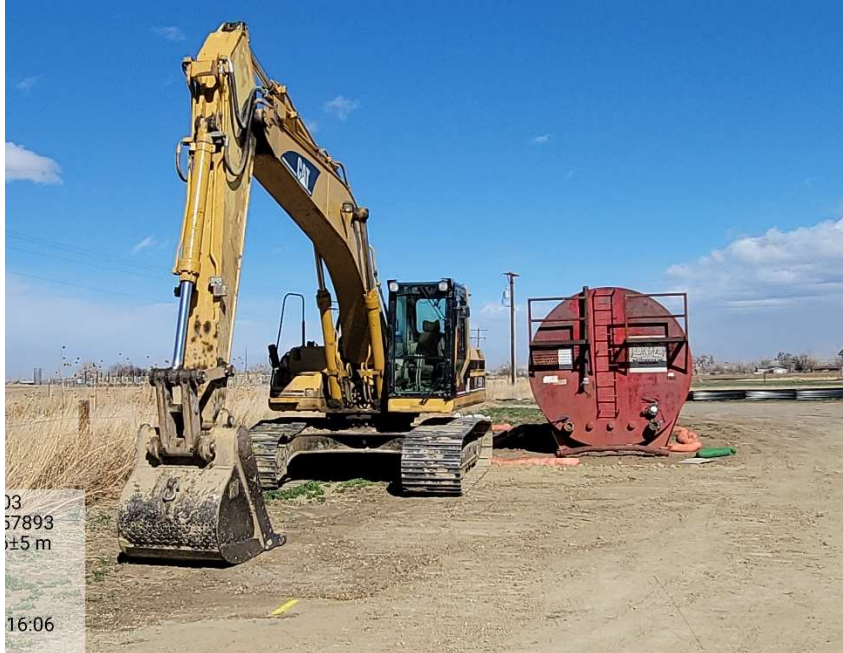
Photo 7 – April 5, 2022 – Improper installation of BMPs

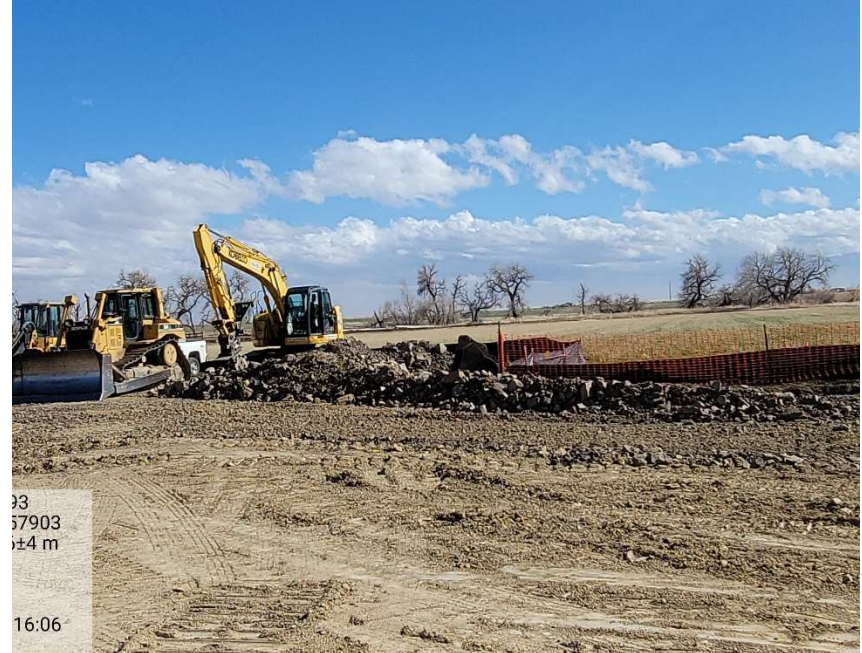
Photo 8 – April 5, 2022 – Stockpiled soil with inadequate BMPs

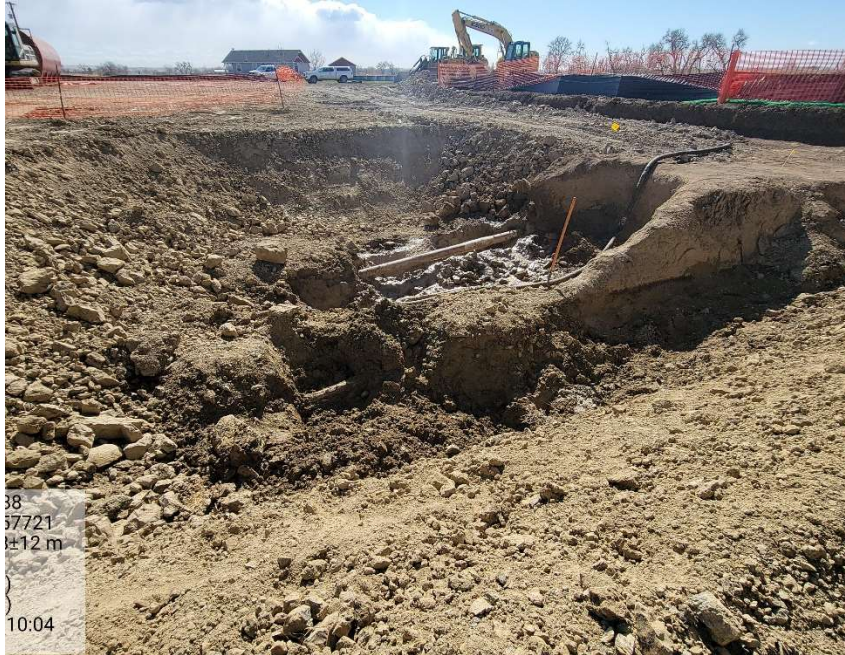
Photo 9 – April 7, 2022 – Fencing and exposed flowline

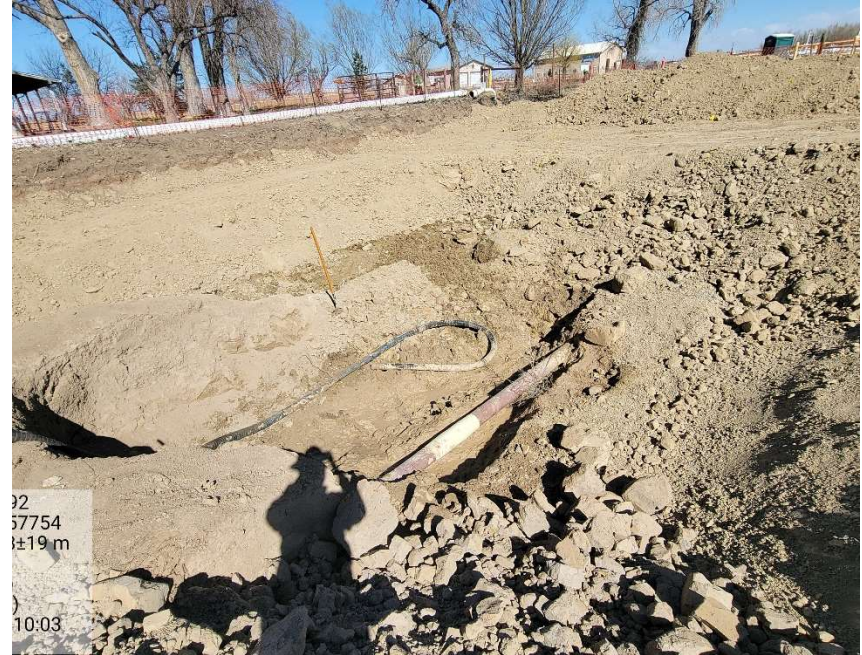
Photo 10 – April 7, 2022 – Exposed flowline
