Caerus Piceance LLC
K17E
Location # 334791

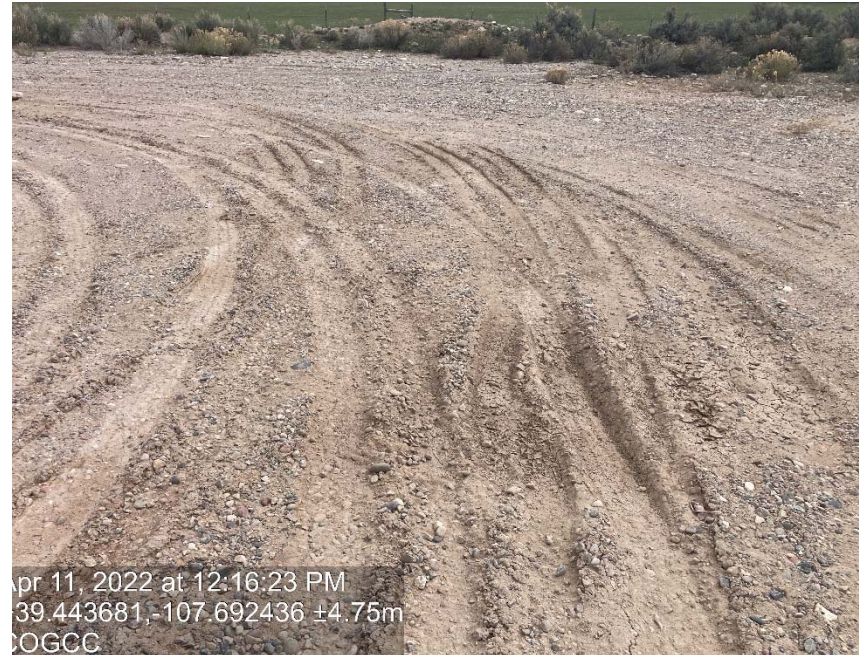
Some areas of lack of stabilization/compaction

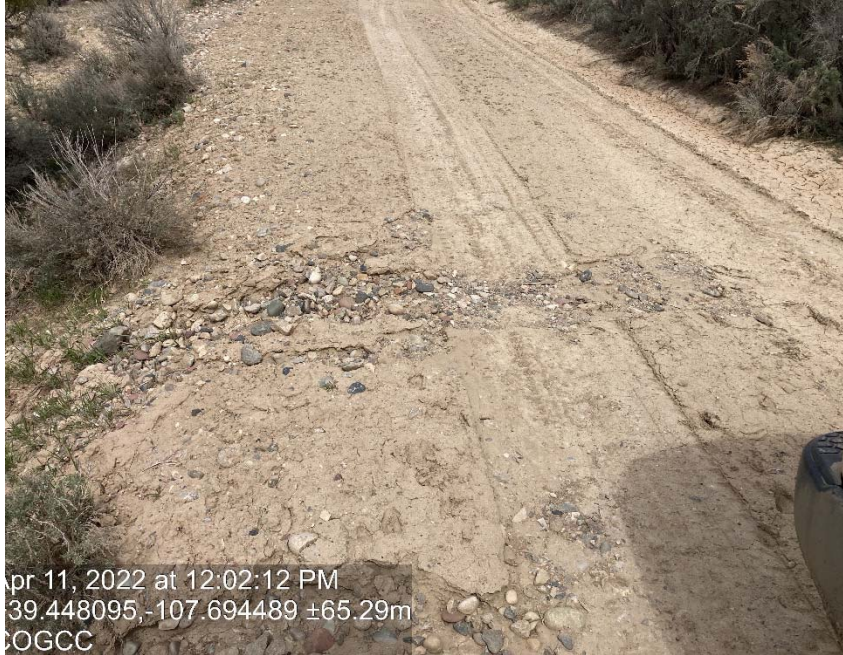
Erosion

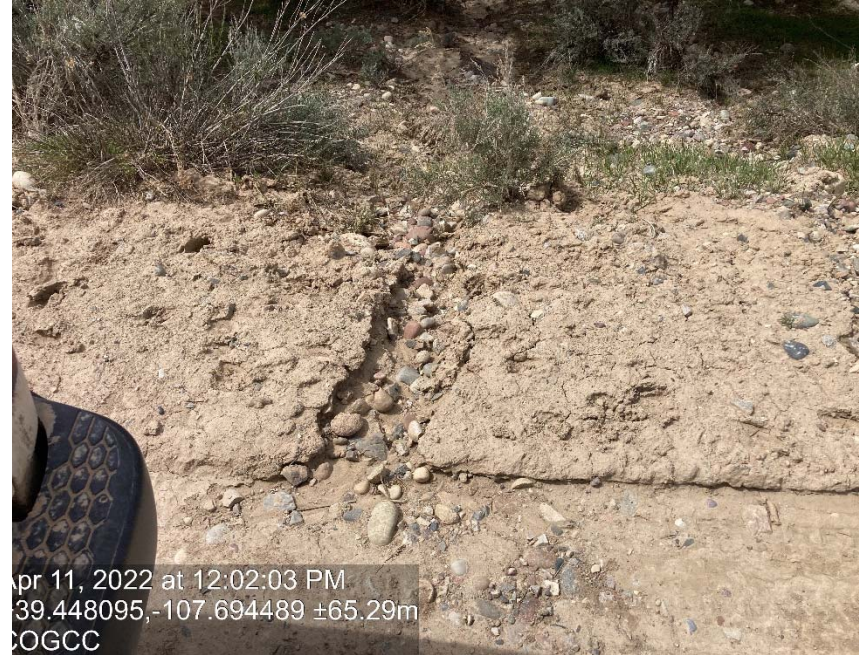
Erosion

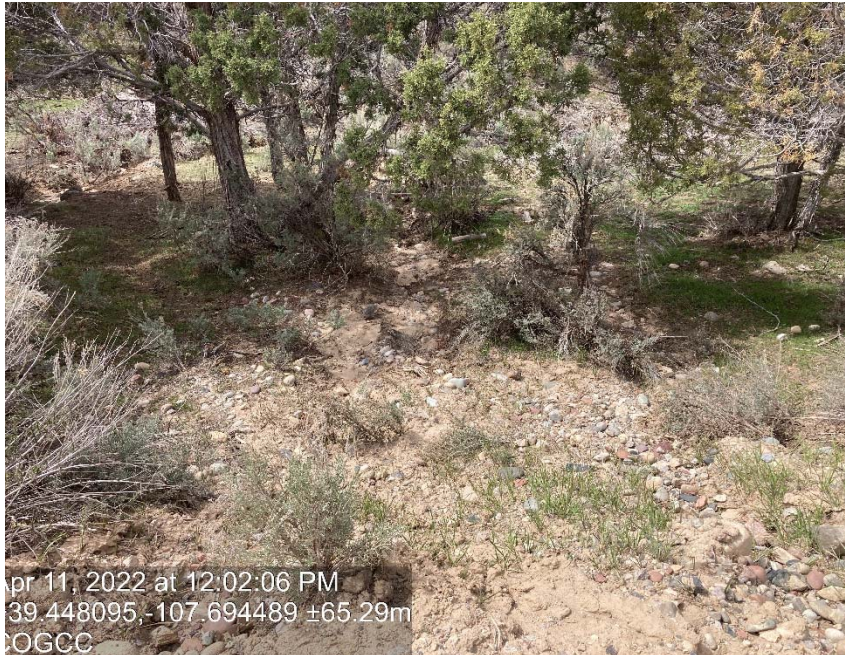
Sediment migration

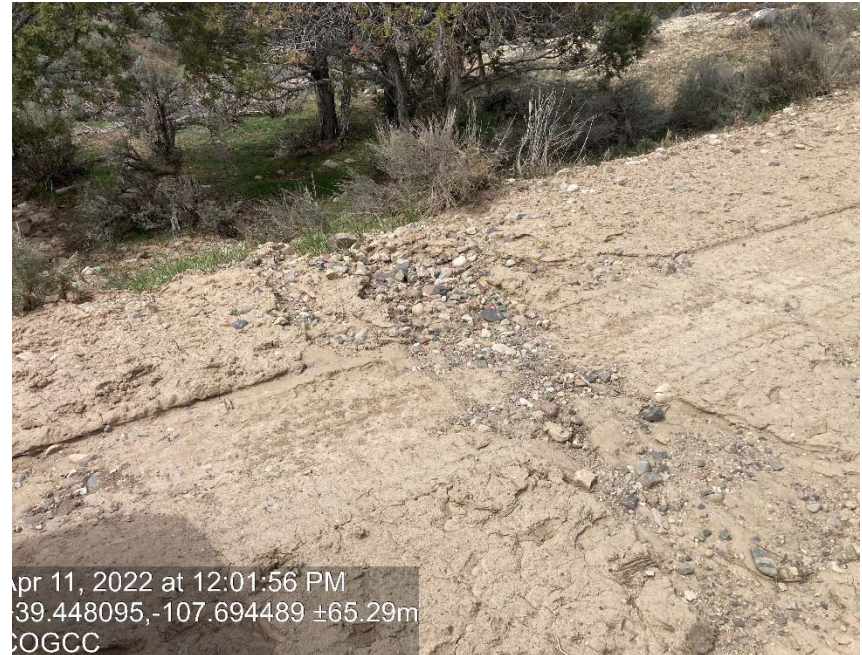
Erosion

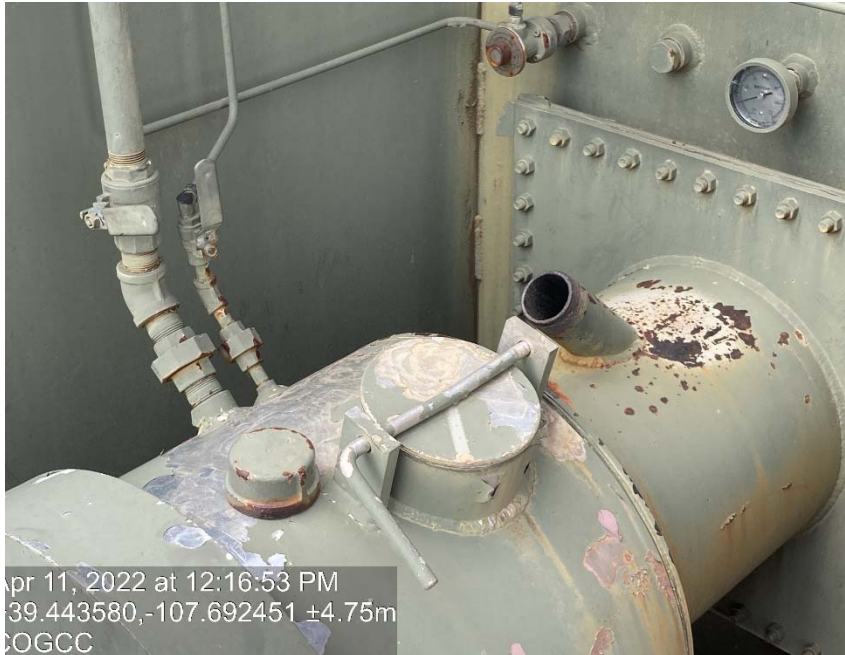
Cap on burner not installed and burner is running

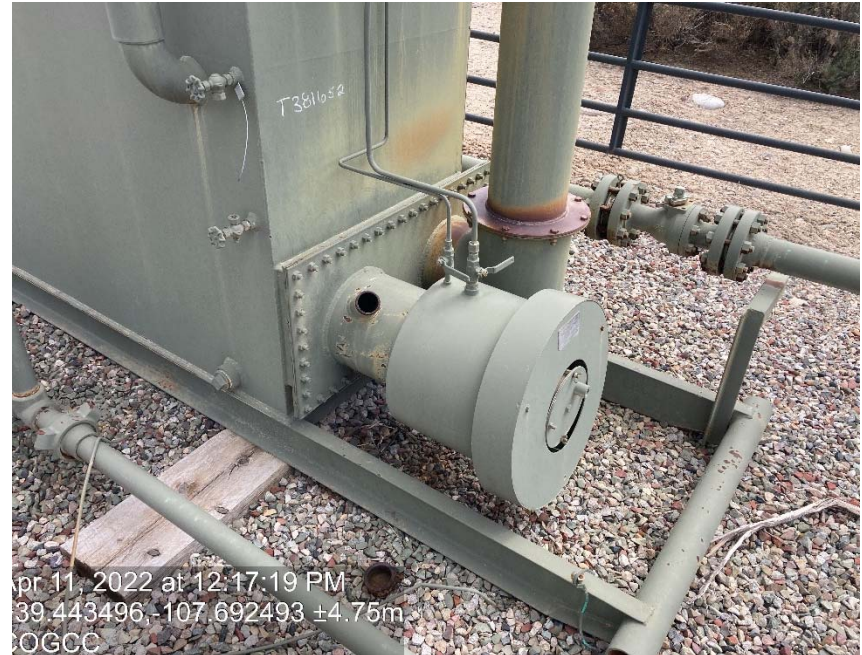
Cap on burner not installed, burner is not running.
