TEP
Overacker 20-13B
Location # 335139

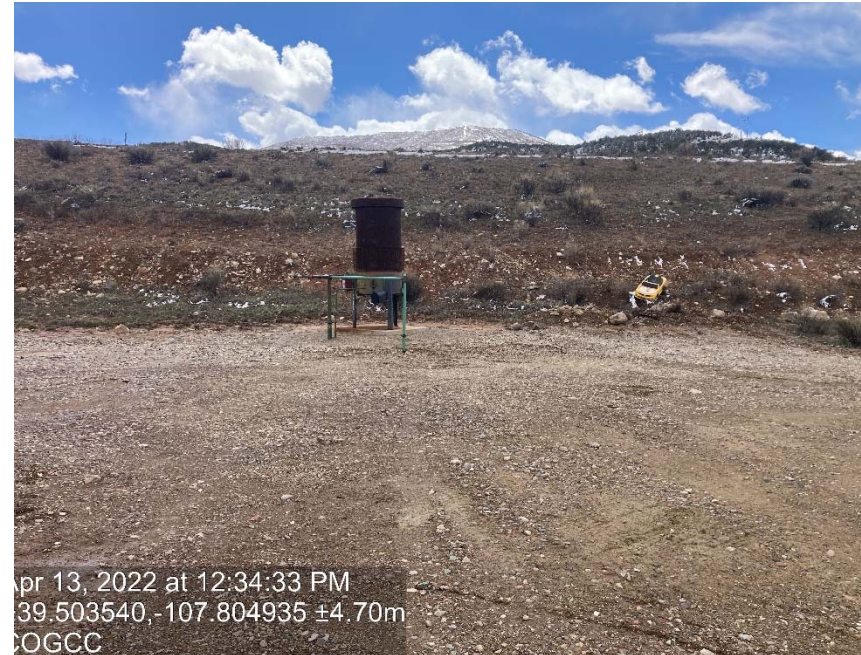
location and debris

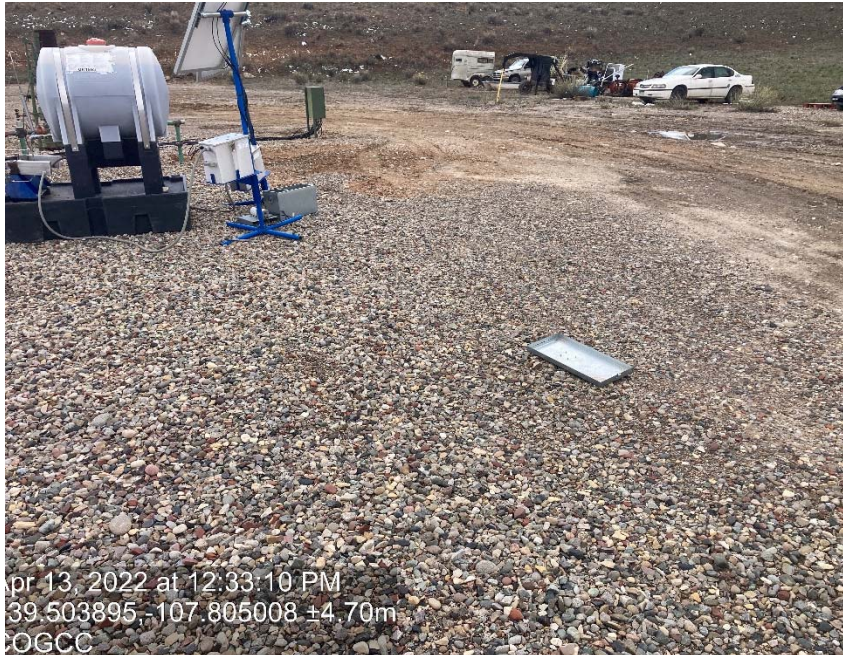
Stored vehicles/ trailers and debris

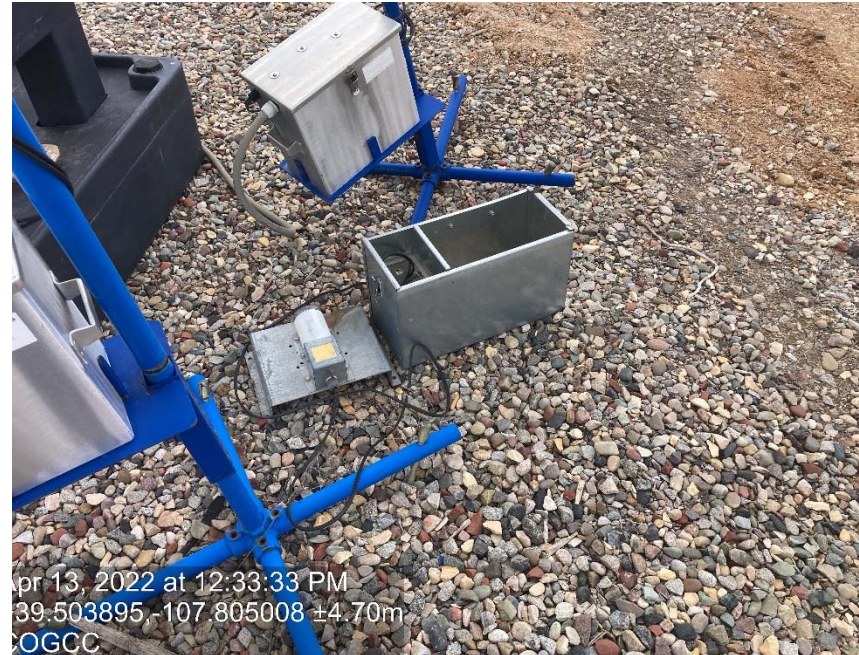
Debris

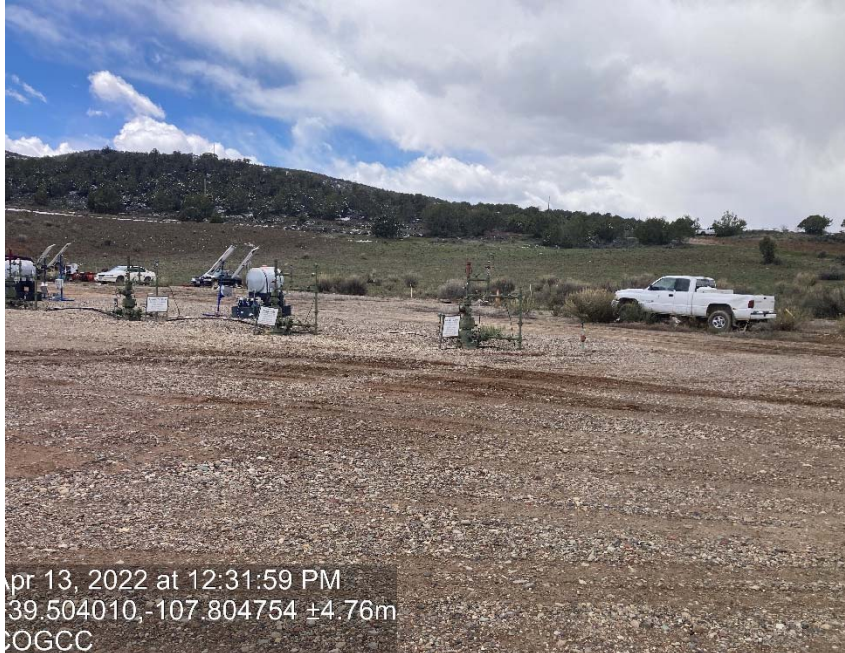
Stored vehicles/ trailers

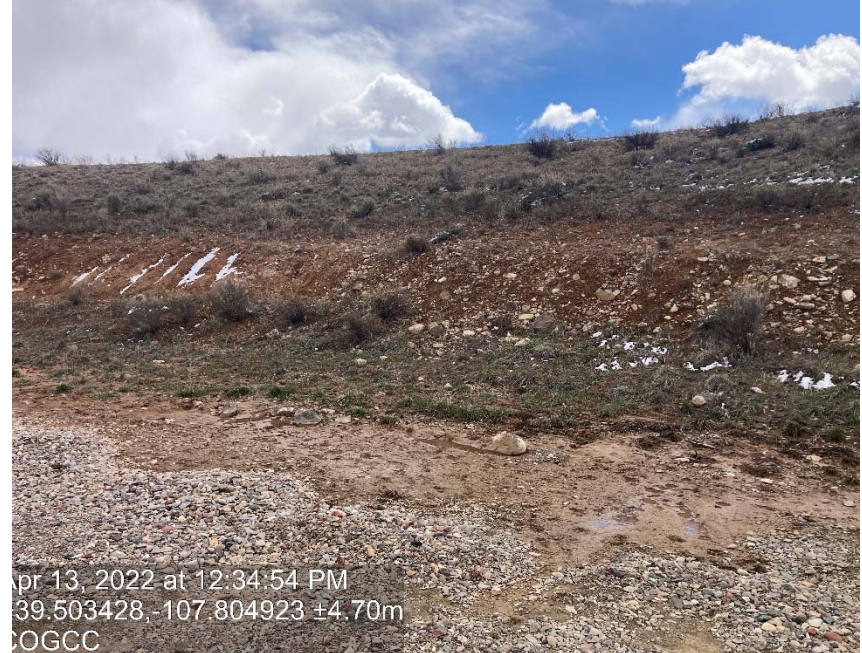
**Cut slope shows signs of lack of stabilization/
erosion**

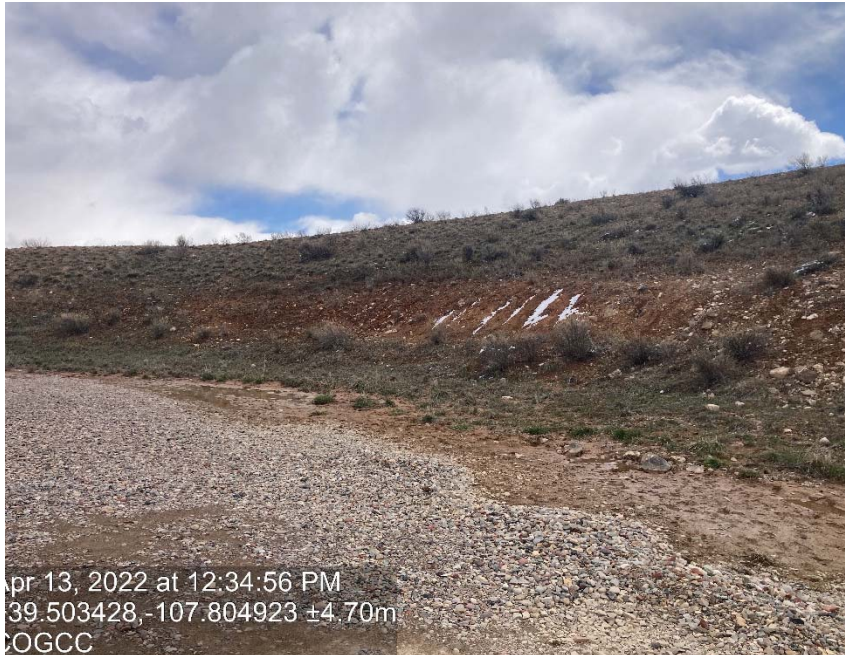
**Cut slope shows signs of lack of stabilization/
erosion**

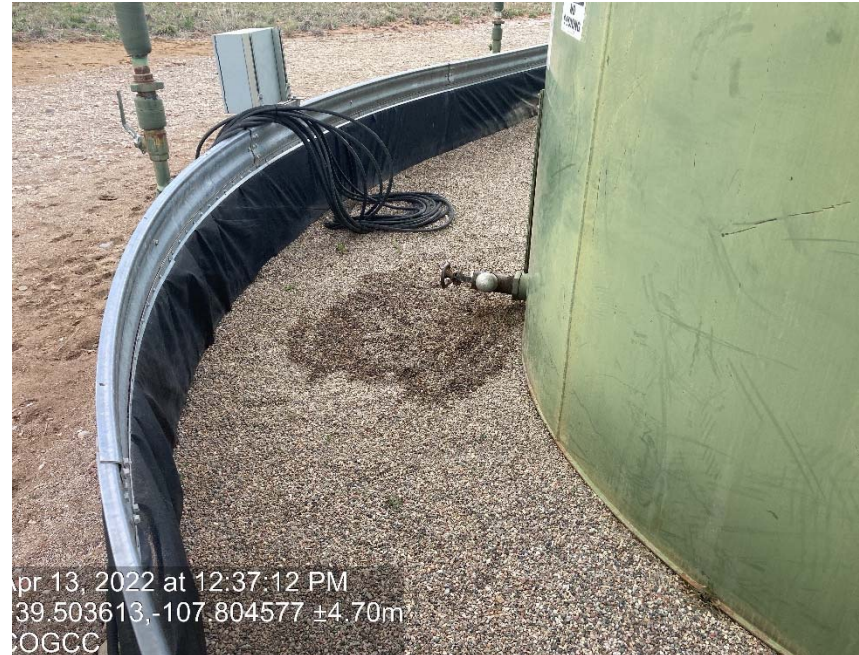
Staining

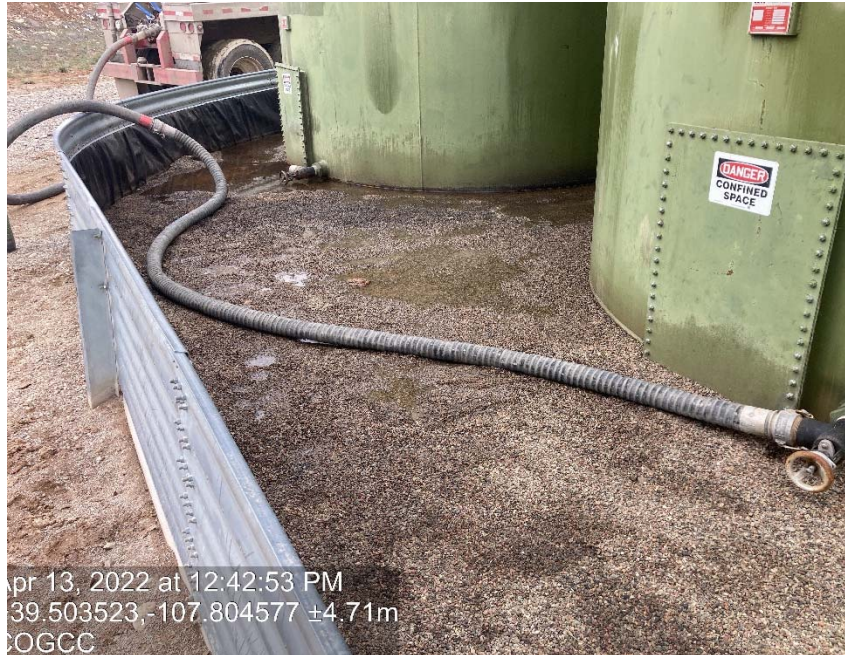
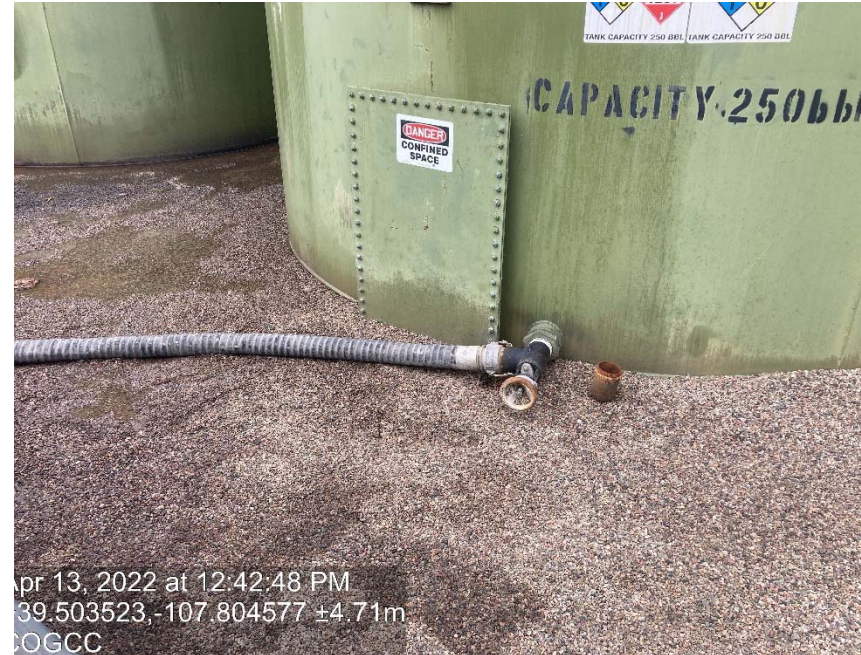
Truck loading fluids from valve on tank. Operator considers this valve is NOT used as a line to load trucks with fluid. Truck was actively loading fluid at time of inspection.
