Inspection Photos
Operator: Simcoe
API: 067-07787
Date: 4/8/2022

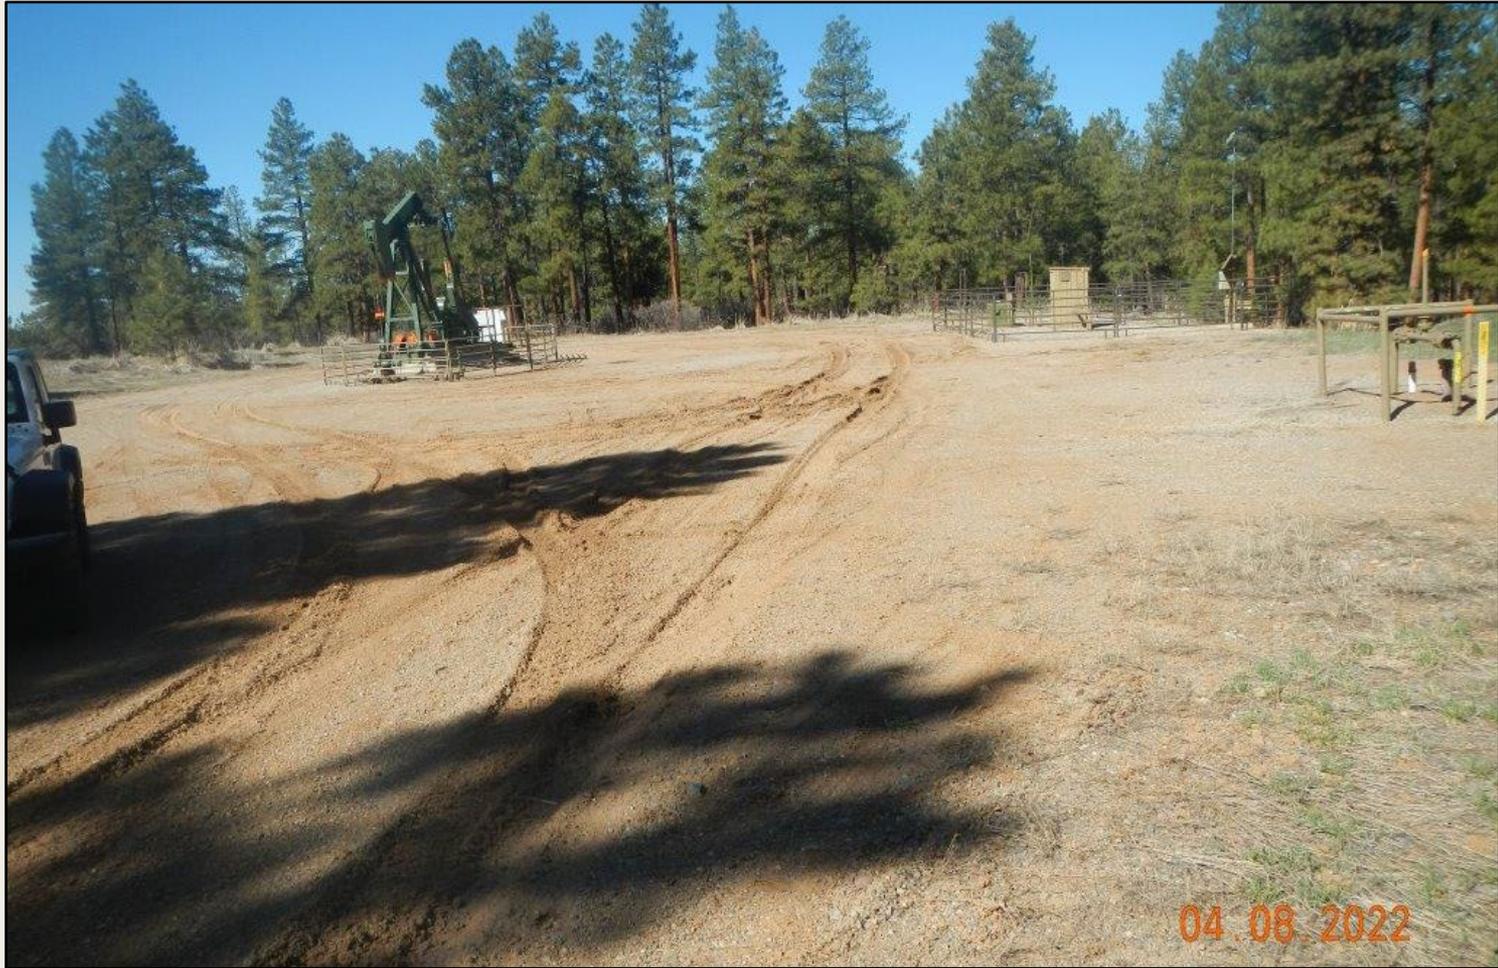
Photo 1. View of the project area from the well pad entrance facing center.

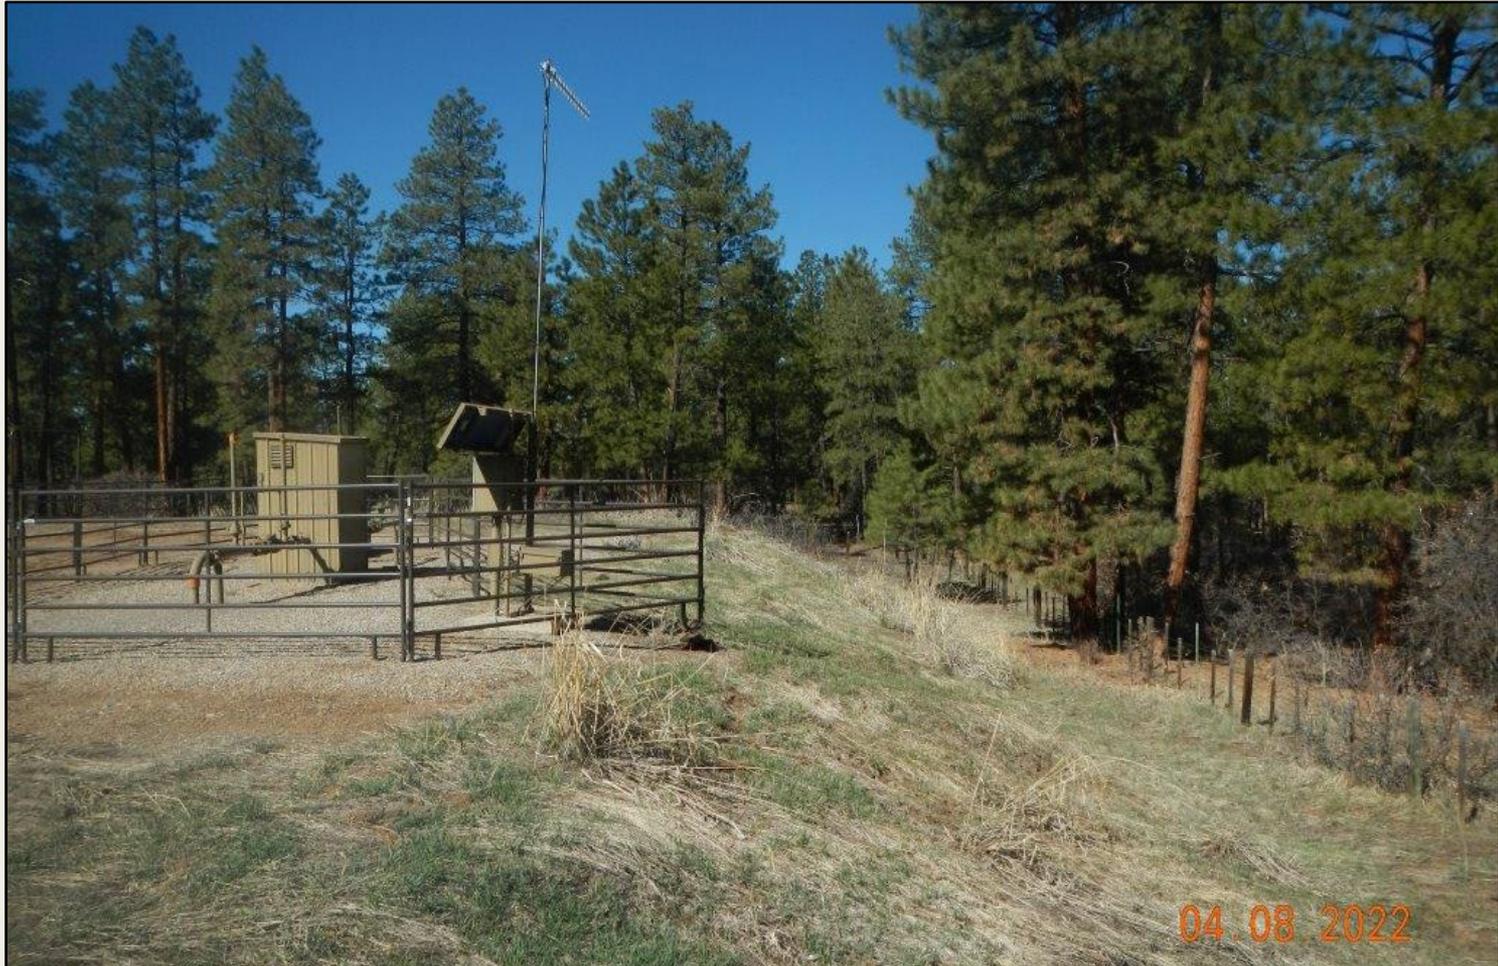
Photo 2. View of the northern project area from the northeastern corner facing westward. Revegetation is progressing with western wheatgrass, smooth brome, and sleepy grass.

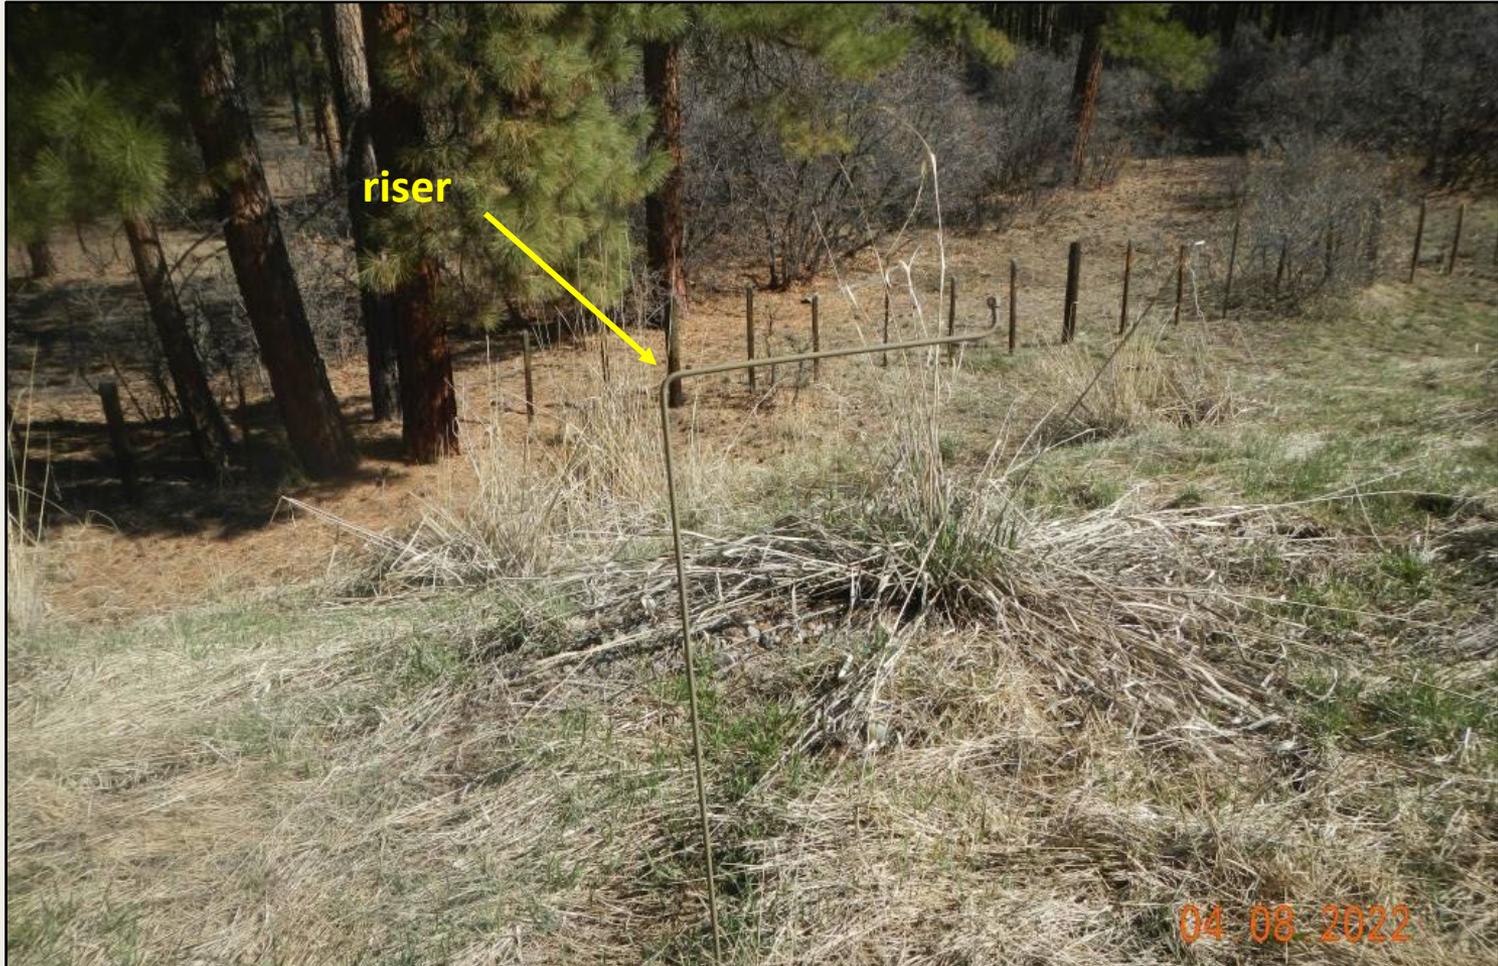
Photo 3. View of unknown riser within the northern project area.

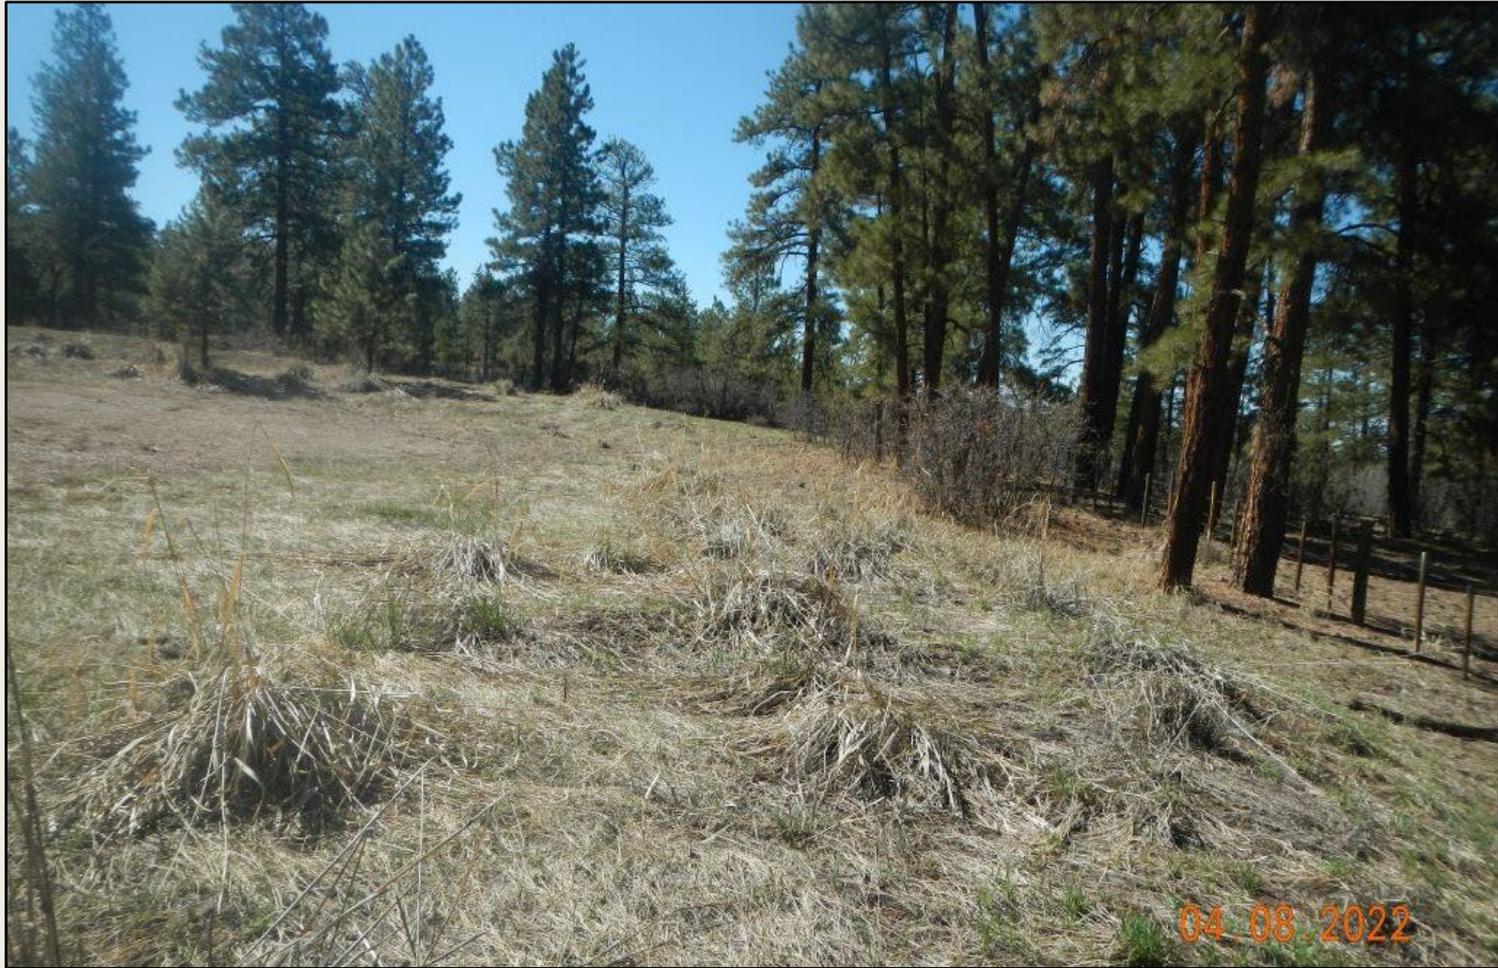
Photo 4. View of the western project area from the southwestern corner facing northward.

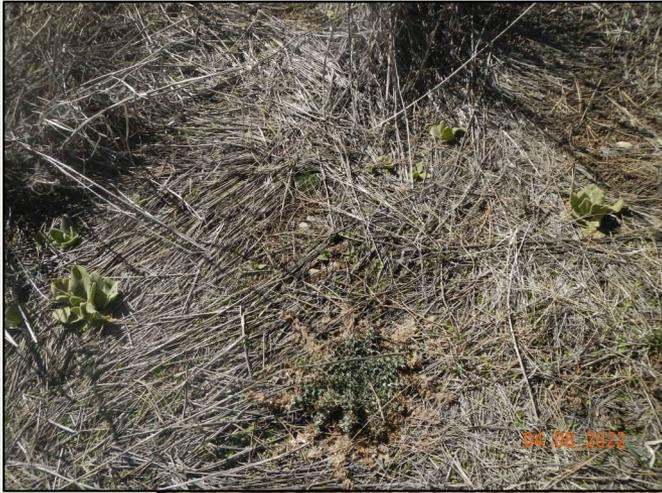
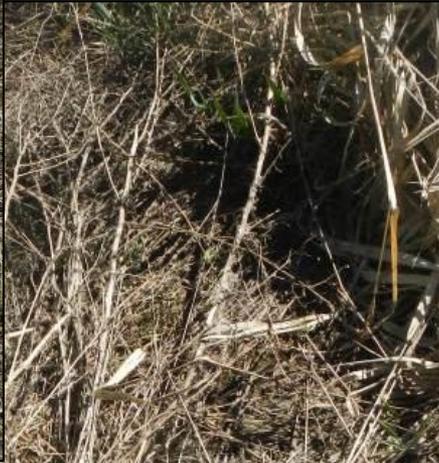
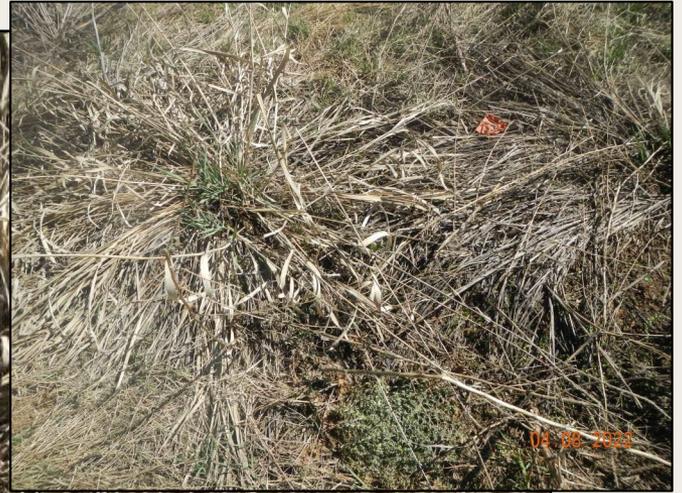
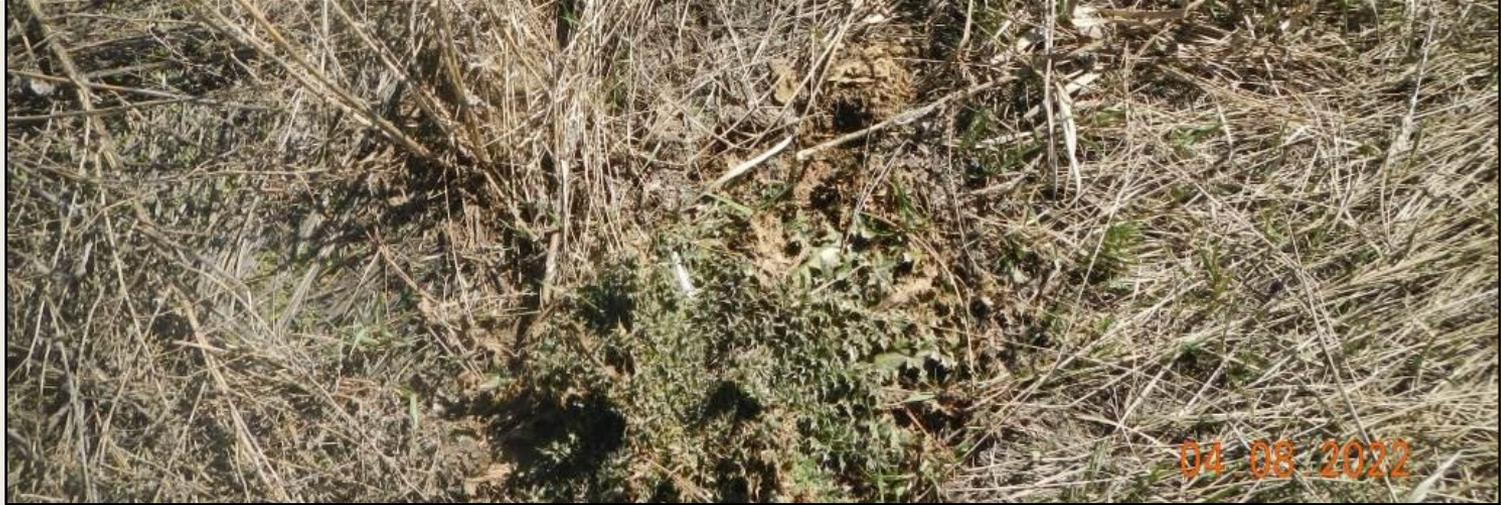
Photo 5. View of musk thistle rosettes within the northwestern portion of the interim reclamation area.

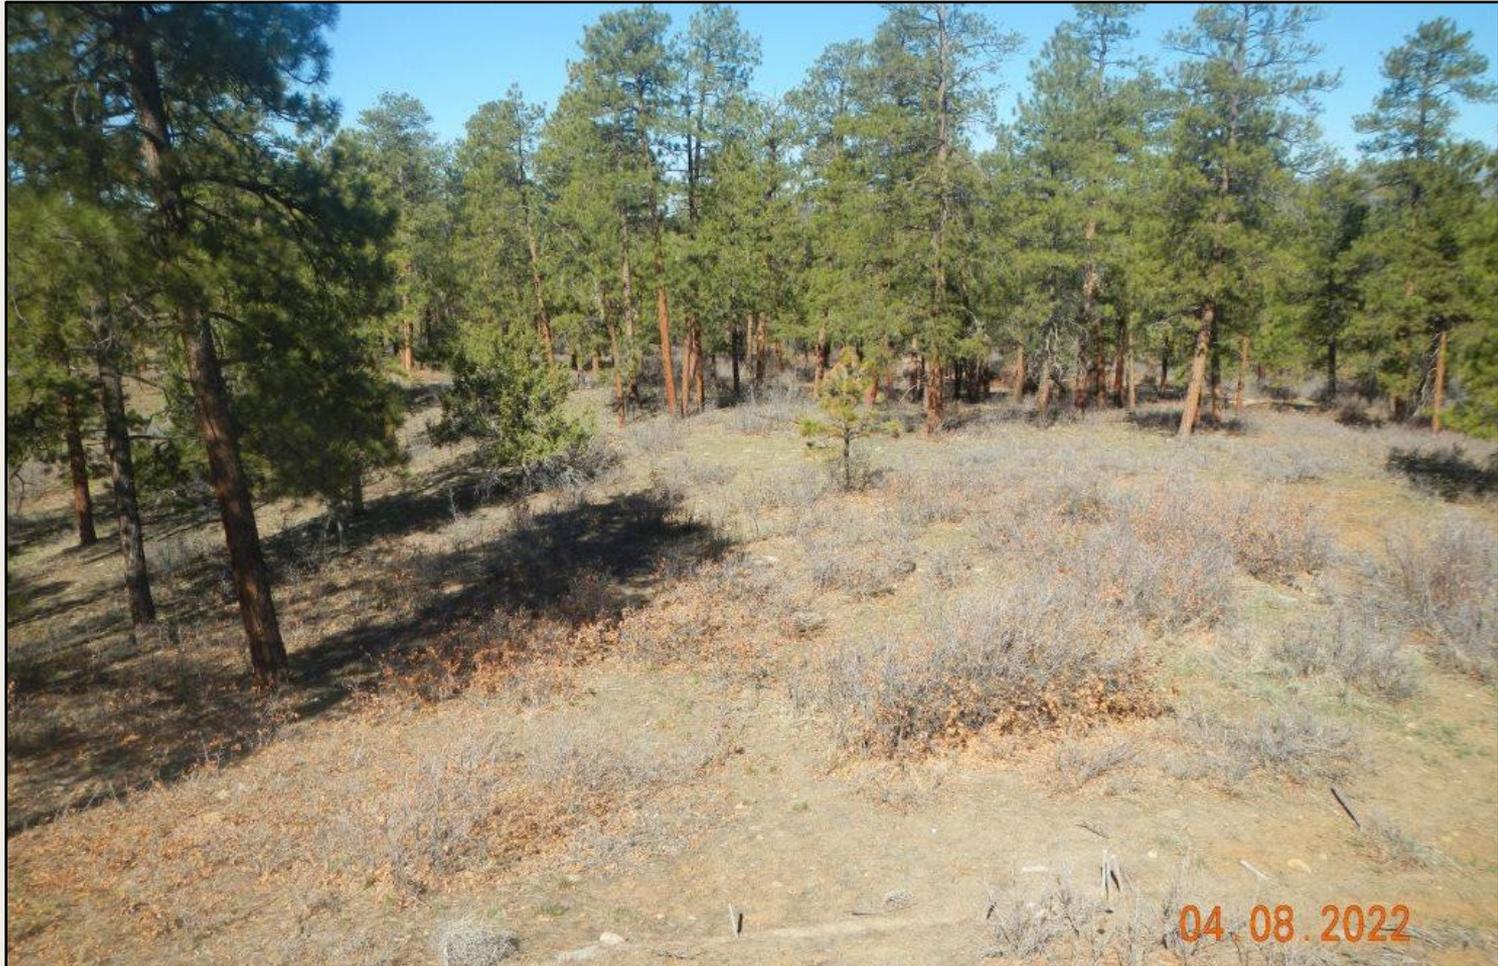
Photo 6. View of reference area comprised of ponderosa pine woodland with understory of gambel oak, James galleta, western wheatgrass, and sandberg bluegrass.
