Inspection Photos
Operator: Simcoe
API: 067-07030
Date: 4/8/2022

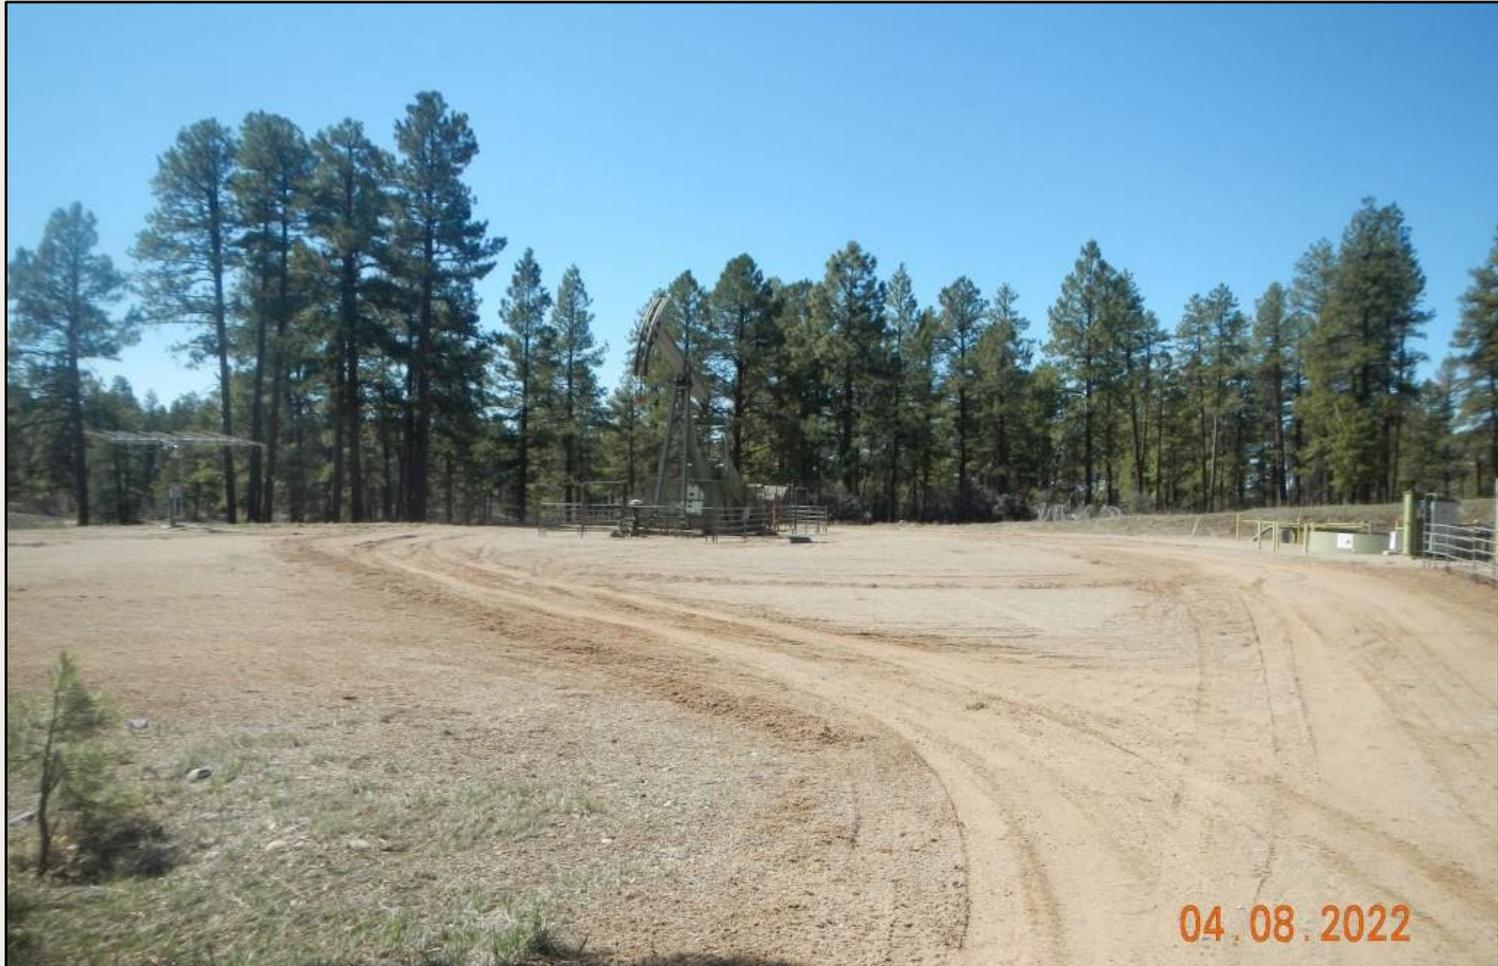
Photo 1. View of the project area from the well pad entrance facing center.

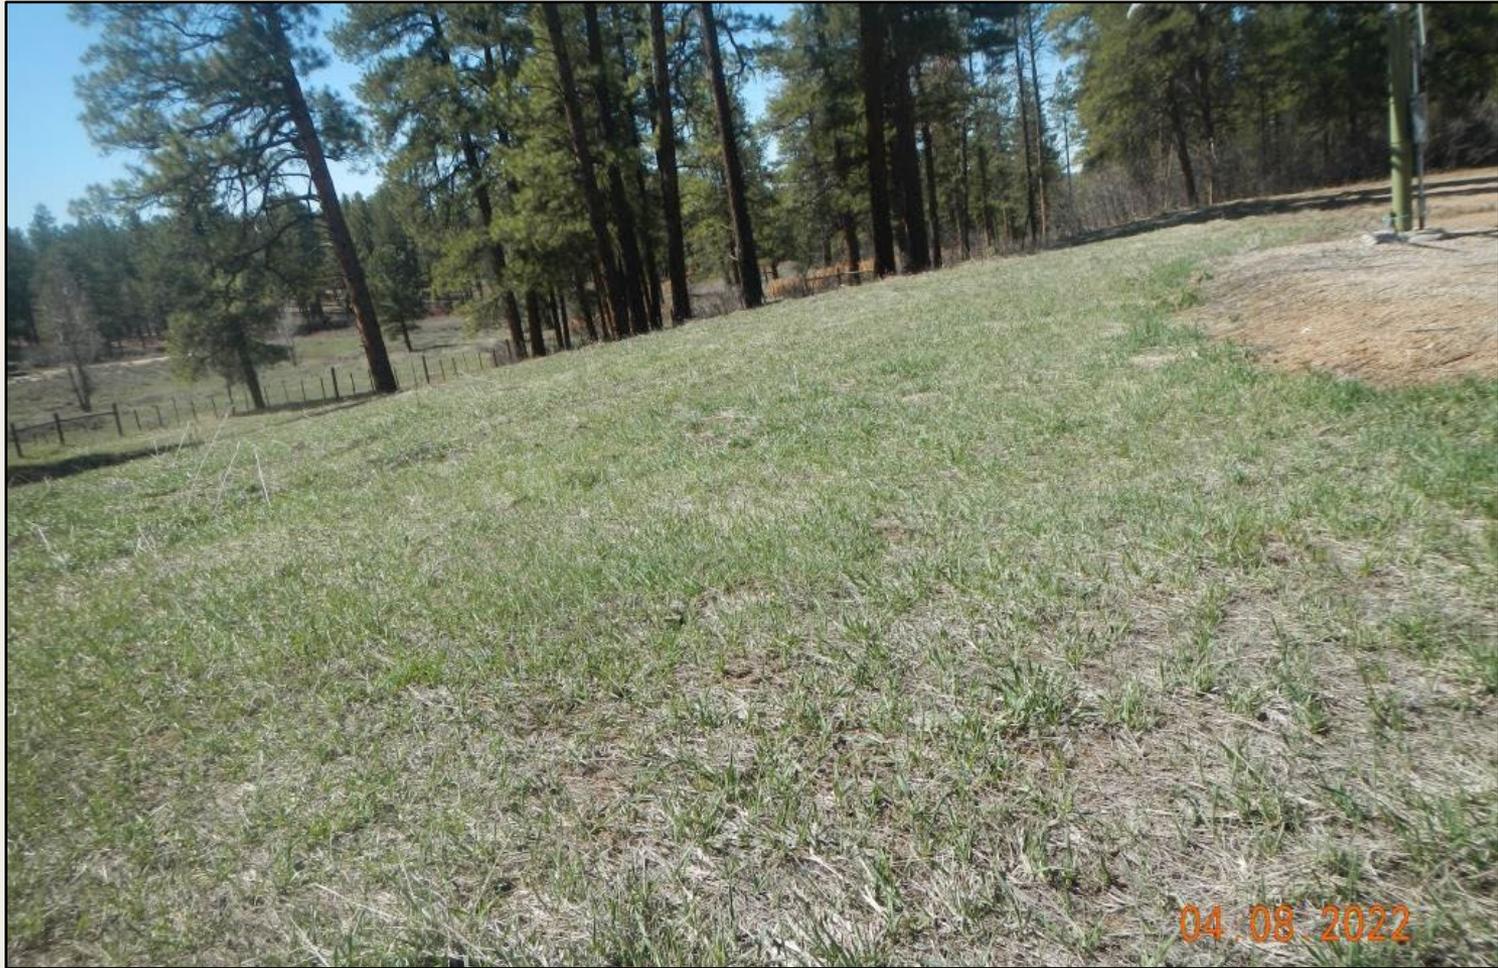
Photo 2. View of the southeastern project area from the eastern corner facing southwestward. Revegetation is progressing with western wheatgrass and smooth brome.

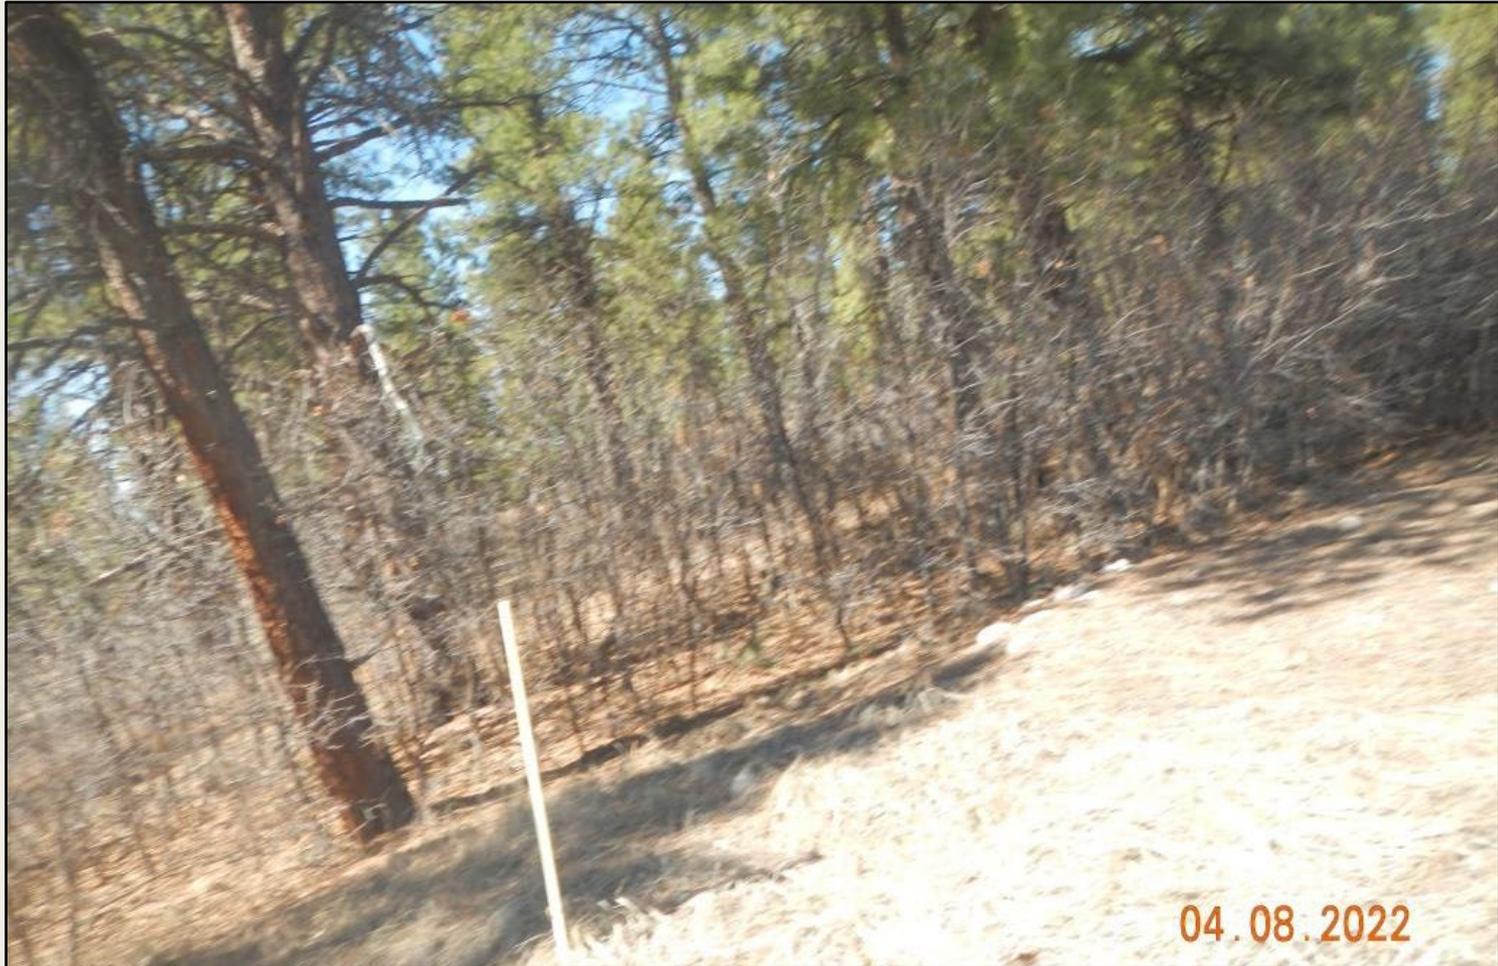
Photo 3. View of the southwestern project area from the southern corner facing northwestward.

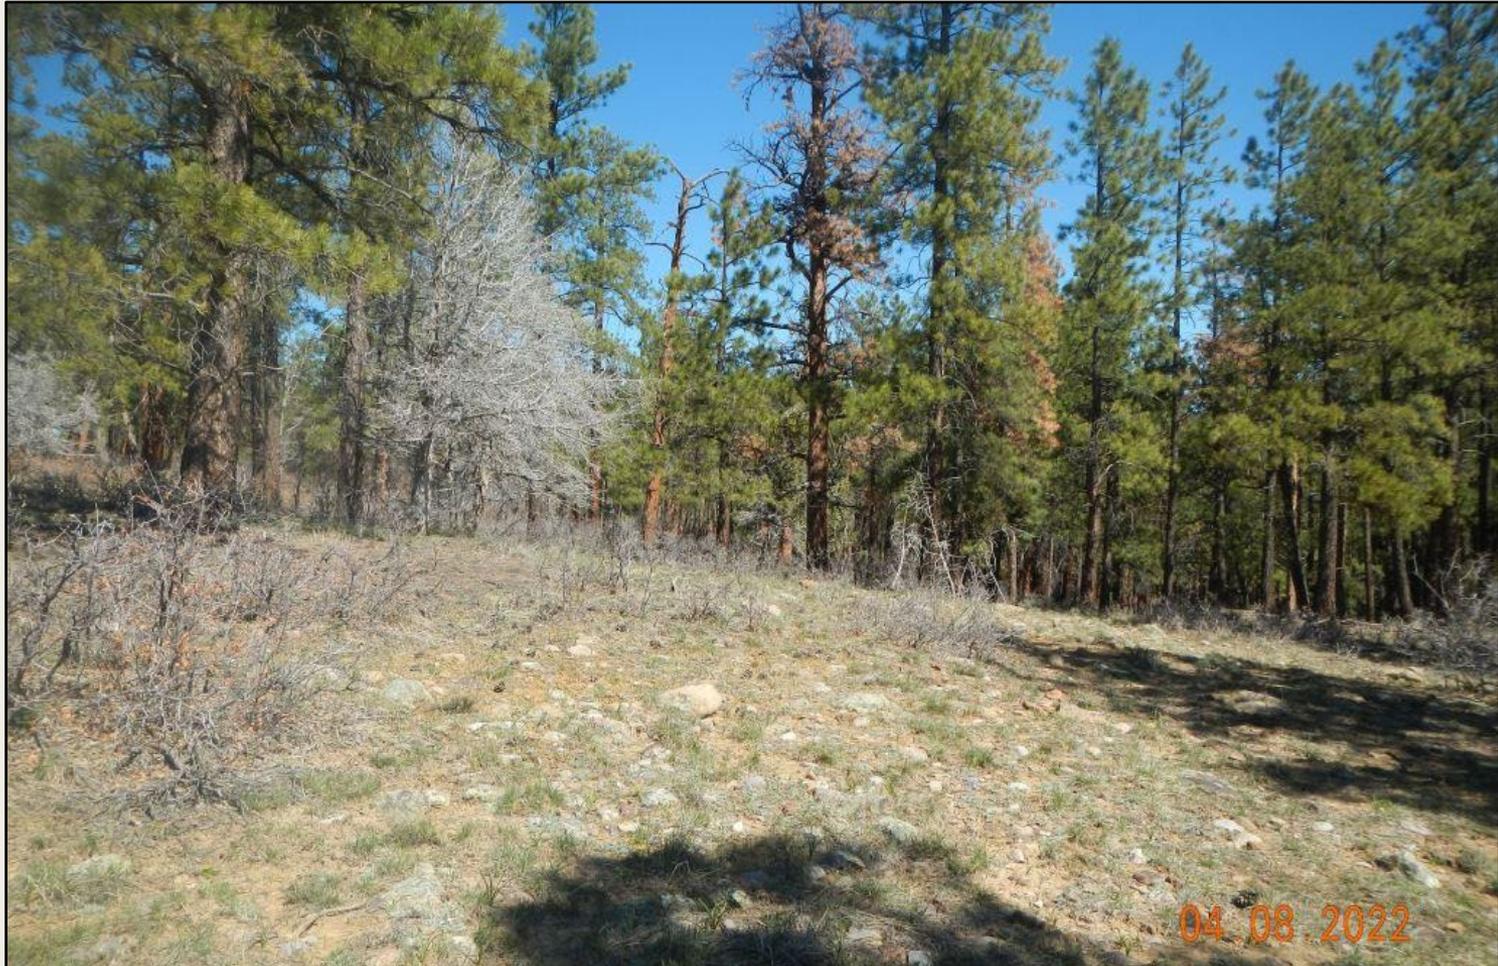
Photo 4. View of reference area comprised of ponderosa pine woodland with black sagebrush, gambel oak, James galleta, Oregon grape, and fringed sage in the understory.
