Inspection Photos
Operator: Simcoe
API: 067-08806
Date: 4/19/2022

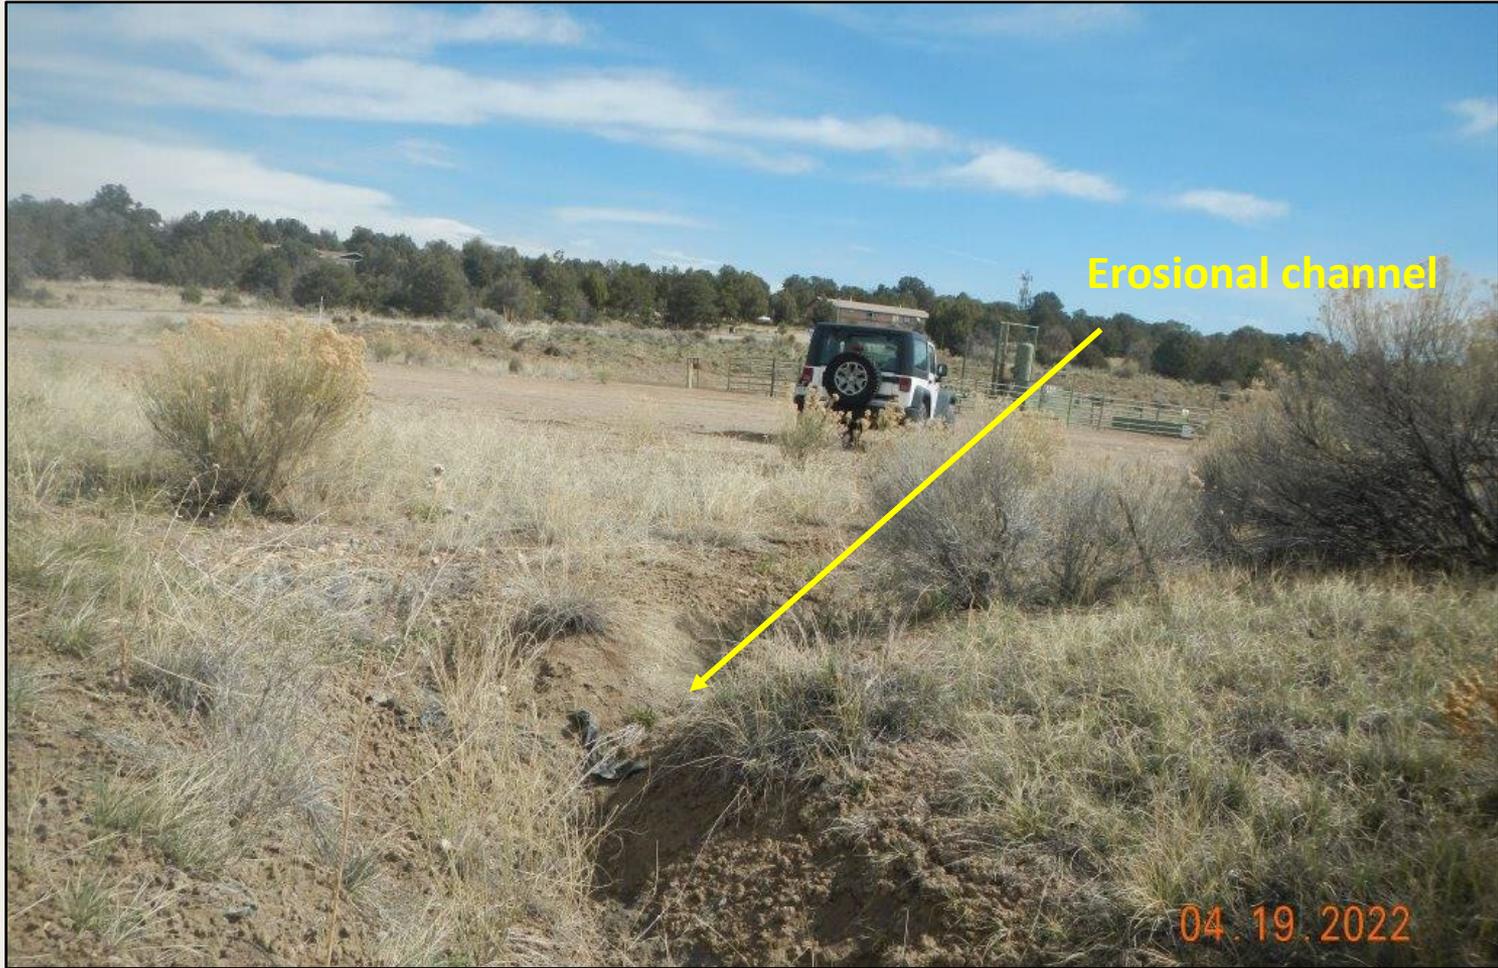
Photo 1. View of the project area from the southwestern corner facing center. BMPs are needed where concentrated stormwater flows of the southwestern corner of the project area.

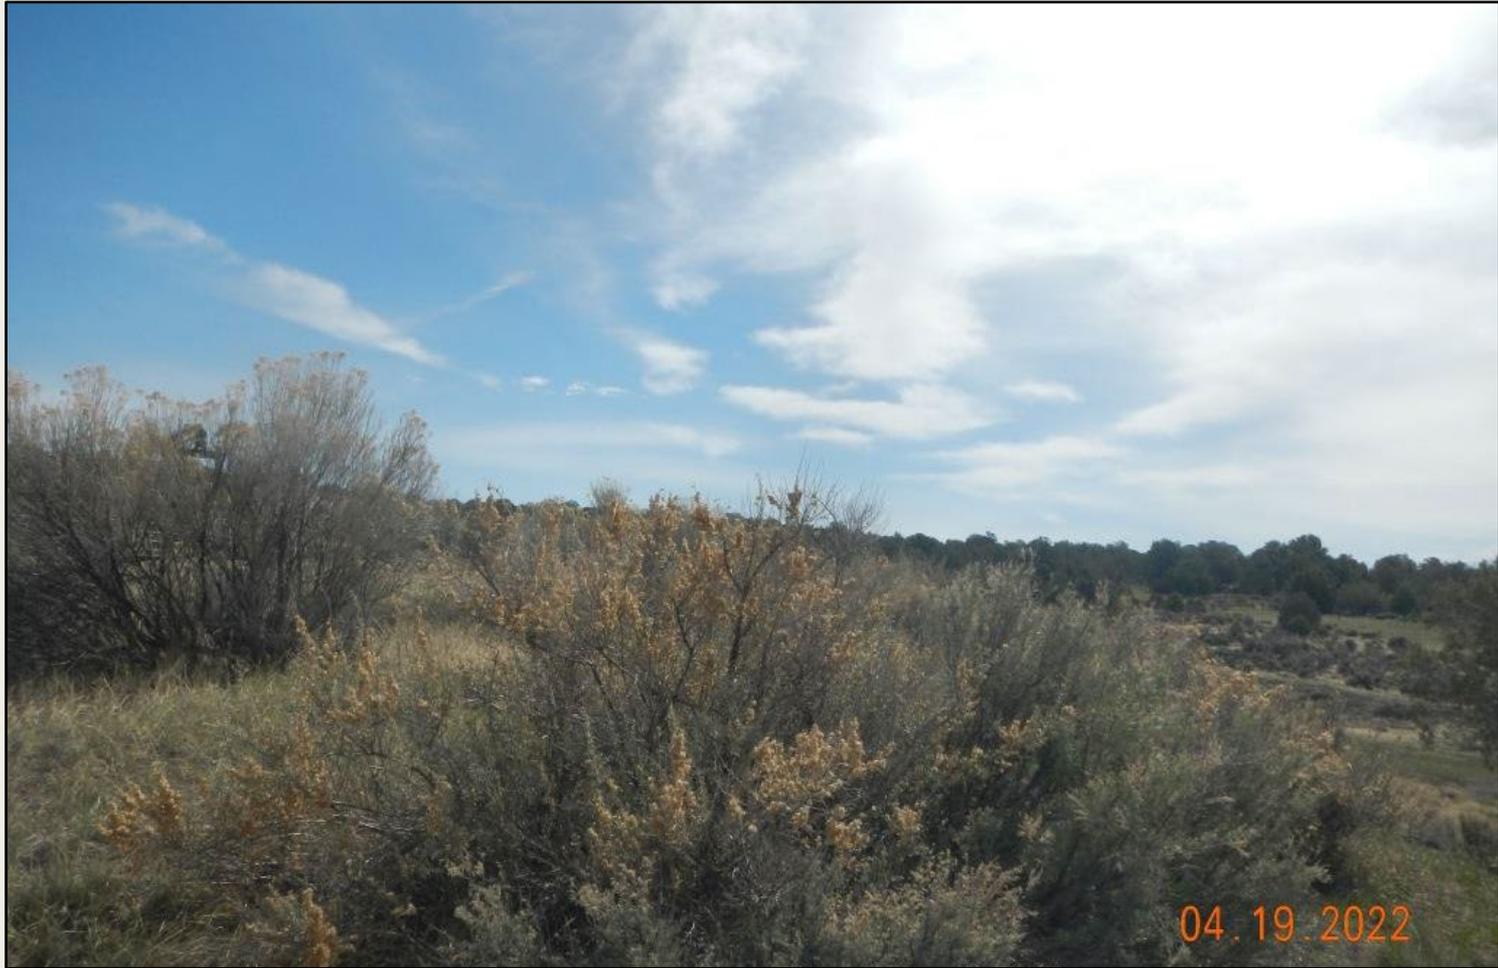
Photo 2. View of the southern project area from the southwestern corner facing eastward. Revegetation is progressing with fourwing saltbush, rubber rabbitbrush, crested wheatgrass, sand dropseed, western wheatgrass and smooth brome.

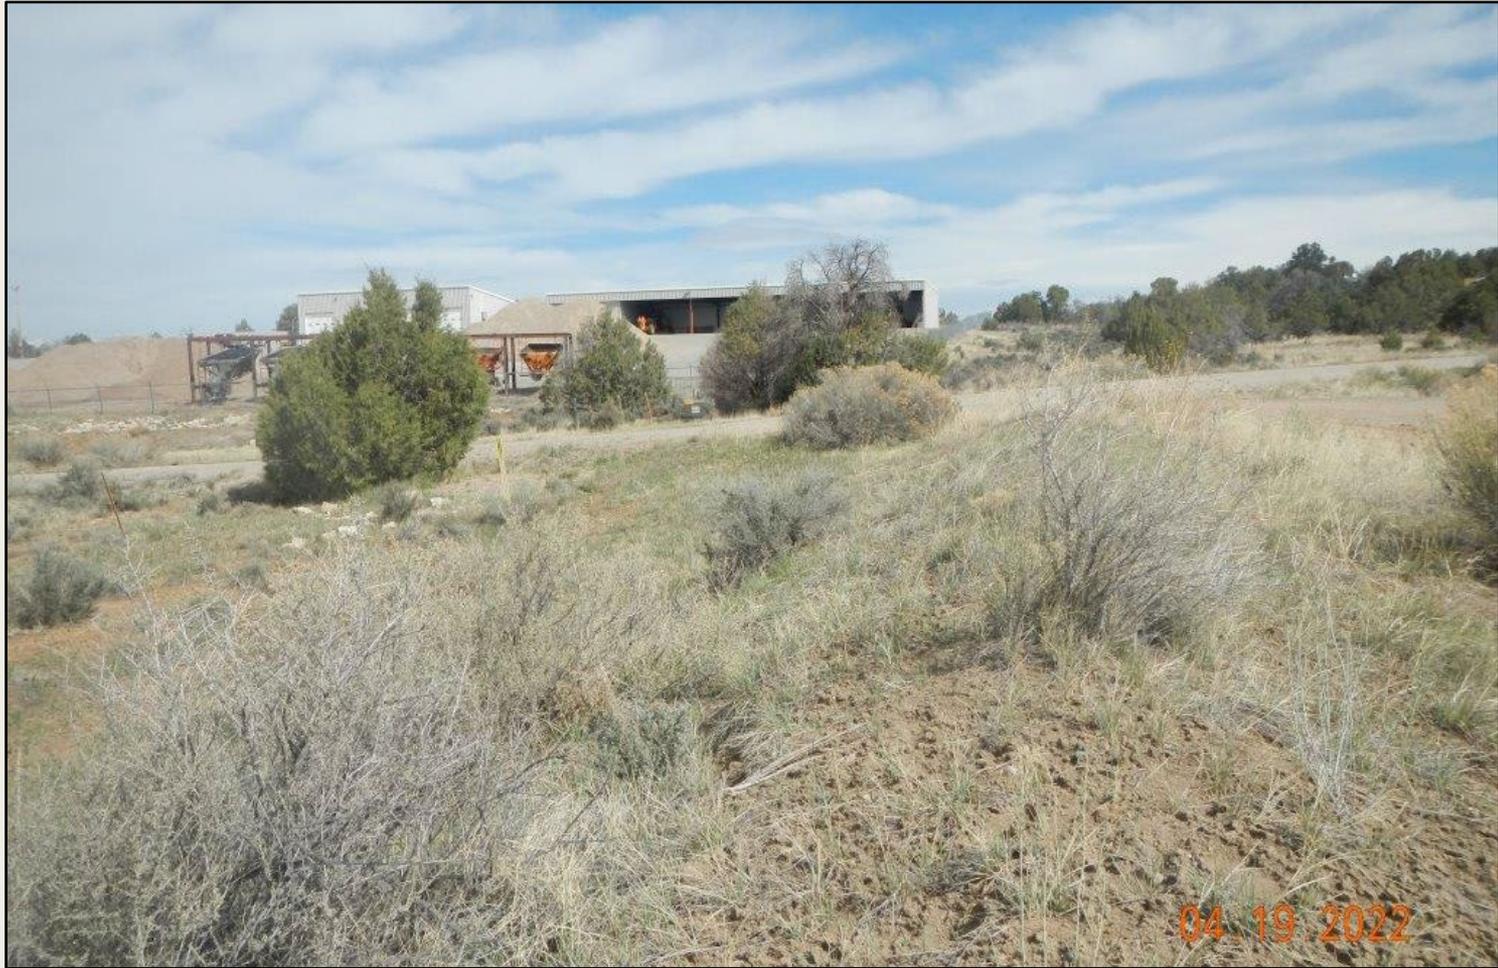
Photo 3. View of the western project area from the southwestern corner facing northward.

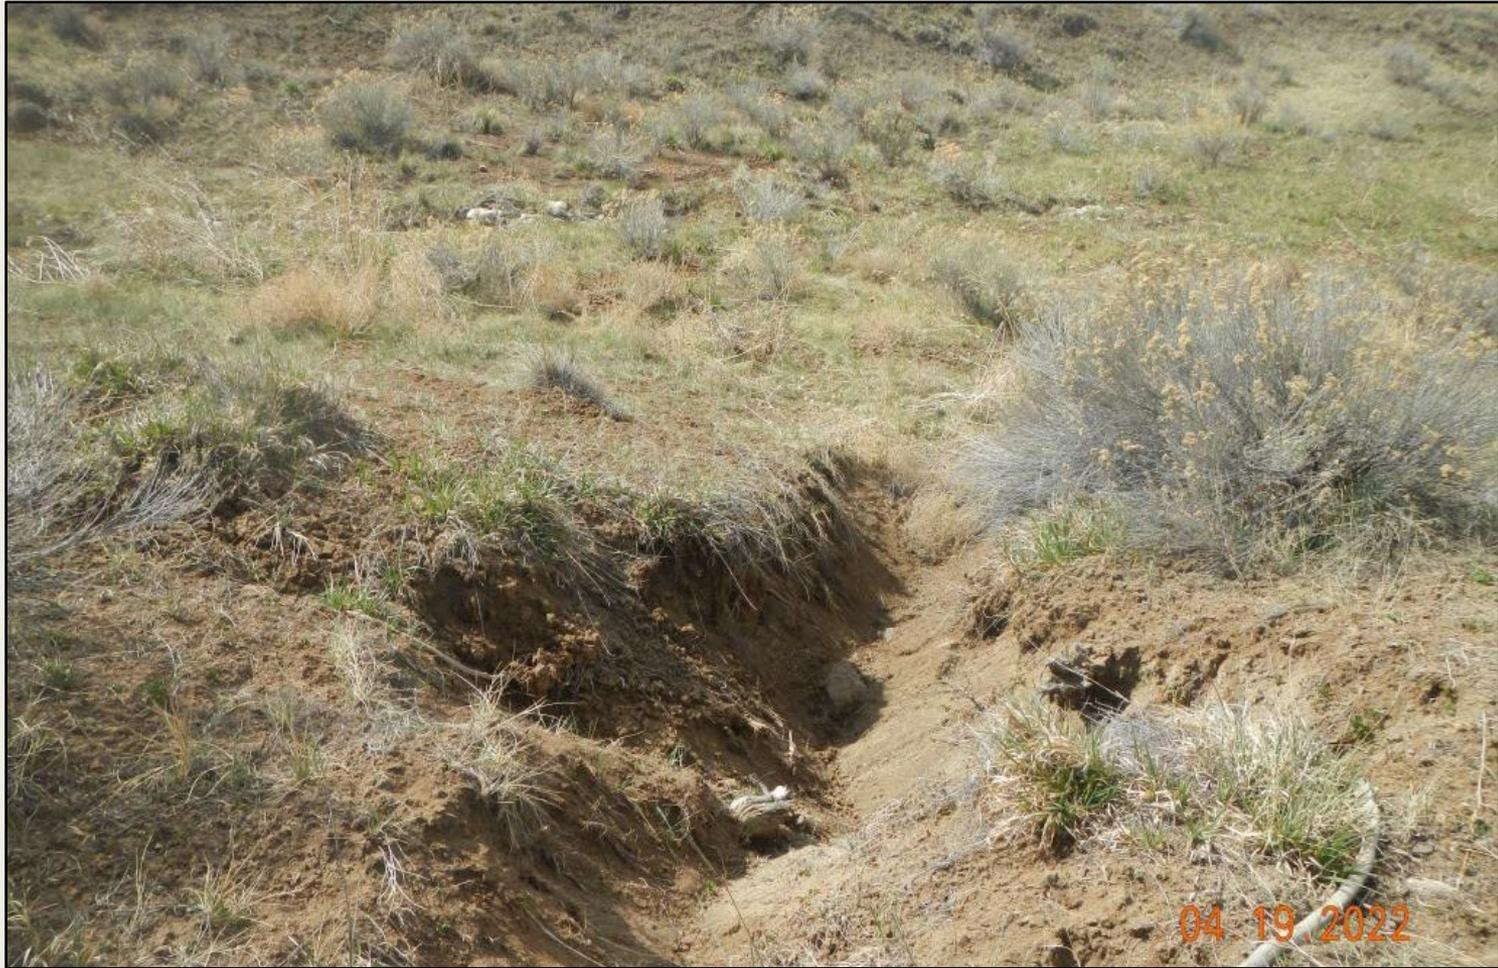
Photo 4. View of headcut erosion observed at the edge of the southwestern corner of the project area; approx 2-3ft wide and deep.

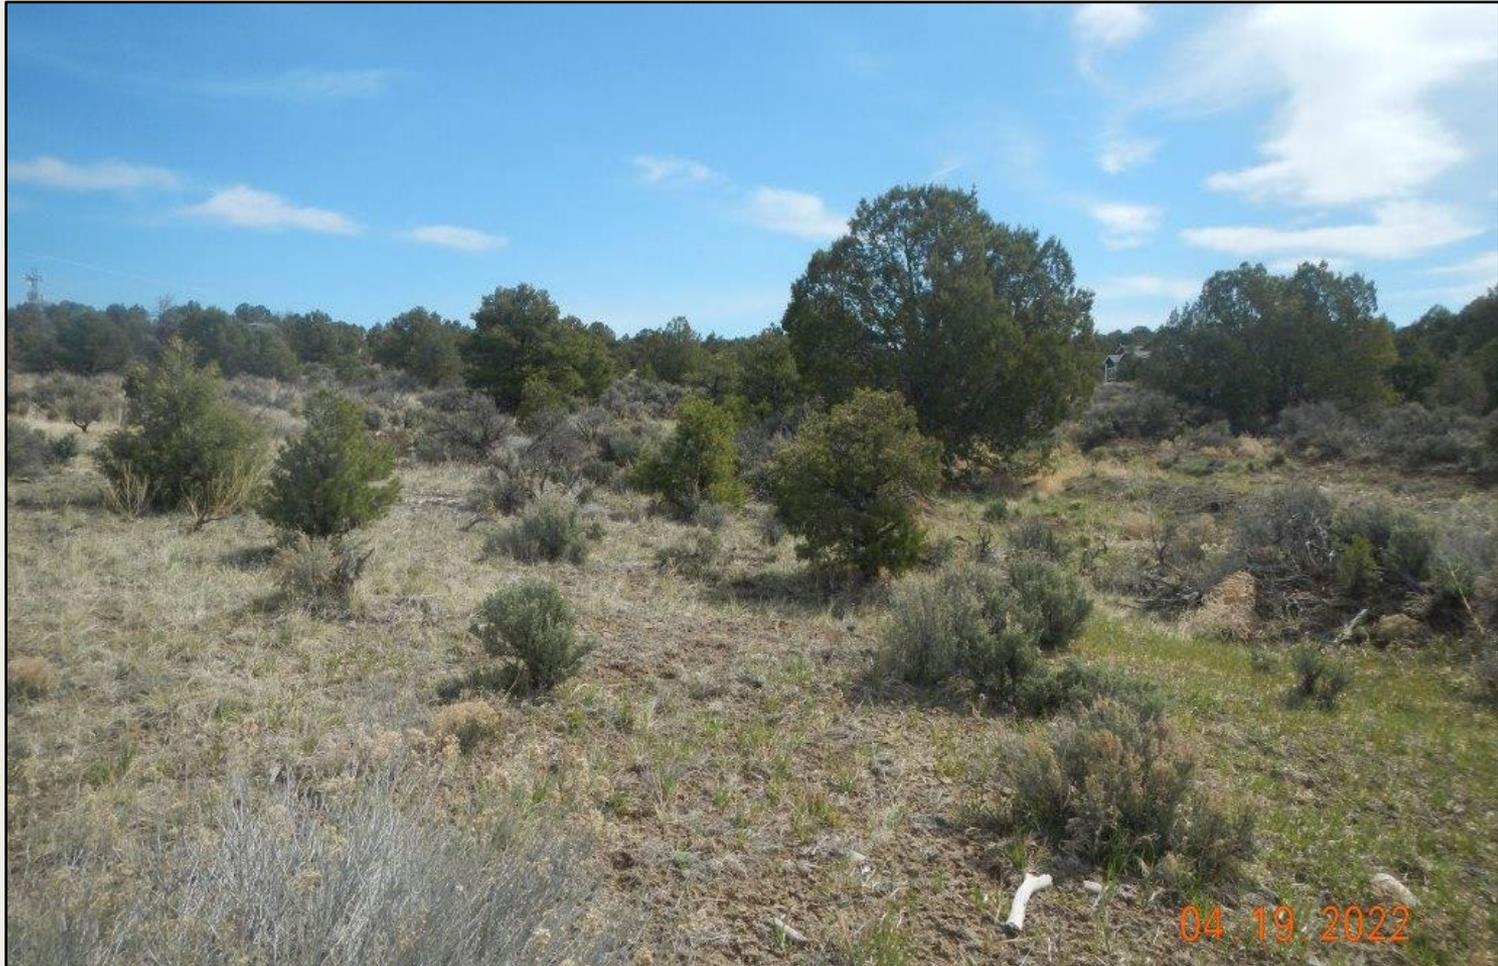
Photo 5. View of reference area comprised of pinyon and juniper woodland with sagebrush, western wheatgrass, James galleta, and yellow milkvetch.
