Inspection Photos

API: 071-08083

Operator: EVERGREEN NATURAL RESOURCES

Inspection Date: 4/19/2022

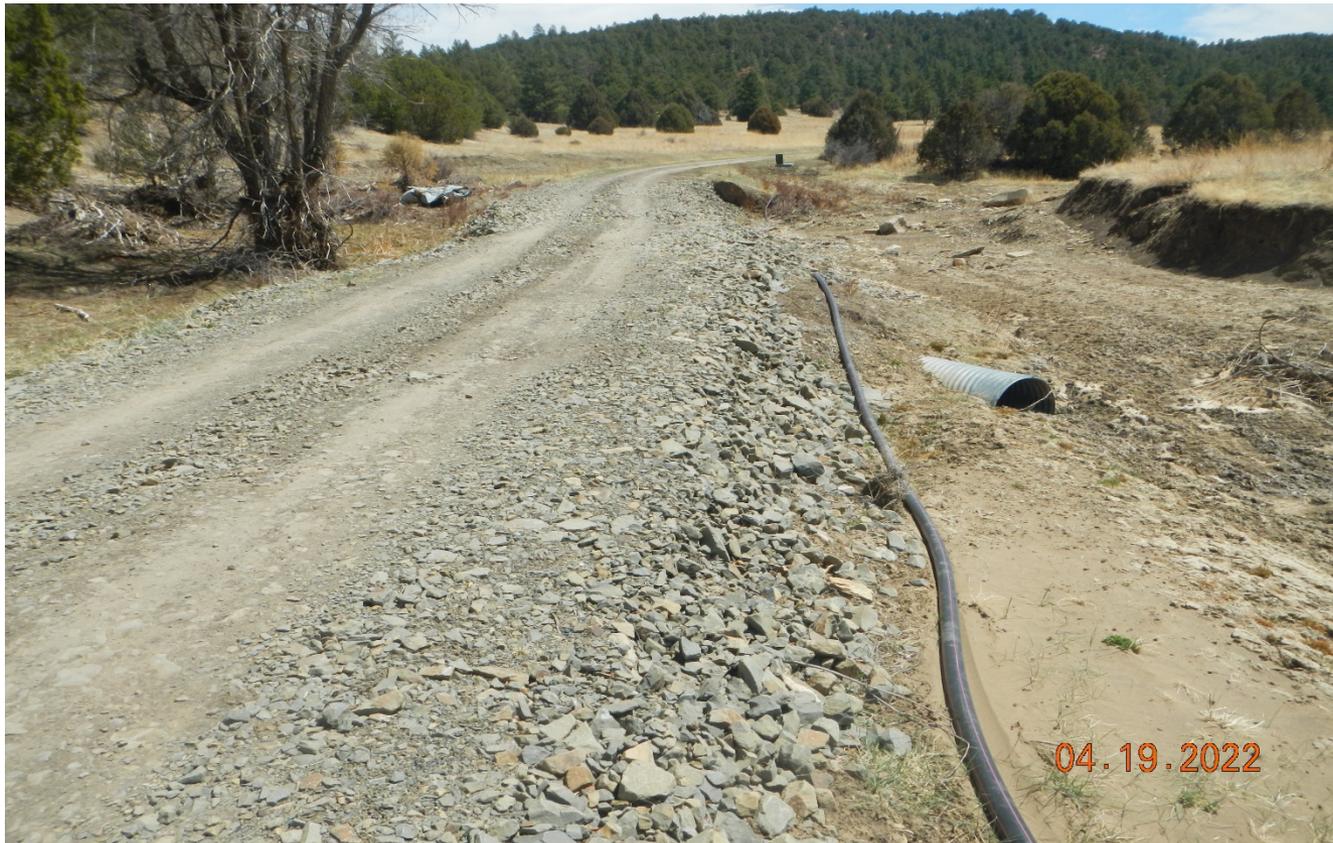
Photo 1. Facing southeast along the main access road. The black poly line remains exposed to potential damage.

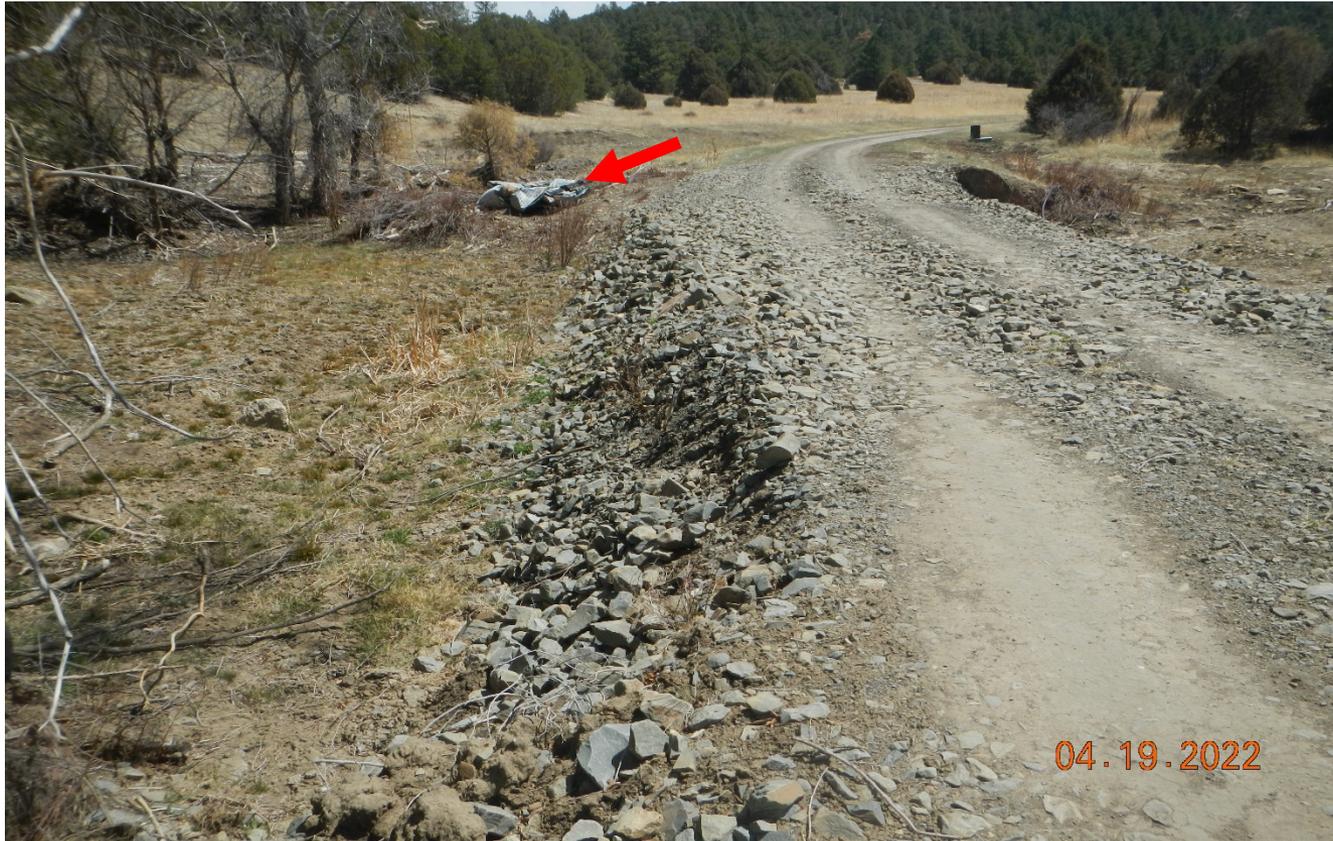
Photo 2. The damaged culvert debris needs to be removed.

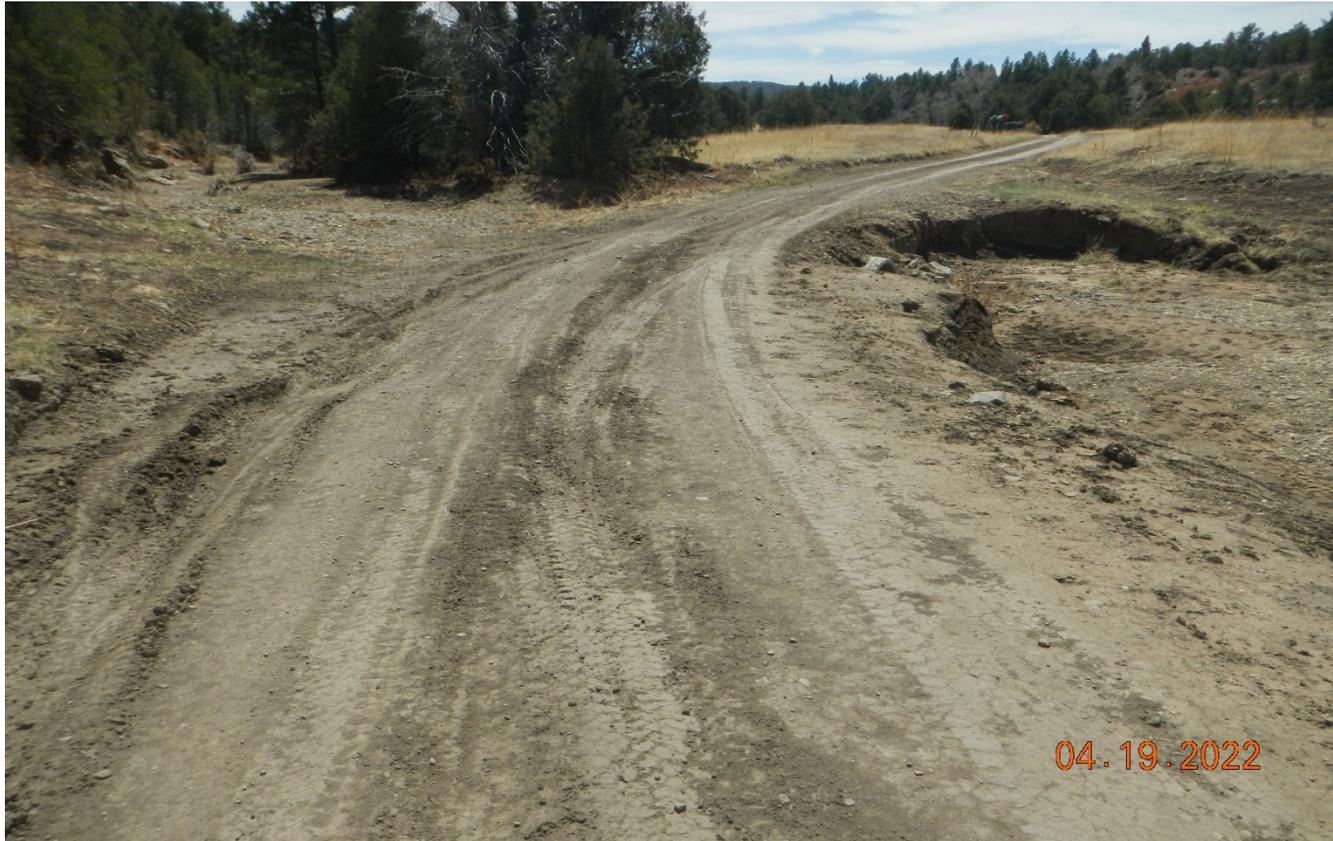
Photo 3. Facing south along the main road. The bank of the stream crossing needs to be stabilized. The cement culvert outlet should be reinstalled.

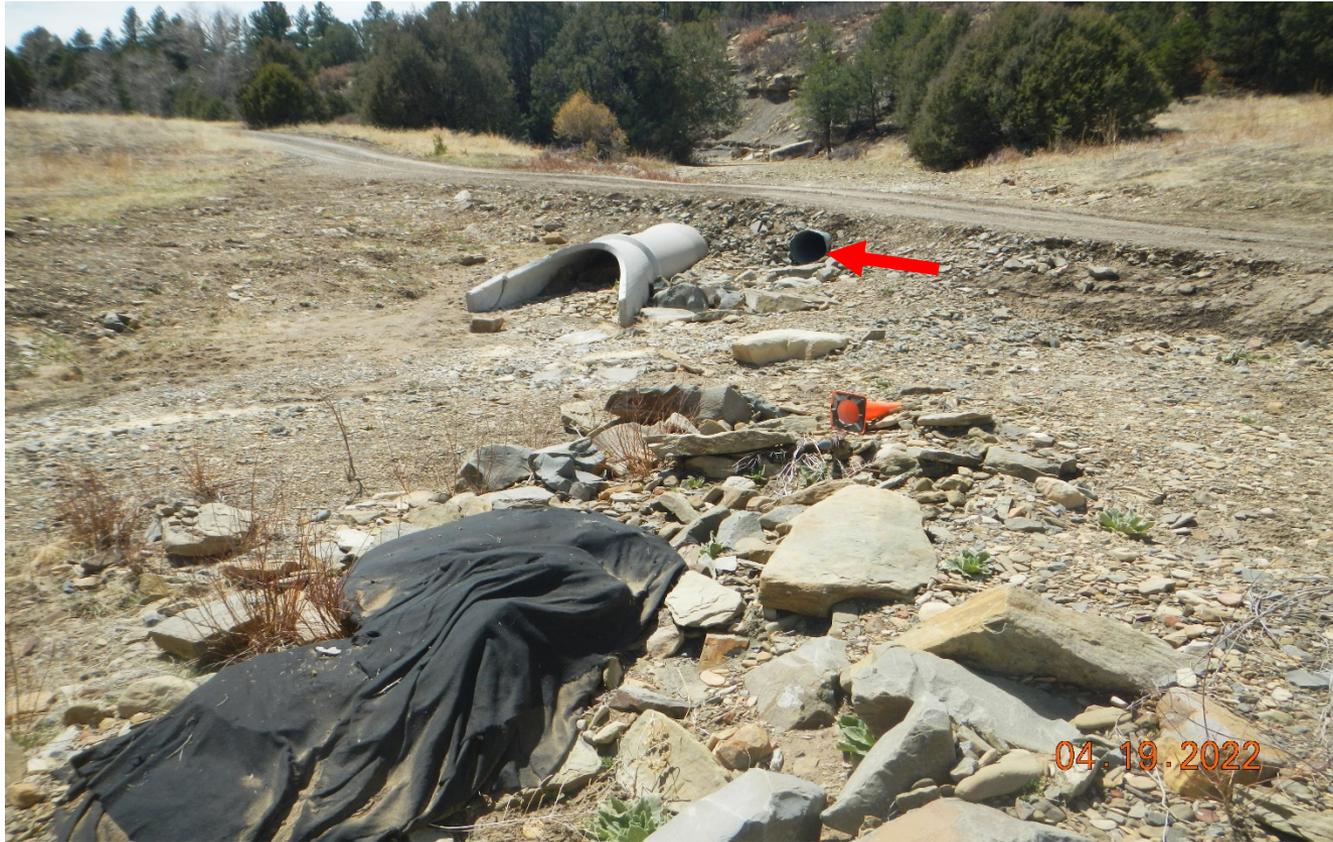
Photo 4. The cement culvert is filled in with sediment. The culvert at red arrow is not sufficient as shown by the size of the previous culvert. The liner debris in lower portion of photo needs to be removed. Previous corrective action was not completed.

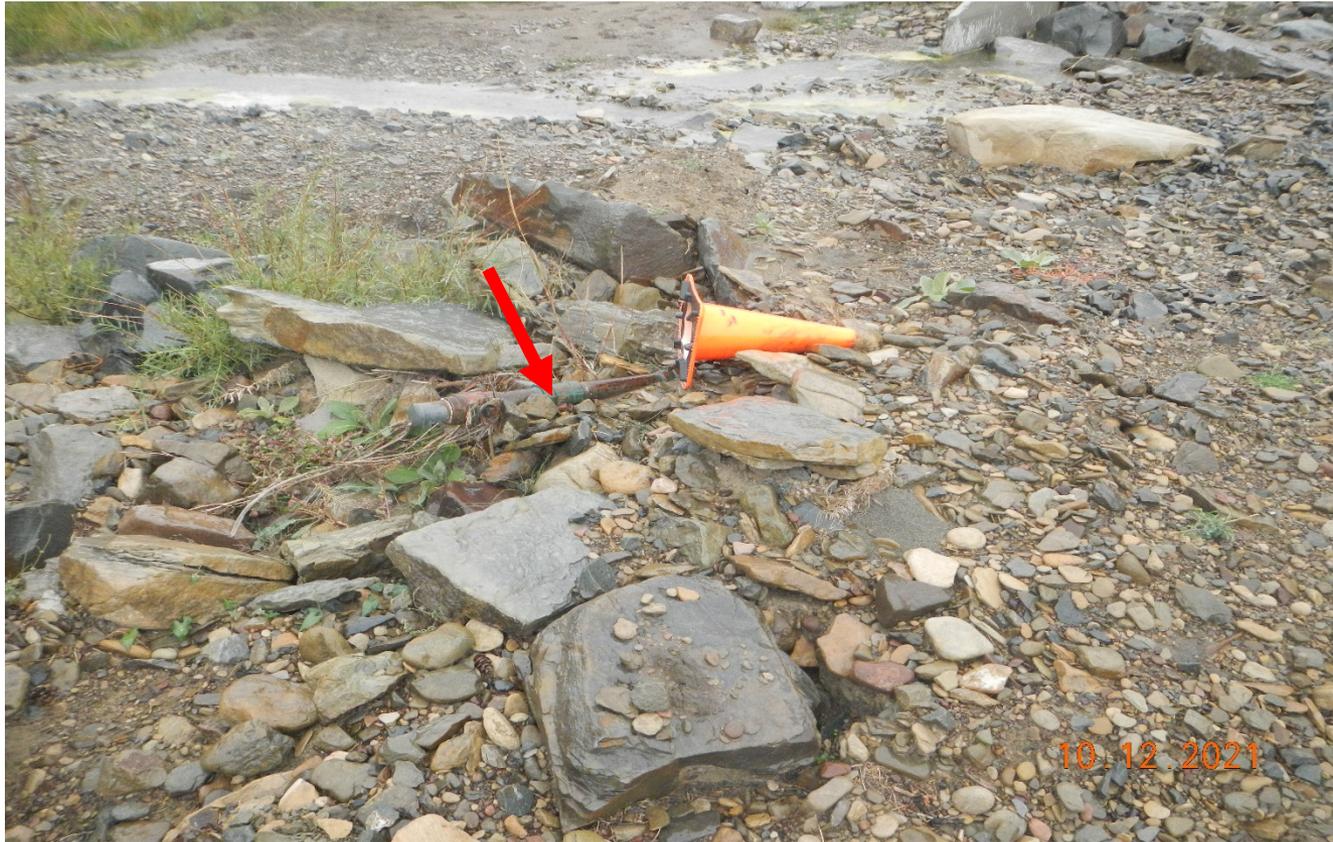
Photo 5. There is a produced water line that is bent over on the ground at the stream drainage which needs to be repaired. Previous corrective action was not completed. Photo taken from previous inspection but is also shown in previous photo.

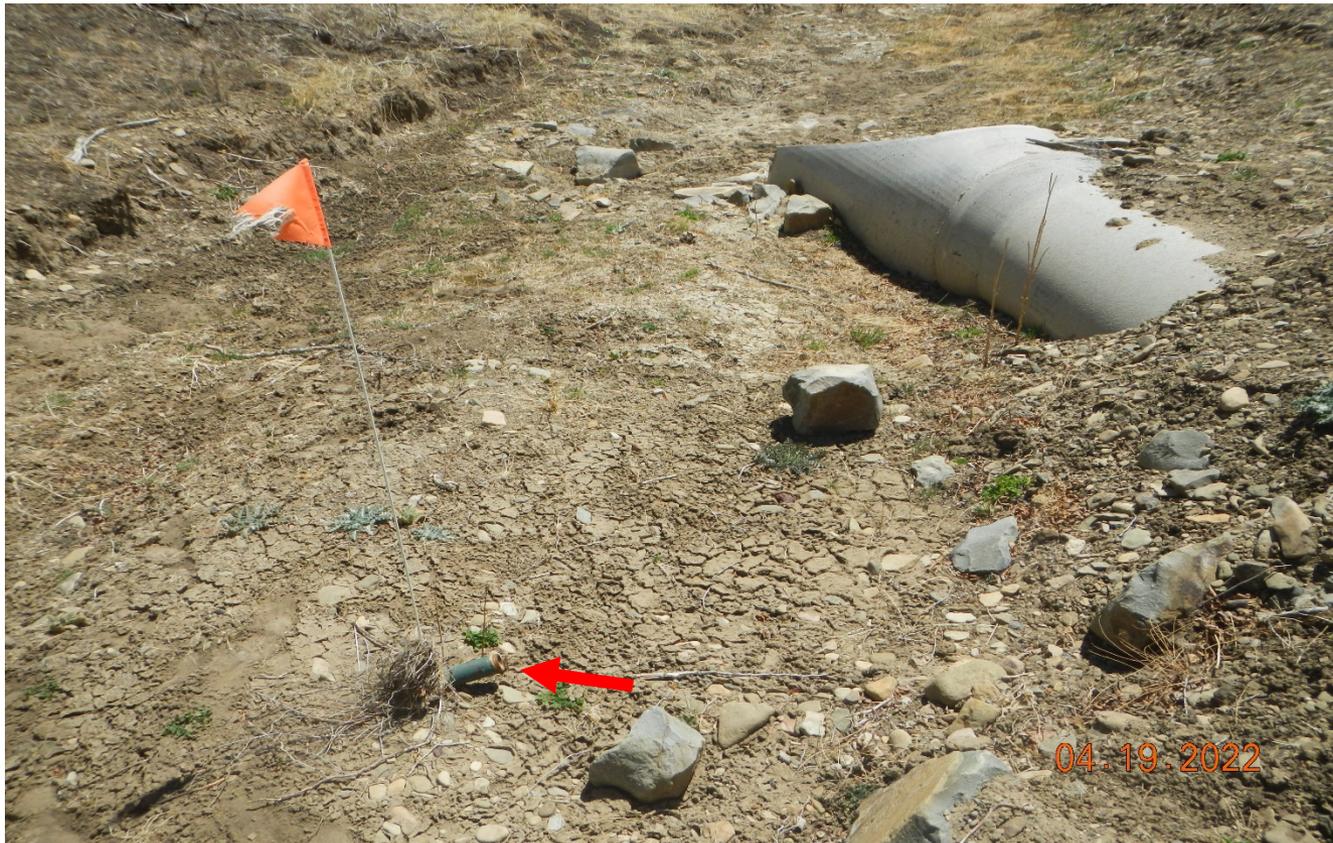
Photo 6. There is another produced water line that is bent over on the ground at the next crossing which needs to be repaired.
