Inspection Photos

Location Name: Elton N Miller 2

Location ID: 318286

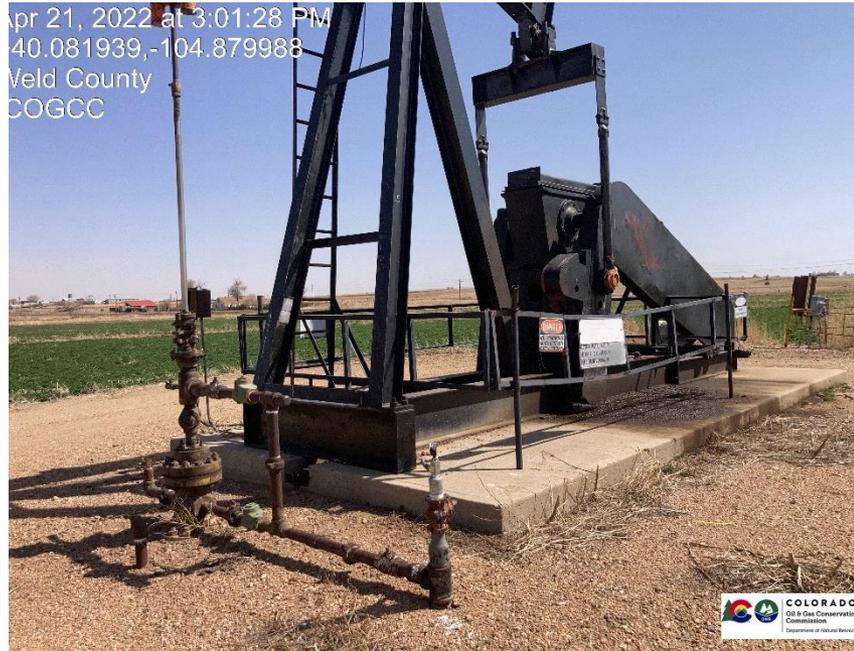
Pic 1 wellhead / pump jack

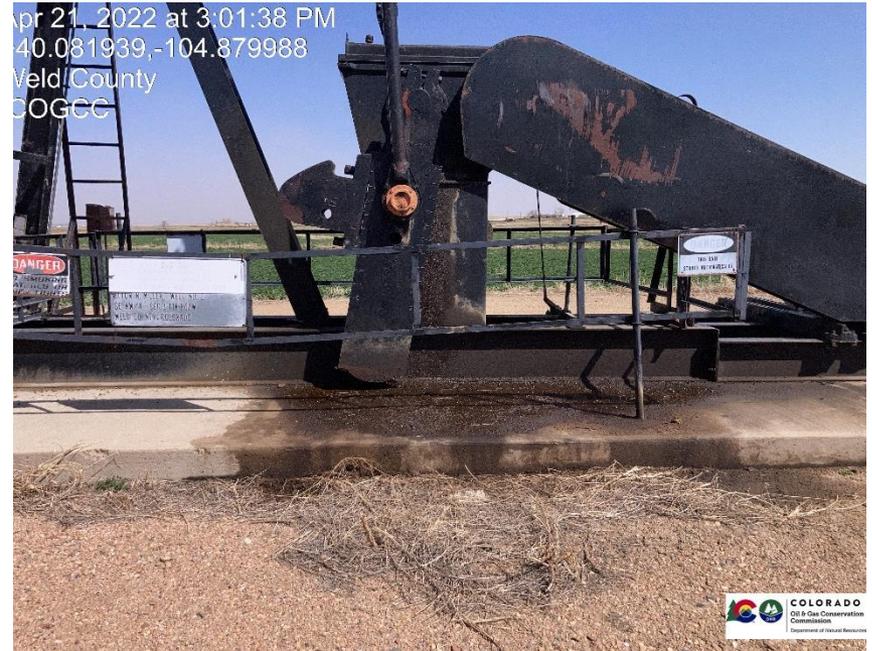
Pic 2 leaking gear oil/stained soil/mechanical issue.
