# Inspection Photos

April 18 and April 21, 2022

Location Name: Shideler-66S92W /32SWNE

Inspection Document #: 702800144

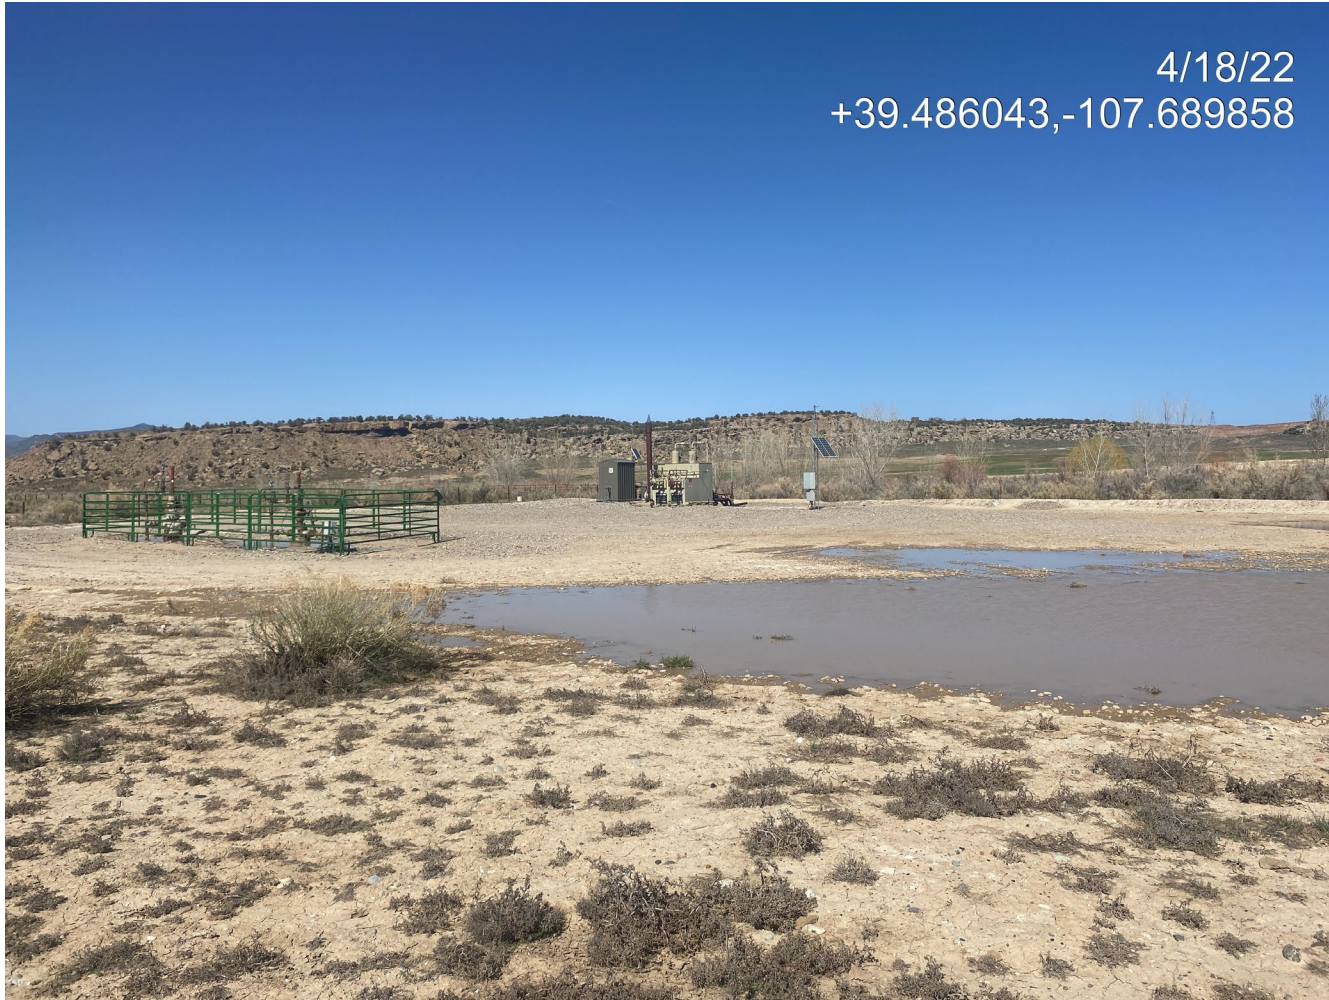
**Photo 1.** Photo taken from the west of the Location facing northeast shows an overview of the Location. Note: due to GPS malfunction, GPS coordinates for this photo are incorrect.

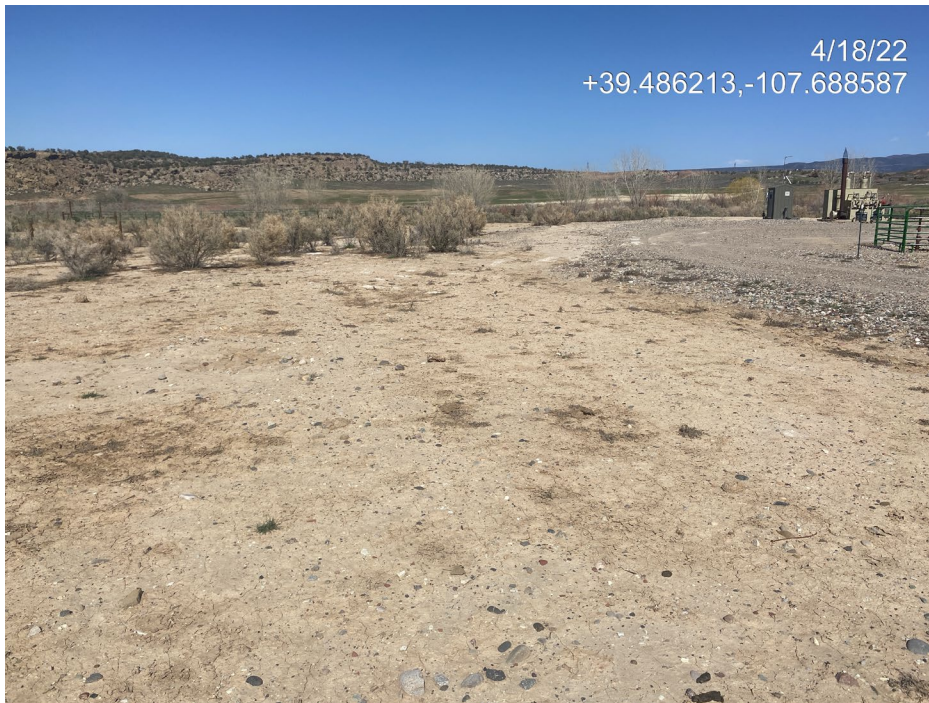
**Photo 2.** Photo taken from the interim area to the north of the Location facing east shows the interim area dominated by bare ground. Note GPS coordinates for this photo are incorrect, due to GPS malfunction.

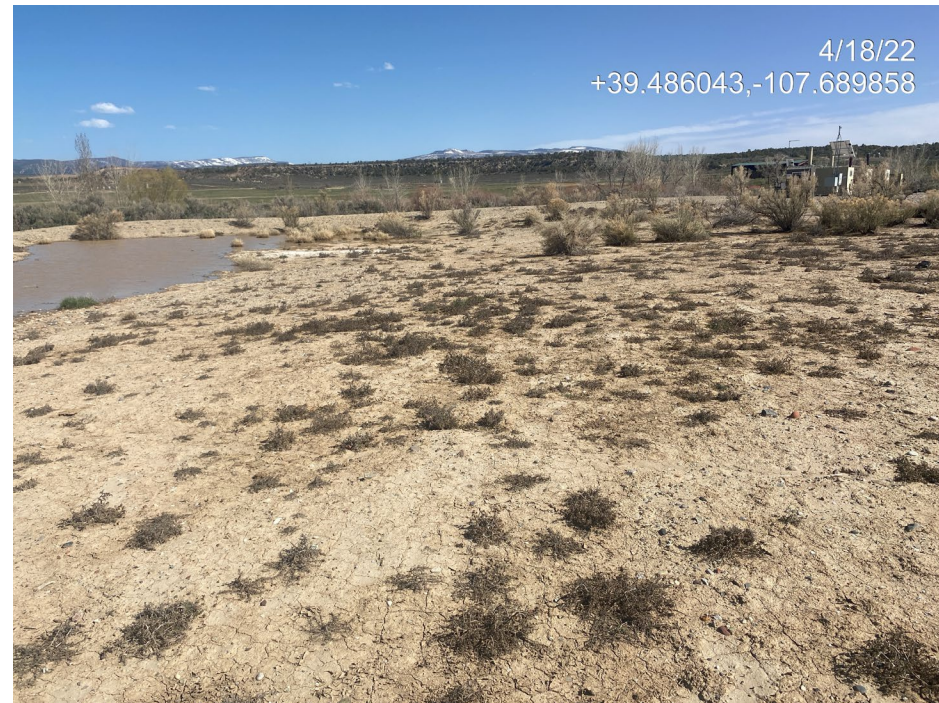
**Photo 3.** Photo taken from the interim area to the west of the Location facing southeast shows the interim area dominated by bare ground and the undesirable plant species/weed kochia. Note GPS coordinates for this photo are incorrect, due to GPS malfunction.

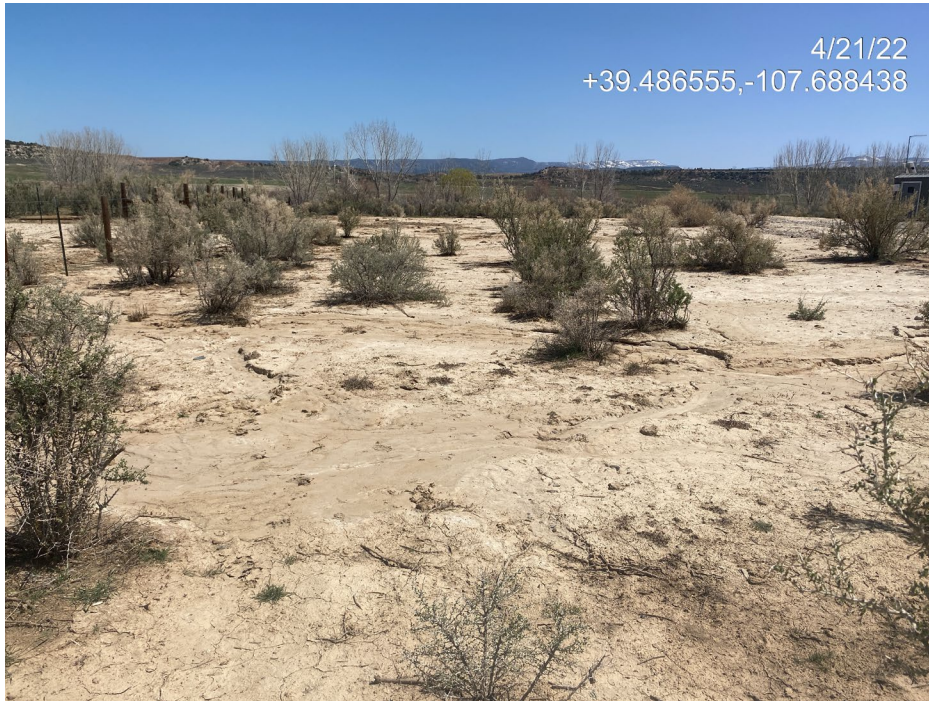
**Photo 4.** Photo taken from the interim area to the north of the Location facing east shows erosion occurring in interim areas dominated by bare ground. Shrubs present do not appear sufficient to stabilize soils.

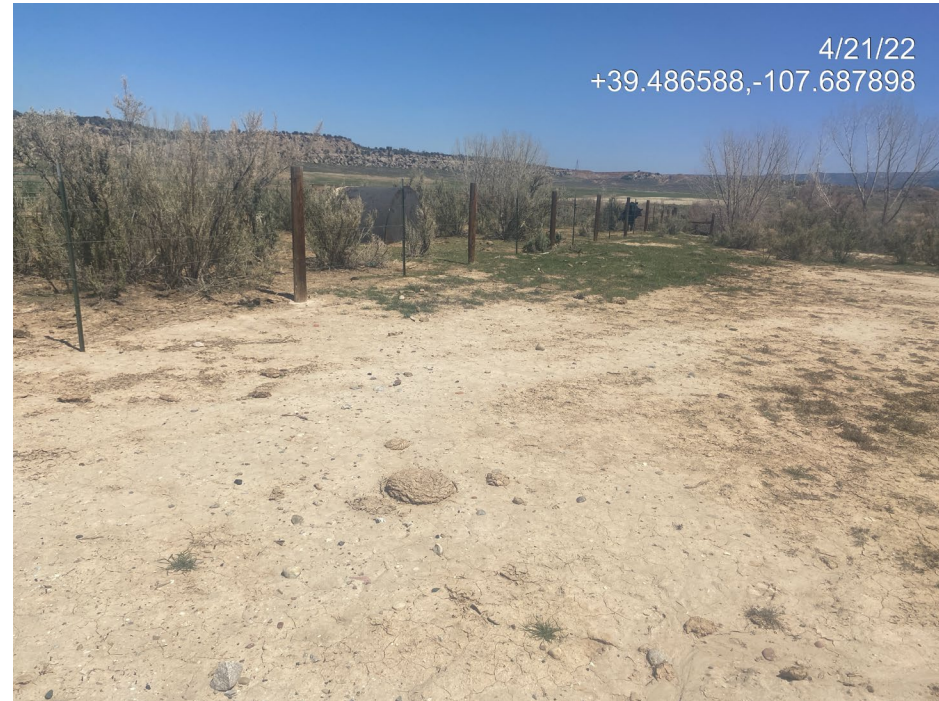
**Photo 5.** Photo taken from the interim area to the east of the Location shows the interim area dominated by bare ground and annual undesirable plant species/weeds.

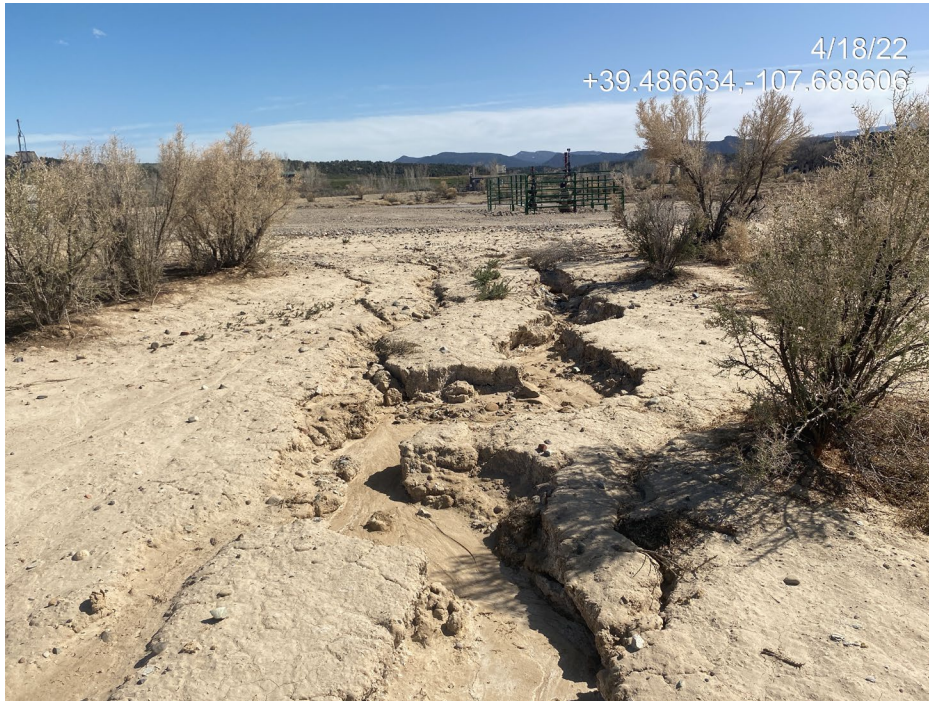
**Photo 6.** Photo taken from the north of the Location shows a gully developing on Location.

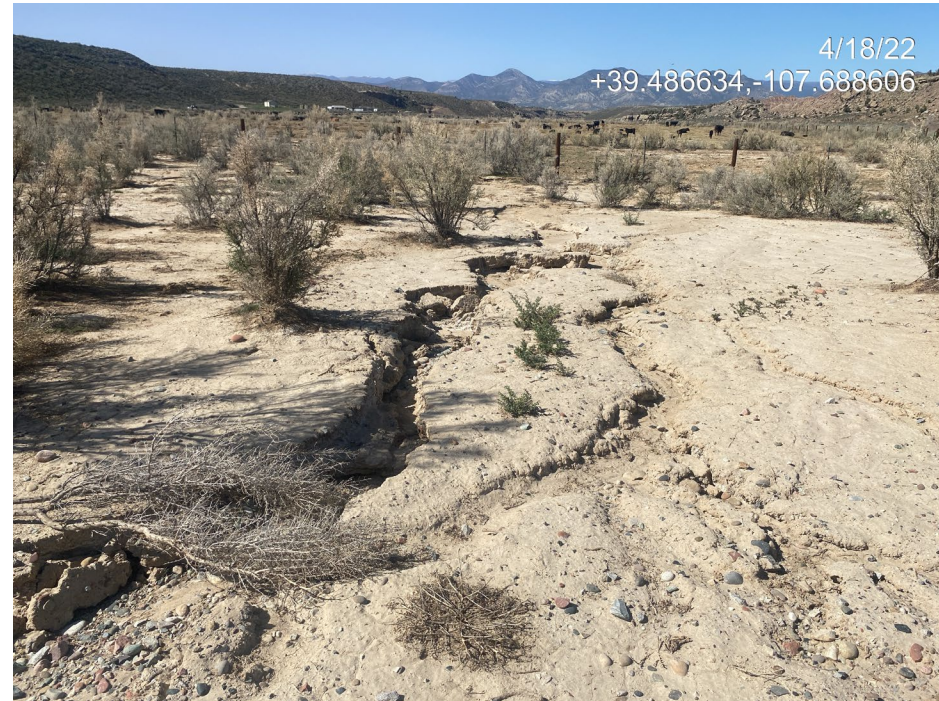
**Photo 7.** Photo taken from the north of the Location shows a gully developing on Location and leading into the adjacent property.

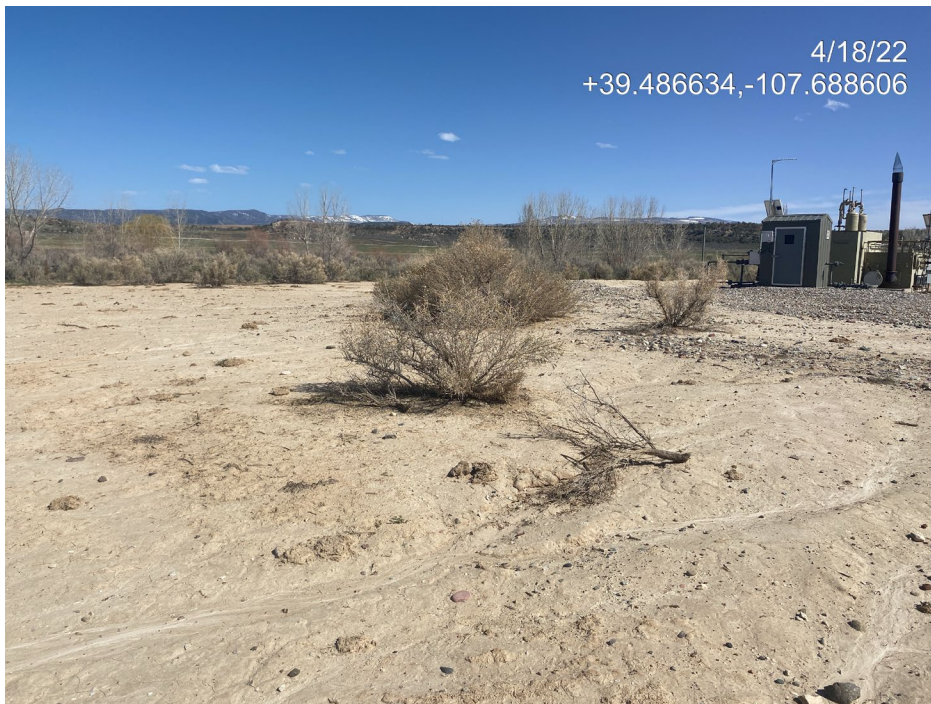
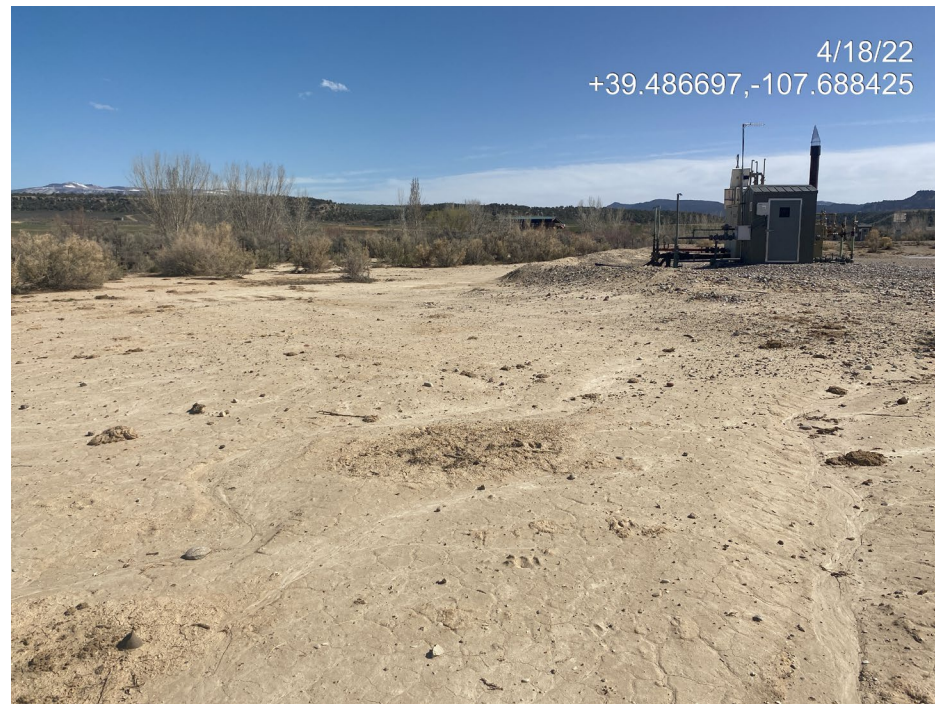
**Photo 8.** Photo taken from the north of the Location facing south shows erosion occurring in unvegetated/unstabilized interim areas.

**Photo 9.** Refer to Photo 8 comment.

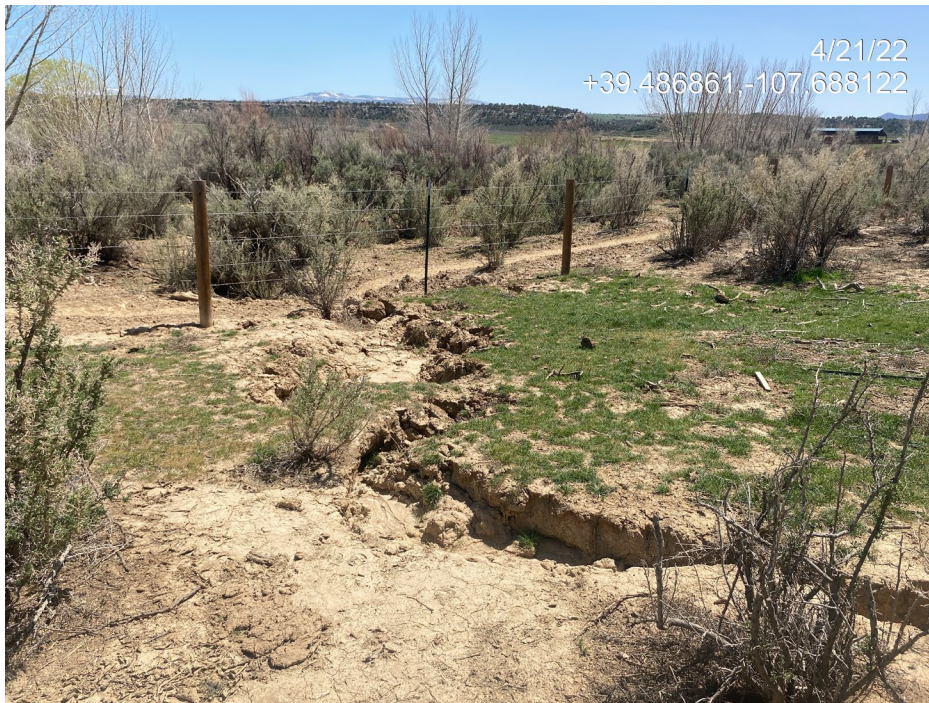
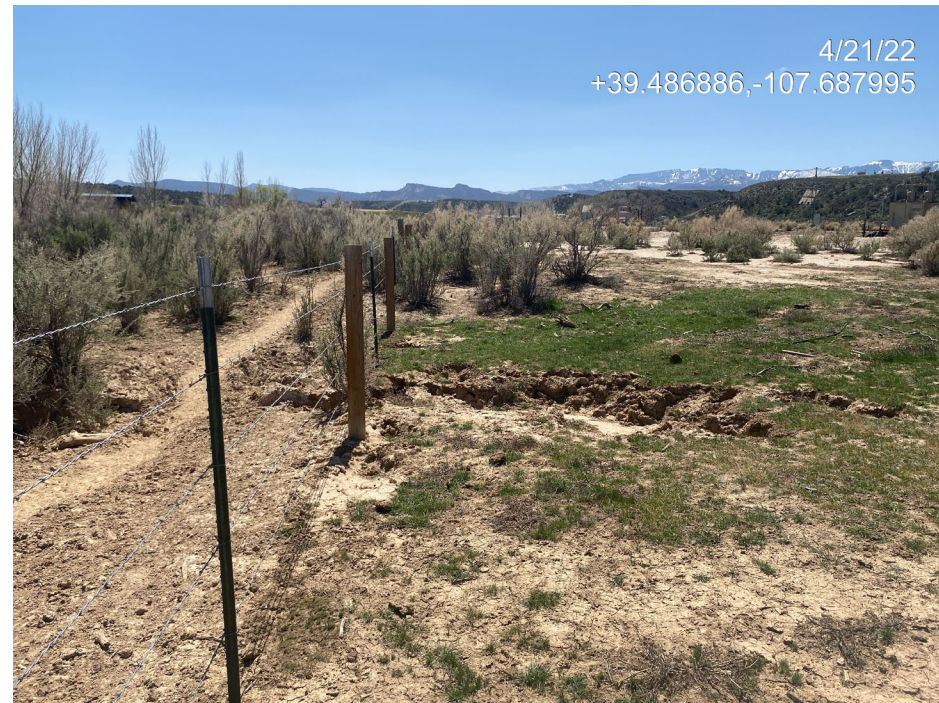
**Photo 10.** Photo taken from the north of the Location shows a gully developing on Location and leading into the adjacent property.

**Photo 11.** Refer to Photo 10 comment.

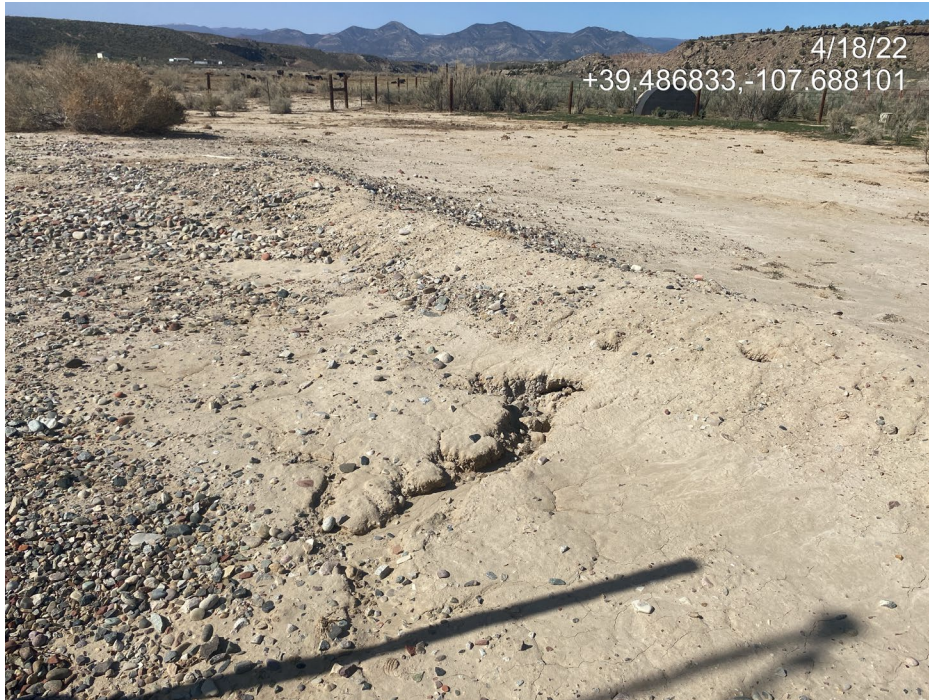
**Photo 12.** Photo taken from the east of the Location behind the separator. Photo is taken on the inside of the undermining berm where sediment is leaving the production area.

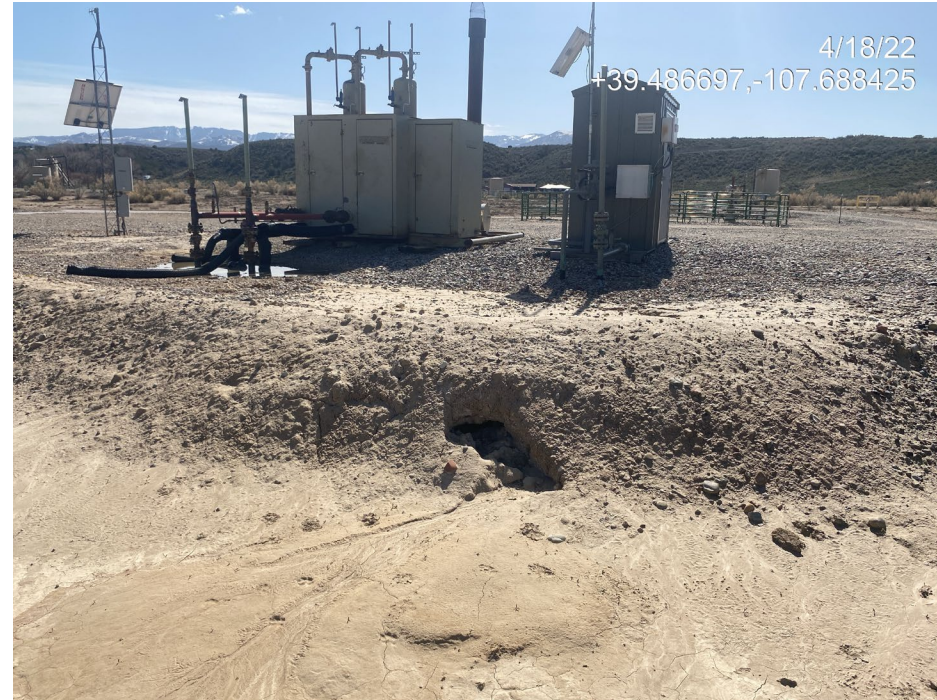
**Photo 13.** Photo taken from the east of the Location behind the separator. Photo is taken on the outside of the undermining berm where sediment is coming through.

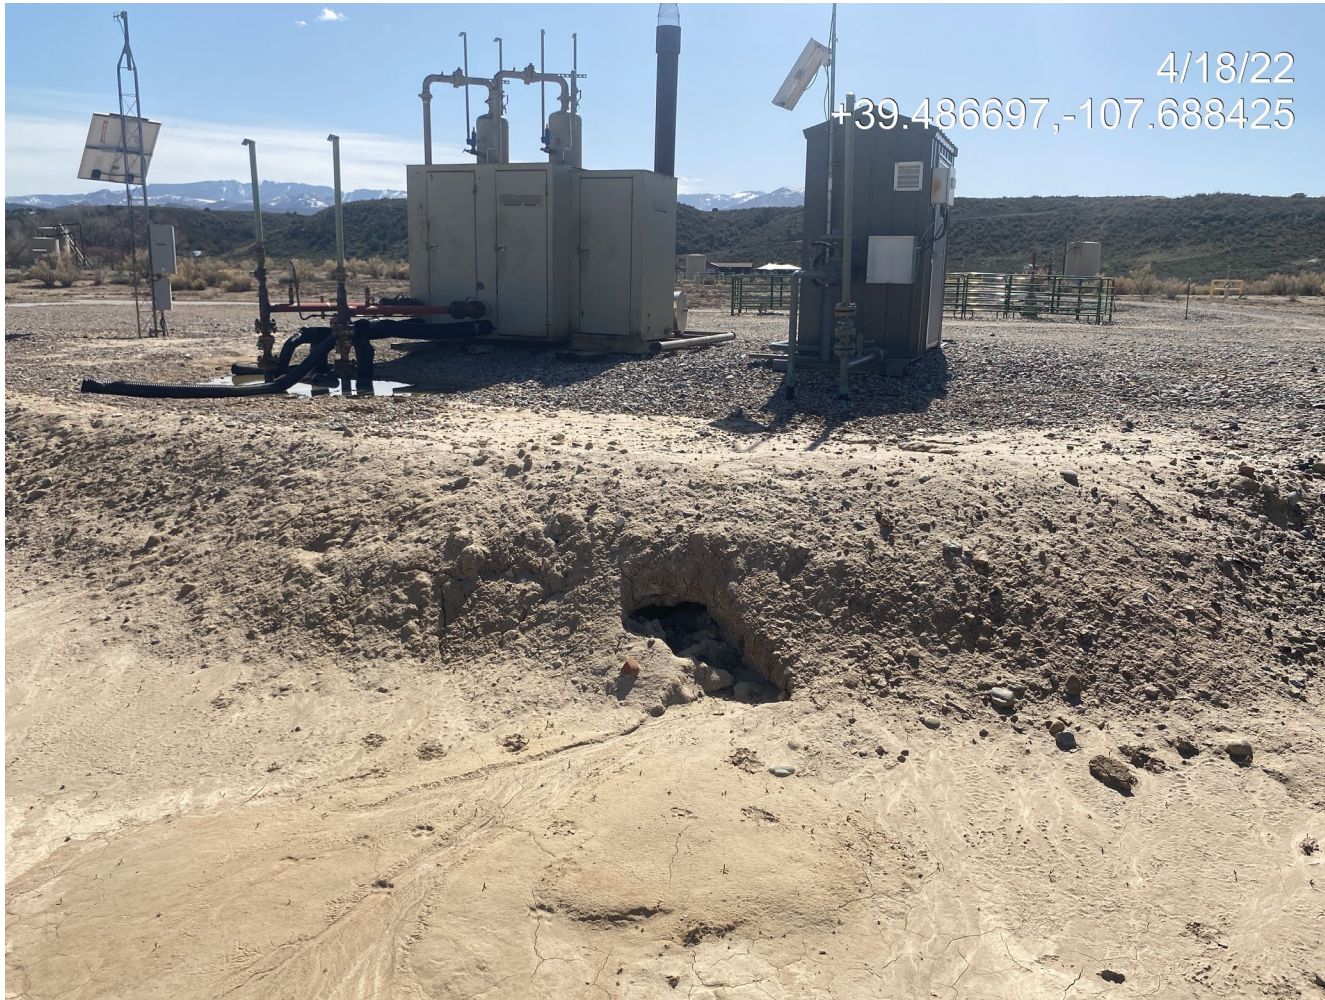
**Photo 14.** Photo taken from the east of the Location behind the separator shows the berm undermining. Sediment is coming through the berm.
