Site Inspection Report

Site: UPRR 43 PAN AM G
CONSOLIDATION #2
04/22/2022

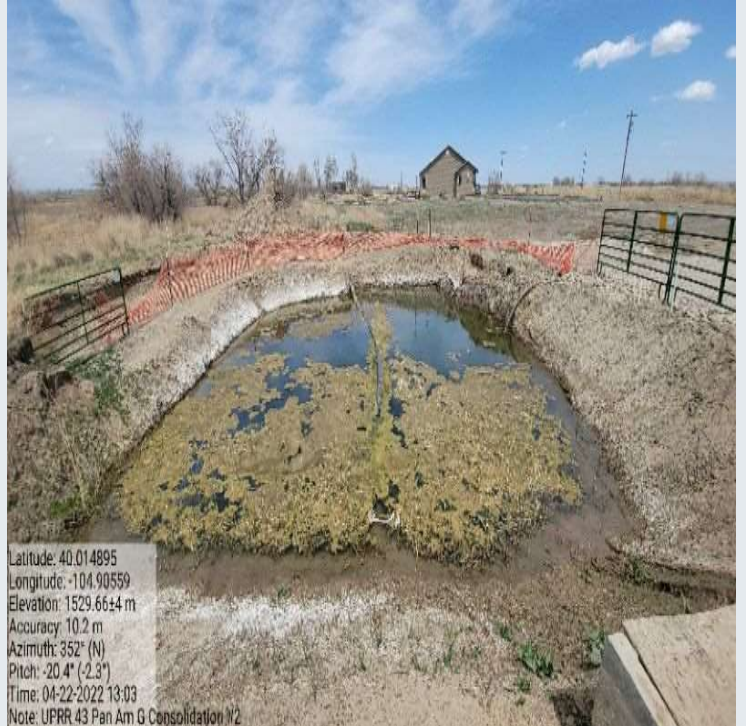
Remediation Activity Checklist	
	Photo
Question: Open excavation? Approximate size (Length x Width x Depth, ft) Response: Yes Notes: 75x15x10

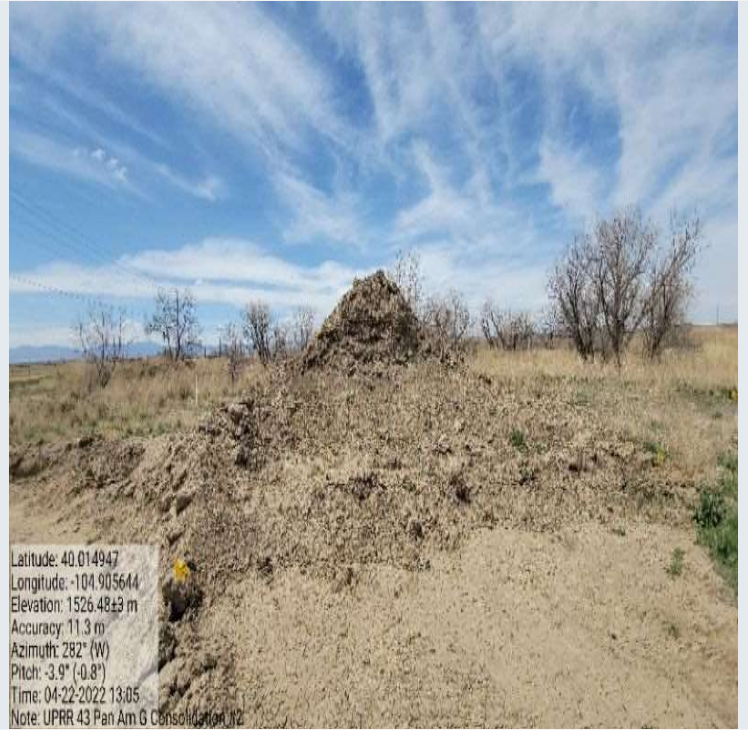
Question: Stockpiled waste and approximate volume (cubic yards)

Response: Yes

Notes: Uncompact earthen berm installed around stockpiled waste has failed. No liner visible or other BMPs installed.

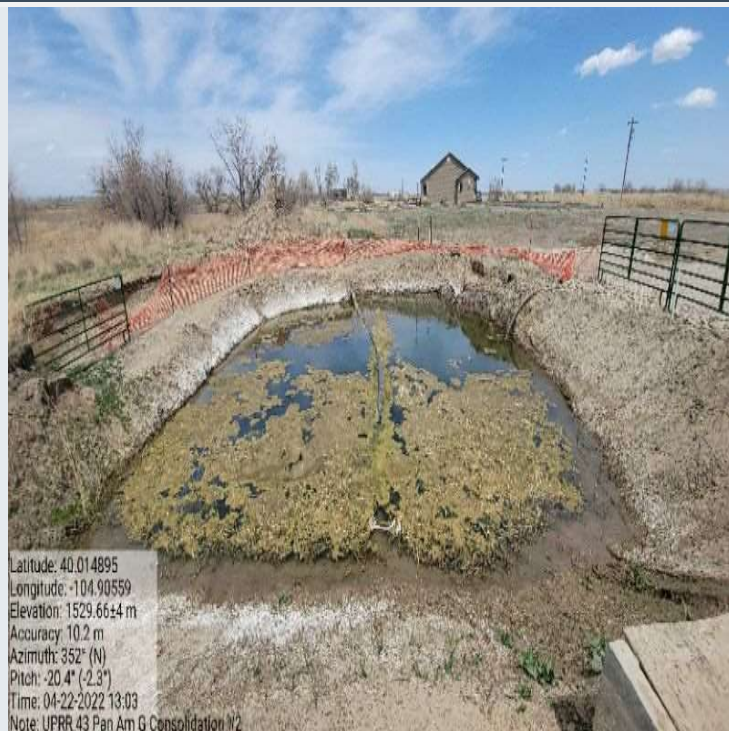
Question: Groundwater present? (Depth, ft) Note: Free product/Sheen
Response: Yes
Notes: Groundwater present. Trash and debris, no apparent sheen.

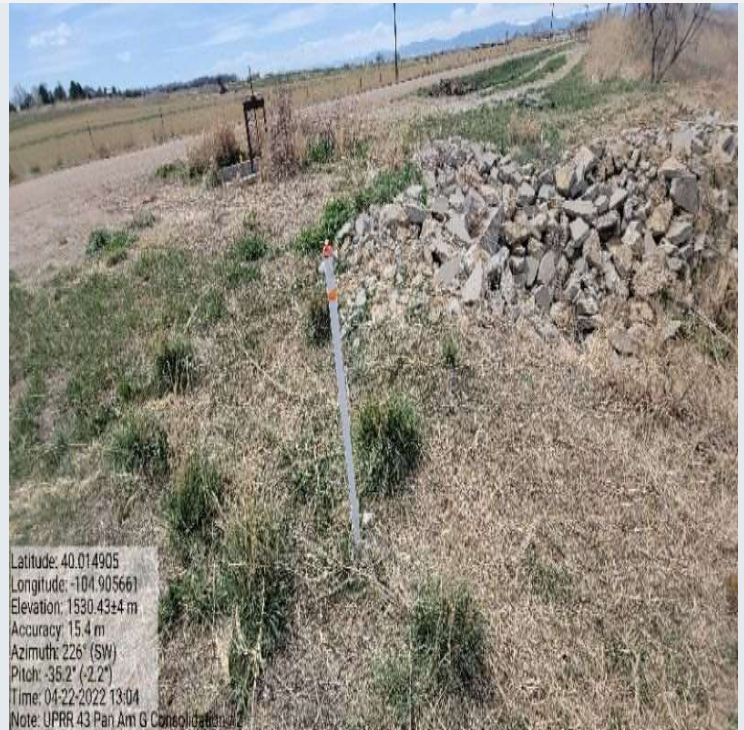
Question: Monitoring well(s) present? If so note number and approximate location

Response: 5

Notes: Stickup – Photos show approximate locations.

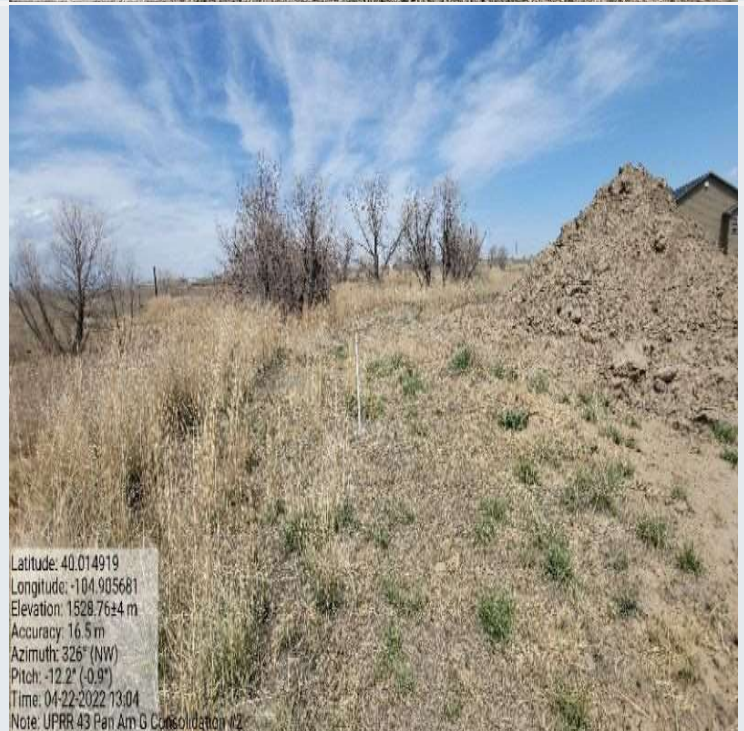
Question: Monitoring well(s) present? If so note number and approximate location

Response: 5

Notes: Stickup – Photos show approximate locations.

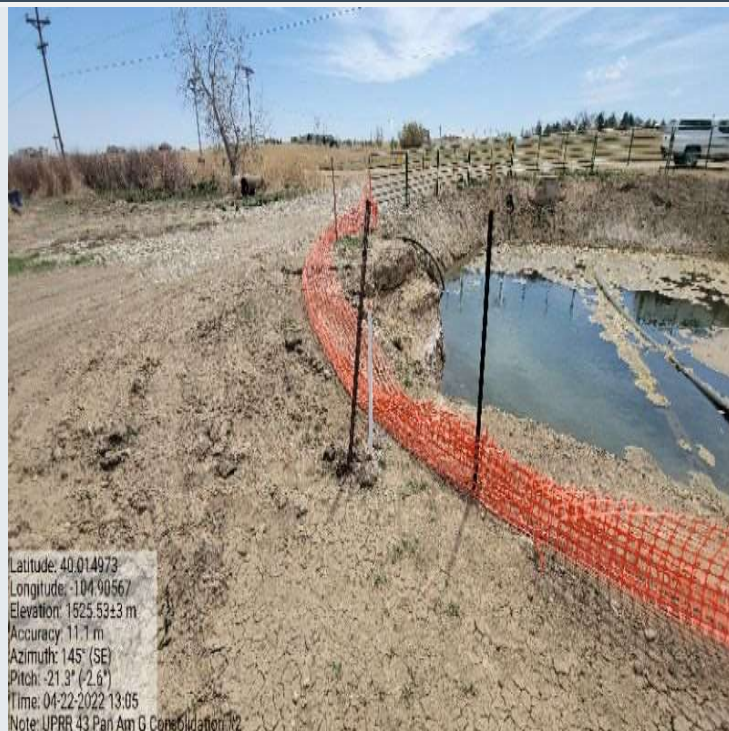
Question: Monitoring well(s) present? If so note number and approximate location

Response: 5

Notes: Stickup – Photos show approximate locations.

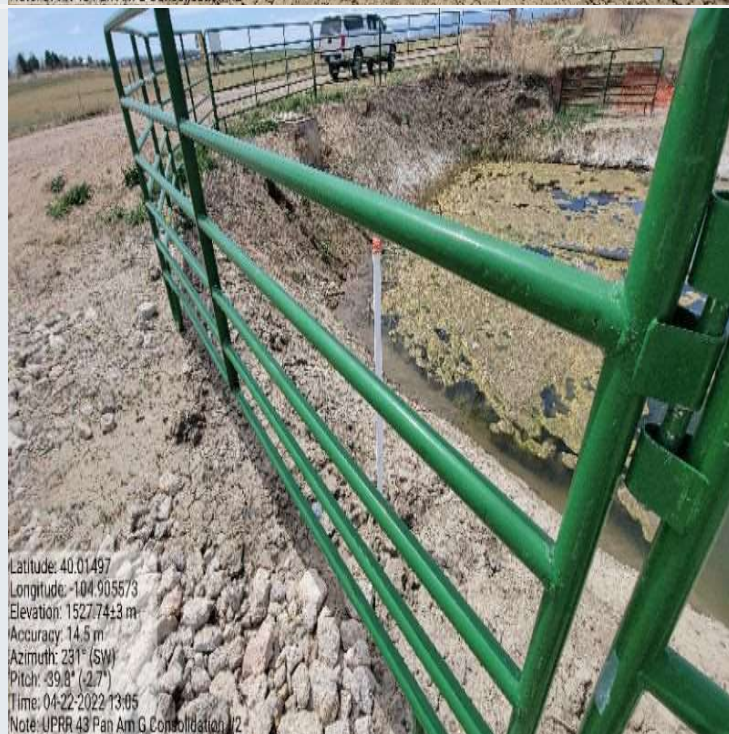
Question: Monitoring well(s) present? If so note number and approximate location

Response: 5

Notes: Stickup – Photos show approximate locations.

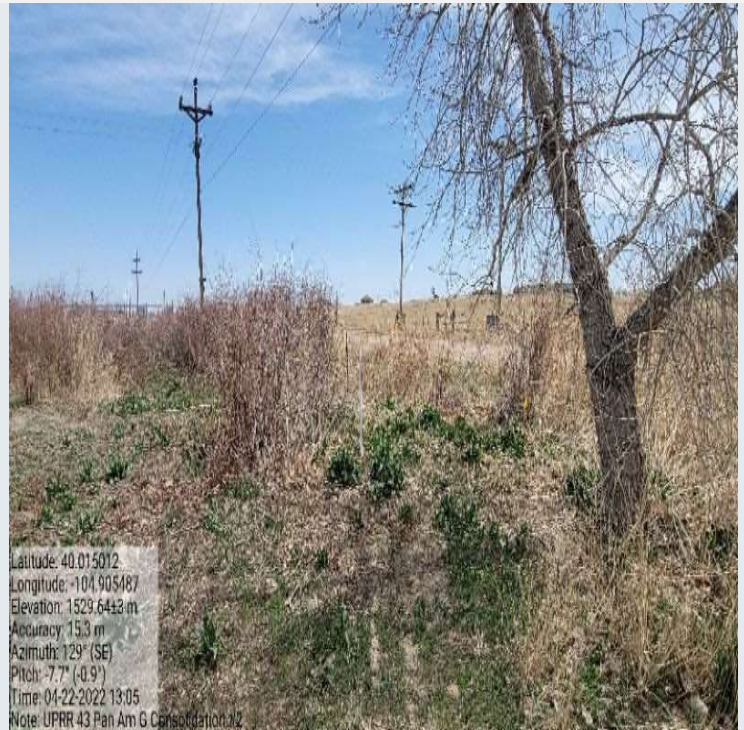
Question: Monitoring well(s) present? If so note number and approximate location

Response: 5

Notes: Stickup – Photos show approximate locations.

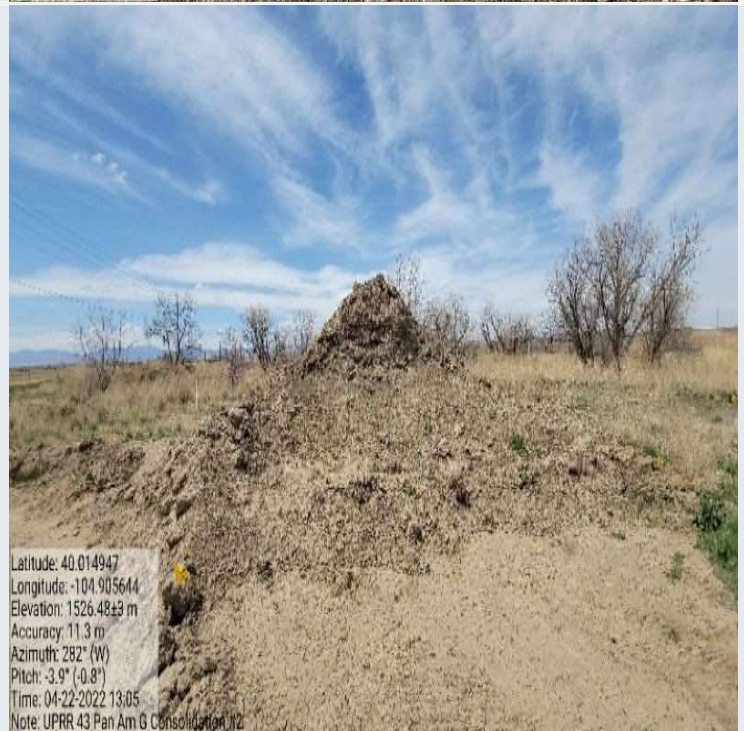
Question: Soil impacts remain in situ?

Response: Yes

Notes: Impacted soil remains insitu within the excavation and stockpiled on site.

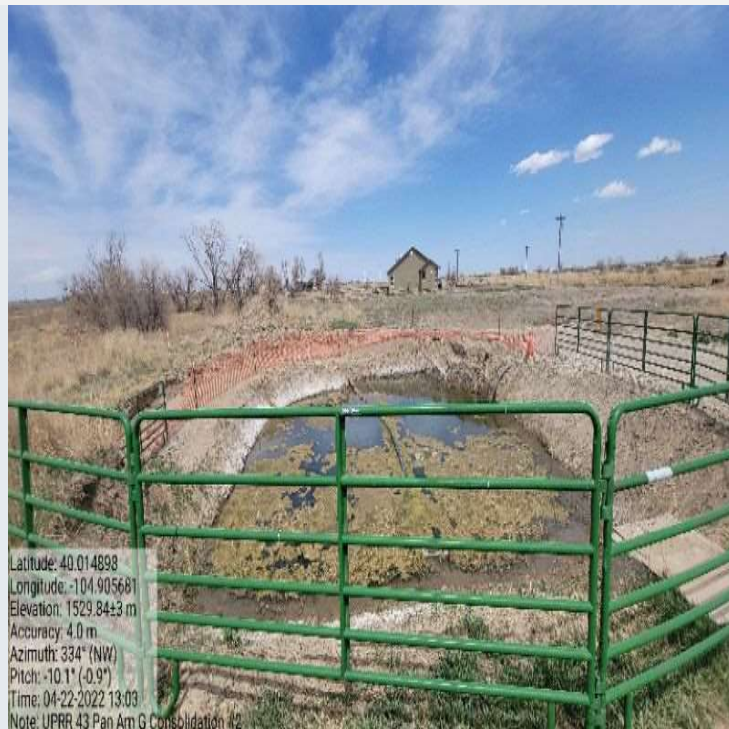
Question: Site properly fenced (in accordance with rule 913.b.(5)B.i)?

Response: No

Notes: Construction fencing around a portion of the excavation has fallen and is in need of repair. Another portion of the excavation is not fenced in.

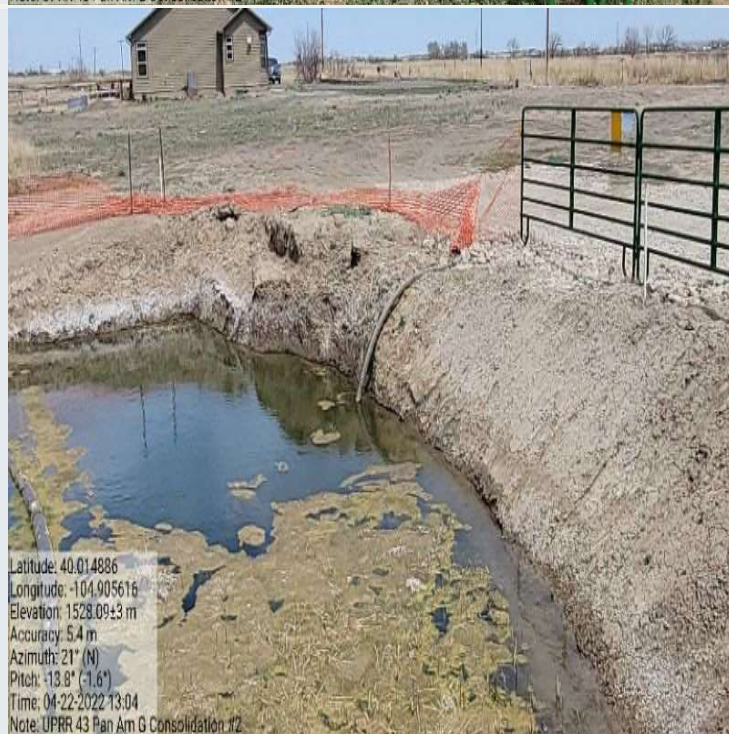
Question: Is fencing adequate/appropriate for site and well maintained?

Response: No

Notes: Construction fencing around a portion of the excavation has fallen and is in need of repair. Another portion of the excavation is not fenced in.

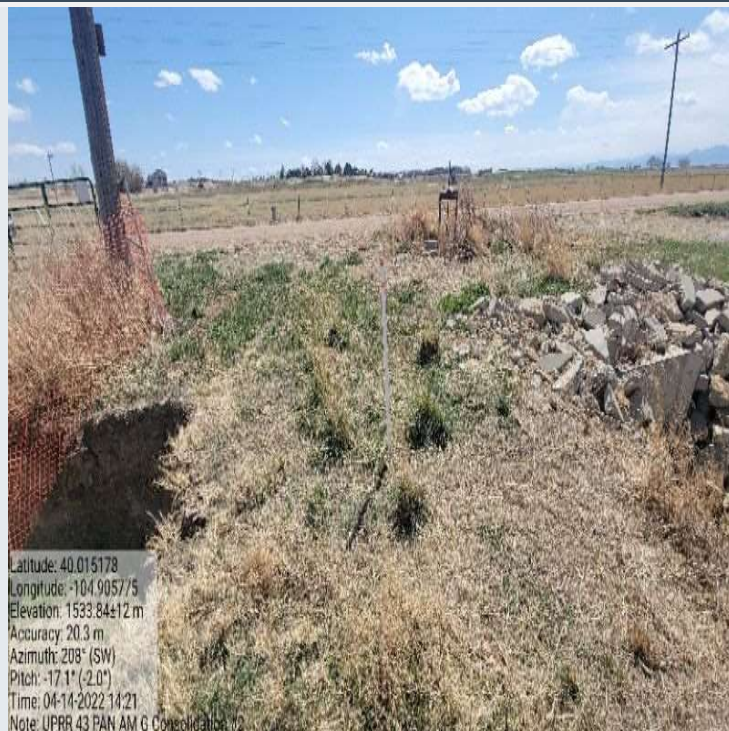
Question: Is fencing adequate/appropriate for site and well maintained?

Response: No

Notes: Construction fencing around a portion of the excavation has fallen and is in need of repair. Another portion of the excavation is not fenced in.

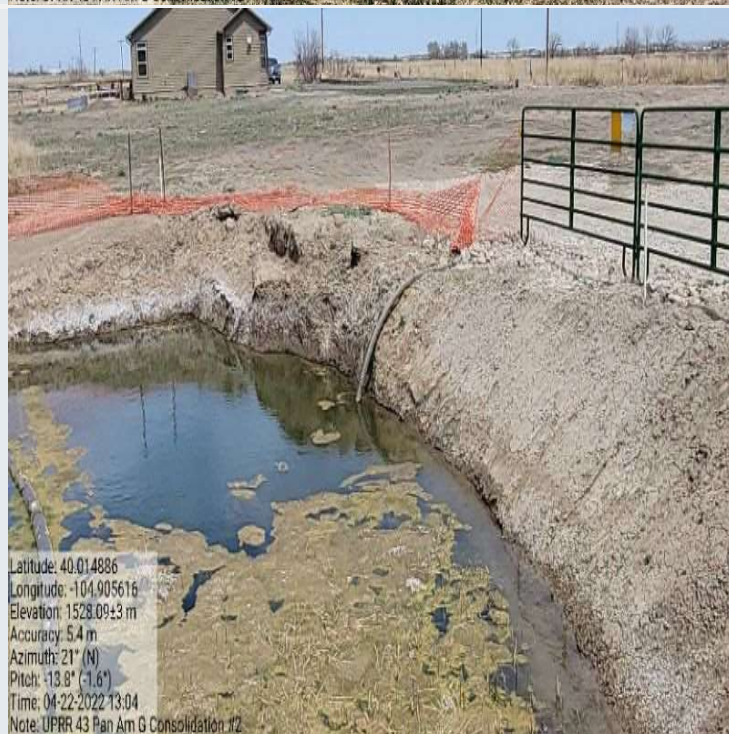
Question: Exposed buried/underground flowlines?

Response: Yes

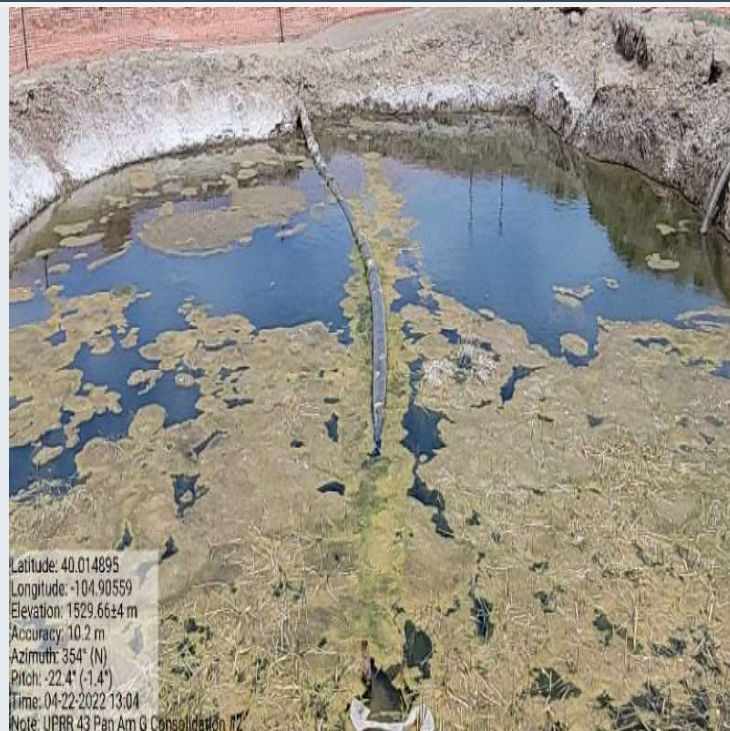
Question: Exposed buried/underground flowlines?

Response: Yes

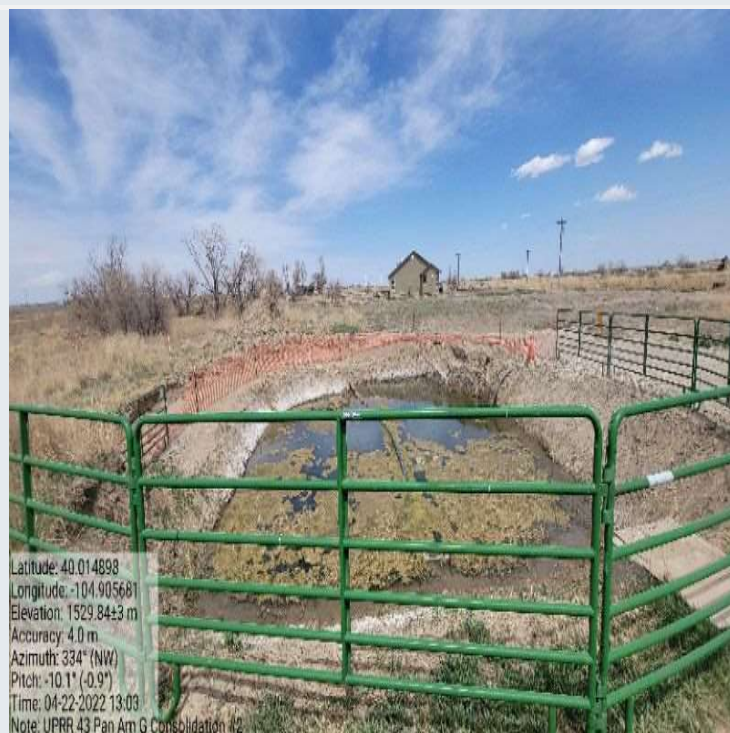
Question: Site is protected from vehicular traffic?

Response: No

Notes: Fallen orange construction fencing around excavation does not provide adequate protection from vehicular traffic.

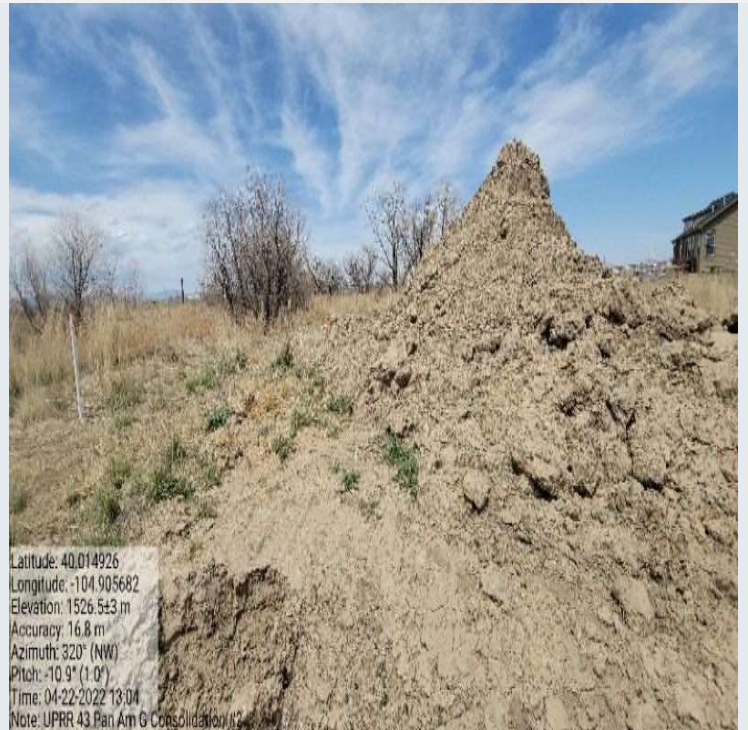
Photo
<p>Question: Is an earthen berm secondary containment present and in good condition (no evidence of erosion, animal burrowing, etc.)?</p> <p>Response: No</p> <p>Notes: Uncompact earthen berm installed around stockpiled waste has failed.</p>

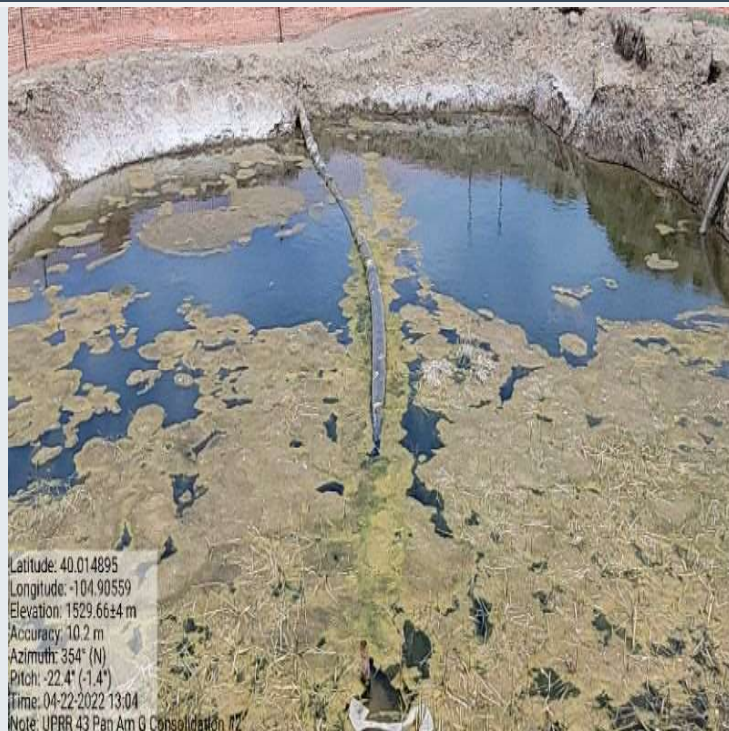
Question: Site is free of debris/trash?

Response: No

Notes: Weeds/debris observed within open excavation and weeds on site.

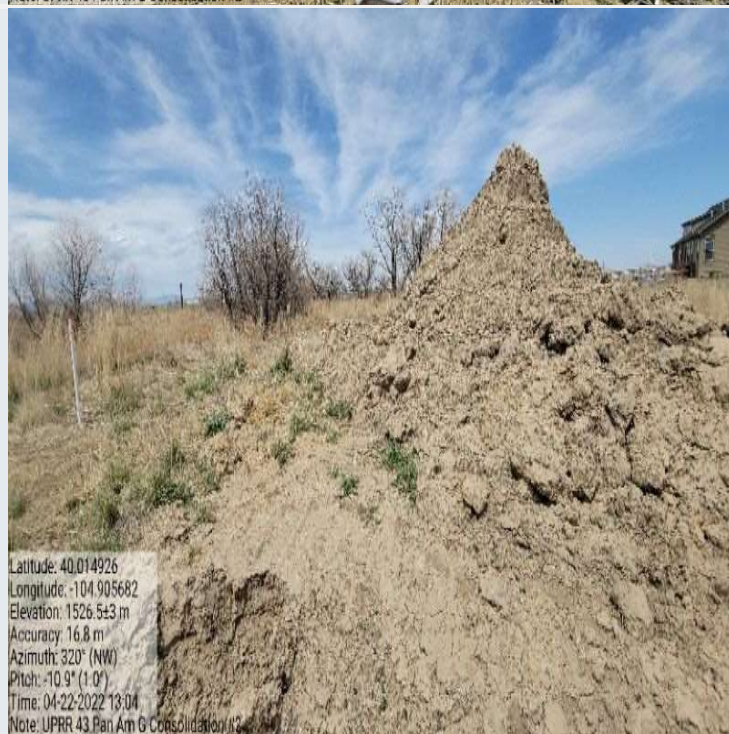
Question: Potential pollutants (trash, material stockpiles) are properly contained?

Response: No

Notes: Inadequate containment - Uncompact earthen berm installed around stockpiled waste has failed. No additional control measures are in place.

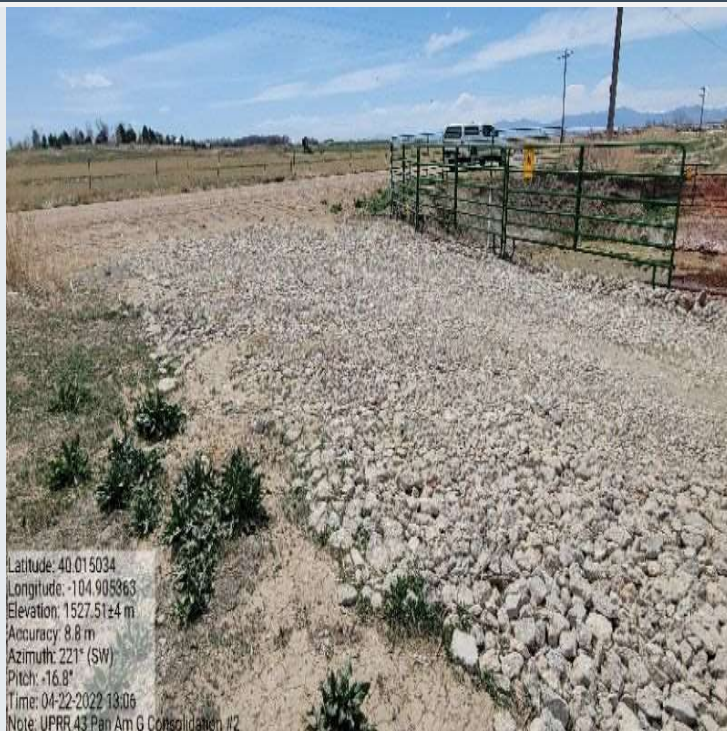
Question: Evidence of sediment/debris observed on adjacent roads? (If yes, is note tracking control BMP presence/conditions)

Response: No

Notes: Trackout control installed.
