Inspection Photos
Operator: Simcoe
API: 067-07138
Date: 4/26/2022

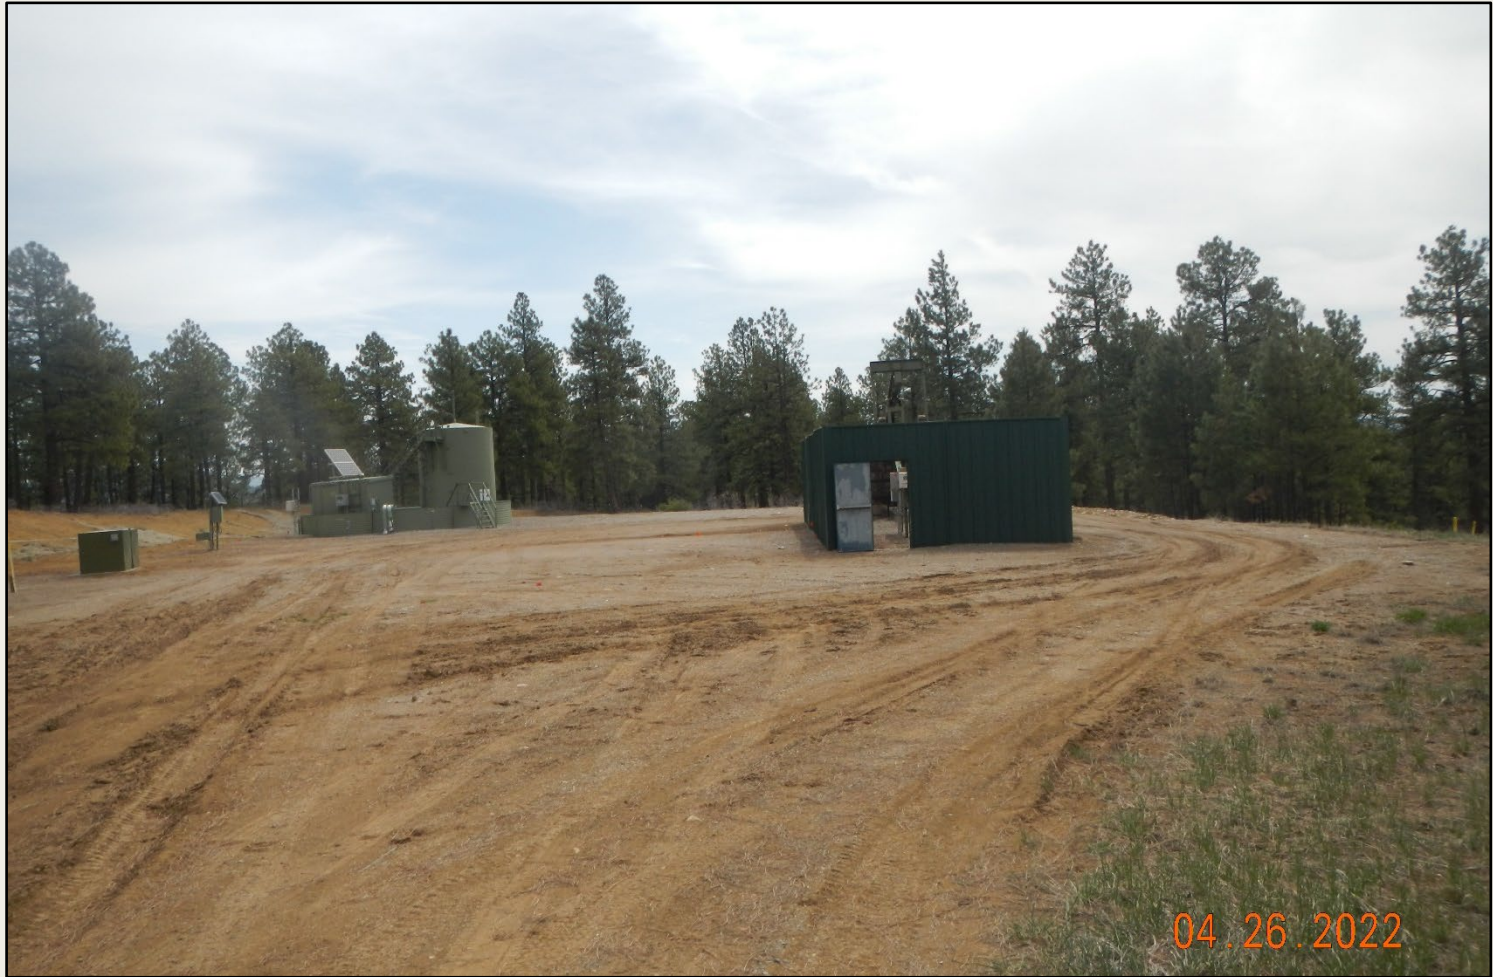
Photo 1. View of the project area from the southeastern corner facing center.

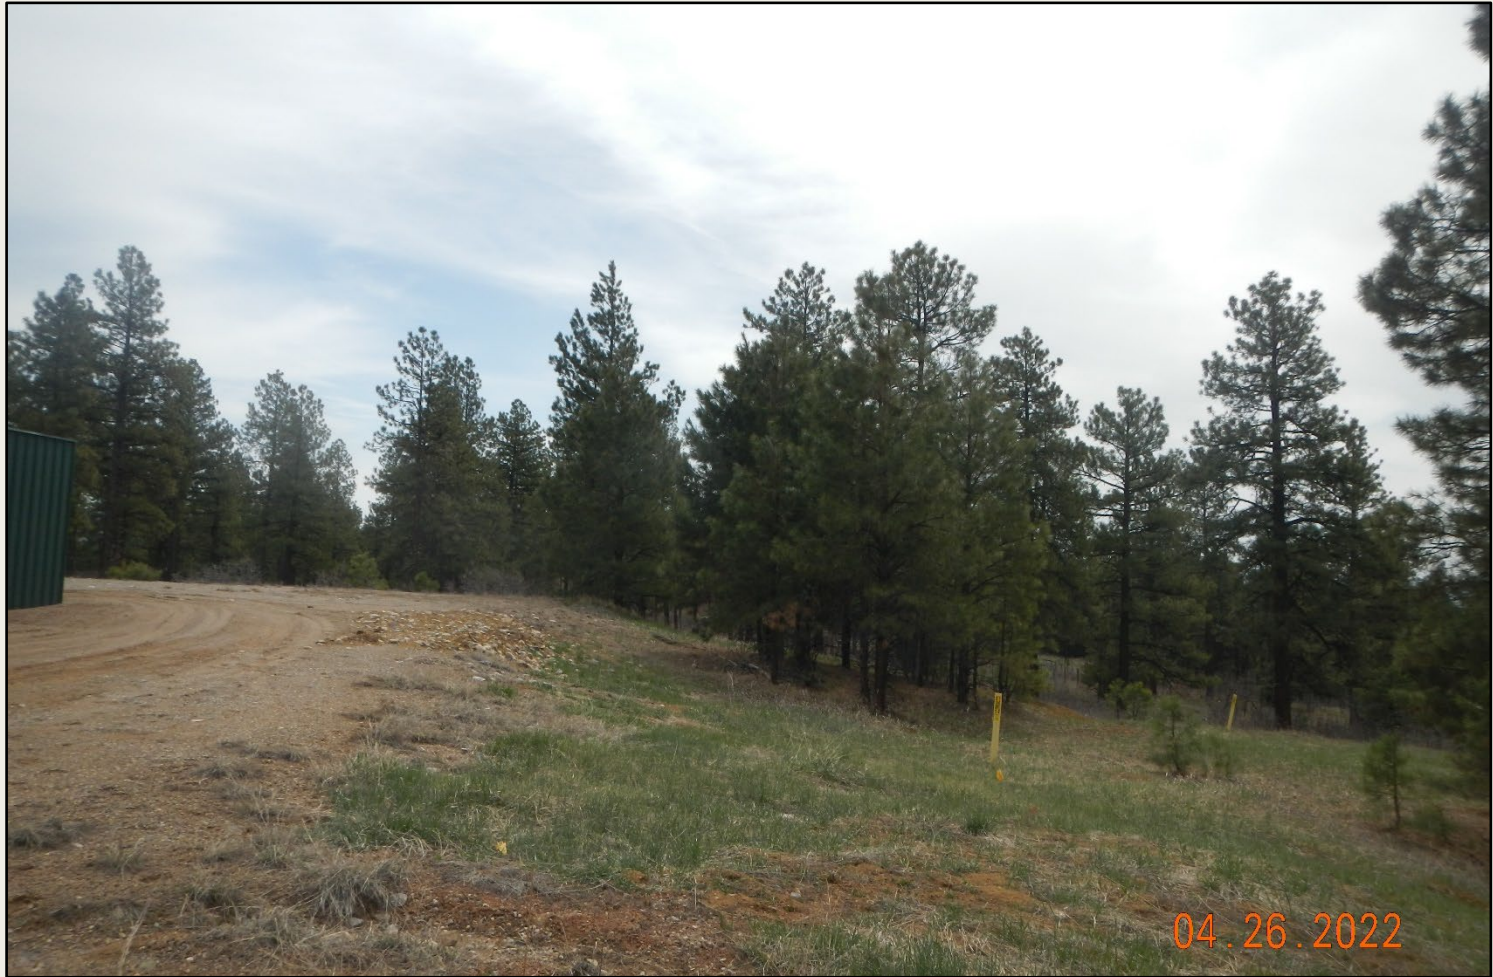
Photo 2. View of the southern project area from the southwestern corner facing eastward. Revegetation is progressing with smooth brome (*Bromus inermis*), western wheatgrass (*Pascopyrum smithii*), and sand dropseed (*Sporobolus cryptandrus*).

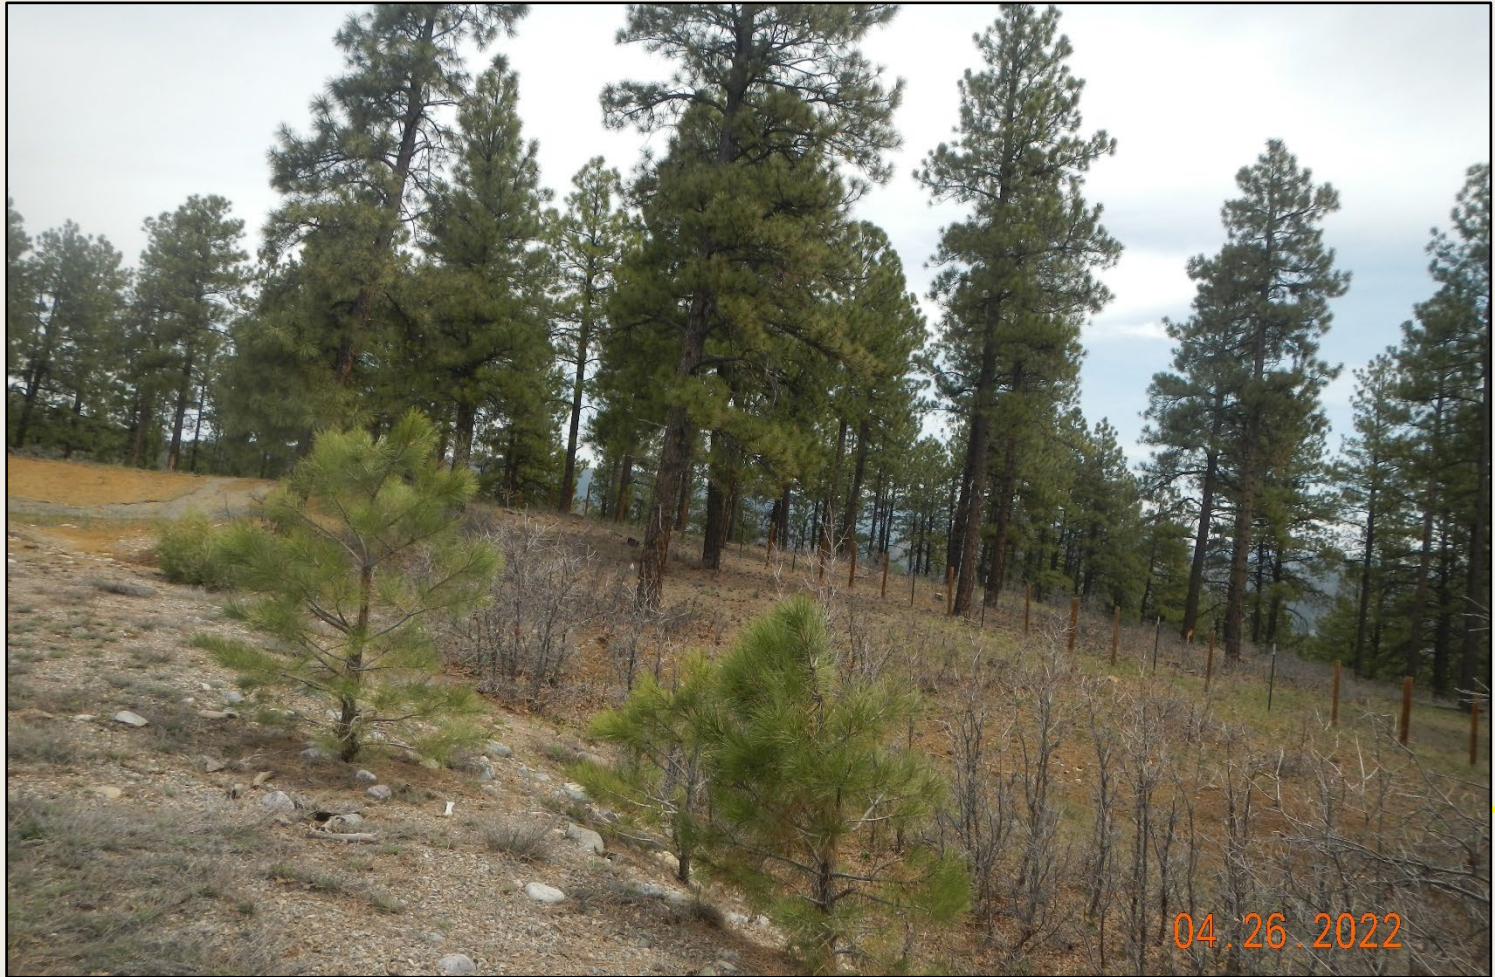
Photo 3. View of the eastern project area from the southeastern corner facing northward.

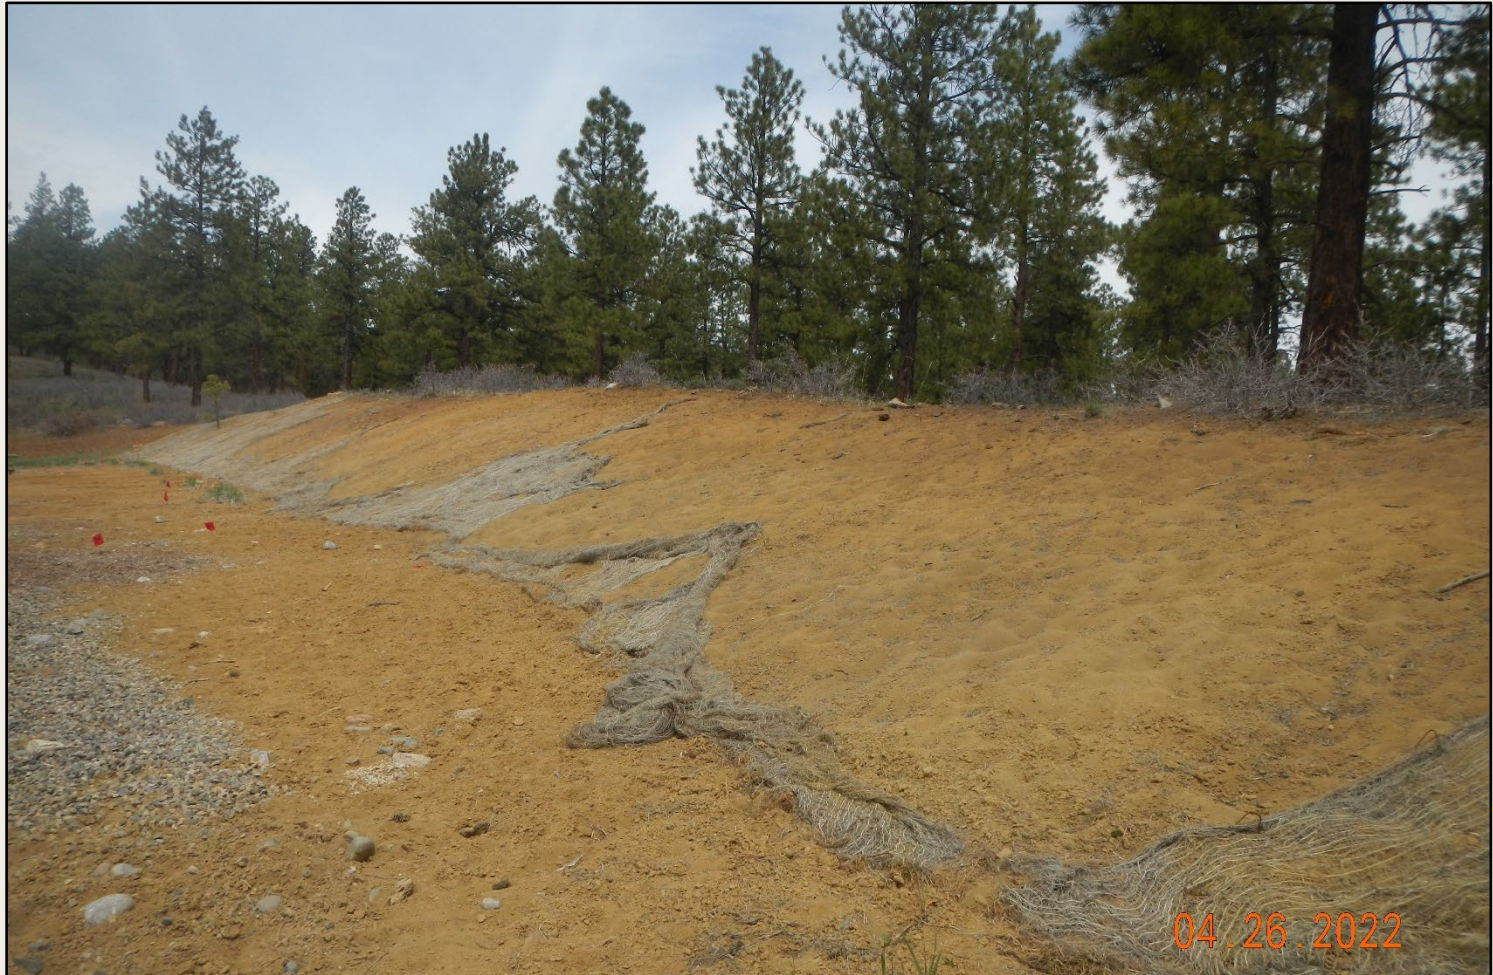
Photo 4. View of straw blankets on the well pad cut-slope no longer functioning.

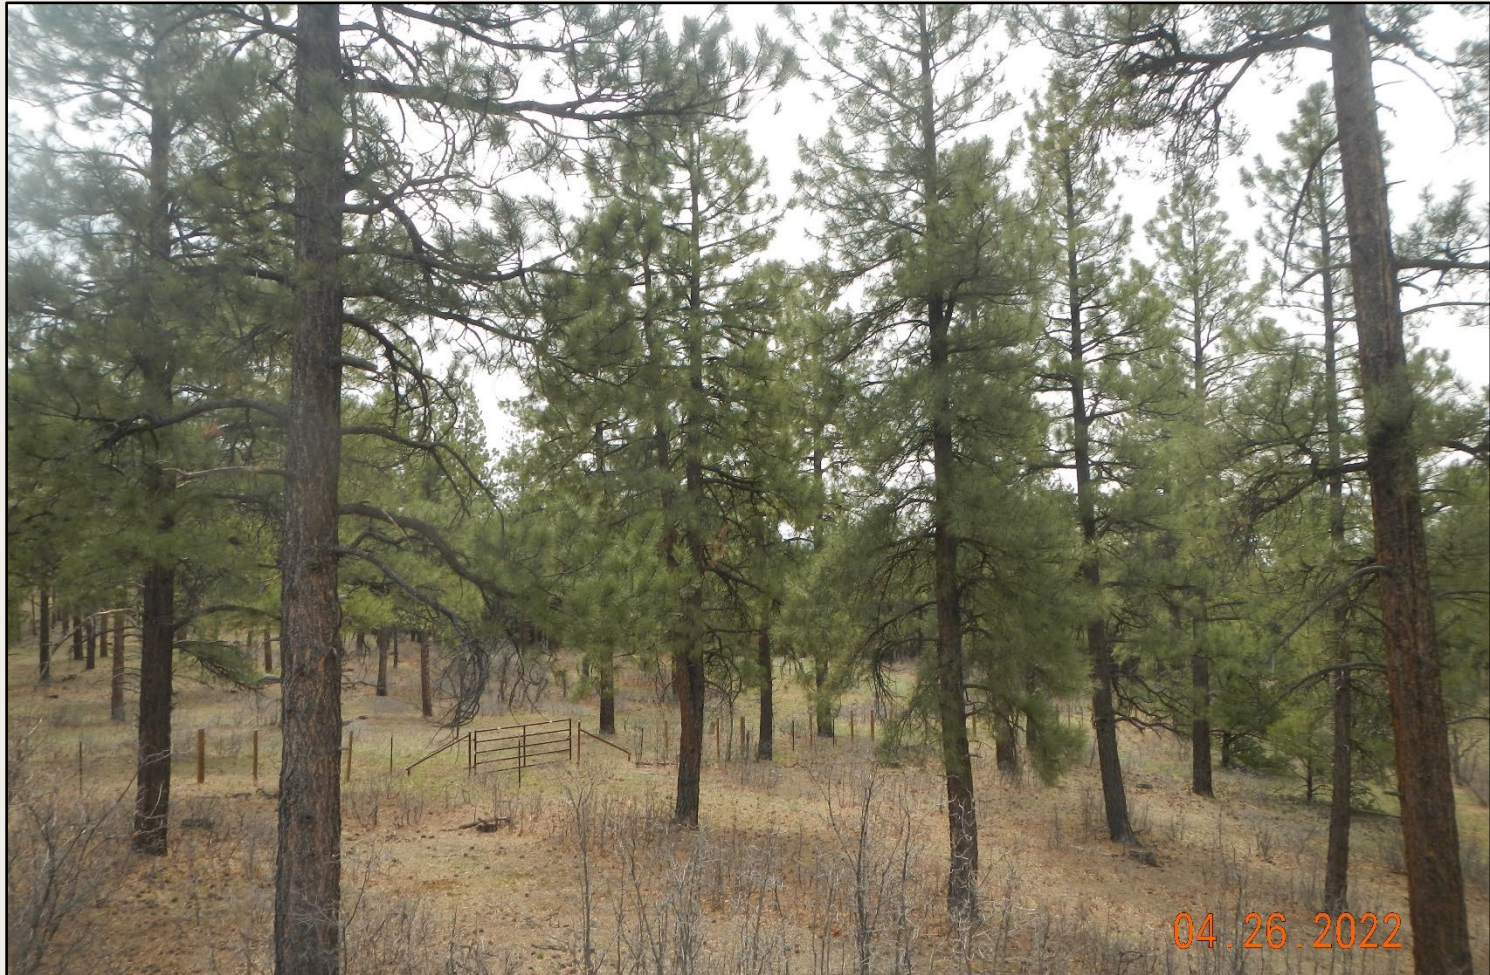
Photo 5. View of the reference area comprised of ponderosa pine forest with gambel oak (*Quercus gambelii*), Oregon grape (*Mahonia repens*), and Idaho fescue (*Festuca idahoensis*).
