# Inspection Photos

API: 061-05138

Operator: WESTERN OPERATING COMPANY

Inspection Date: 4/25/2022

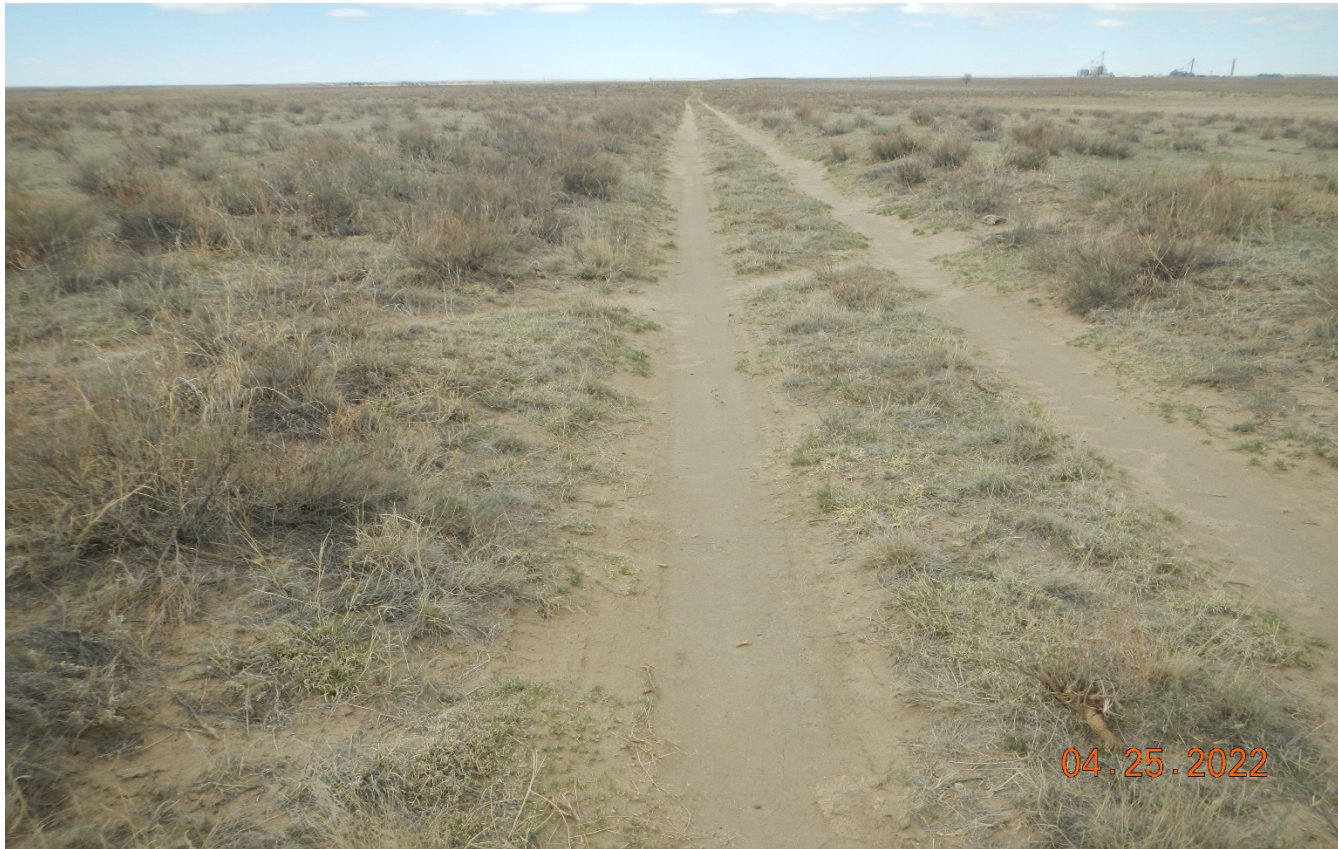
**Photo 1.** Facing north along the access road which has not been recontoured and reclaimed. Previous corrective action not completed.

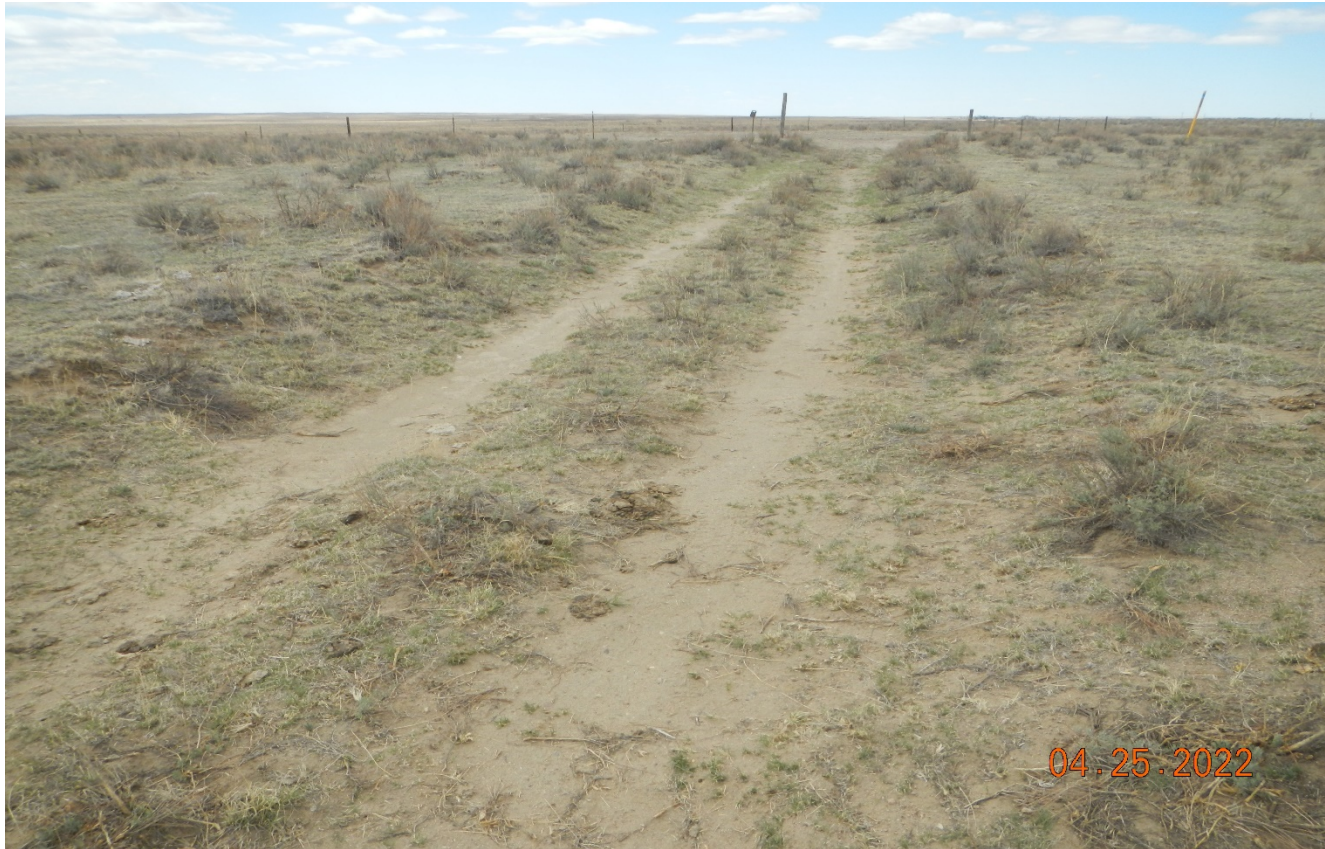
**Photo 2.** Facing northwest toward the former tank battery site located 300' southwest of the well site. The access road has not been recontoured and reclaimed.

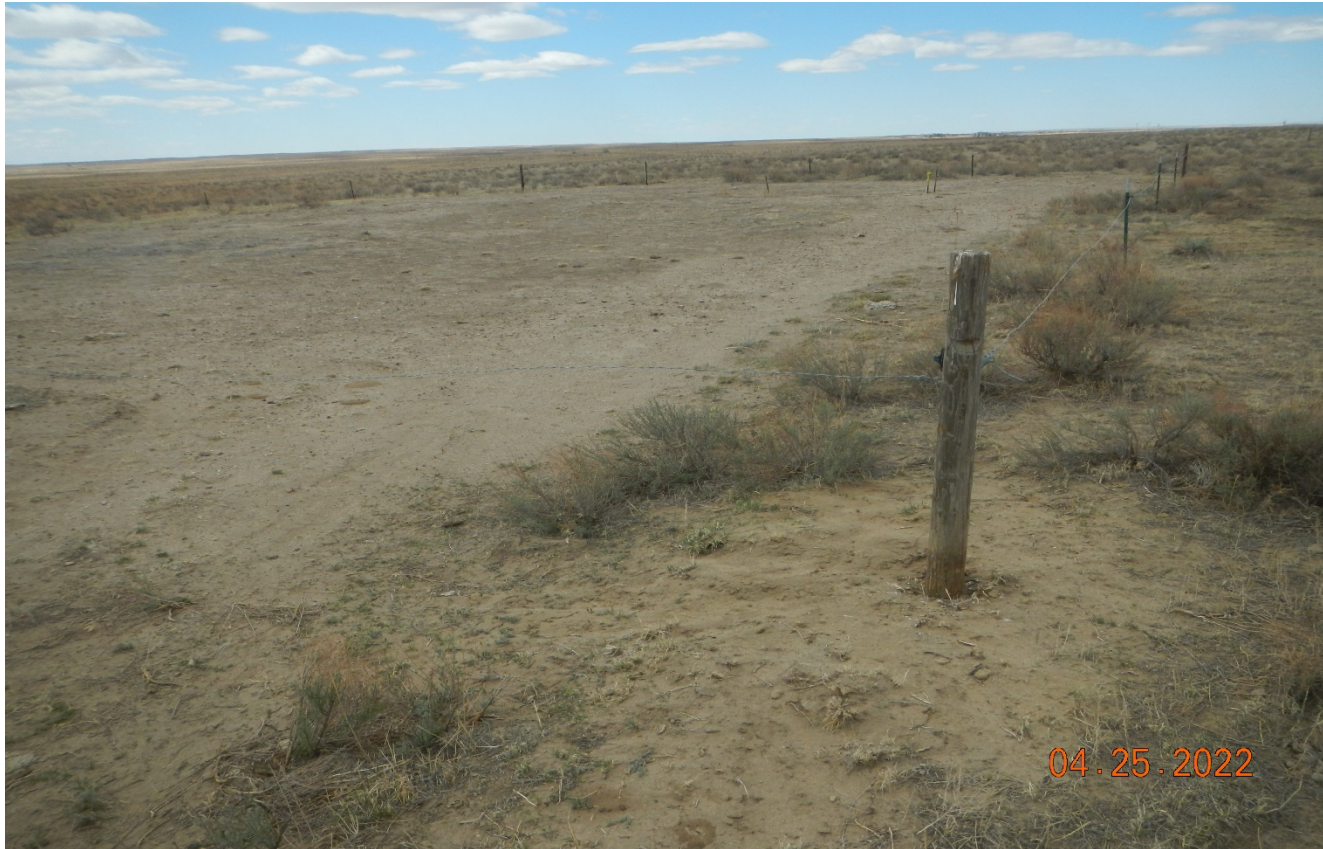
**Photo 3.** Facing northwest toward the former tank battery site located 300' southwest of the well site. This area has not been reclaimed. The electric fence was repaired.

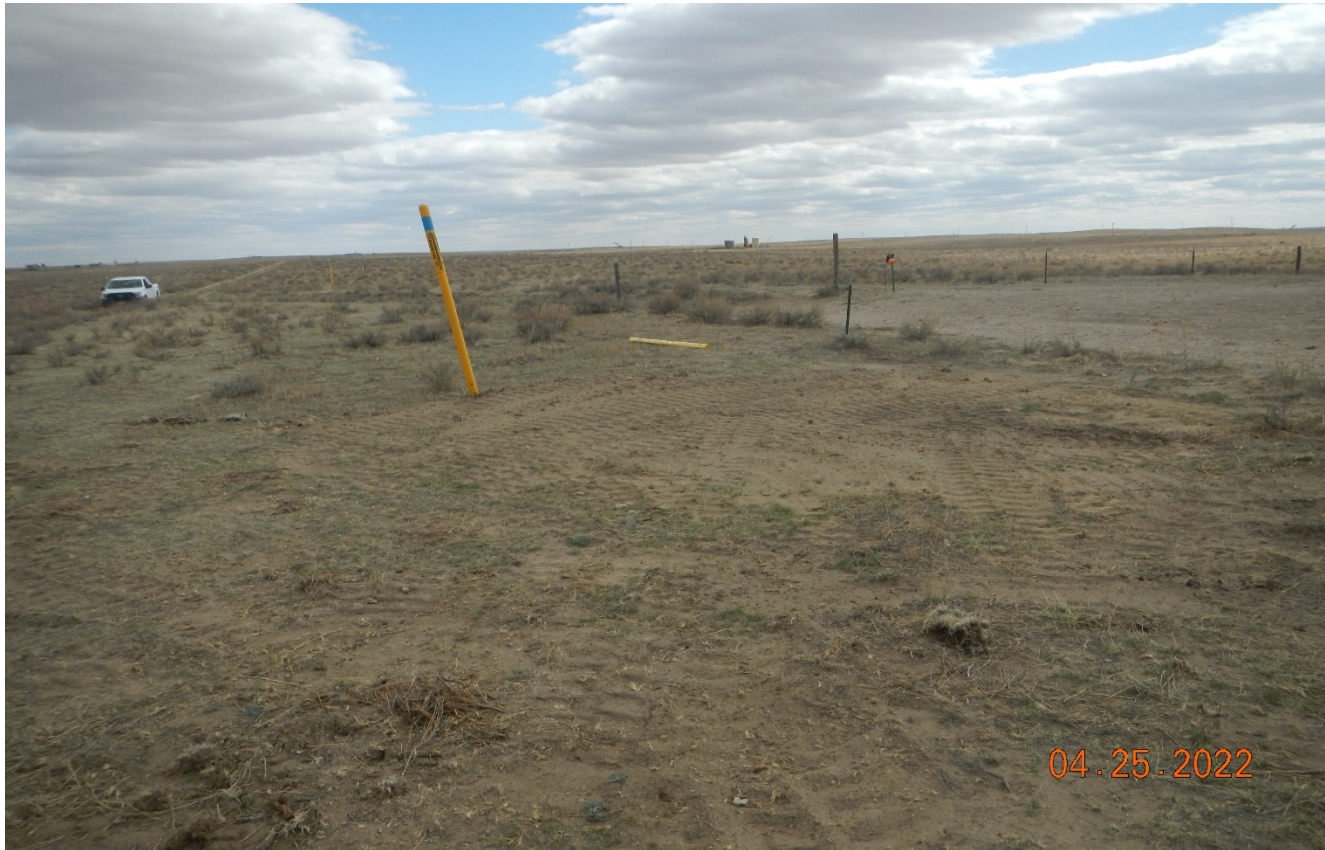
**Photo 4.** There is a pipe riser near the tank battery has been removed.

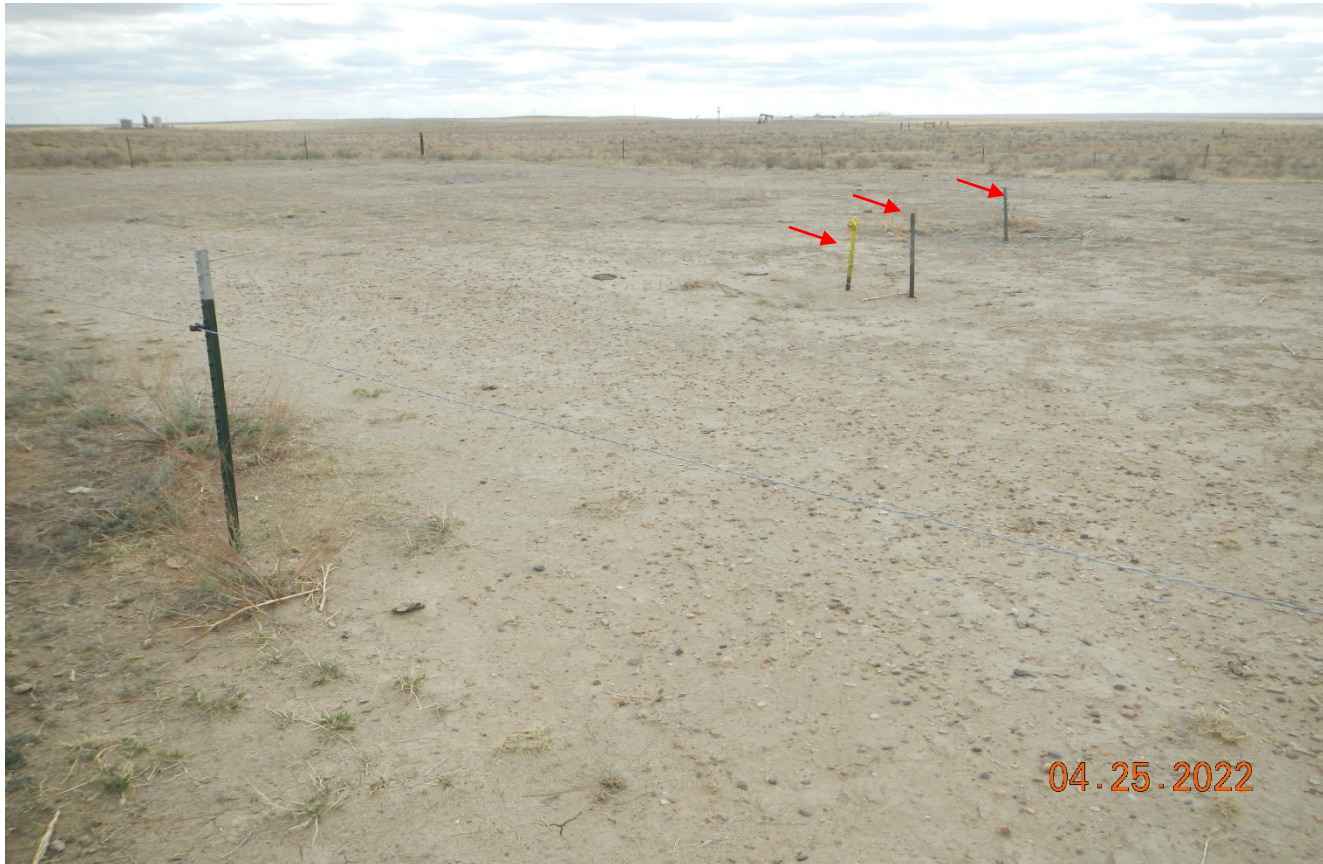
**Photo 5.** There are two pipes that remain at the battery site that need to be removed. Also a T-Post.

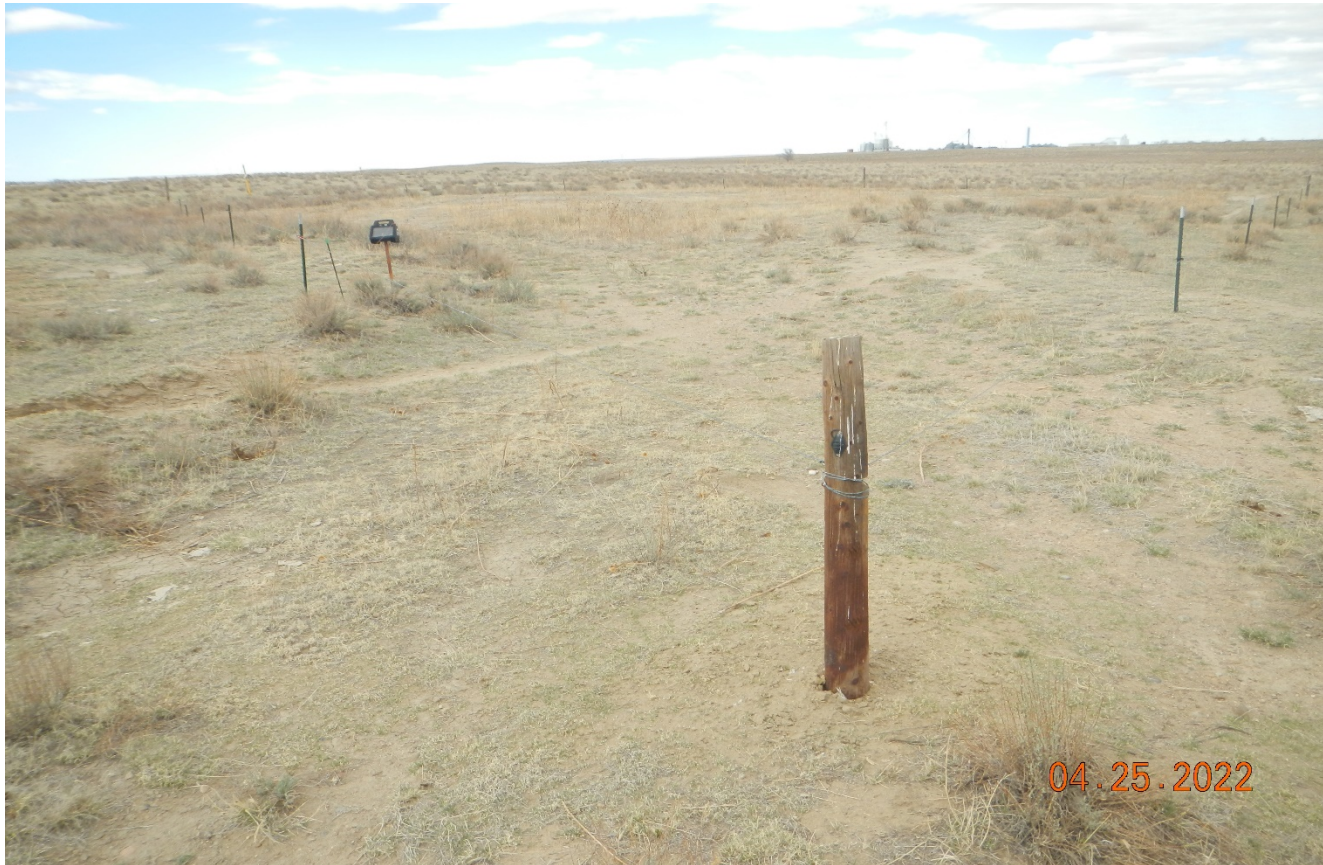
**Photo 6.** Facing southwest toward the abandoned battery site. This area has not been reclaimed. The electric fence was repaired.

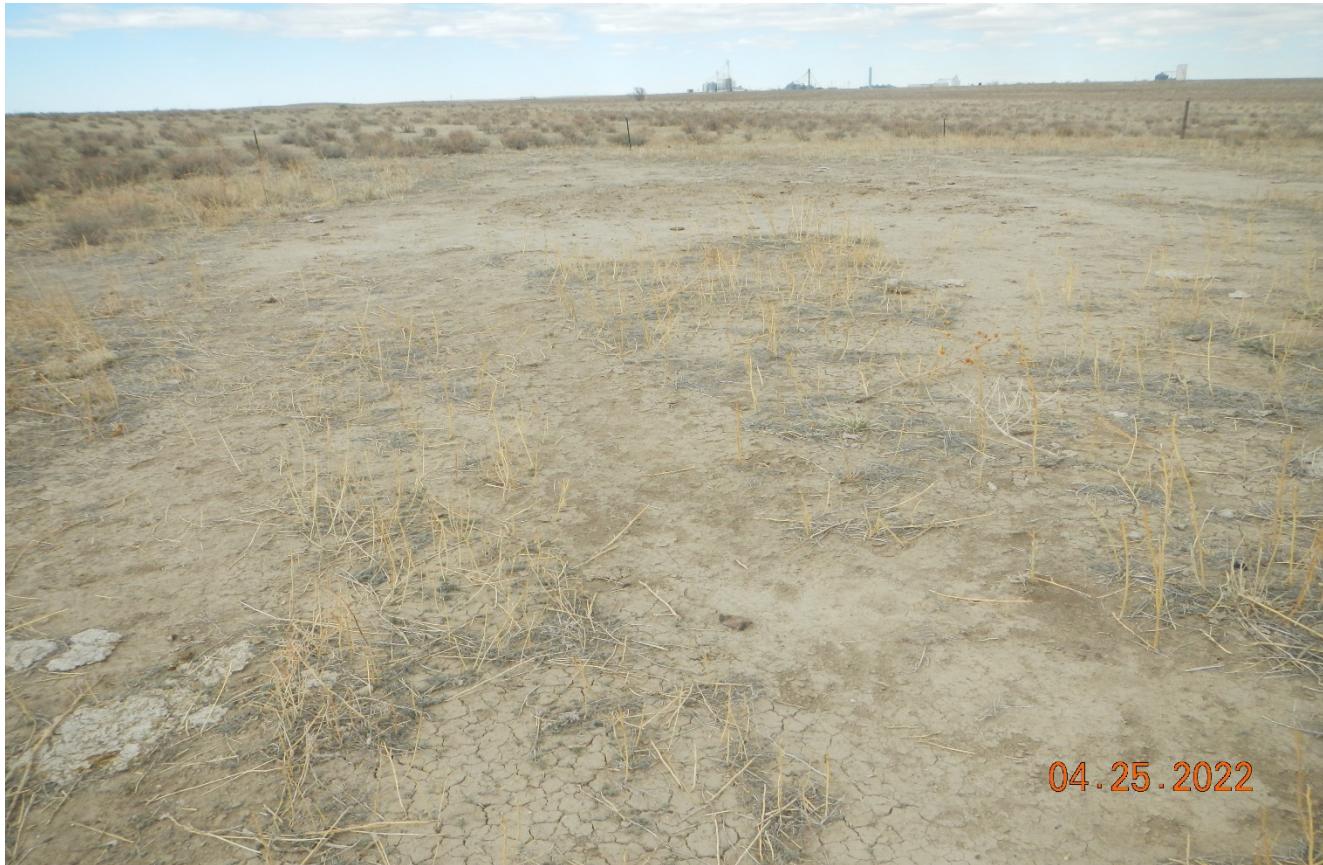
**Photo 7.** Facing northeast toward the abandoned well site. This area has not been reclaimed. Bare soils that are not stabilized and are susceptible to further erosion.

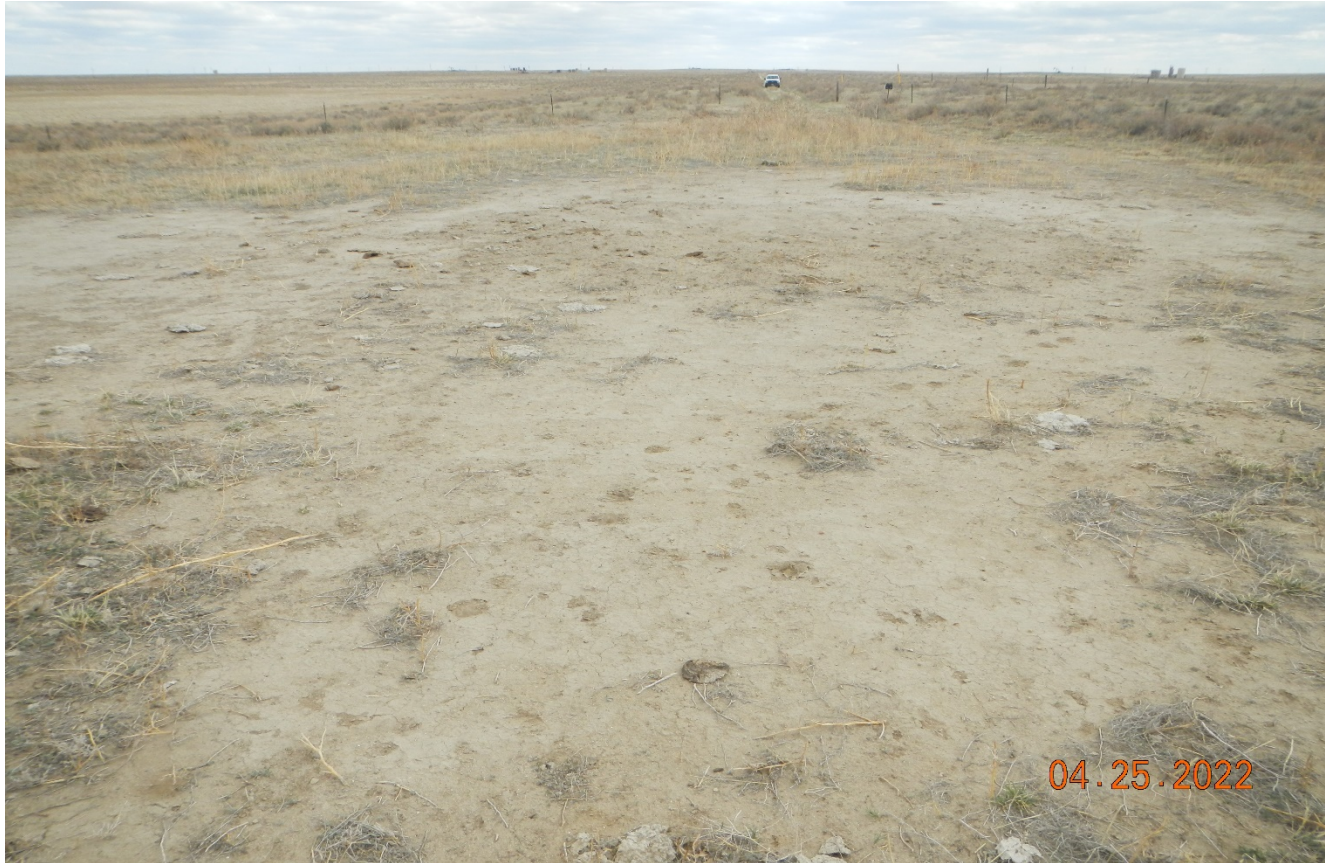
**Photo 8.** Facing south toward the abandoned well site. This area has not been reclaimed. Bare soils that are not stabilized and are susceptible to further erosion.

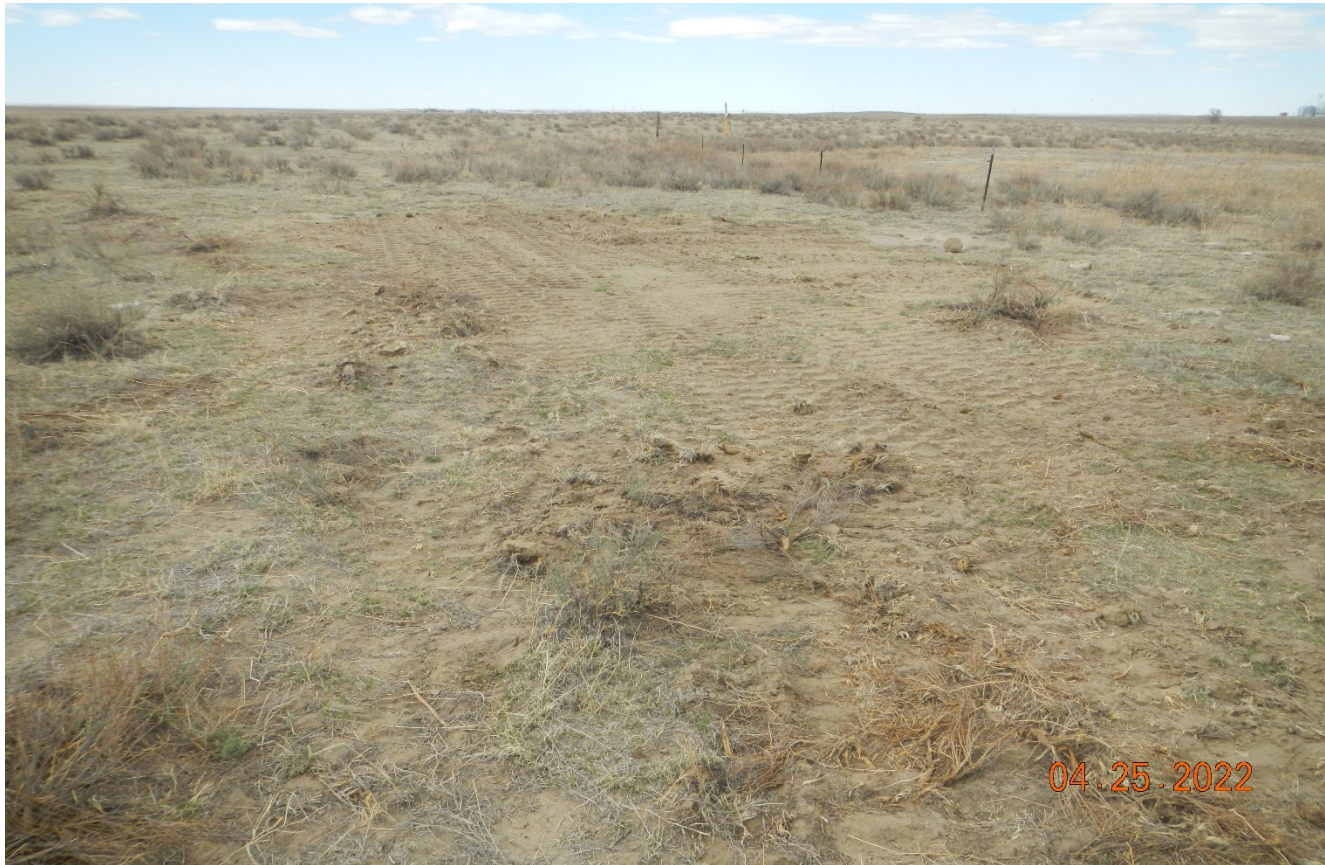
**Photo 9.** The other abandoned risers have been removed at north side of the location.

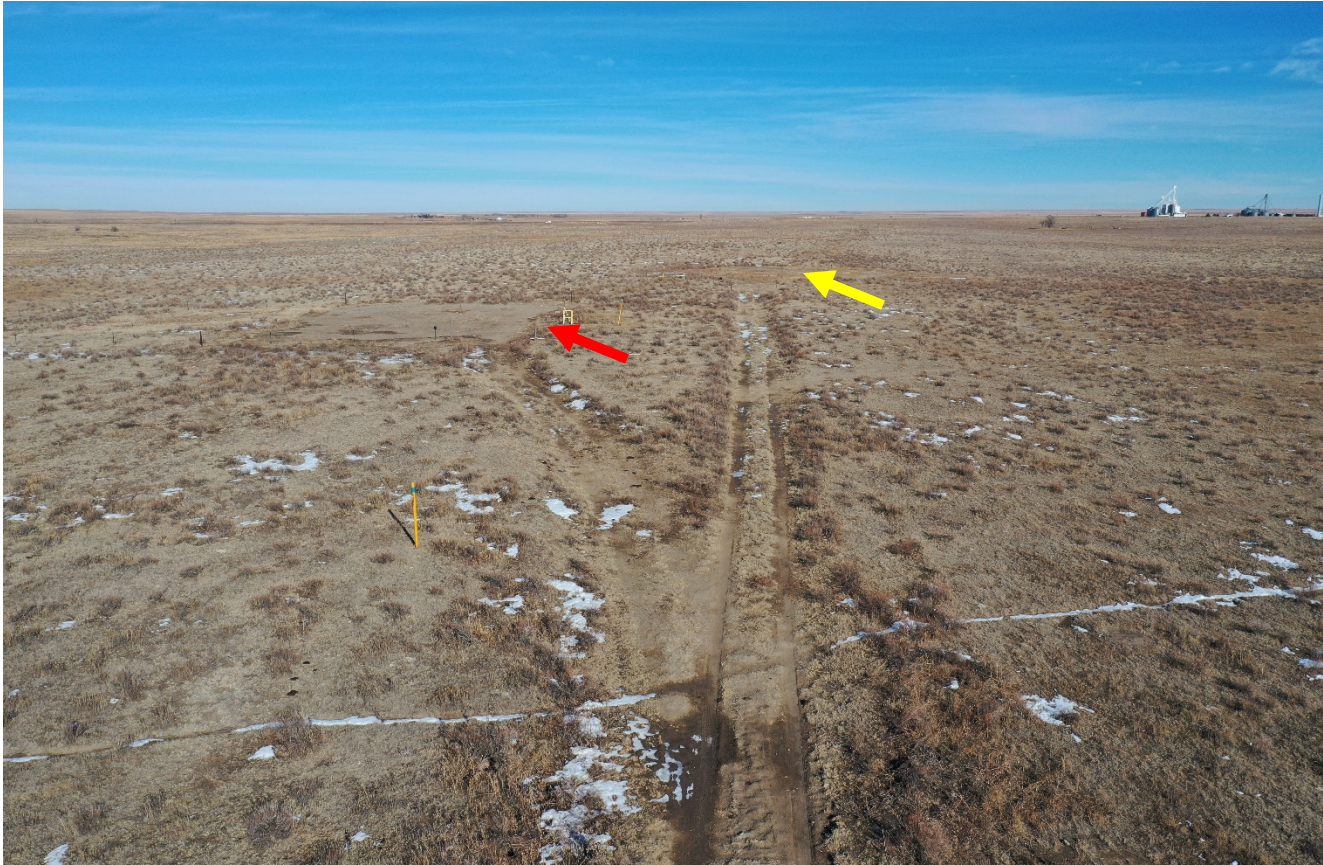
**Photo 10.** Drone aerial photo facing north along the access road toward the location. The red arrow points to the former tank battery site and yellow arrow points to the well site.

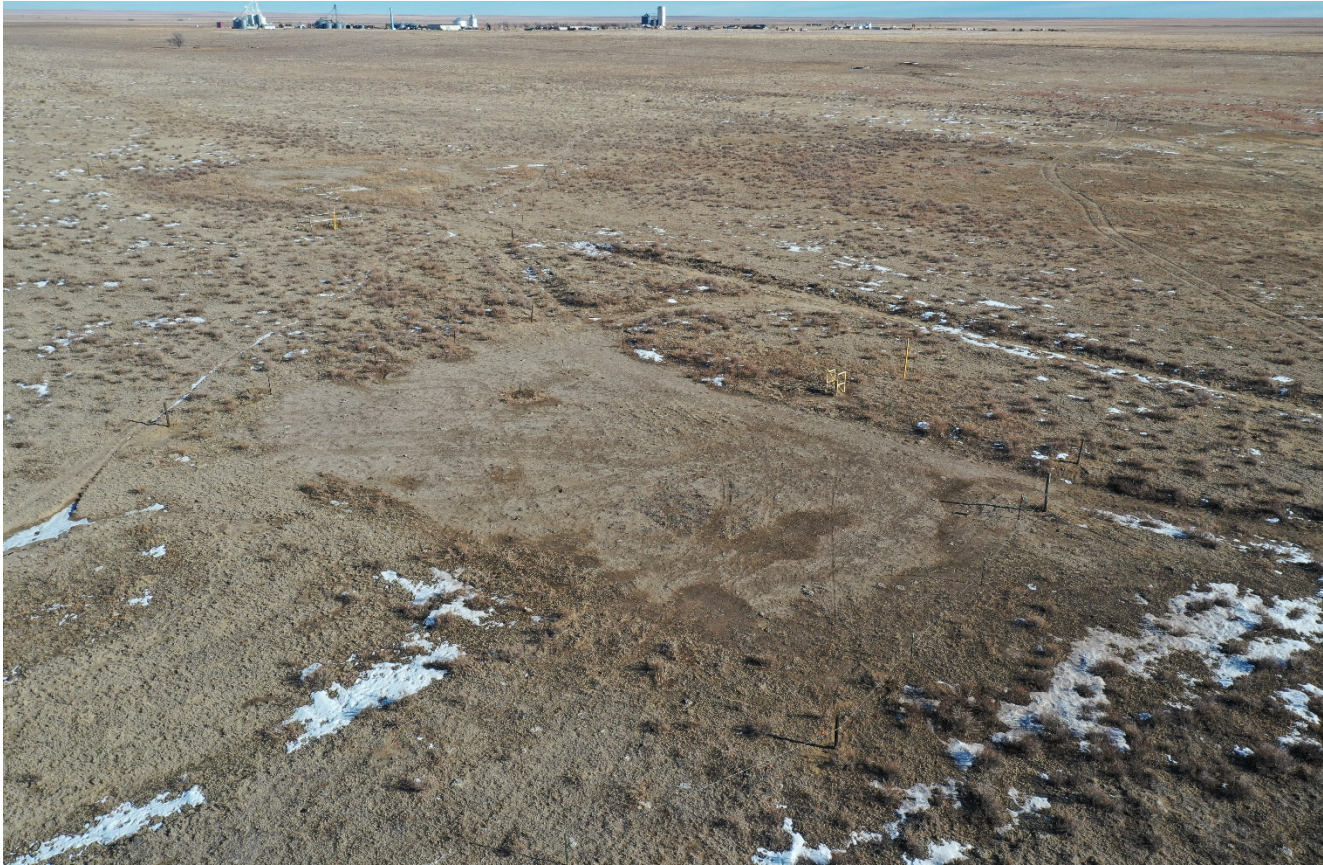
**Photo 11.** Facing northeast toward the tank battery site and well site.

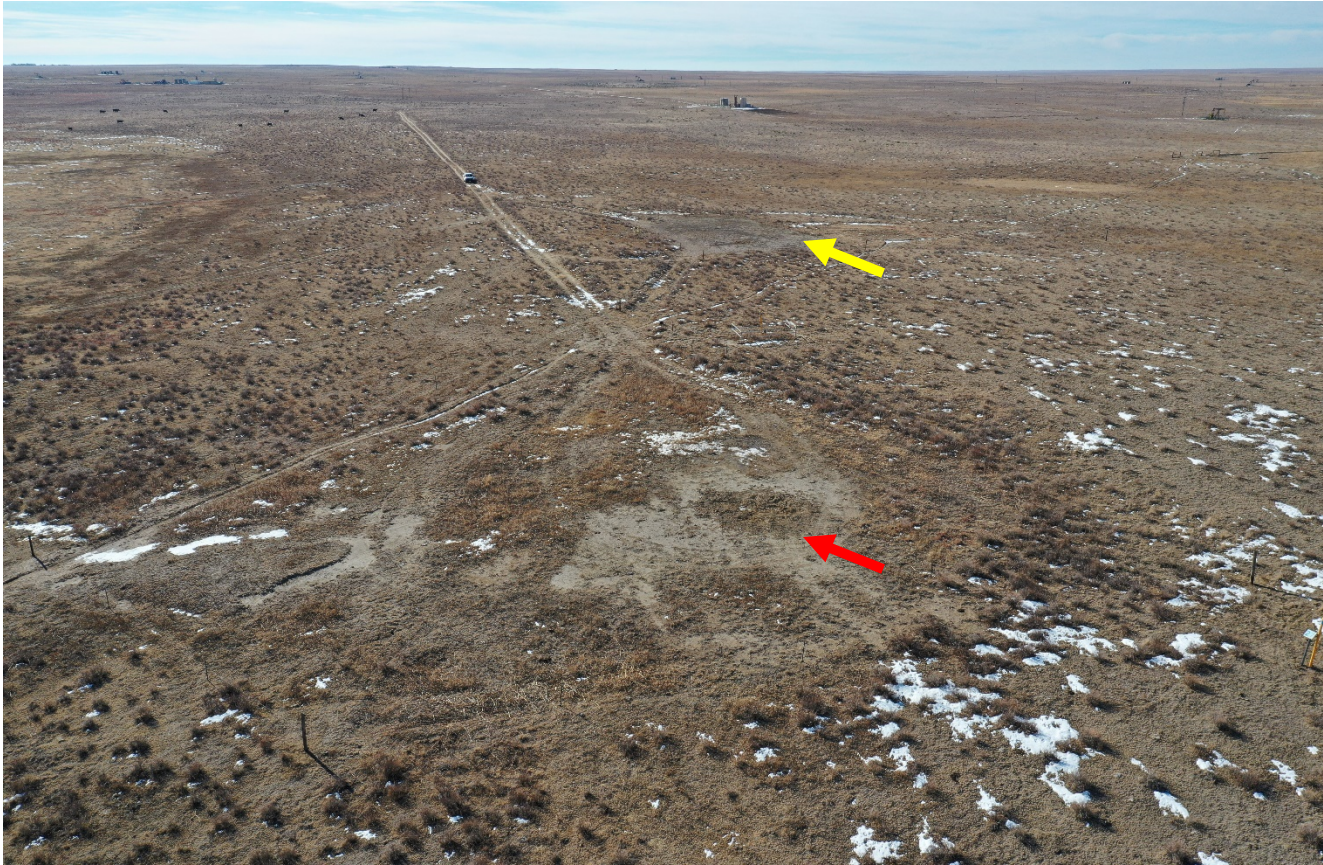
**Photo 12.** Facing back south toward the well site. The red arrow points to the former tank battery site and yellow arrow points to the well site.
