Inspection Photos
Location Name: Holmquist UPRR 1-1
Location ID:319647

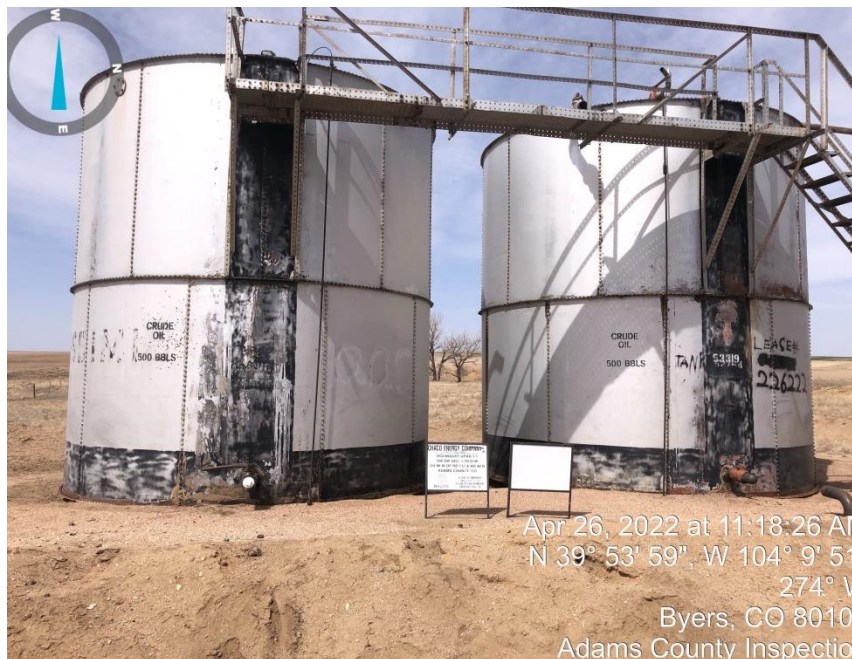
Photo#1 Production Tanks

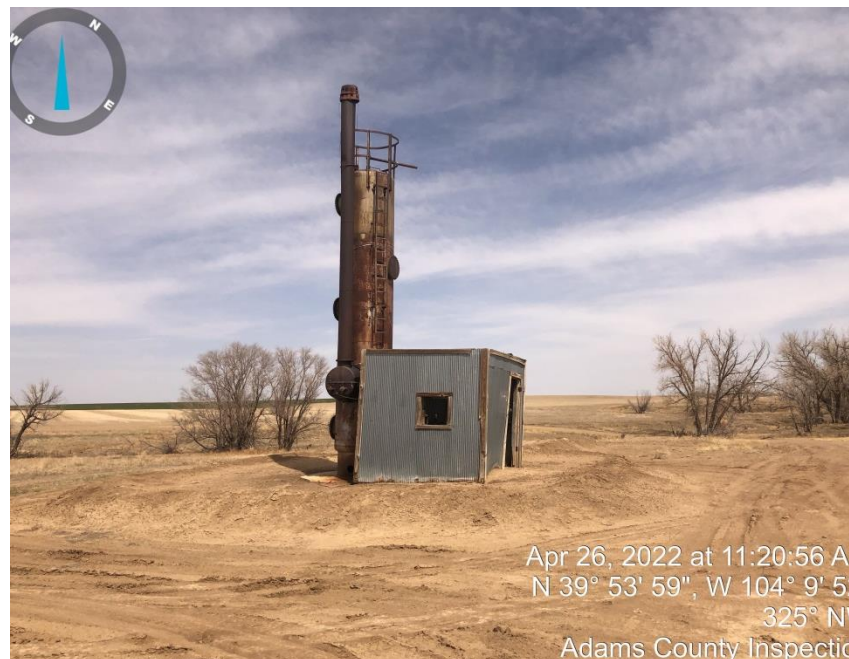
Photo#2 Vertical Separator

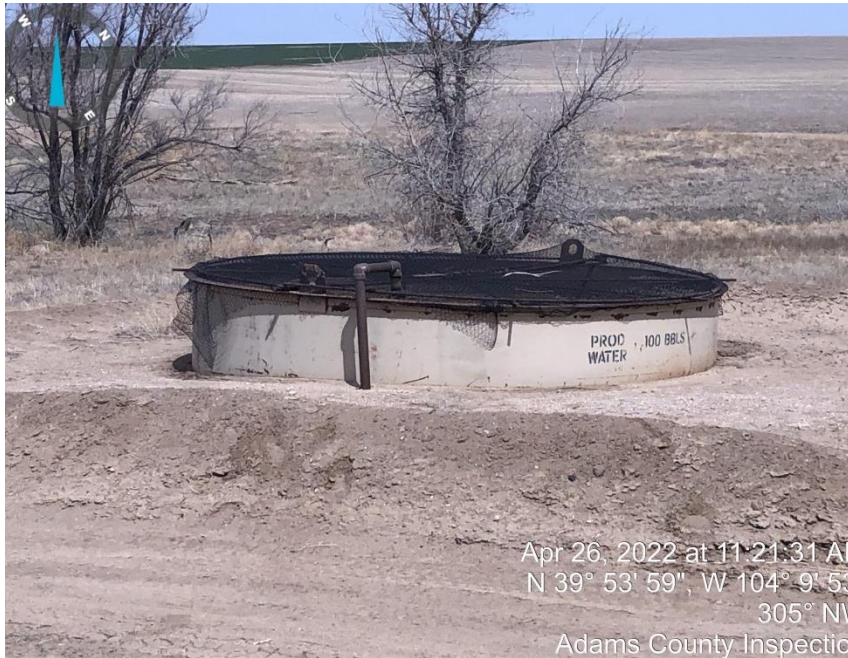
Photo#3 Produced Water Open Top Tank/Hydrocarbons in water. Open top tank is venting gas.

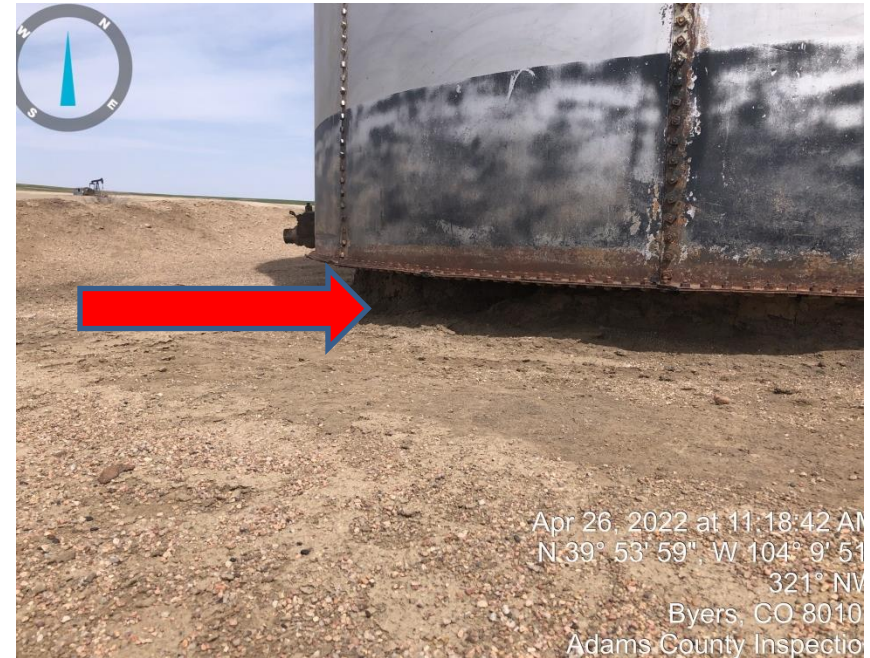
Photo#4 Large gaps under both production tanks

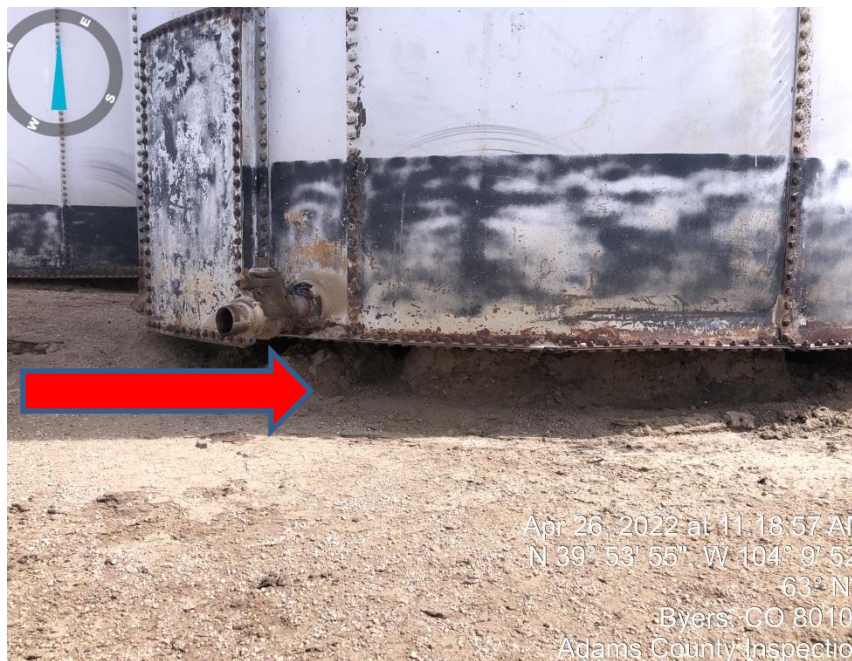
Photo#5 Large gaps under both production tanks

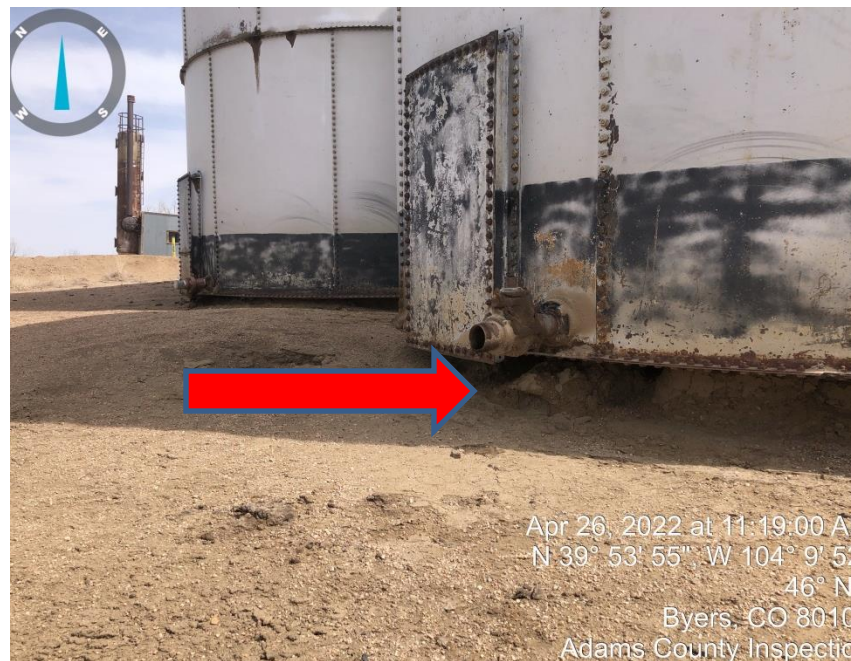
Photo#6 Large gaps under both production tanks

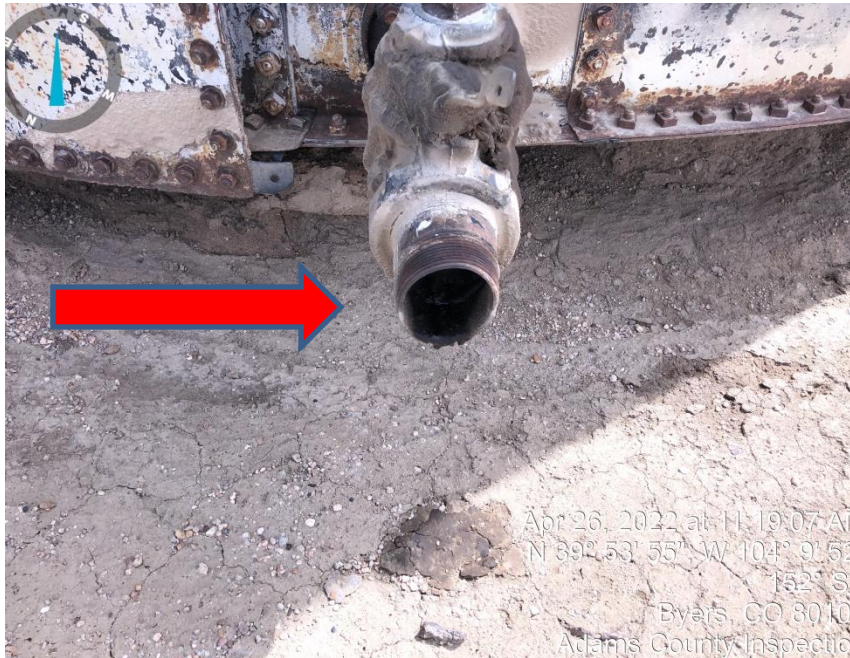
Photo#7 No Bullplug/Stained Soil

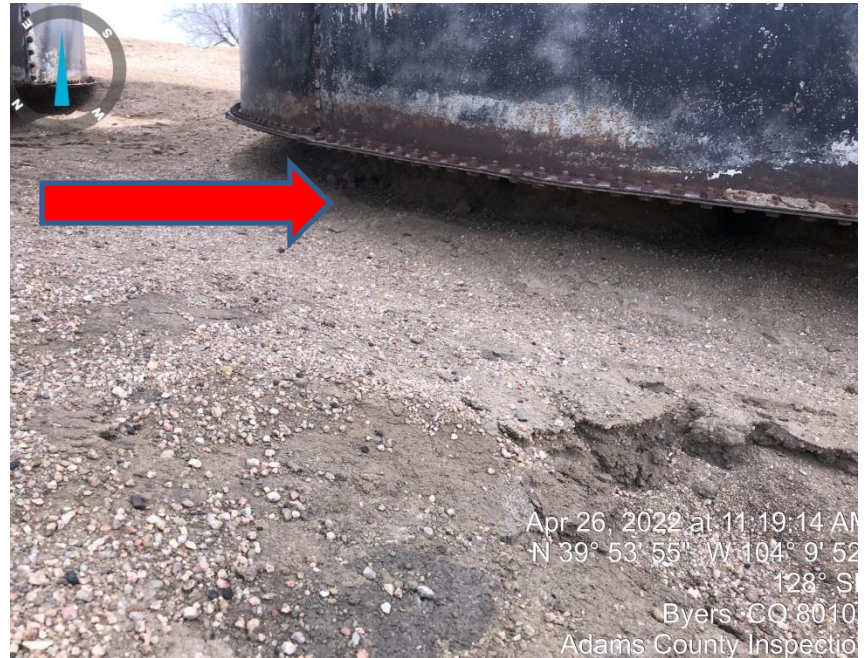
Photo#8 Large gaps under both production tanks

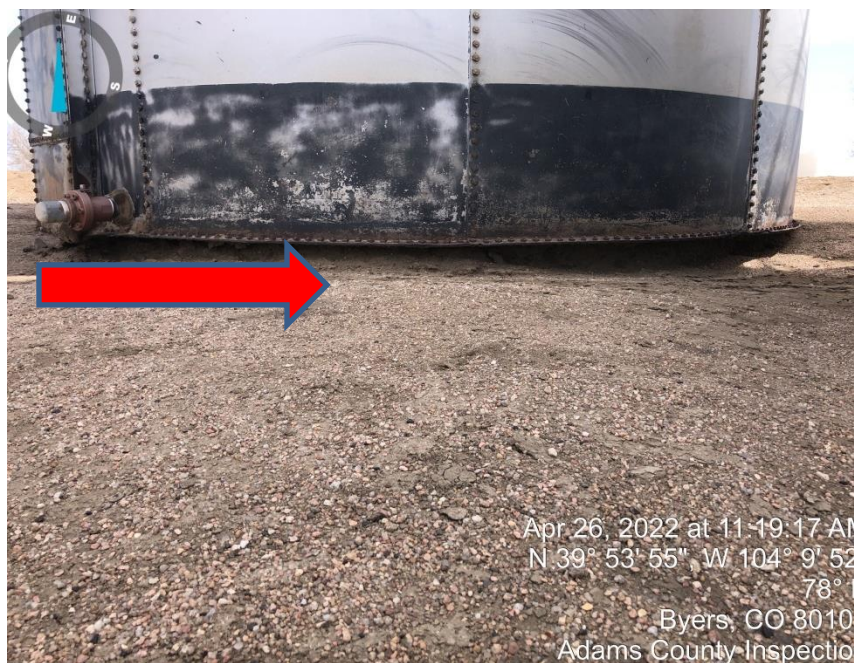
Photo#9 Large gaps under both production tanks

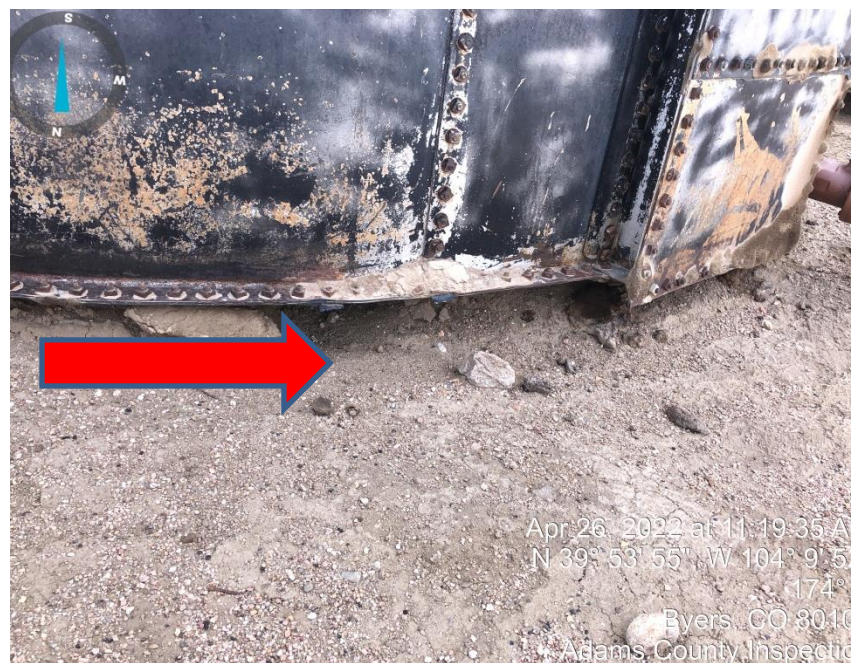
Photo#10 Large gaps under both production tanks

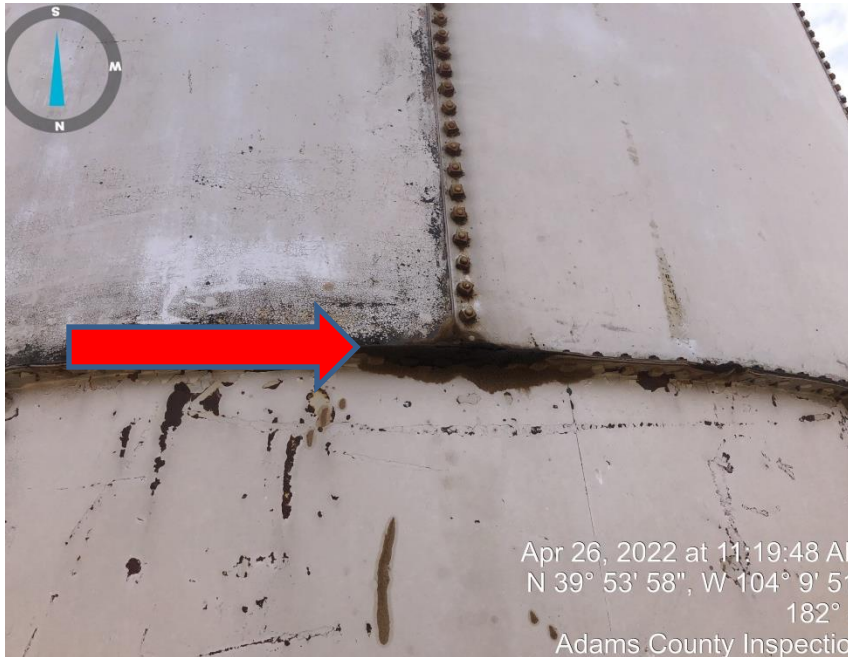
Photo#11 Small leak on north tank

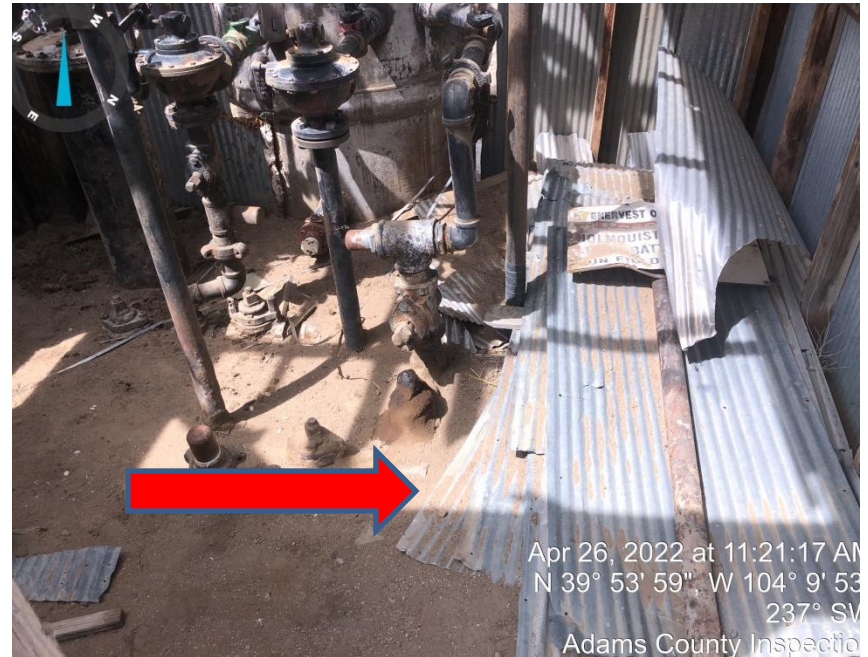
Photo#12 Debris/Unused Equipment

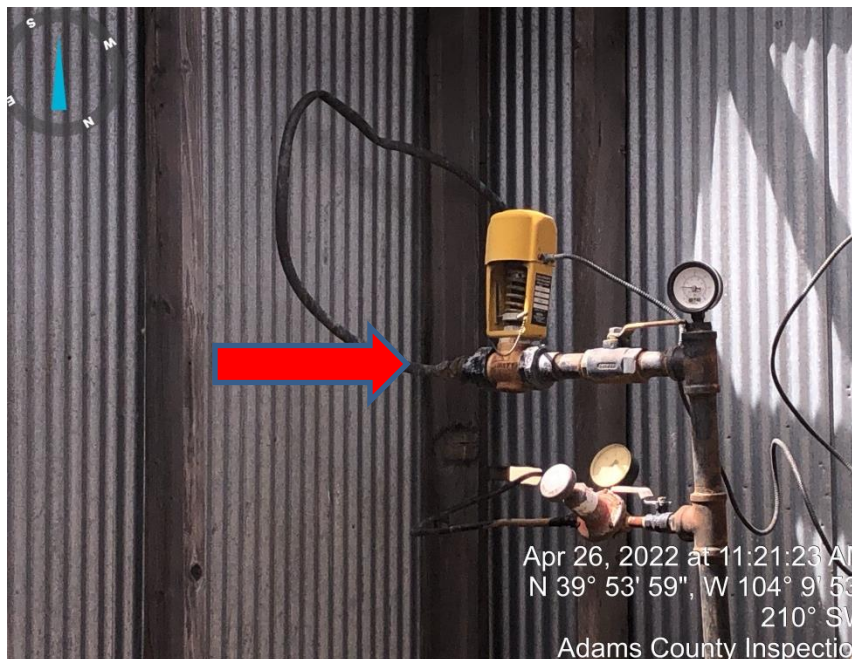
Photo#13 Small leak

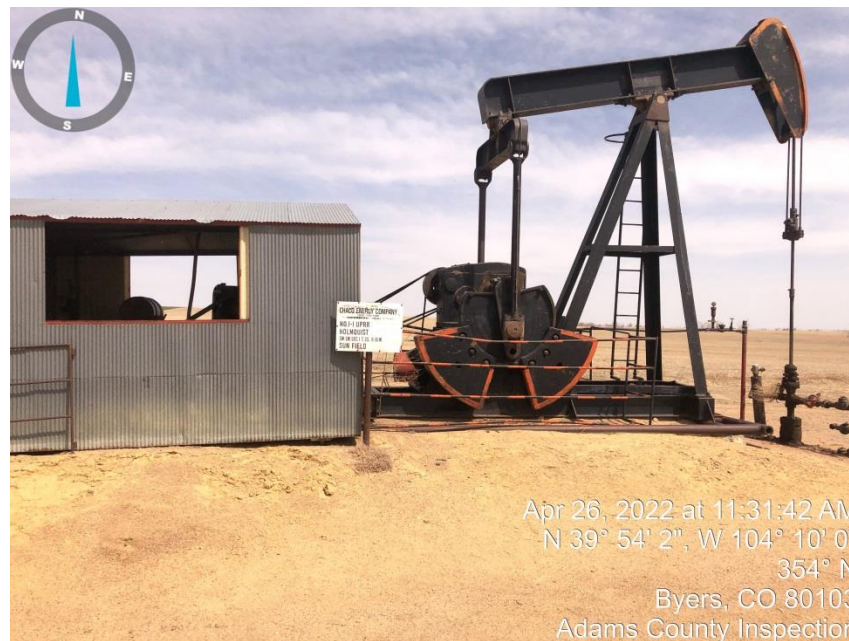
Photo#14 Pumpjack

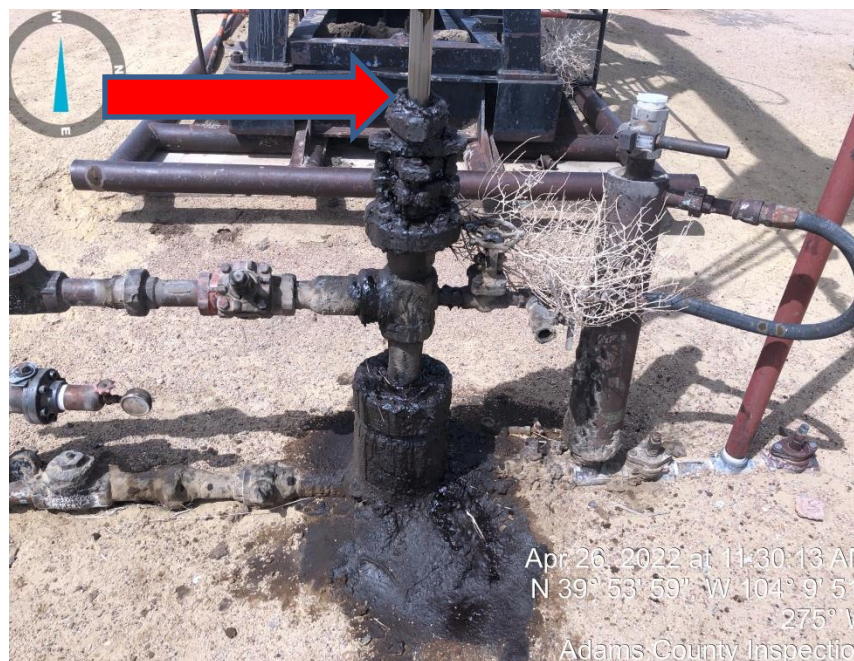
Photo#15 Wellhead leaking

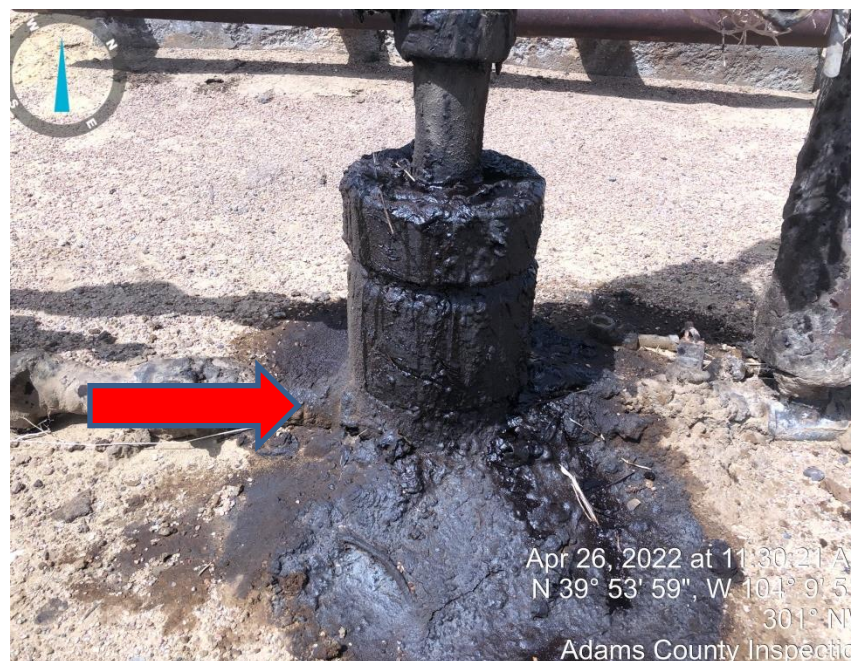
Photo#16 Wellhead leaking

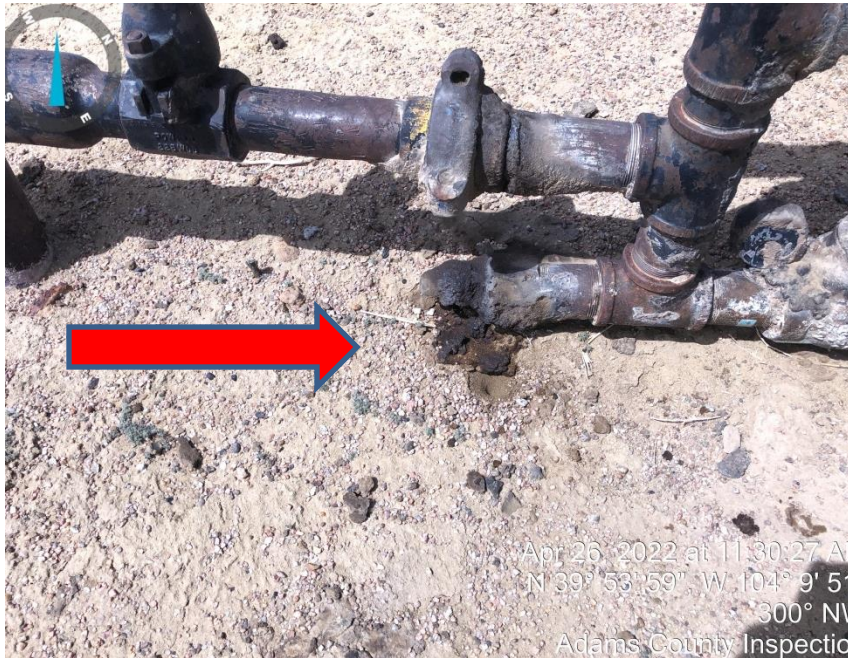
Photo#17 Stained Soil

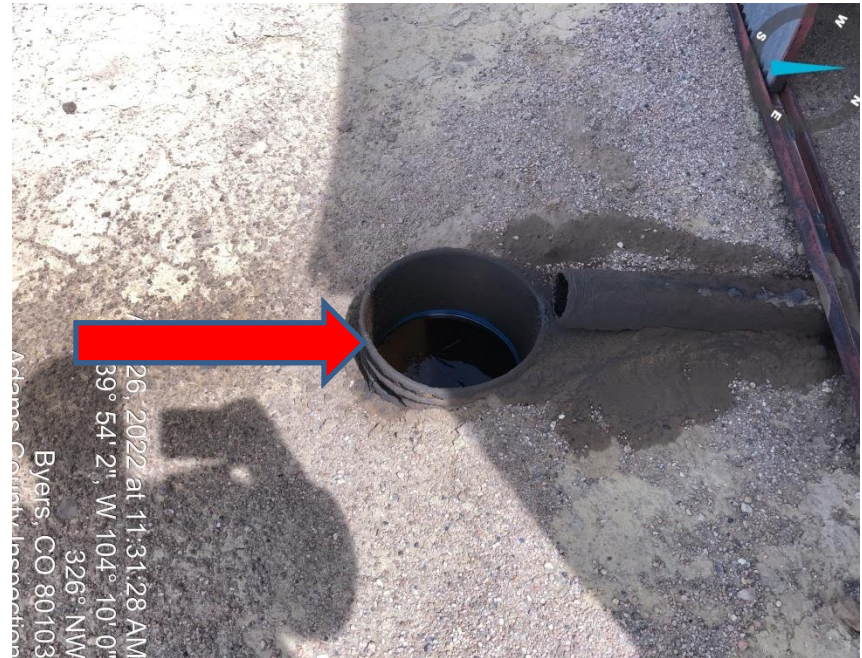
Photo#18 Bucket needs emptied
