Inspection Photos
Location Name: Sack G Unit
Location: 320295, API: 05-001-08895

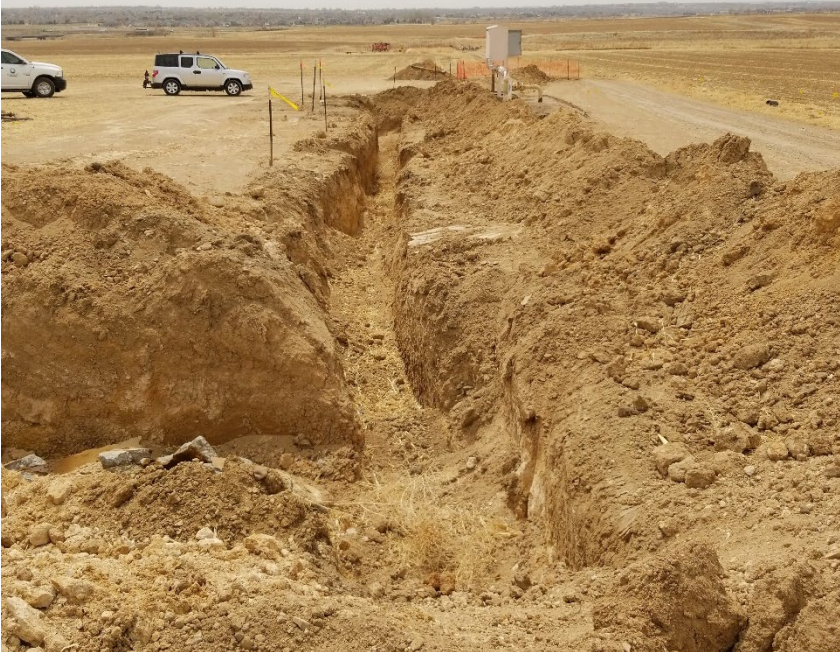
Open Excavation with inadequate safety fencing.

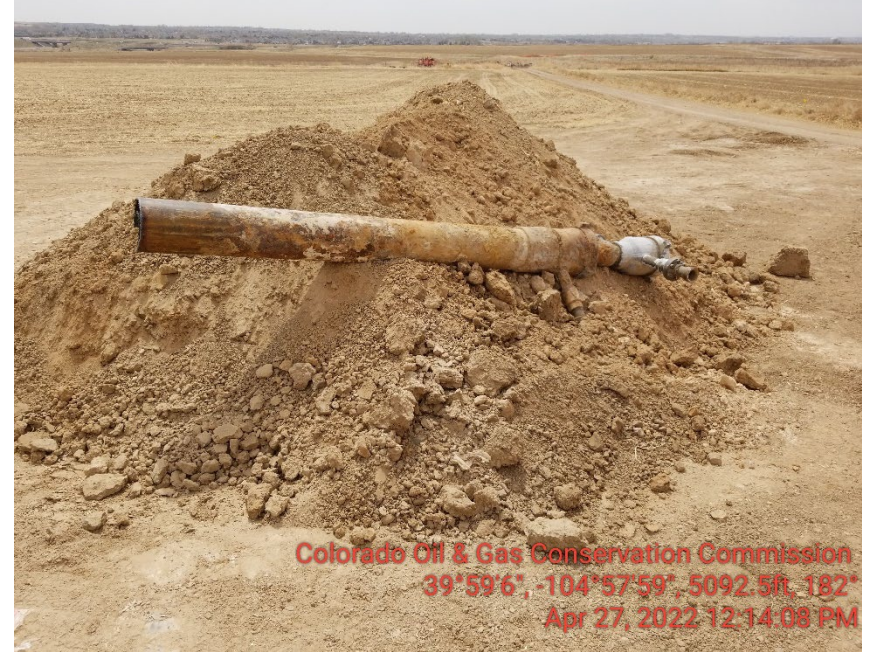
Spoils pile, and debris from cutting and capping the Sack G Unit 1, with inadequate stormwater BMPs.

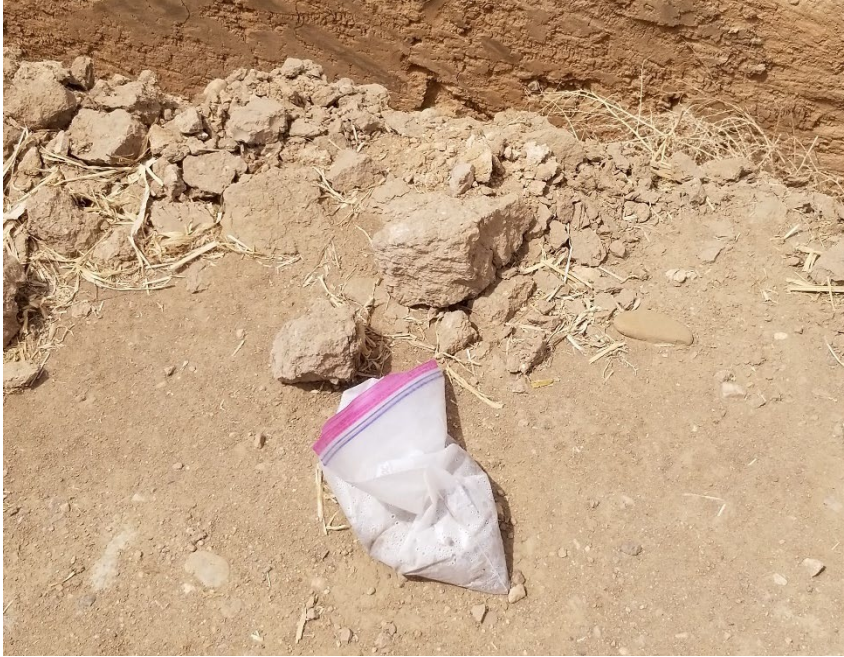
1 of 5 unlabeled zip lock bags of what is assumed to be investigation-derived waste.

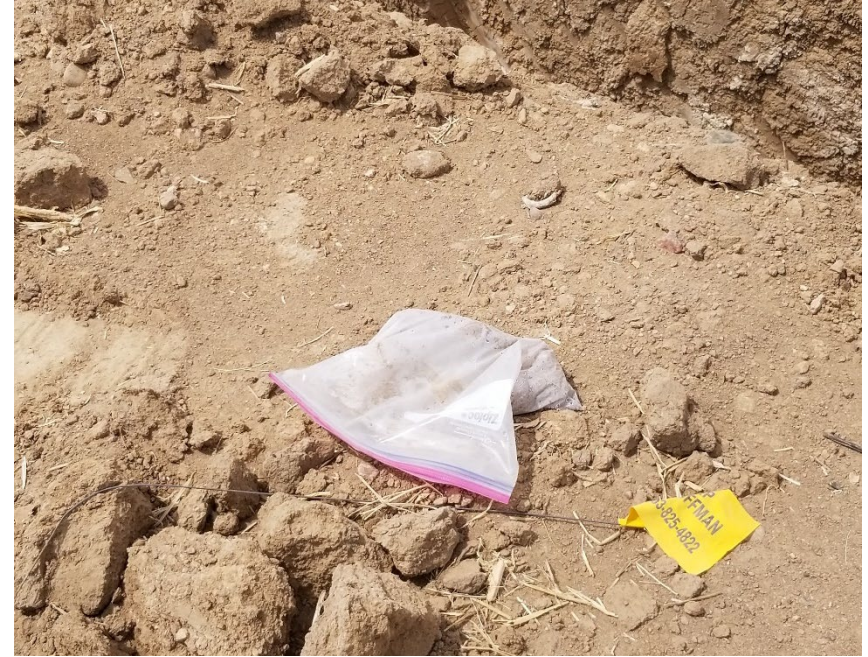
1 of 5 unlabeled zip lock bags of what is assumed to be investigation-derived waste.

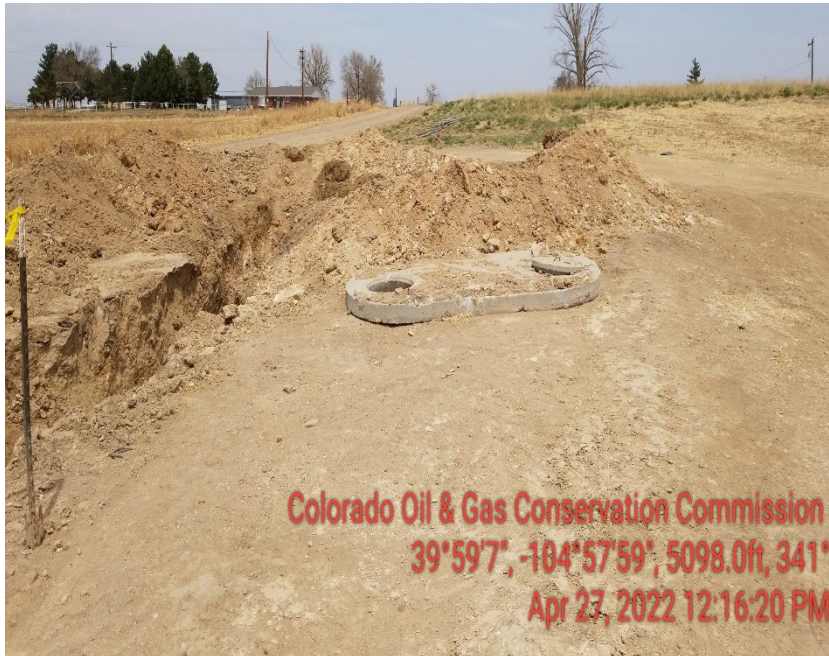
Top of former concrete partially buried vessel on the ground next to an open excavation in which the operator has placed non-E&P waste, specifically, broken pieces of the concrete vessel.

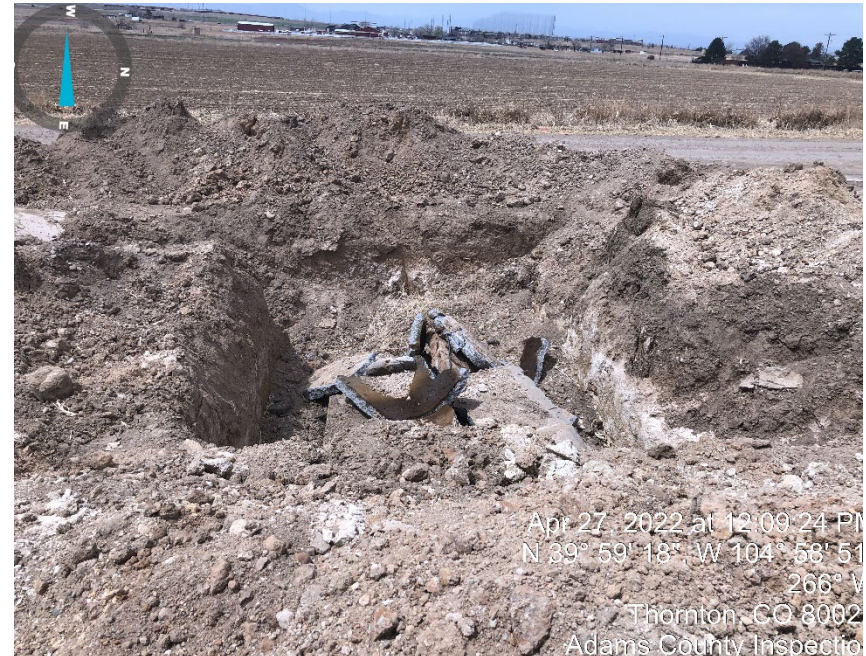
Concrete partially buried vessel, broken into pieces which were placed in an open excavation.

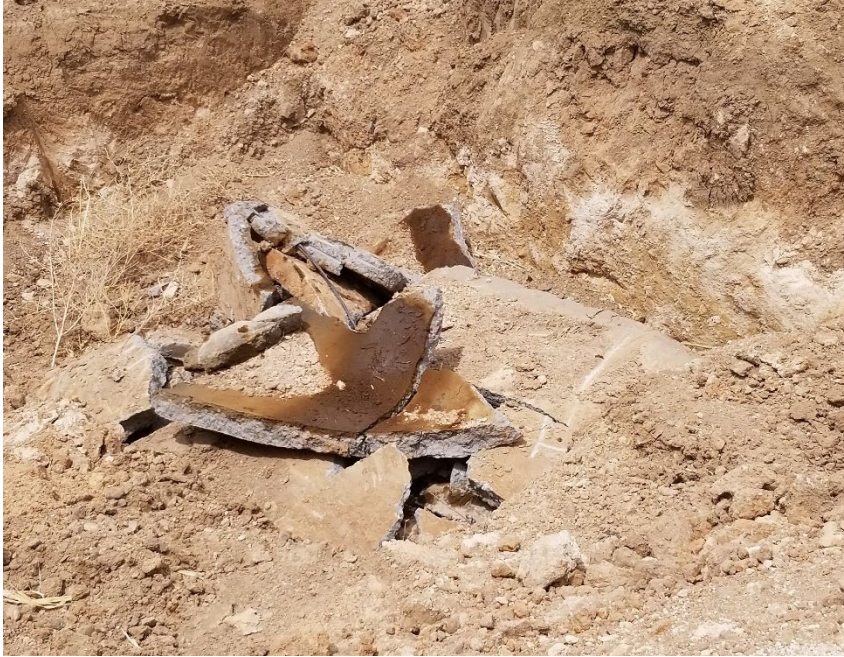
Concrete partially buried vessel, broken into pieces which were placed in an open excavation.

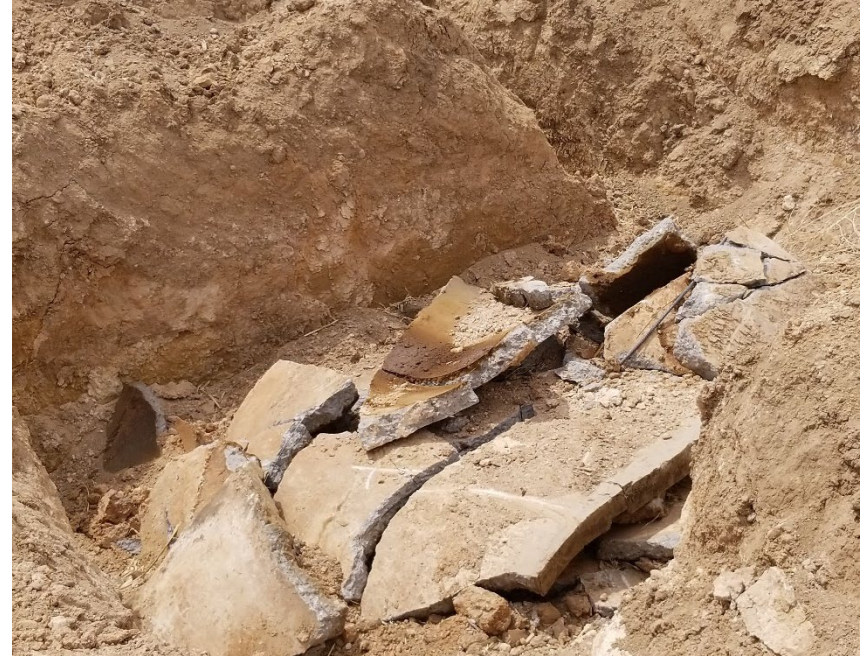
Concrete partially buried vessel, broken into pieces which were placed in an open excavation.

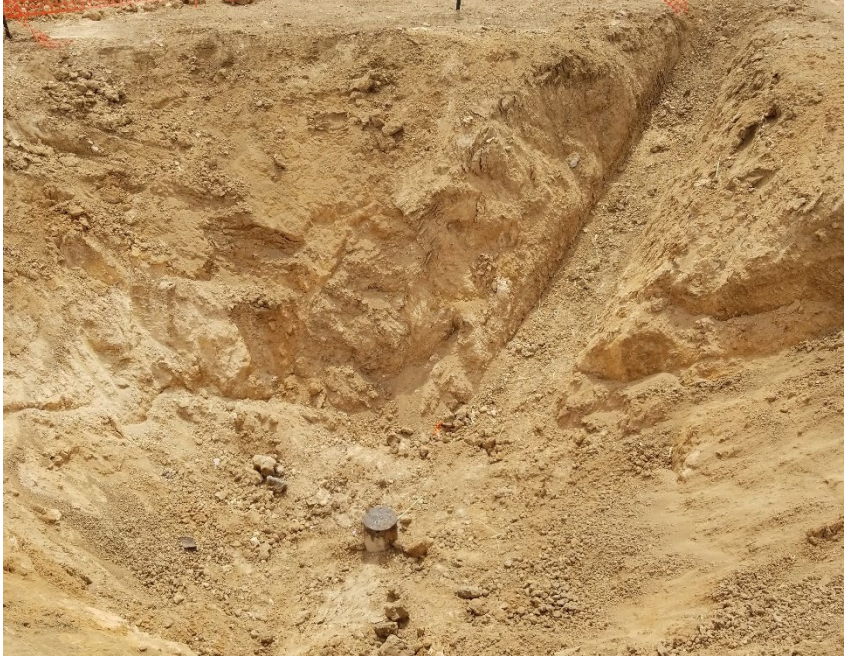
Sack G Unit 1 after being cut and capped.

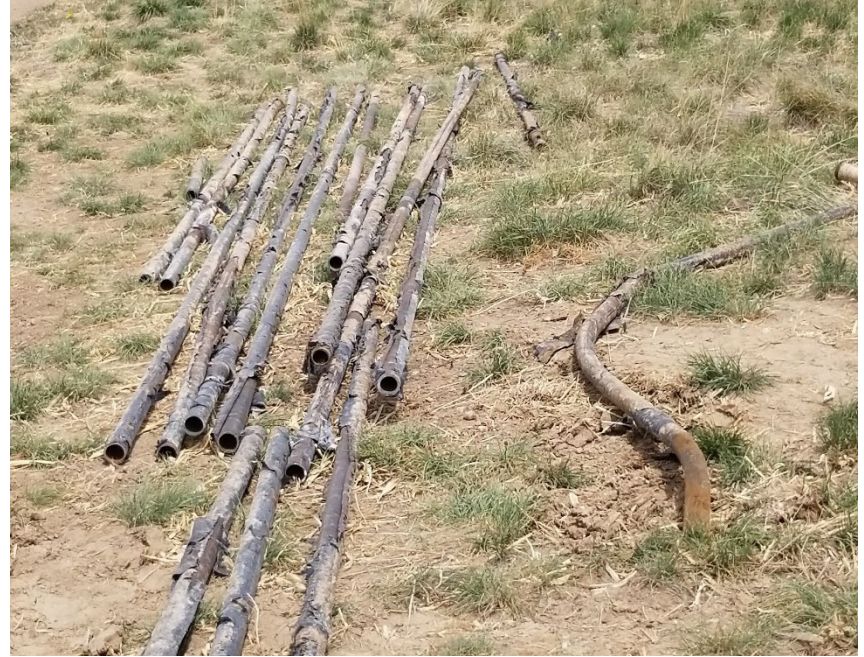
Sections of flowline being staged on location.
