Inspection Photos
facility ID 427371, REM 17852
427370, REM 17848
286608, REM 17854
Inspection Date: 4/26/2022
All Photos taken by Kris Neidel

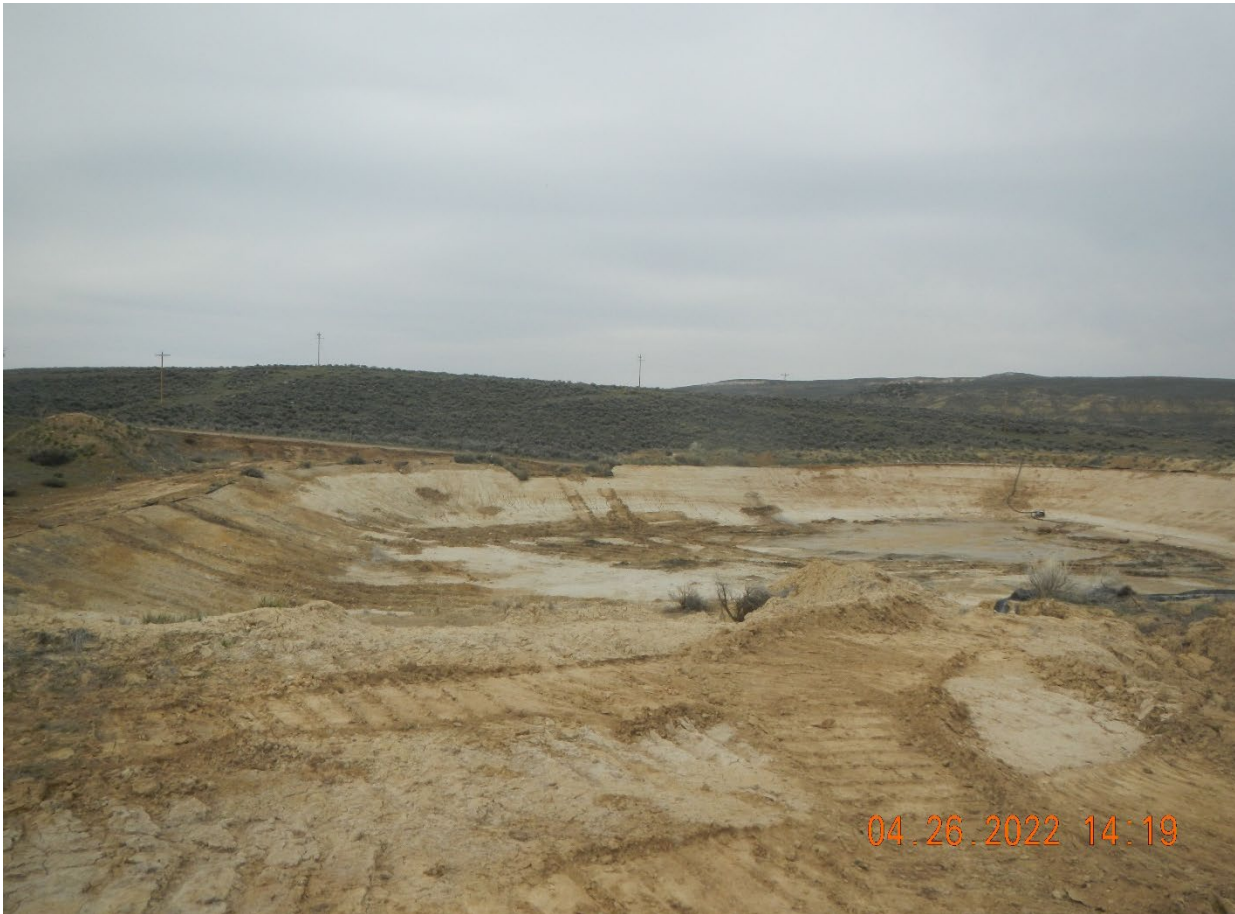
Photo #1, upper pit facility 427371. The anchor trench portion of the liner is still in ground. All liner must be removed, including the anchor trench. Some water was present in pit, No obvious hydrocarbon or salt impacts were observed.

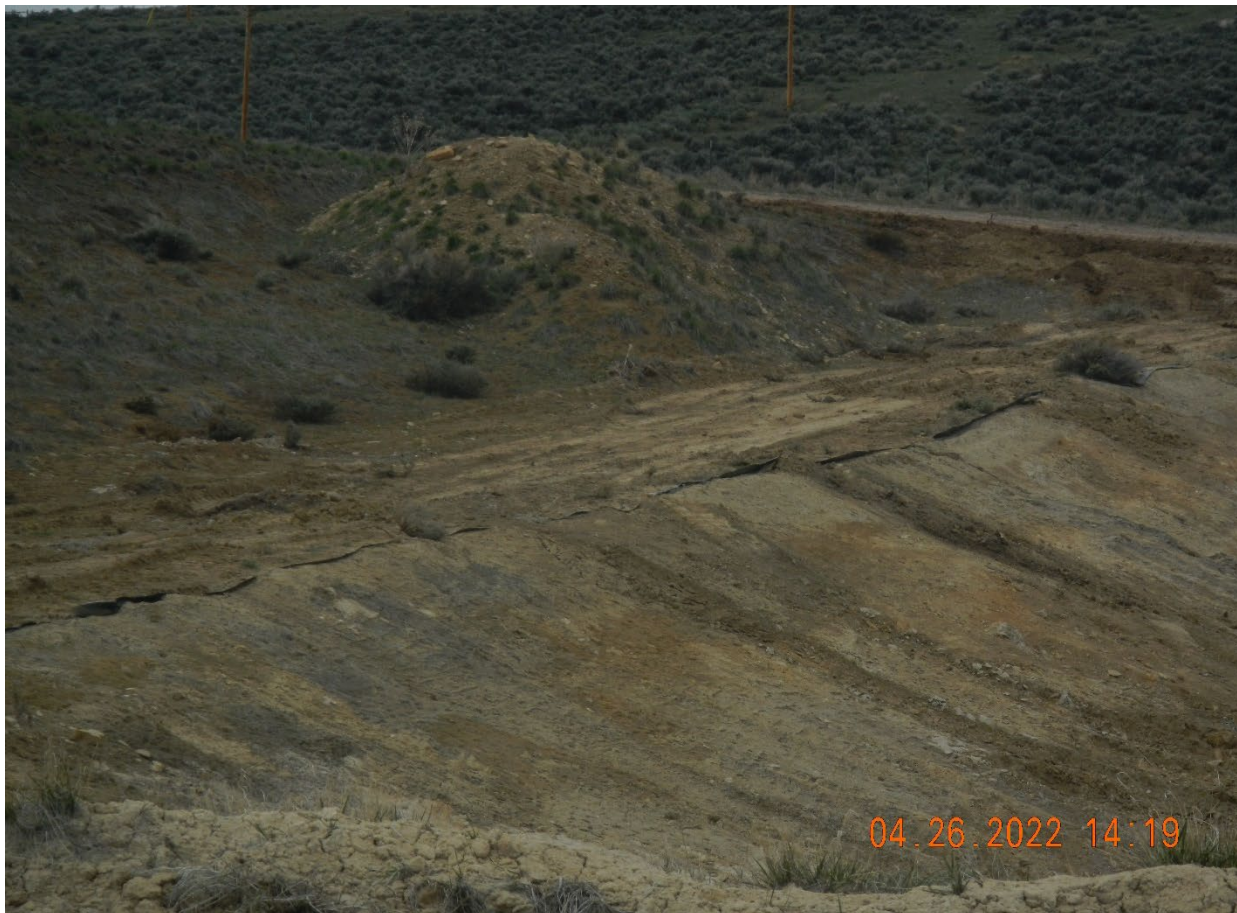
Photo #2, upper pit, facility 427371. The anchor trench portion of the liner is still in ground. All liner must be removed, including the anchor trench.

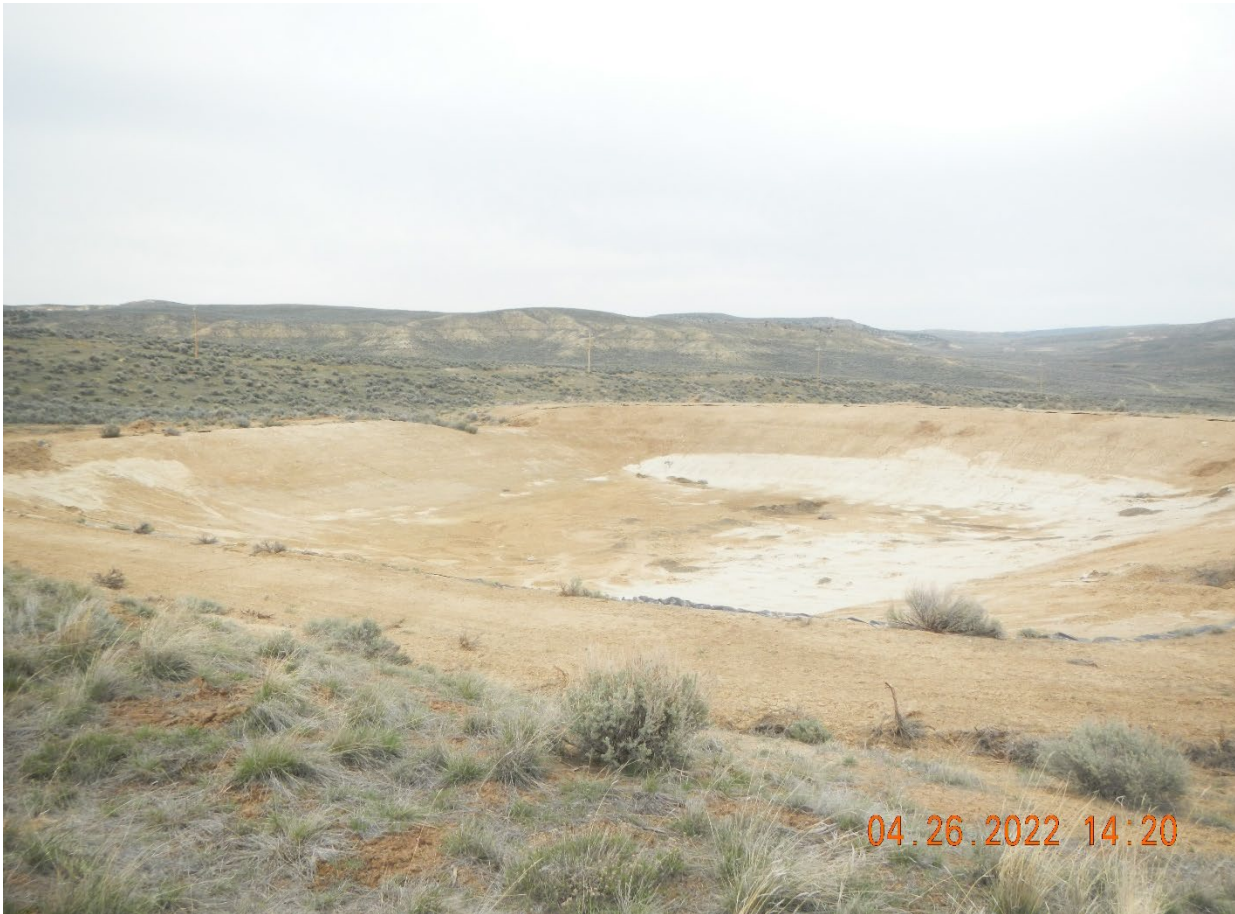
Photo #3 Middle Pit, Facility 427370. The anchor trench portion of the liner is still in ground. All liner must be removed, including the anchor trench.

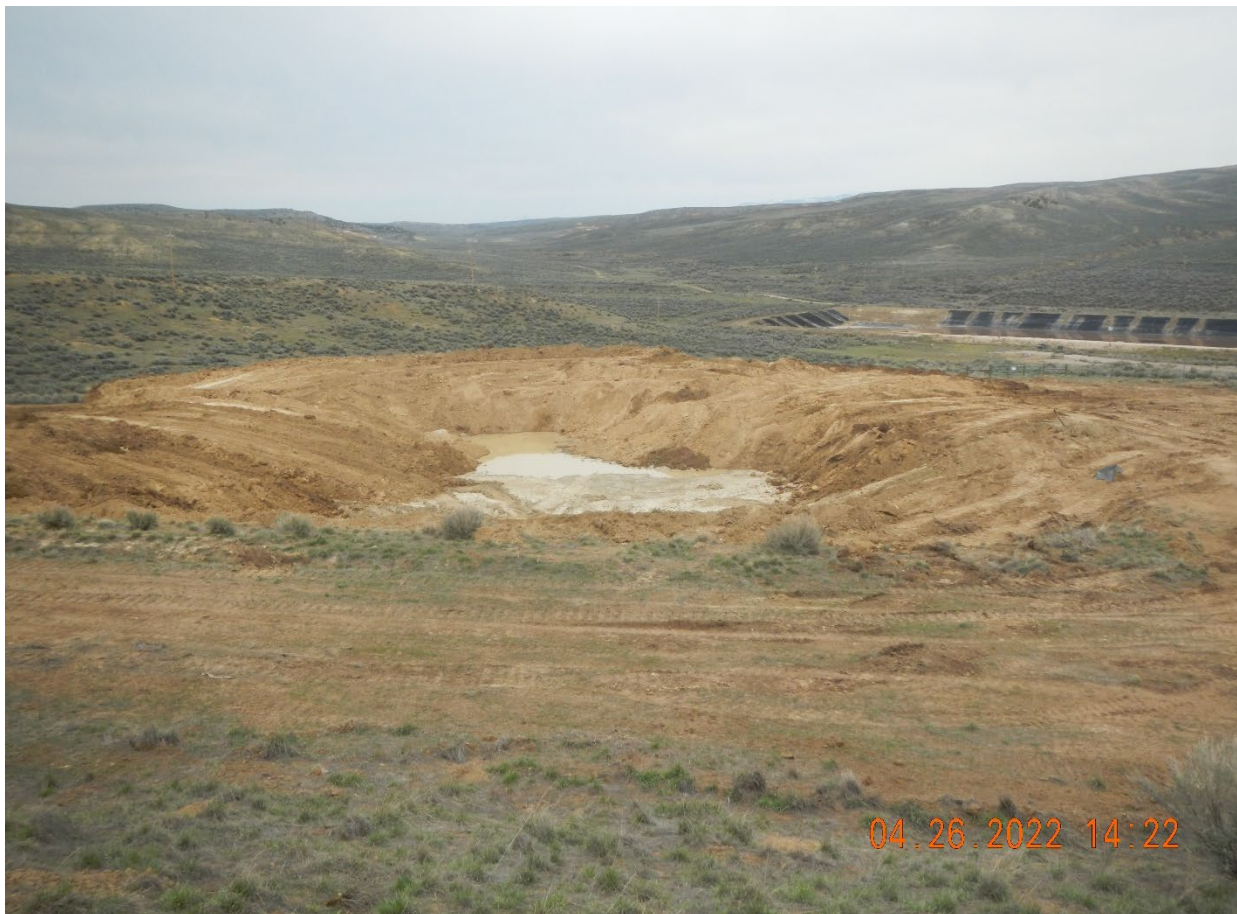
Photo #5 lower Pit, No liner appeared to be present. Facility 286608.

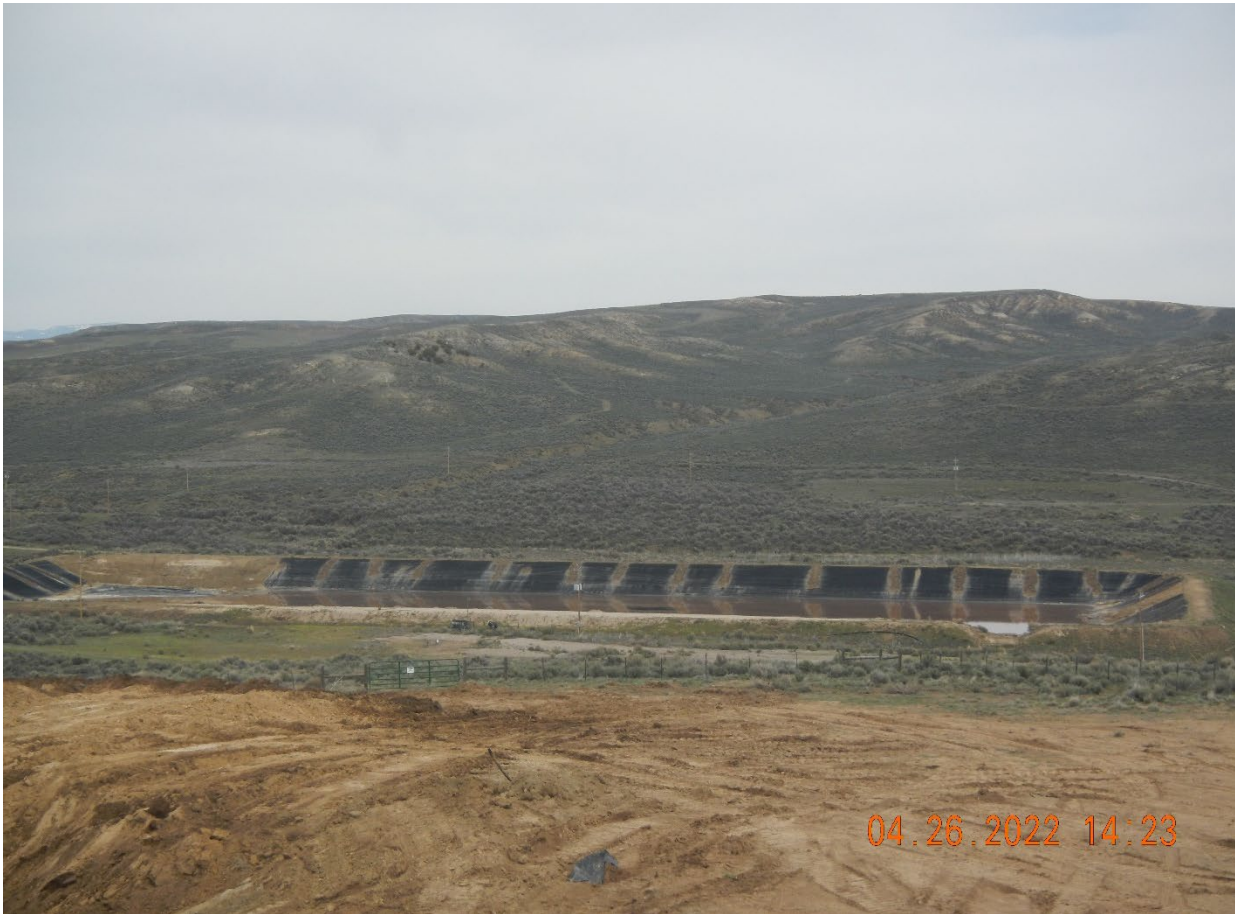
Photo #6 Large Pit, facility 427372, August 2022 is expected date of closure, per SWN meeting 4/26/22.
