## Inspection Photos

Location Name: CAERUS PICEANCE LLC SHORE-67S95W /16SWNE

Location ID: 334599

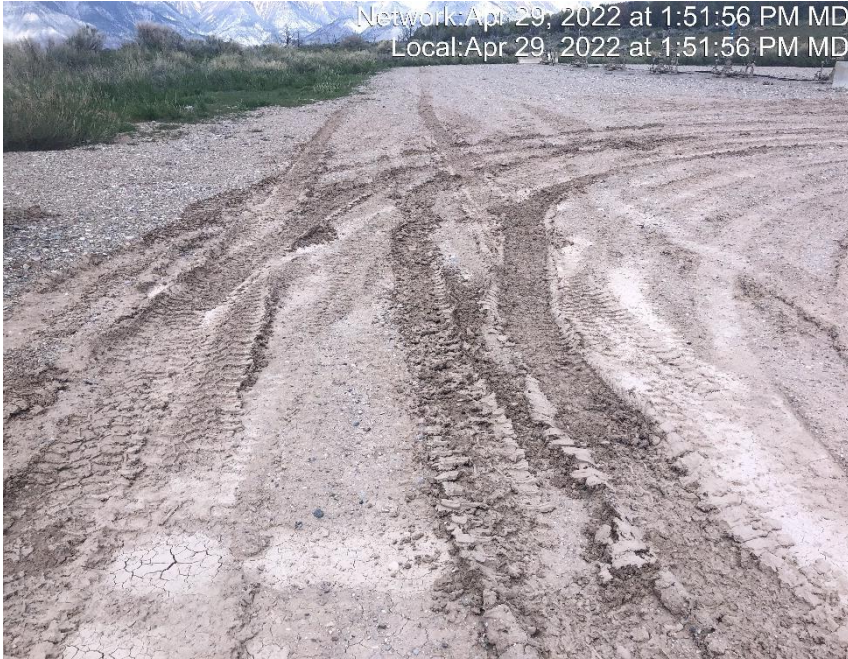
**Photo #6584** Location lacks stabilization.

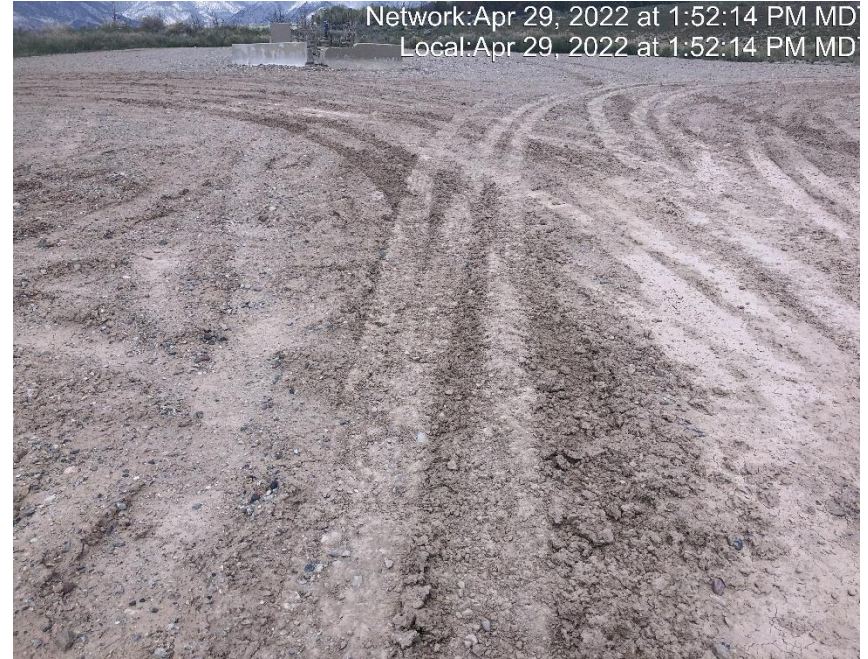
**Photo #6585** Location lacks stabilization.

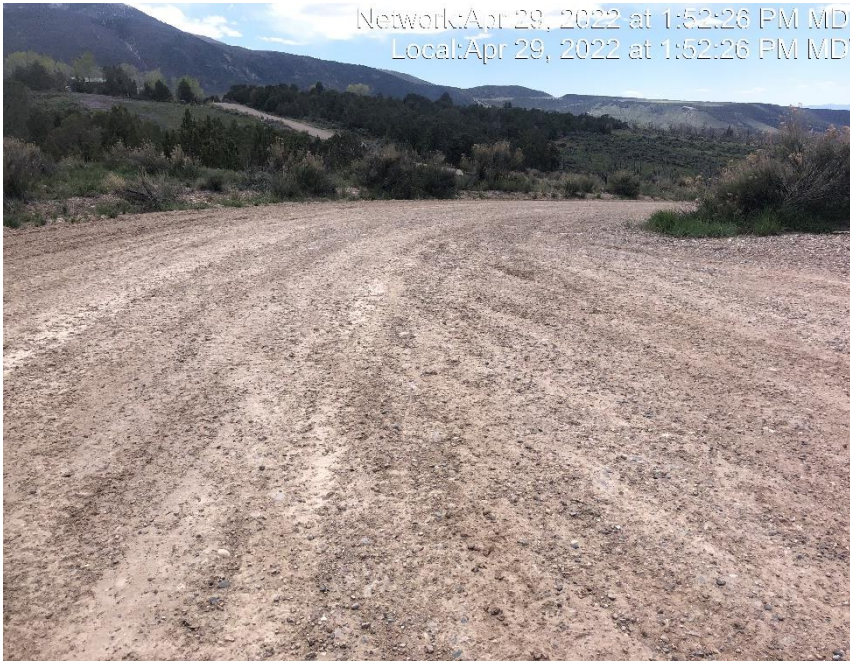
**Photo #6586 Insufficient tracking BMP at entrance to location.**
