Site Inspection Report

Site: MUSICK-MCCLINTOCK #5
04/26/2022

SITE/LOCATION	DATE	TIME	INSPECTOR
MUSICK-MCCLINTOCK #5	04/26/2022	10:48 AM	COGCC Subcontractor
Comments			
Work Activity Notes			
Changes since previous inspection?	Yes	Drive by inspection	No
Actively being worked?	No		
Fieldwork Oversight Performed?	Yes	Oversite Type	Confirmation soil sampling
Were Oversight Samples Collected?	Yes	Sample Details	10 sidewall and 4 base soil samples collected for confirmation of clearance. COGCC subcontractor collected 1 sidewall and 1 base for split samples. PIDs for multiple base samples were elevated.

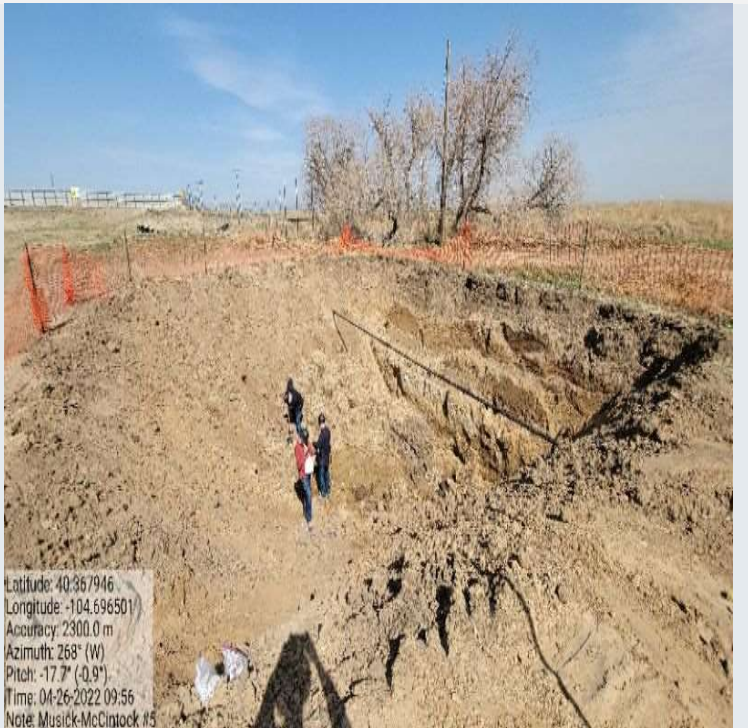
Remediation Activity Checklist	
	Photo
<p>Question: Open excavation? Approximate size (Length x Width x Depth, ft)</p> <p>Response: Yes</p> <p>Notes: LxW not measured – Depth ~12 feet.</p>

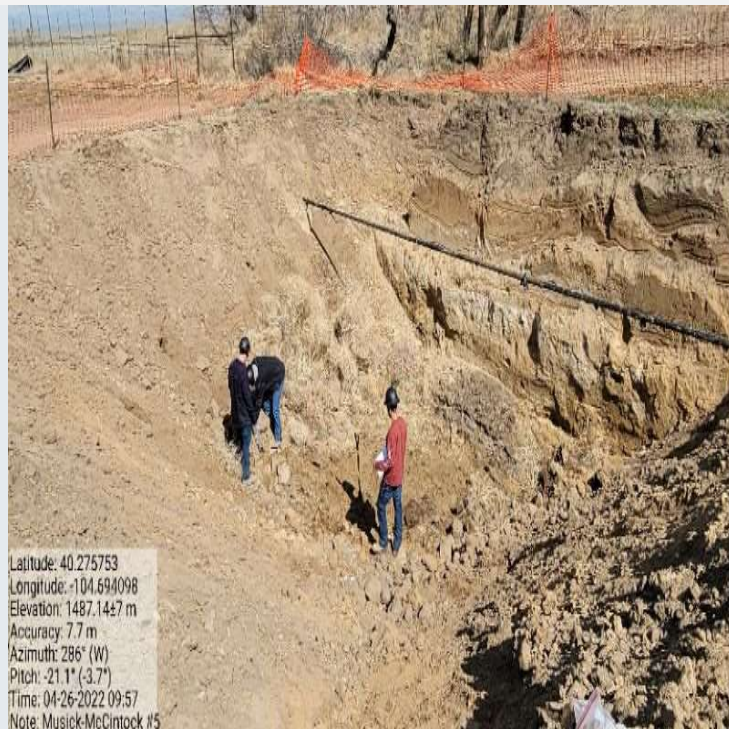
Question: Open excavation? Approximate size (Length x Width x Depth, ft)

Response: Yes

Notes: LxW not measured – Depth ~12 feet.

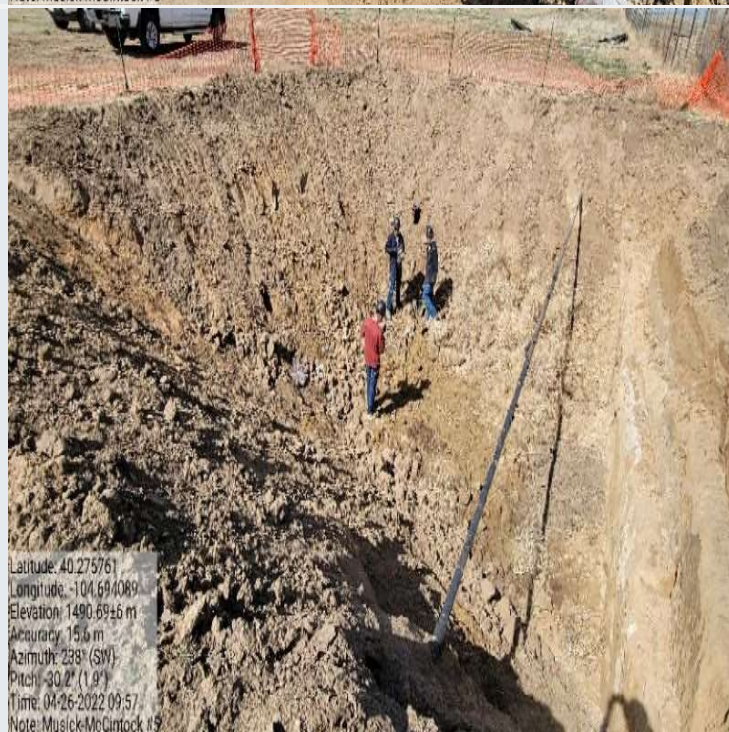
Question: Open excavation? Approximate size (Length x Width x Depth, ft)

Response: Yes

Notes: LxW not measured – Depth ~12 feet.

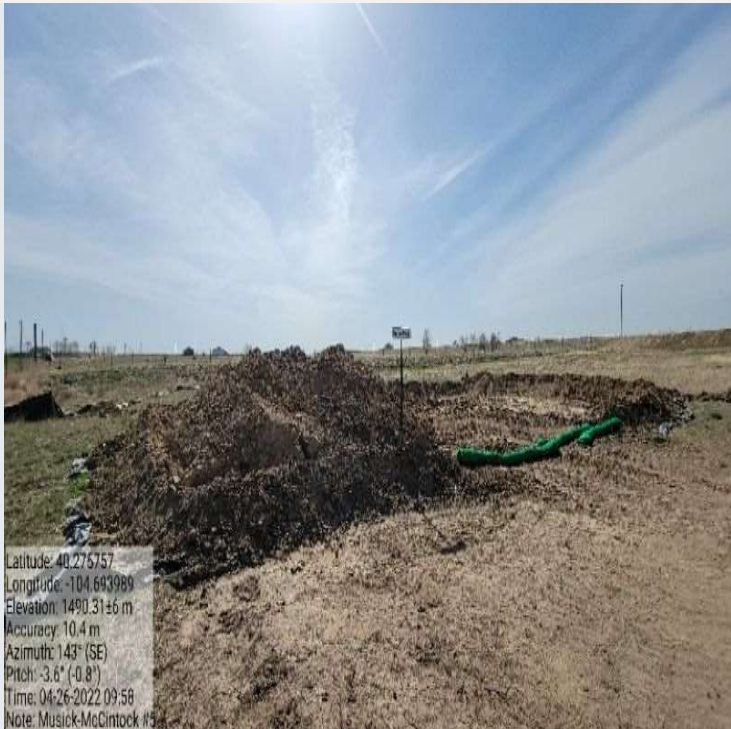
Photo
<p>Question: Stockpiled waste and approximate volume (cubic yards)</p> <p>Response: Yes</p> <p>Notes: Not measured. BMPs inadequate – Not installed properly.</p>

Notes: Silt fencing and stockpiled soil BMPs are in need of repair/installation/replacement.

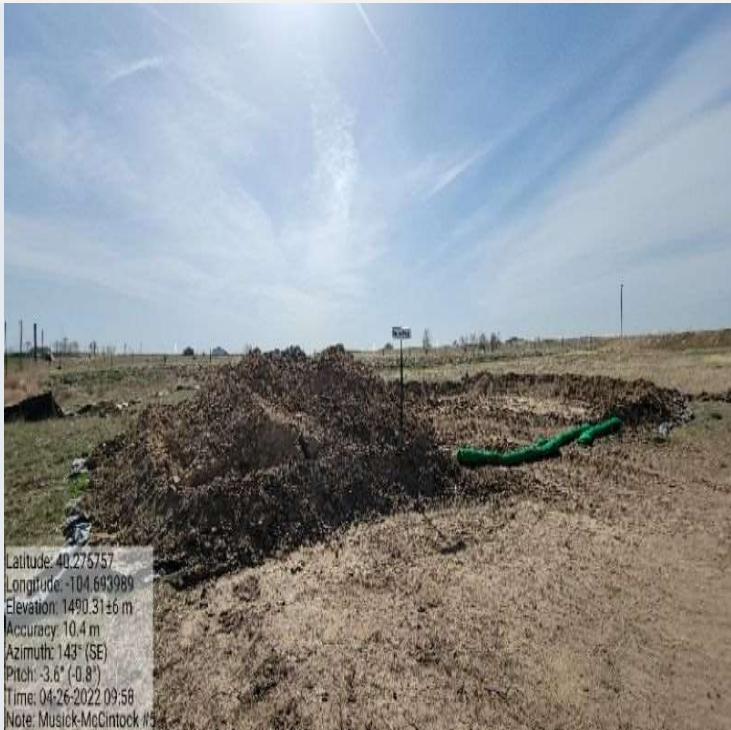
Site Condition Checklist	
	Photo
<p>Question: Waste signage present, legible is accurate and up to date (in accordance with rule 913.b.(5)B.iv)?</p> <p>Response: Yes</p> <p>Notes:</p>

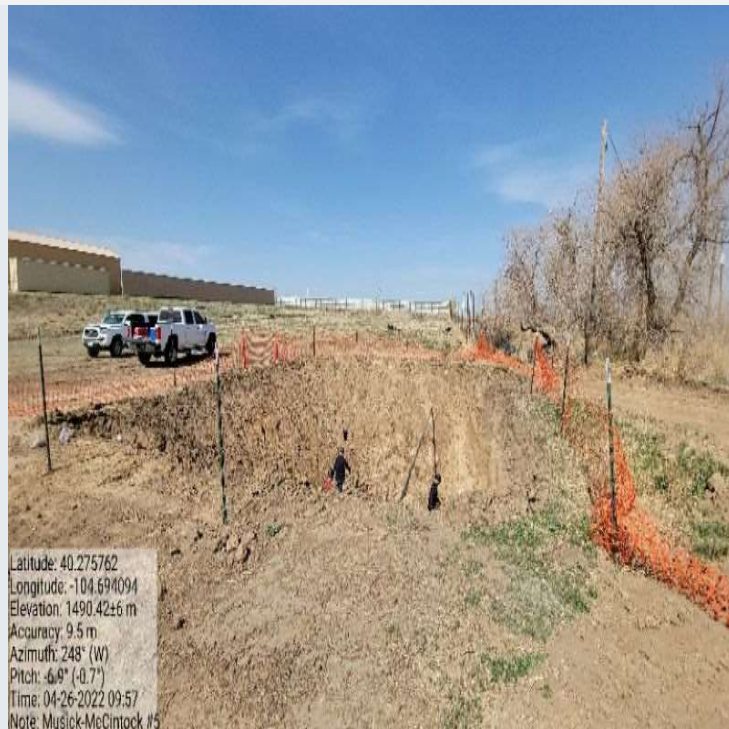
Question: Is fencing adequate/appropriate for site and well maintained?

Response: No

Notes: Fencing around excavation has fallen.

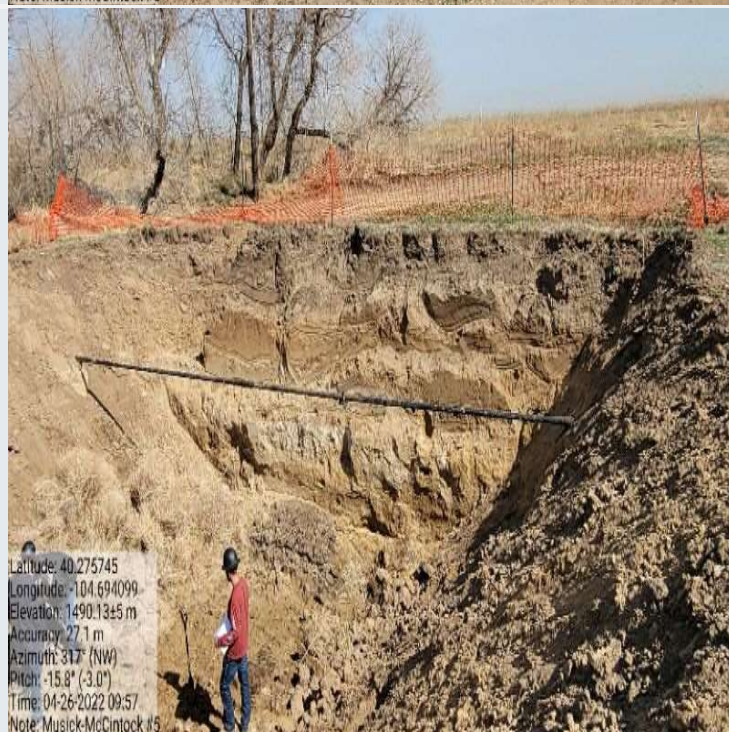
Question: Exposed buried/underground flowlines?

Response: Yes

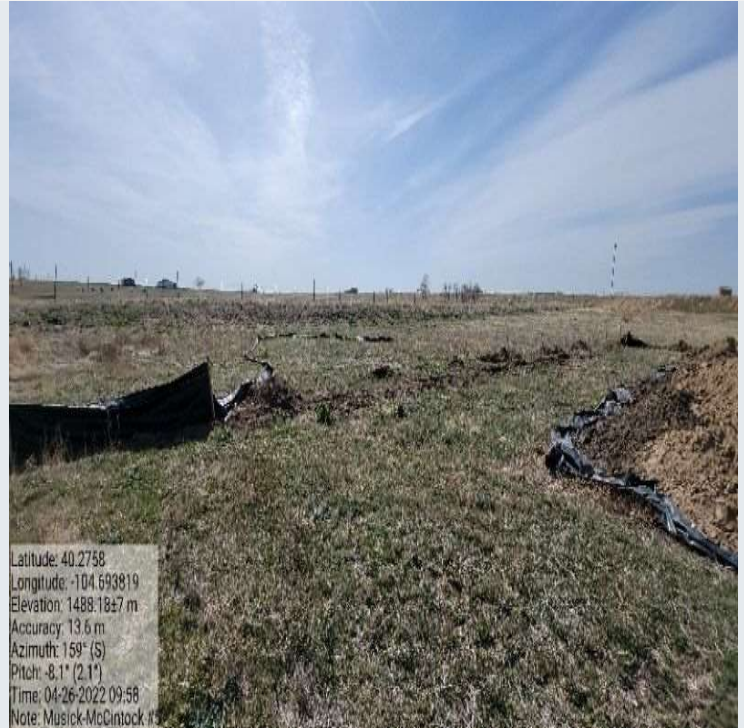
Question: Evidence of pollutants being discharged off-site?

Response: Yes

Notes: Torn silt fence trash/debris has blown offsite.

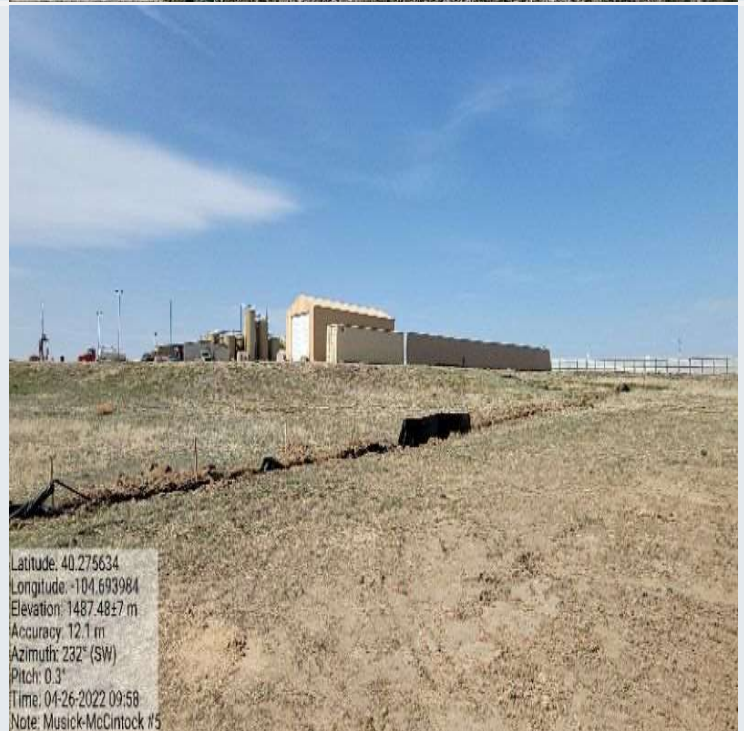
Question: All stormwater erosion control measures and BMPs are present and in good/working condition?

Response: No

Notes: Silt fencing around perimeter of the site has been torn/fallen

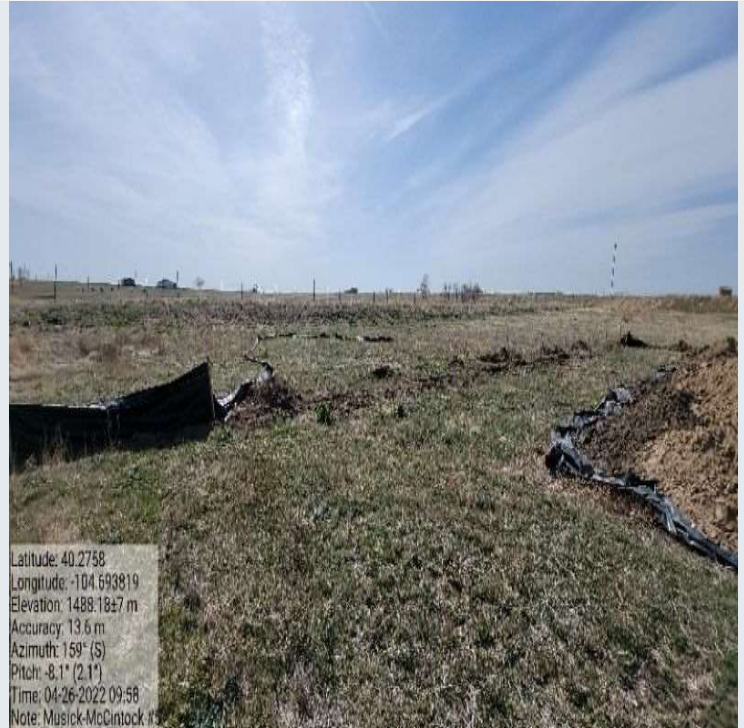
Question: All stormwater erosion control measures and BMPs are present and in good/working condition?

Response: No

Notes: Silt fencing around perimeter of the site has been torn/fallen

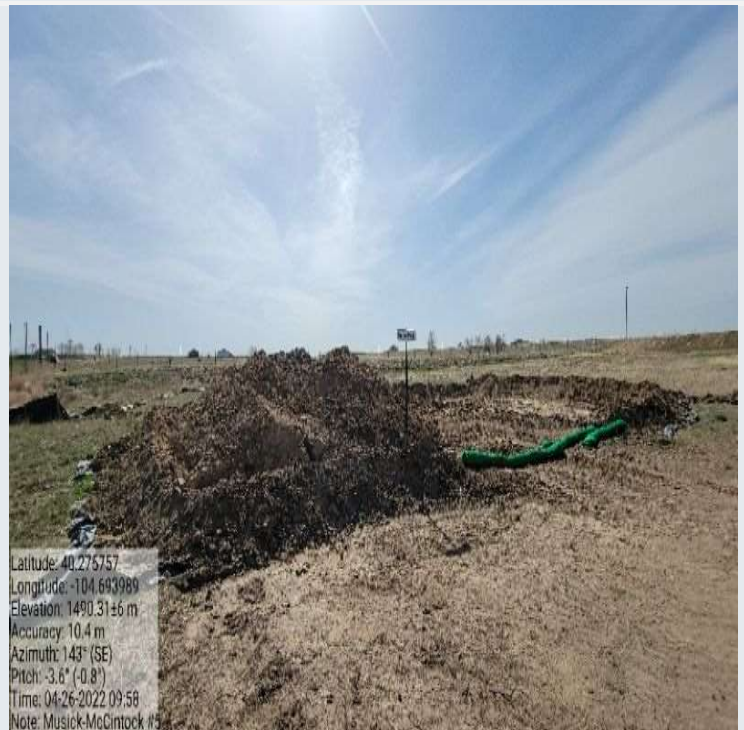
Question: Site is free of debris/trash?

Response: No

Notes: Torn silt fence trash/debris has blown offsite.
