# Inspection Photos

API: 009-06236

Operator: DOVER ATWOOD CORPORATION

Inspection Date: 5/6/2022

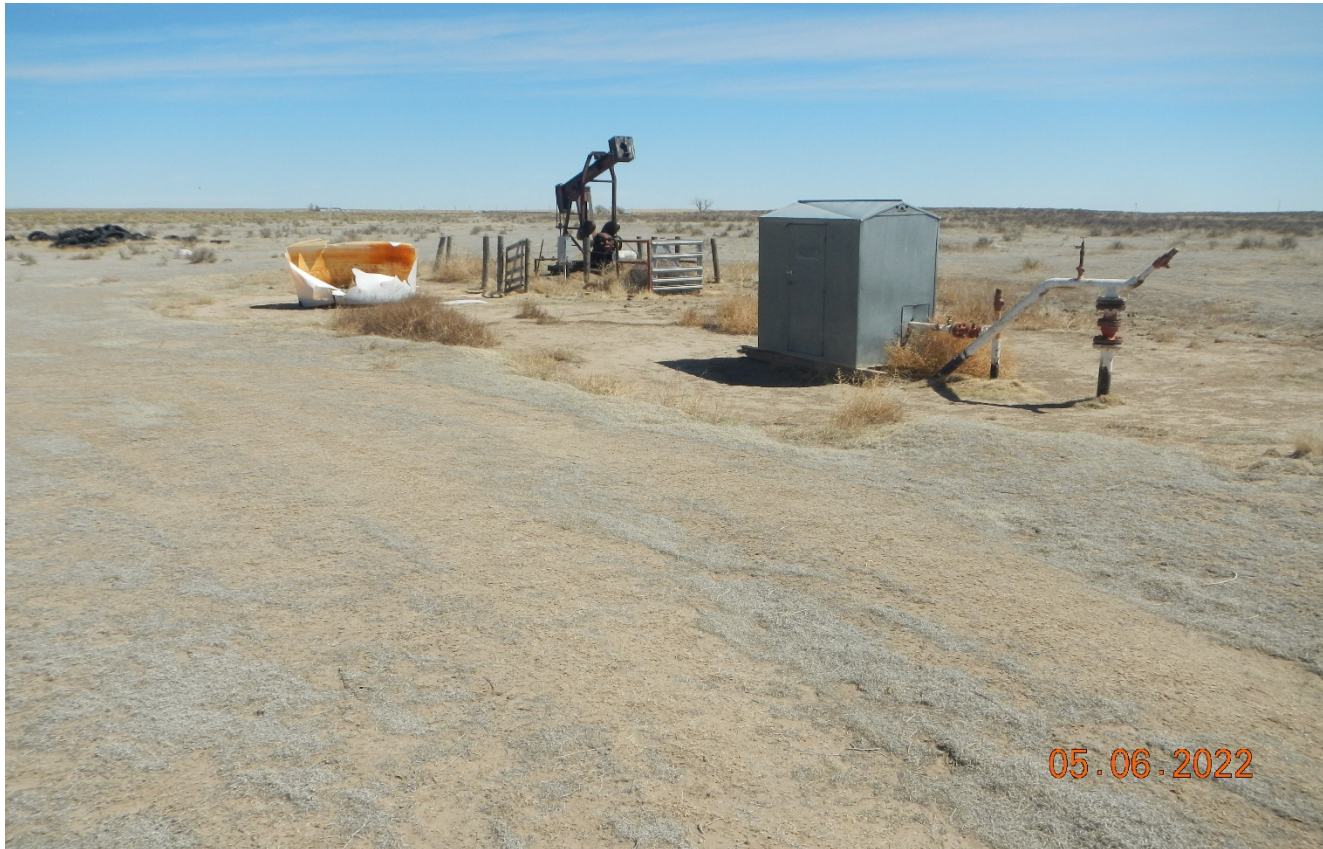
**Photo 1.** Facing northeast toward wellsite. Previous corrective action is not completed.

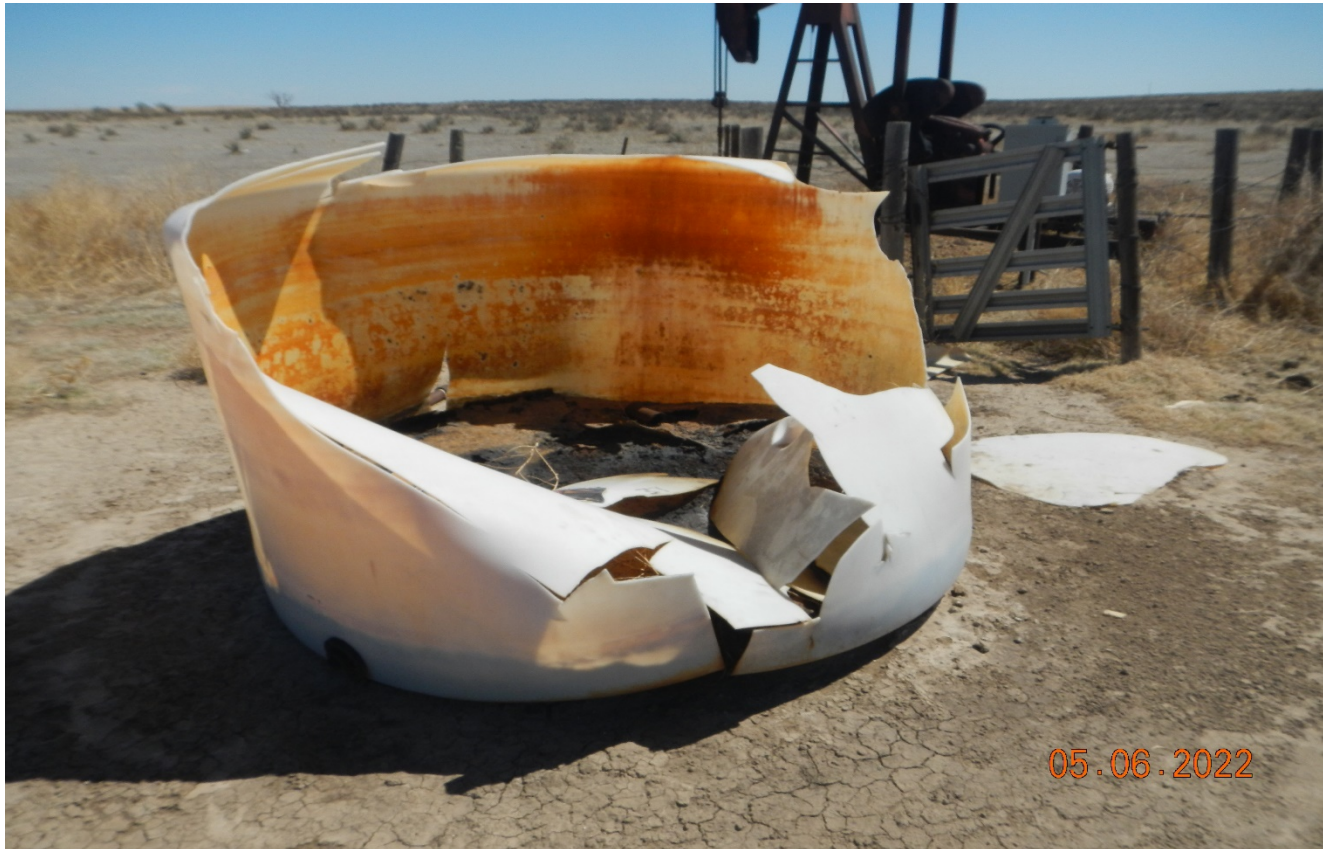
**Photo 2.** The tank on the location is busted apart and there is a solidified oily substance inside the tank which appears to have spilled out. Previous corrective action is not completed.

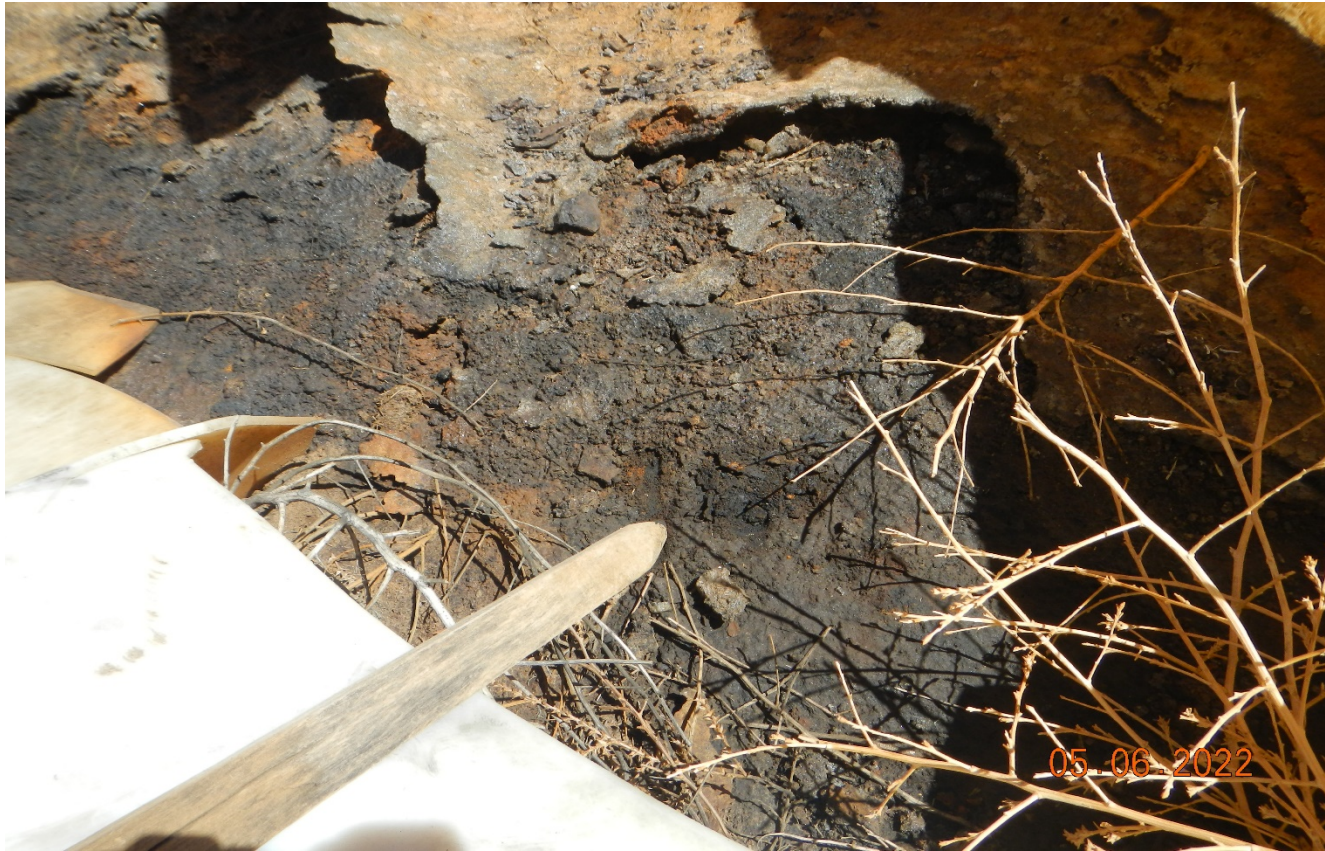
**Photo 3.** This photo shows the solidified oily substance inside the tank. Previous corrective action is not completed.

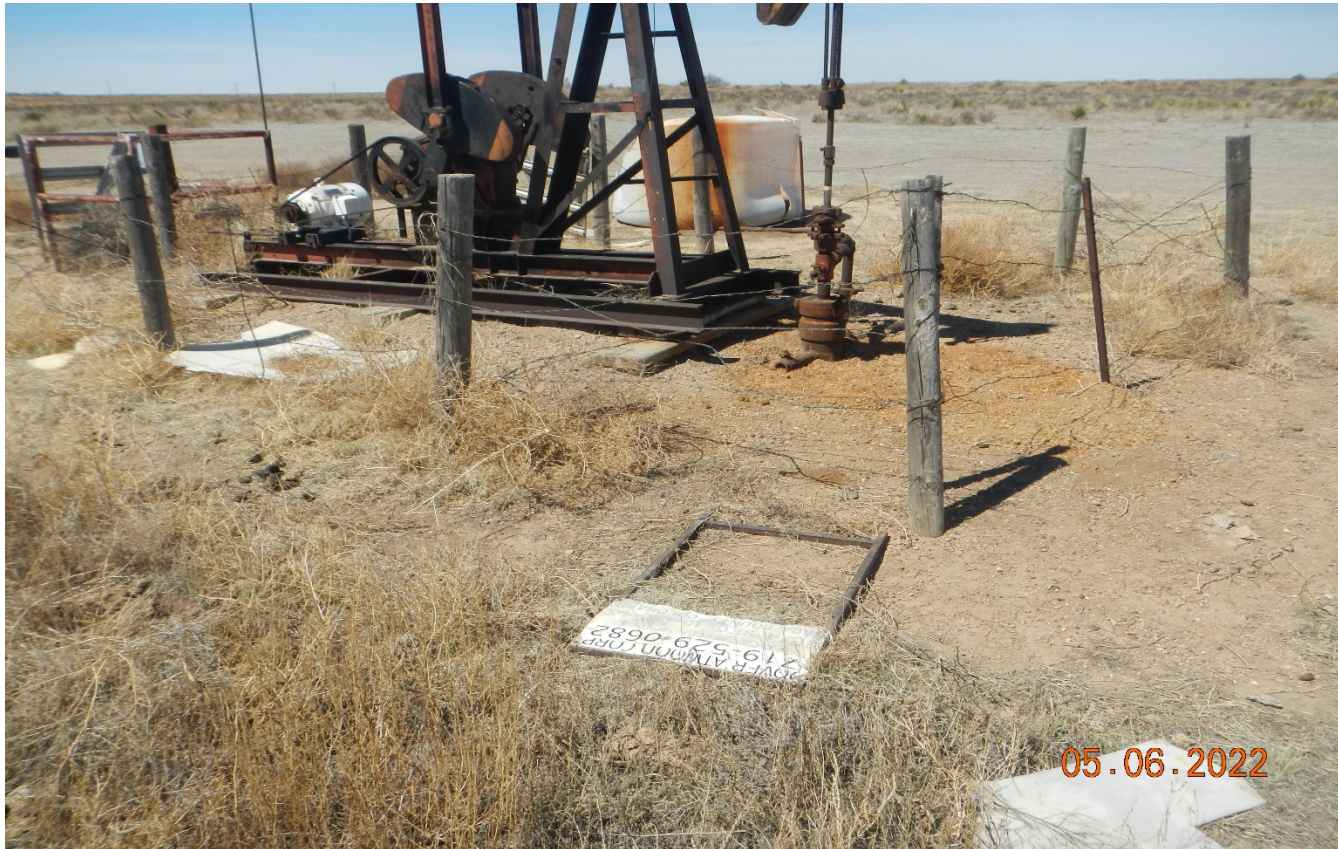
**Photo 4.** There is weed debris around the equipment which is a fire hazard. The well sign has fallen over and needs to be properly installed. The emergency contact number was not valid and does not meet the signage requirements. Previous corrective actions have not been completed.
