Inspection Photos

ID:438617

Operator: DOVER ATWOOD CORPORATION

Inspection Date: 5/6/2022

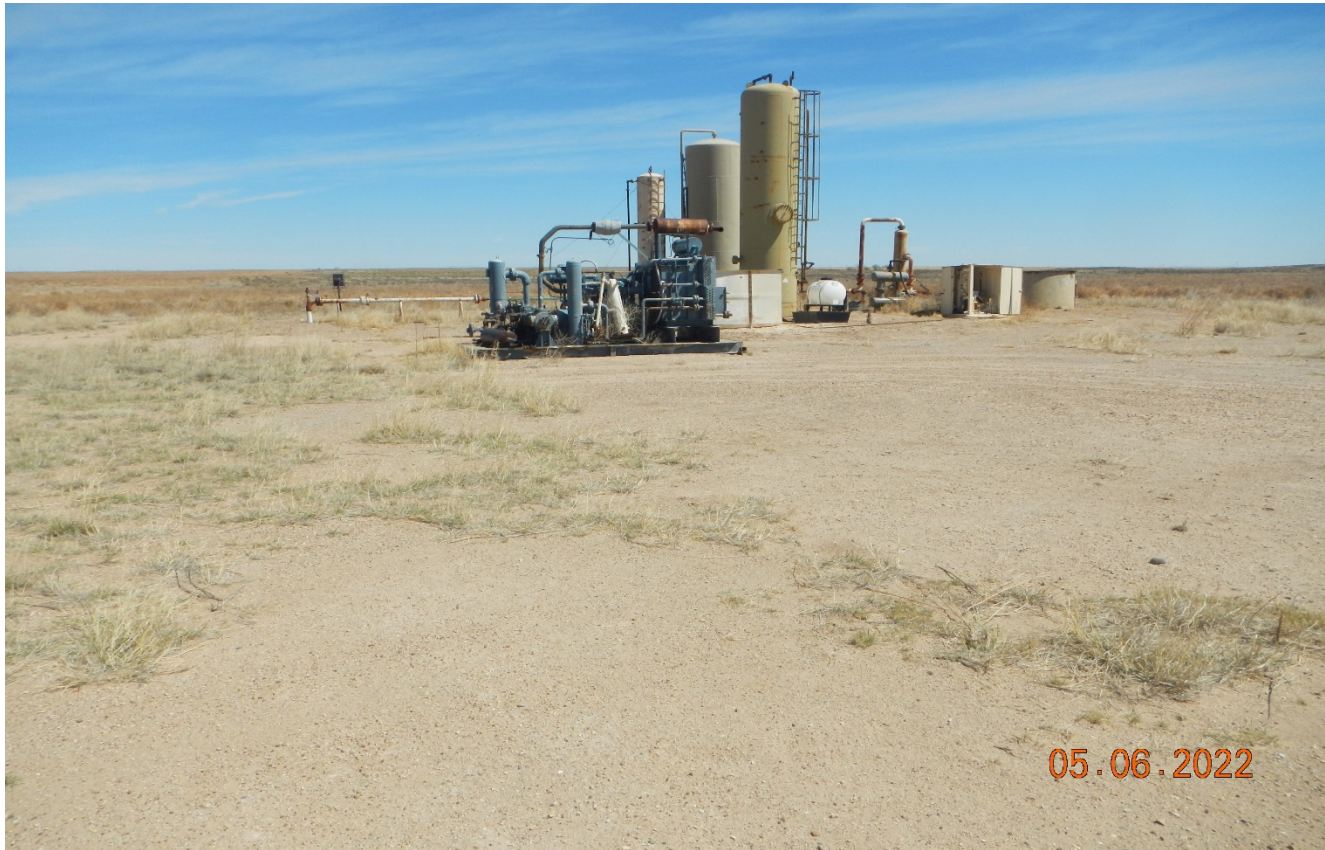
Photo 1. Facing northeast toward the gas treatment facility.

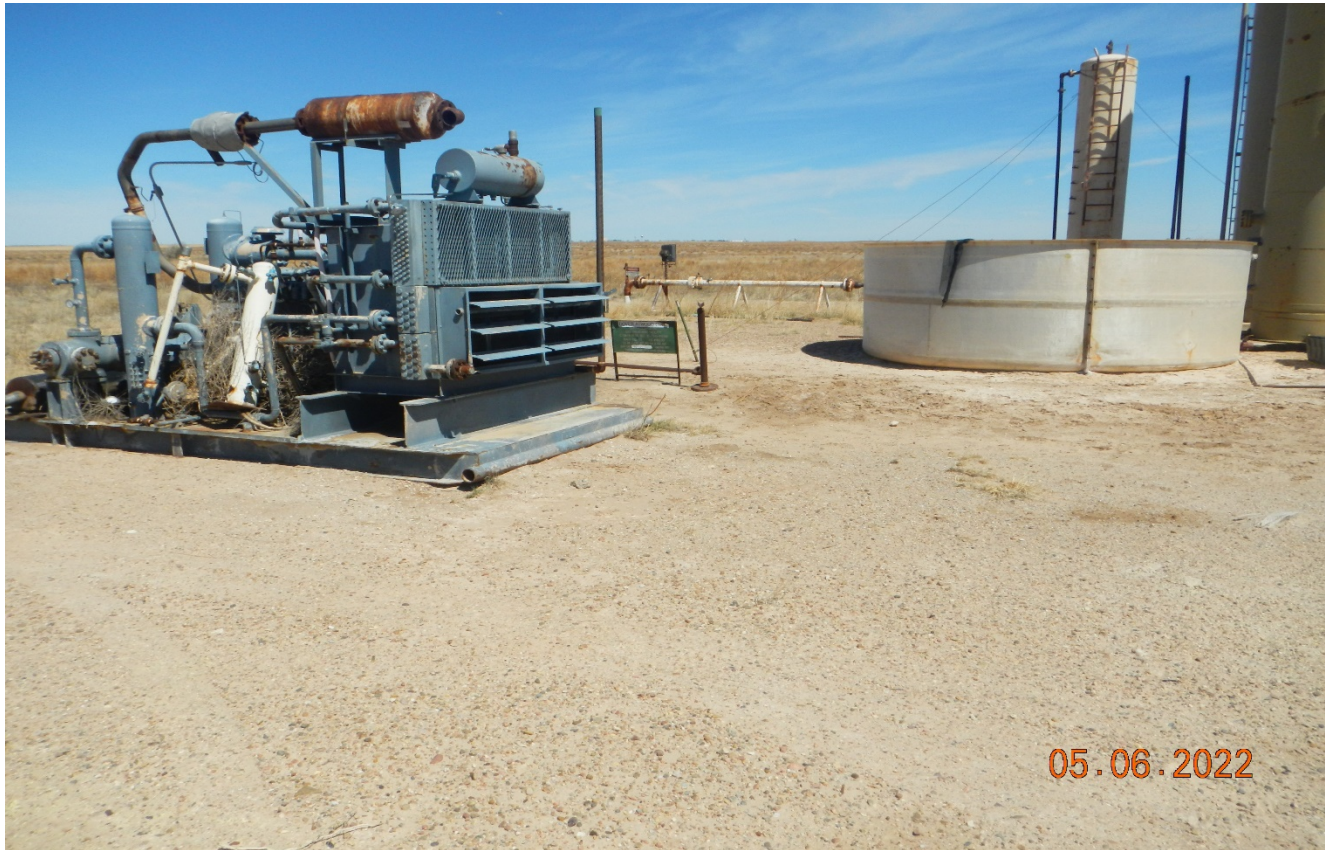
Photo 2. There is an unused compressor stored on location that need to be removed. Previous corrective action is not completed.

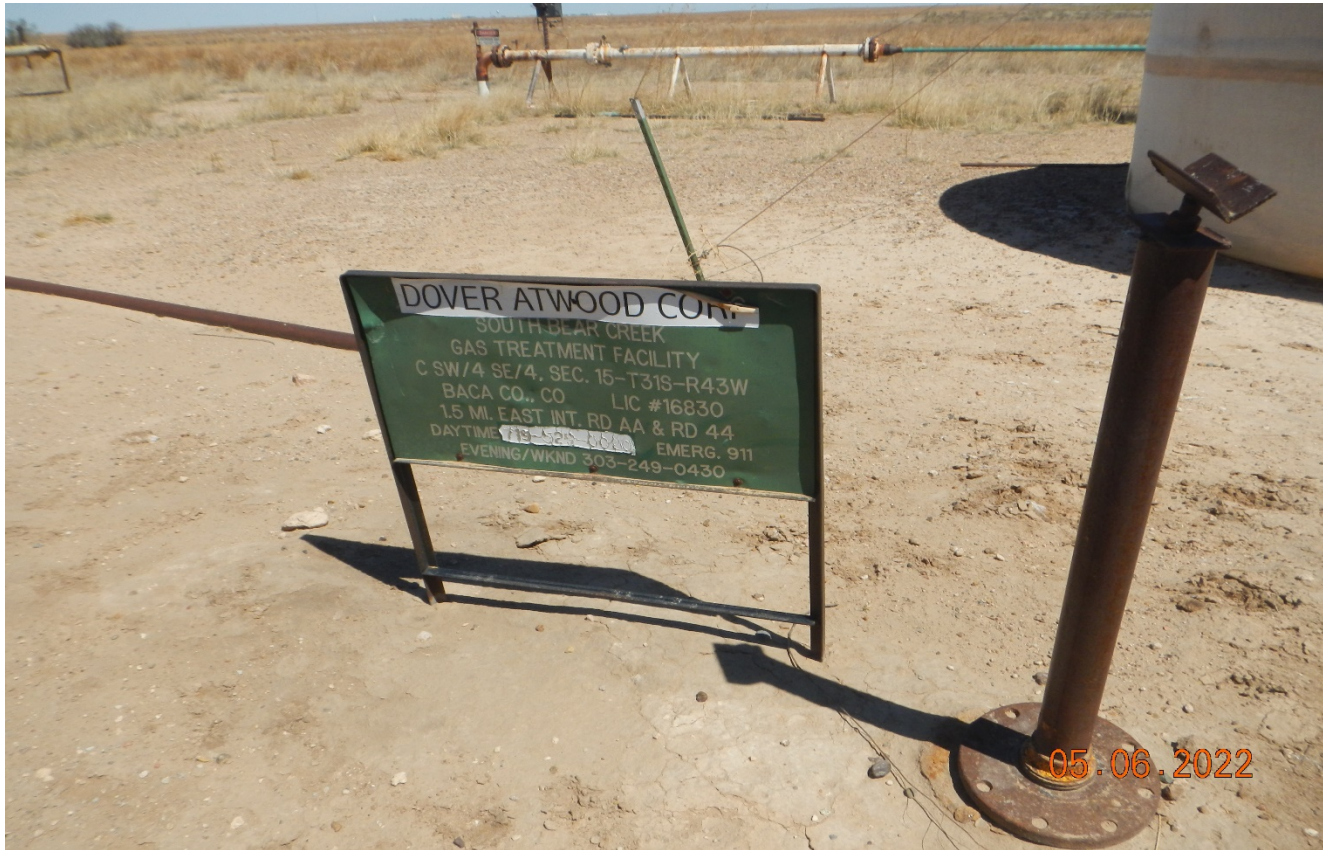
Photo 3. The facility sign is obscured behind the compressor. The emergency contact number is not valid. Previous corrective action is not completed.

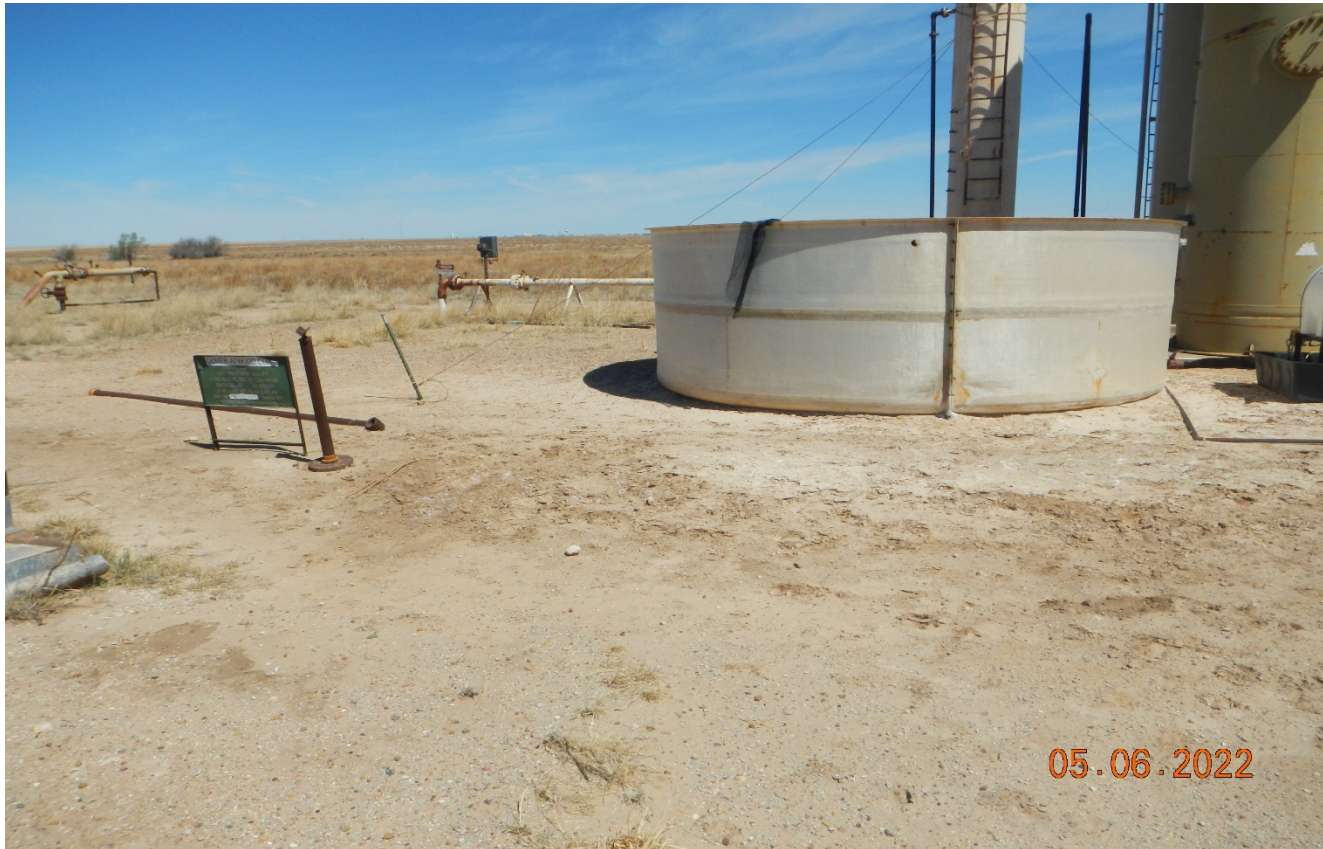
Photo 4. Facing toward the open top tank. It appears the tank has previously leaked due to white stained soil. There is no secondary containment around the tank. There is no signage on the tank. Previous corrective action is not completed.

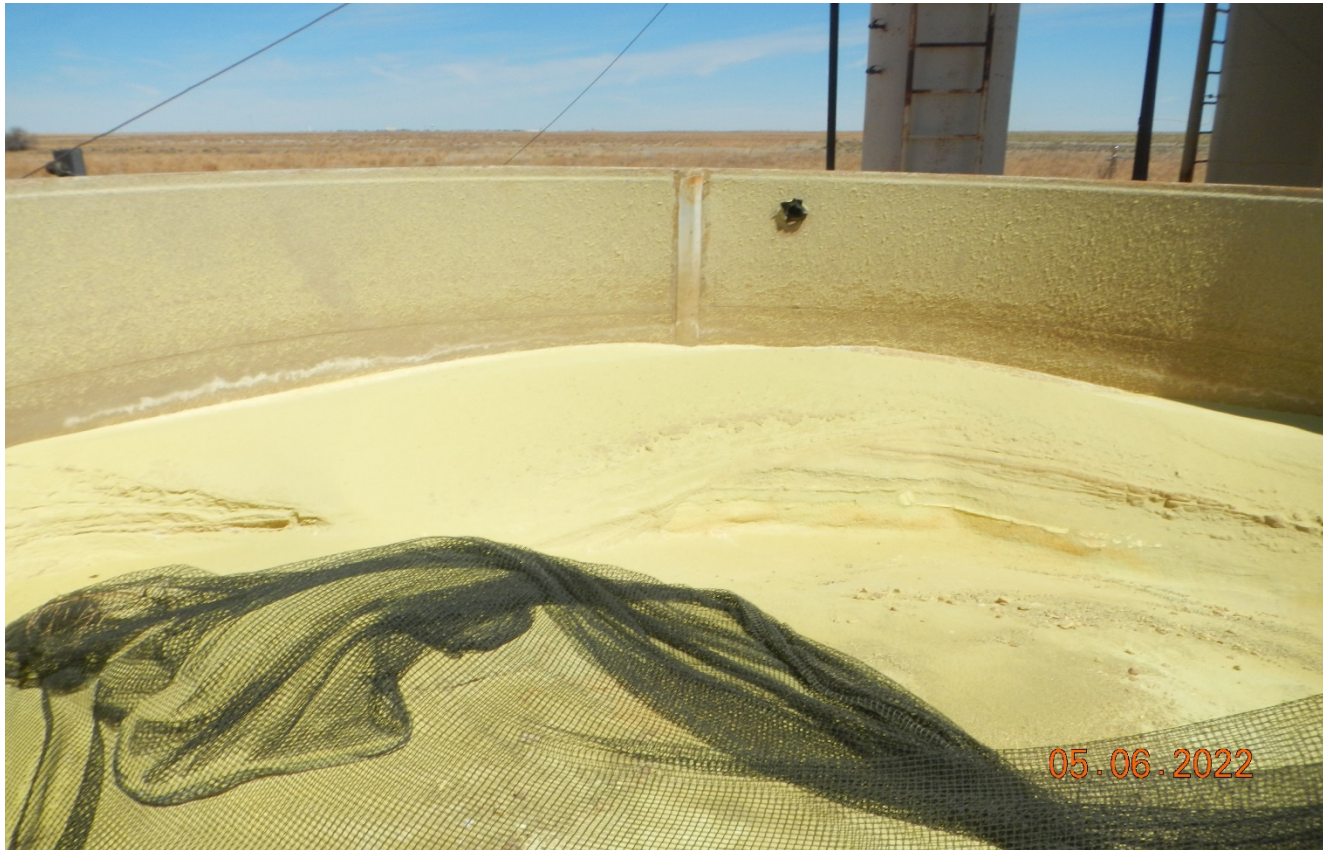
Photo 5. The netting over the tank is not installed. Previous corrective action is not completed.

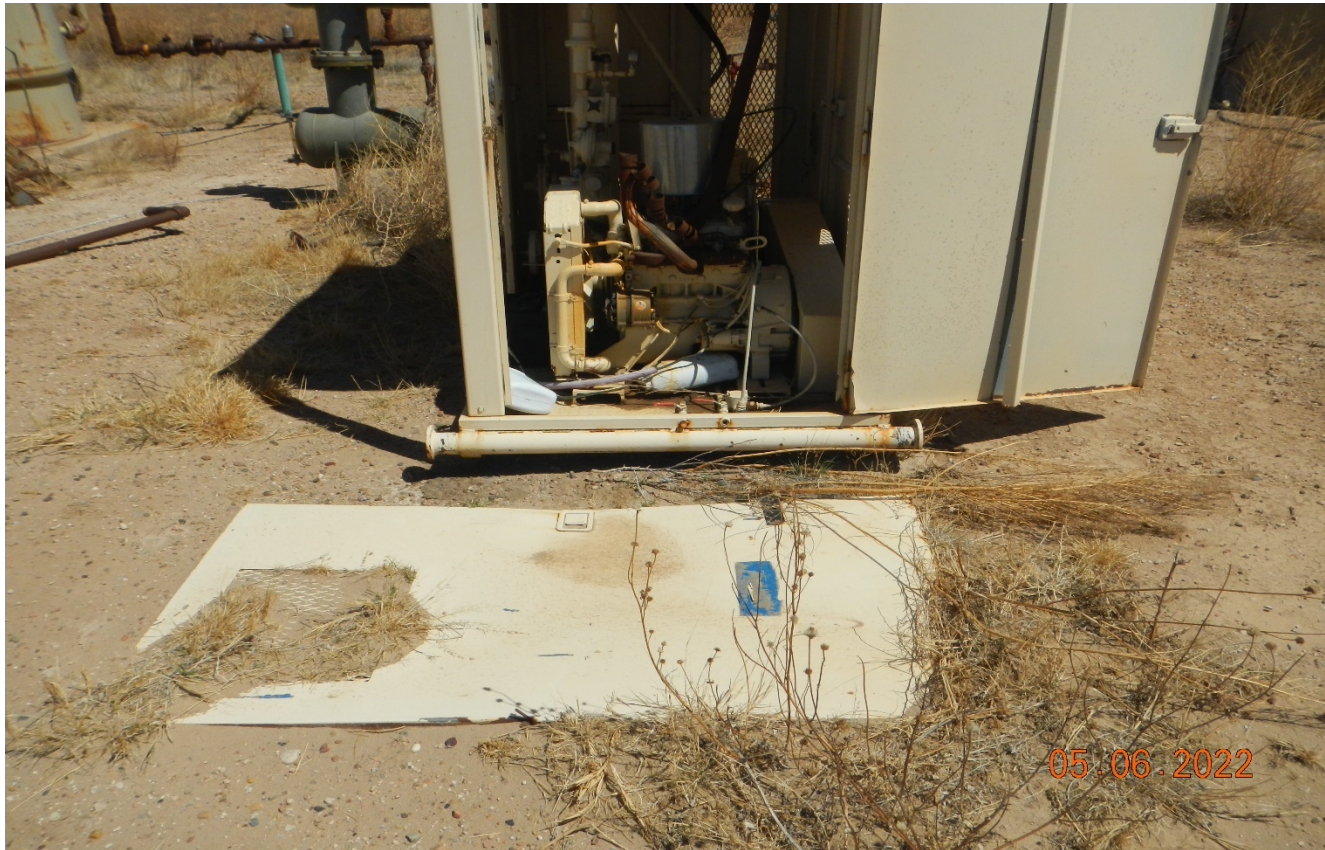
Photo 6. There is equipment not maintained on location. Door has fallen off this shed. Previous corrective action is not completed.

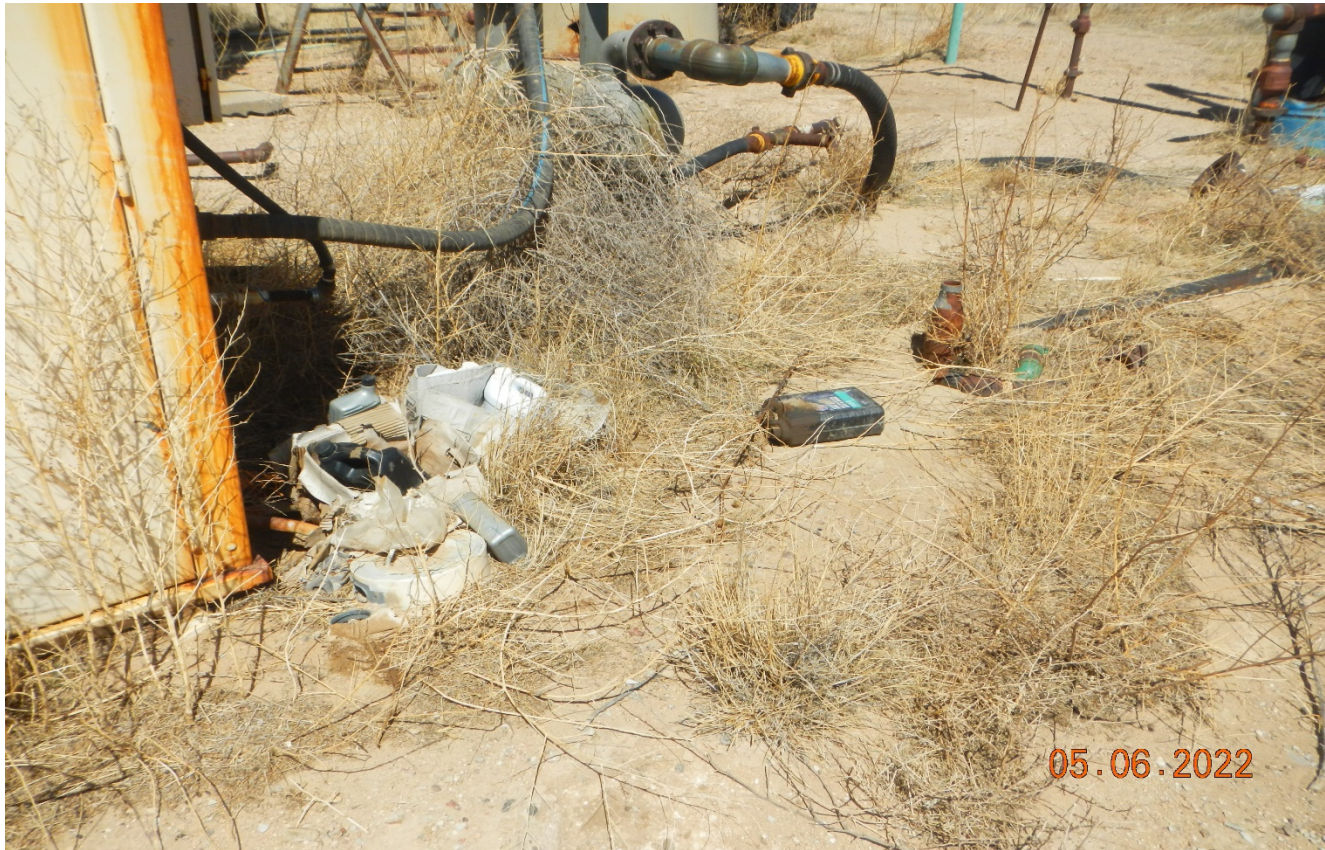
Photo 7. There is oil/chemical containers and trash not properly or disposed of. Previous corrective action is not completed.

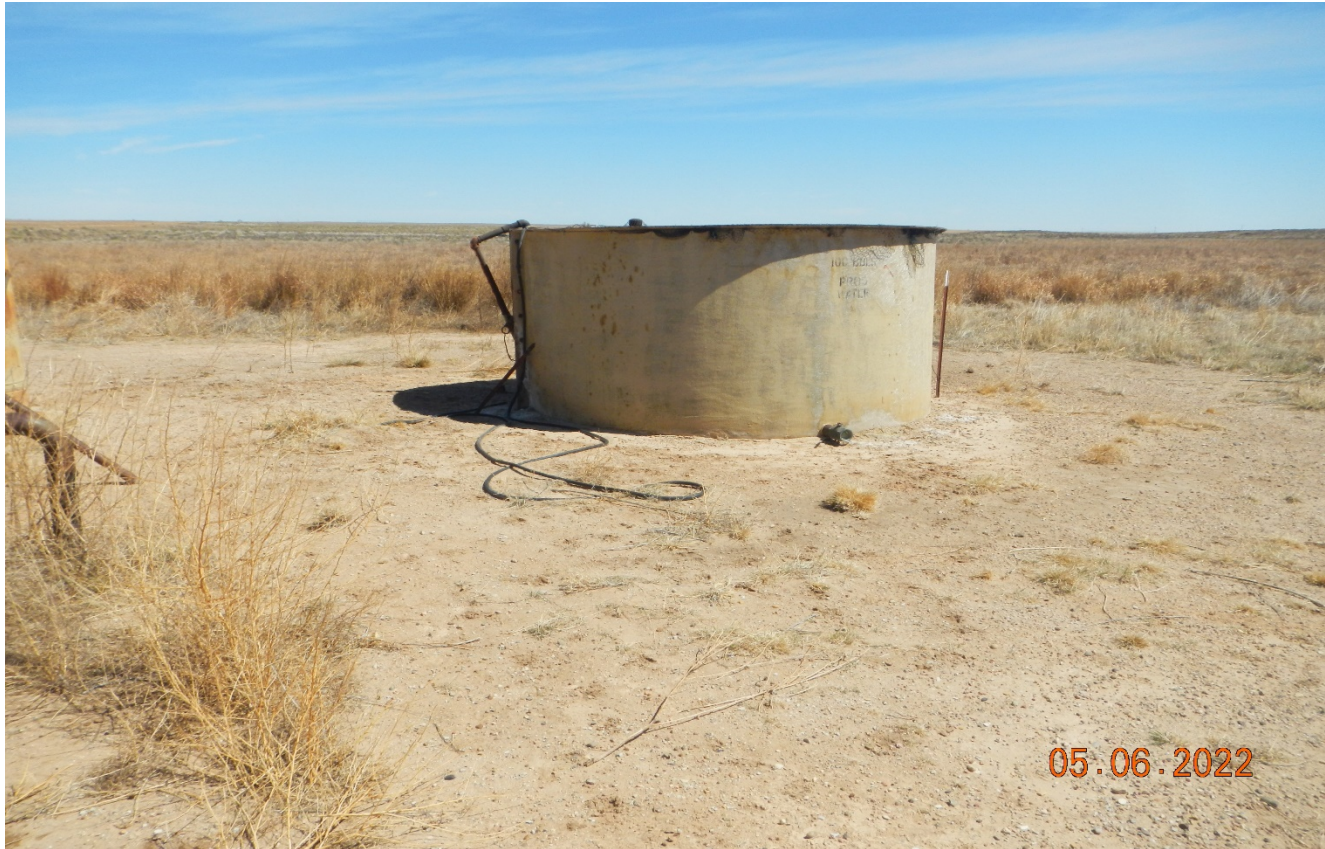
Photo 8. There is an open top tank at the east side of the location. It appears the tank has previously leaked due to white stained soil. There is no secondary containment around the tank. The signage has faded. Previous corrective action is not completed.

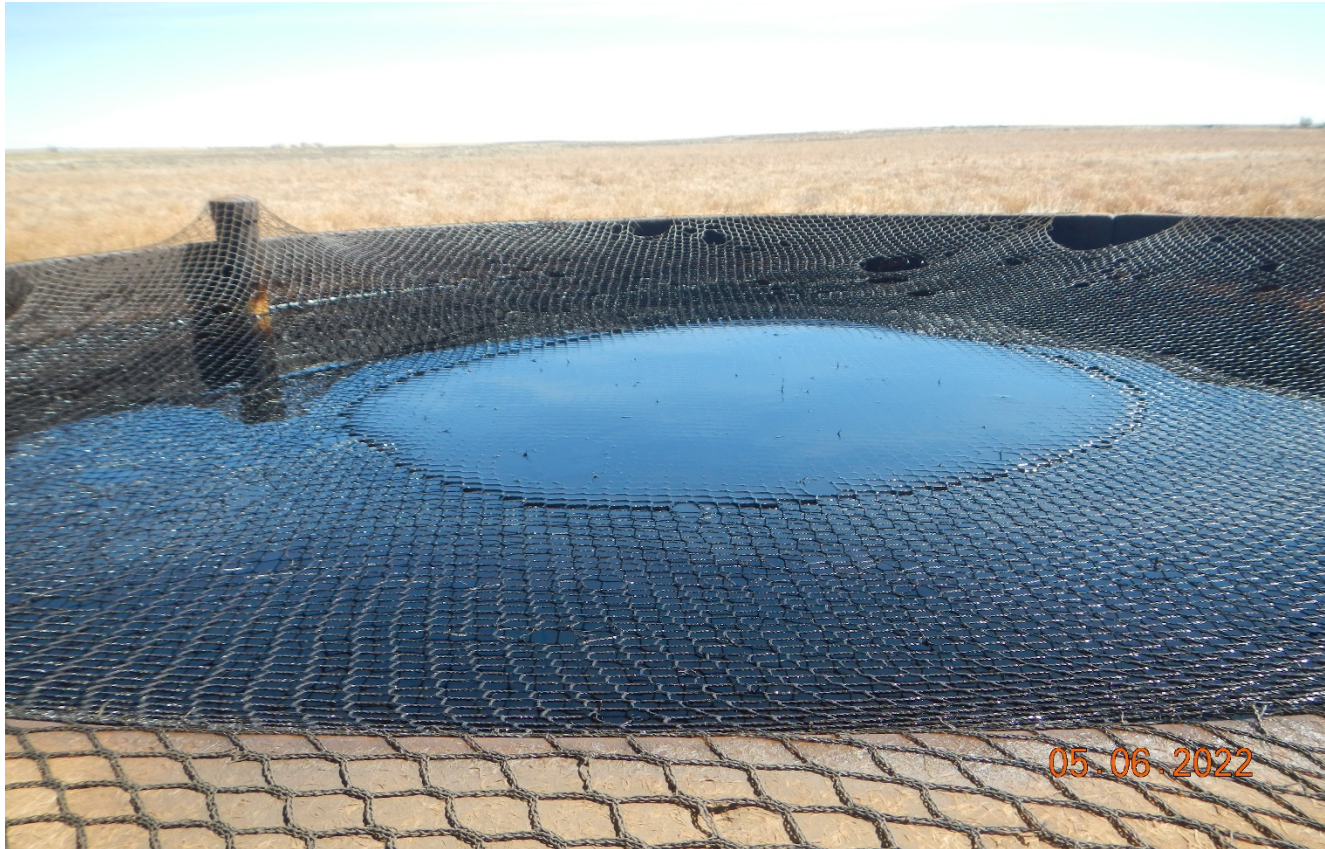
Photo 9. The liquid in the tank is near the top which could spill over. The netting is not adequate to prevent wildlife entry. Previous corrective action is not completed.

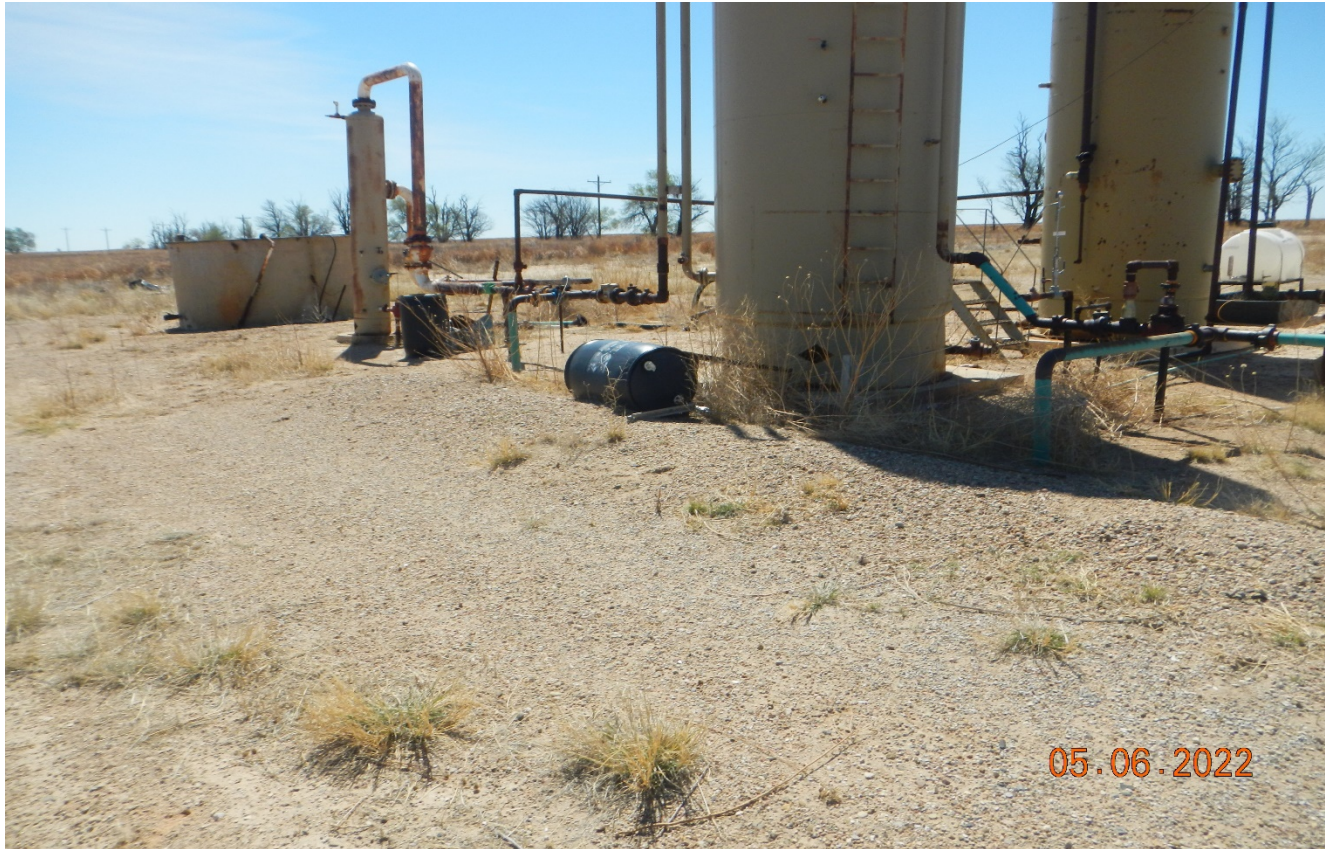
Photo 11. There is unused supplies and a black barrels with no labeling. Previous corrective action is not completed.

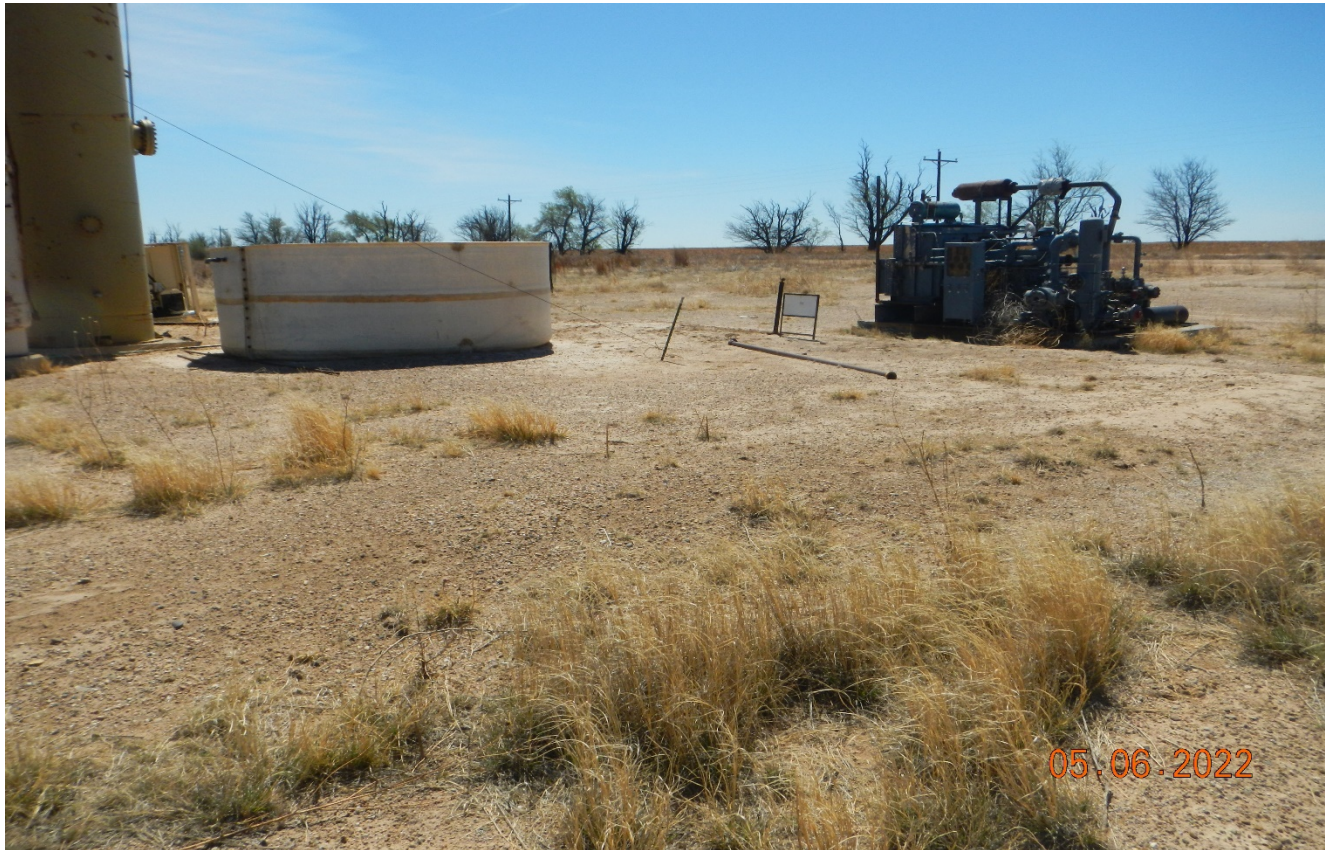
Photo 12. Facing east toward the facility.
