Inspection Photos

API: 009-06268

Operator: DOVER ATWOOD CORPORATION

Inspection Date: 5/6/2022

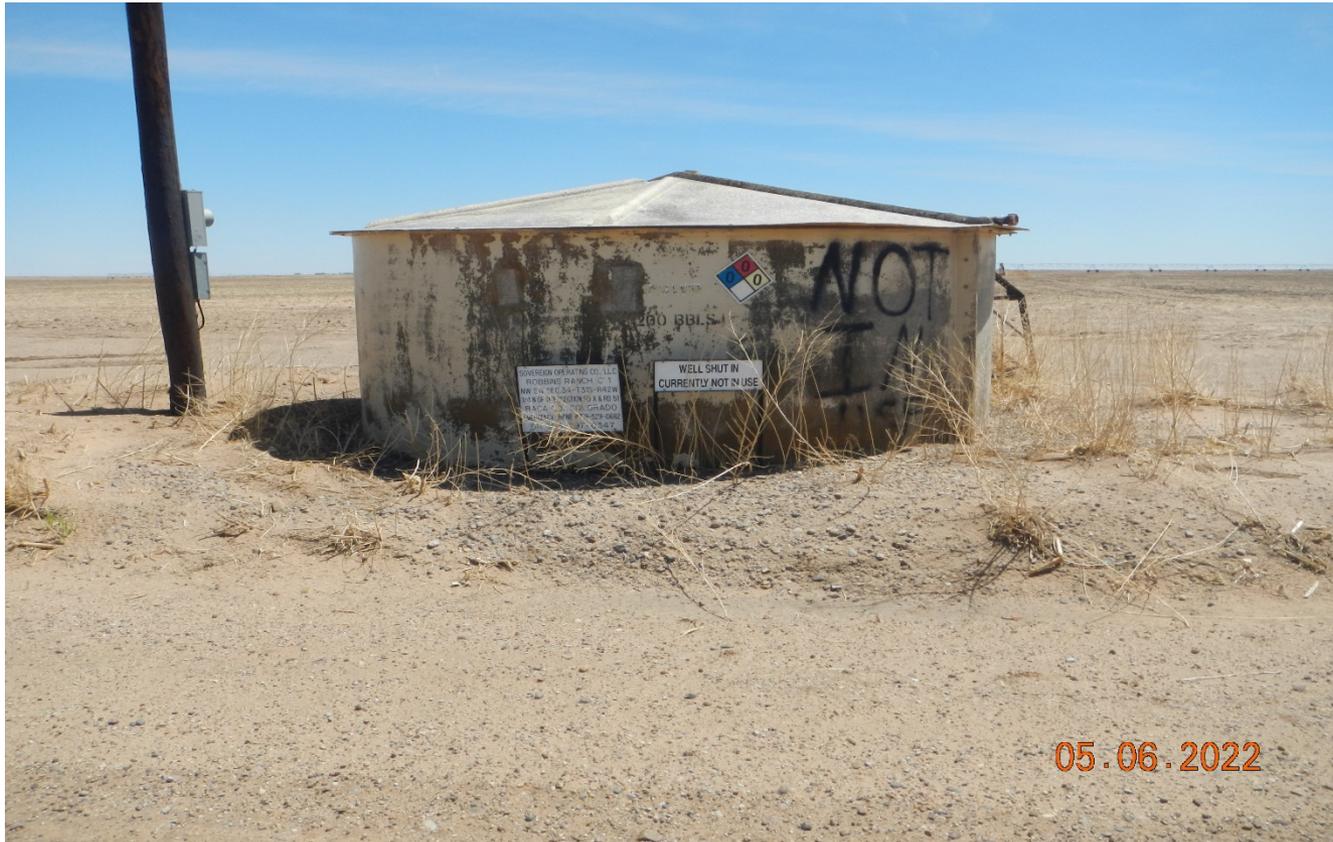
Photo 1. Facing east toward the tank battery along the access road. Sign does not reflect current Operator or emergency contact INFO. If take is not in use it must be removed. Tank berm is inadequate.

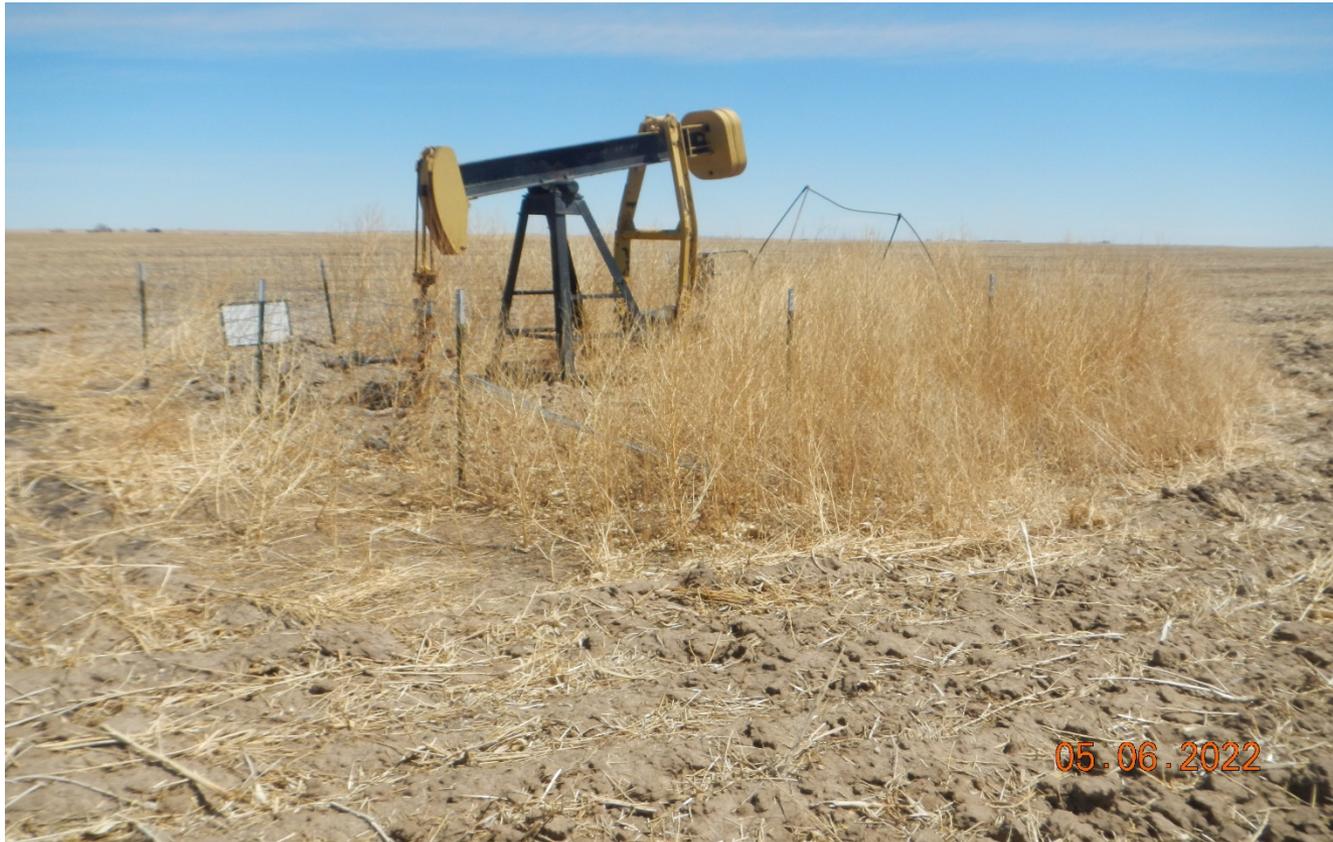
Photo 2. Facing toward the well site. There is weed debris near the pumpjack which is a fire hazard.

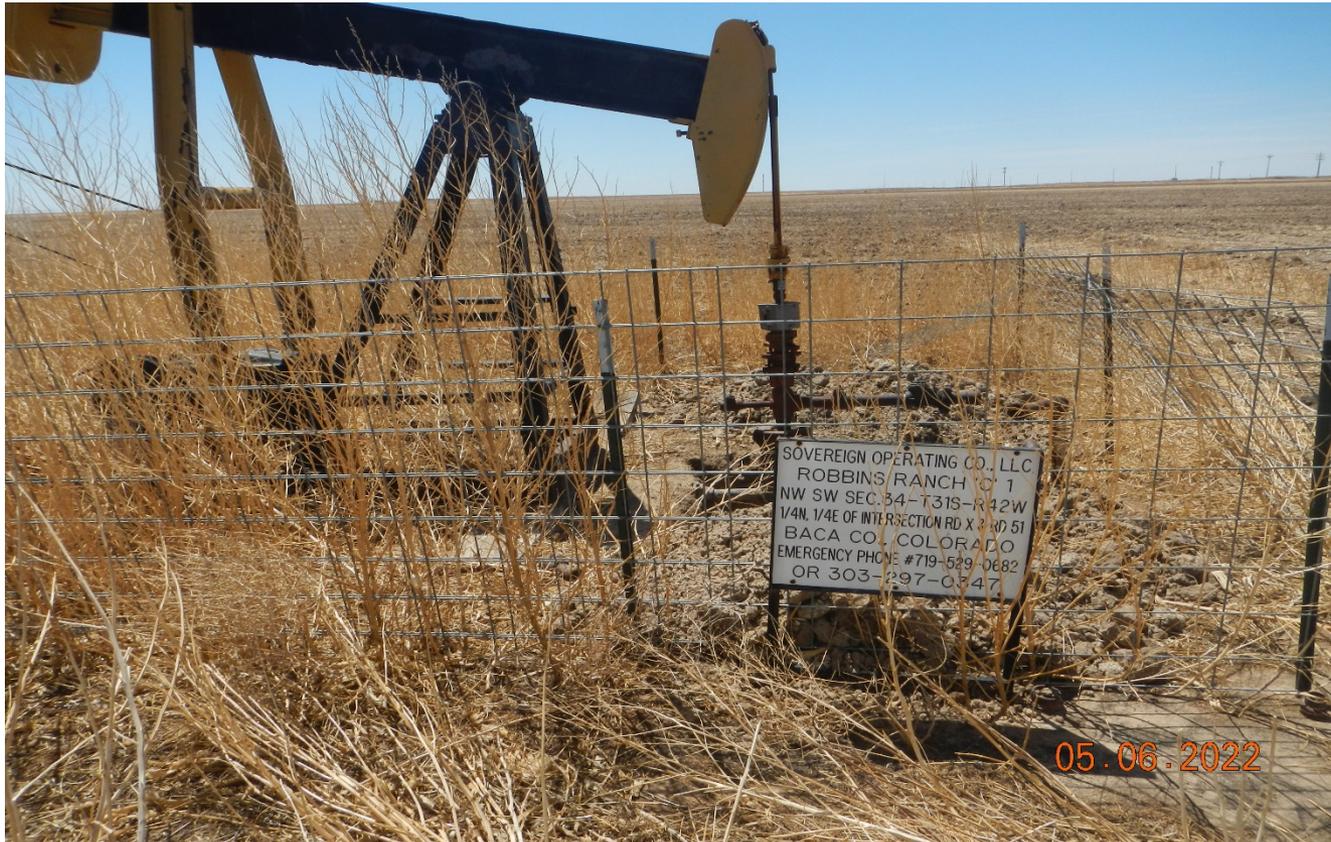
Photo 3. Well sign does not reflect current Operator or emergency contact INFO.

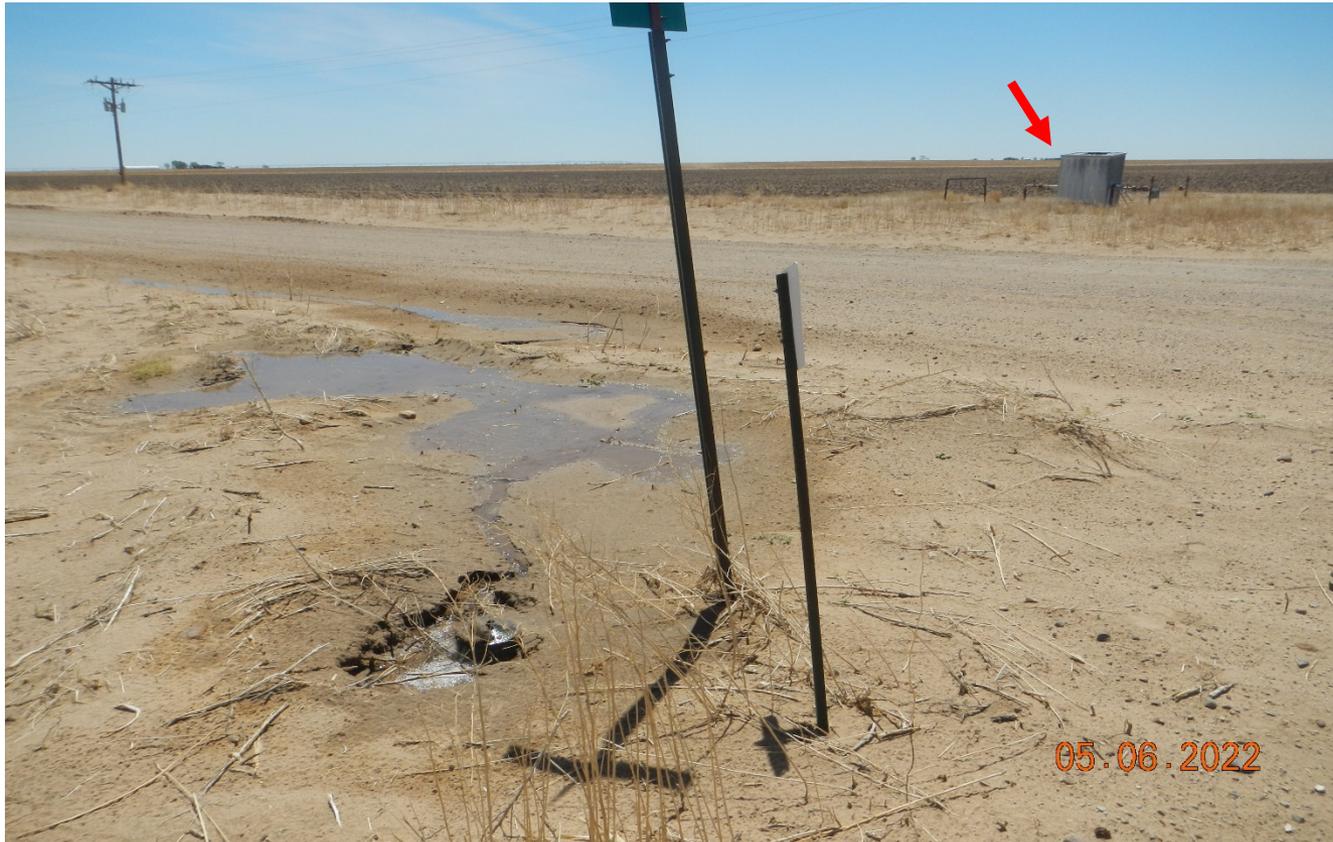
Photo 4. There was a water leak observed at intersection of CR X and 51. There is a meter run located at red arrow 1500 Ft. SW of well.

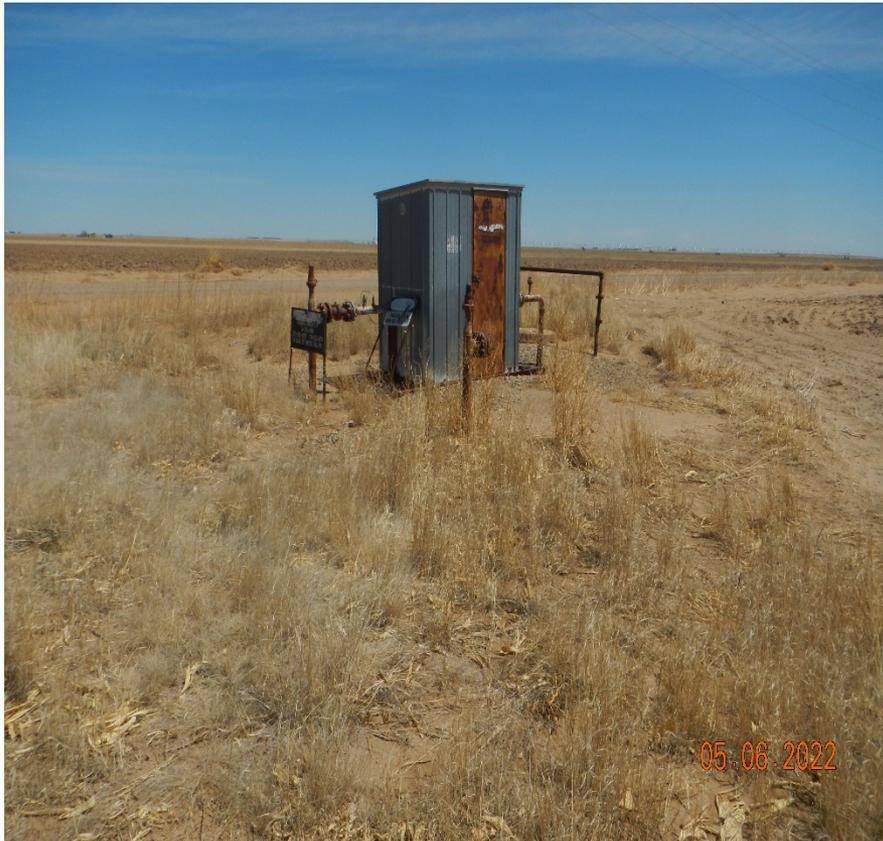
Photo 5. There is a meter run located on the southeast corner of CR X and 51.

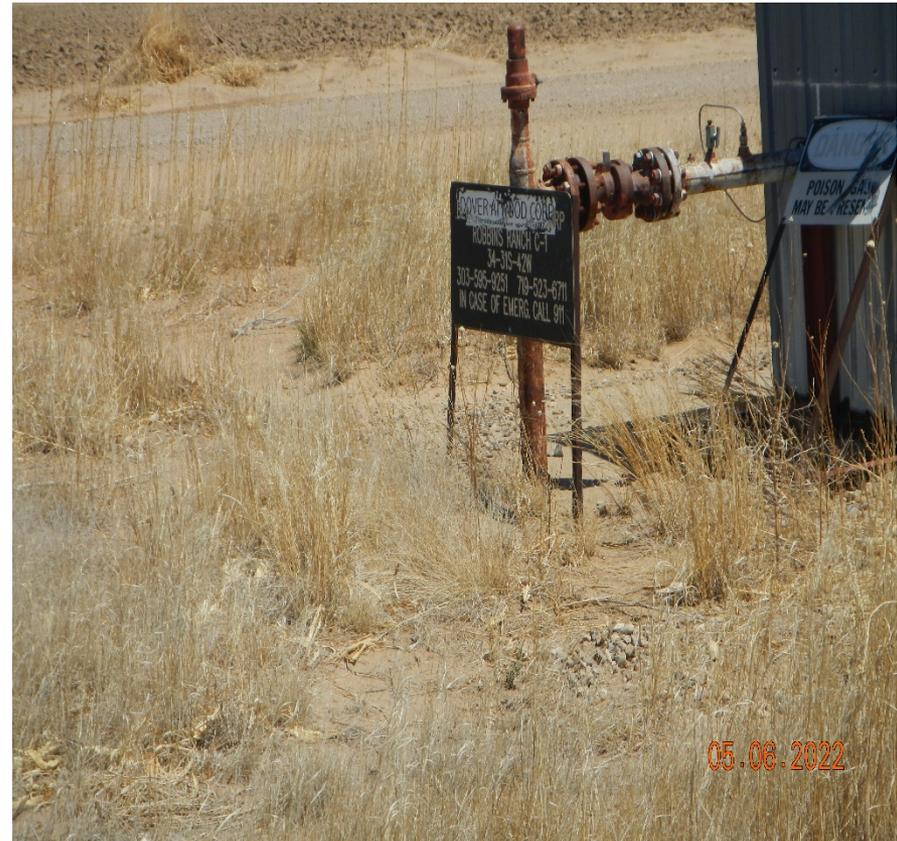
Photo 6. Sign INFO does not have valid emergency contact.
