Inspection Photos

API: 009-06174

Operator: DOVER ATWOOD CORPORATION

Inspection Date: 5/6/2022

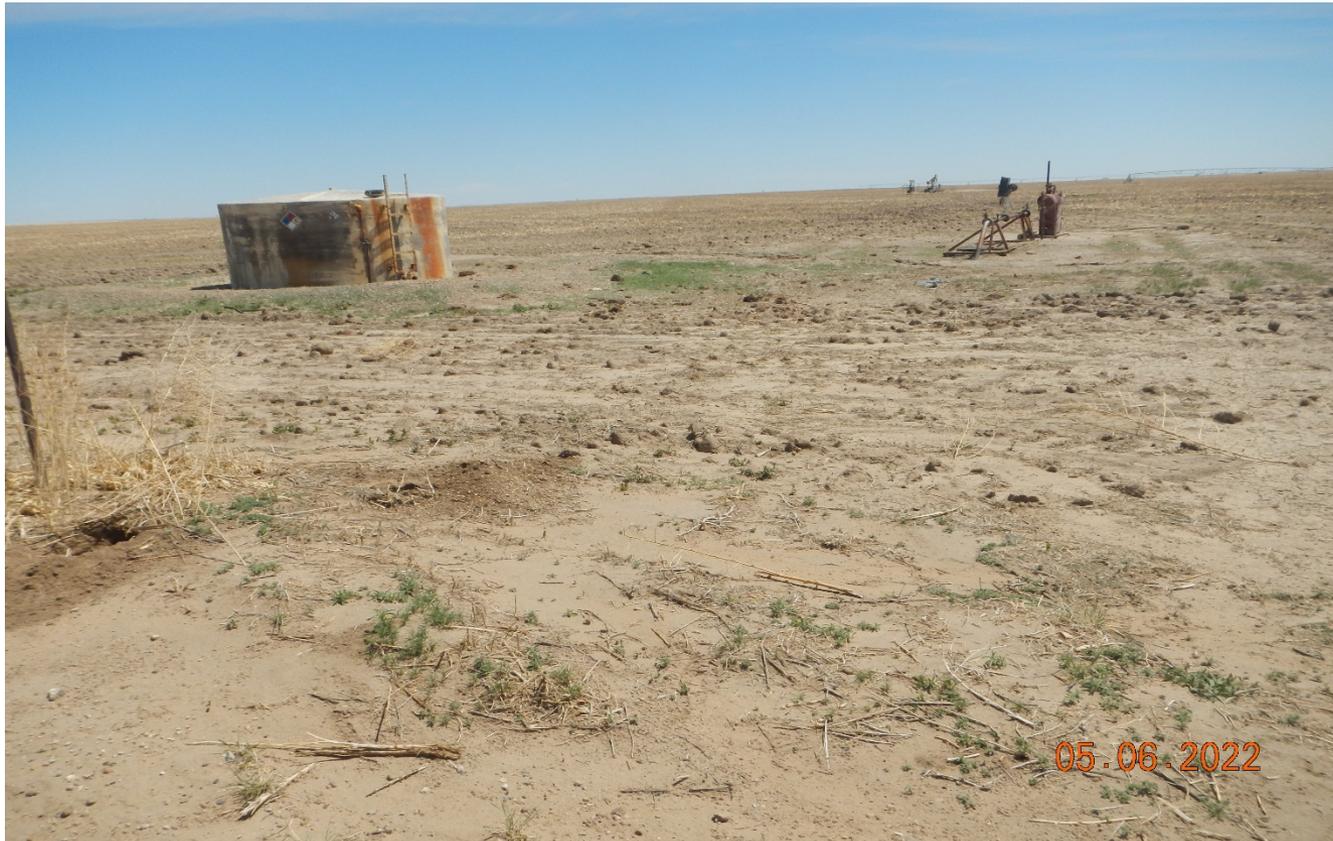
Photo 1. Facing northeast toward the tank battery.

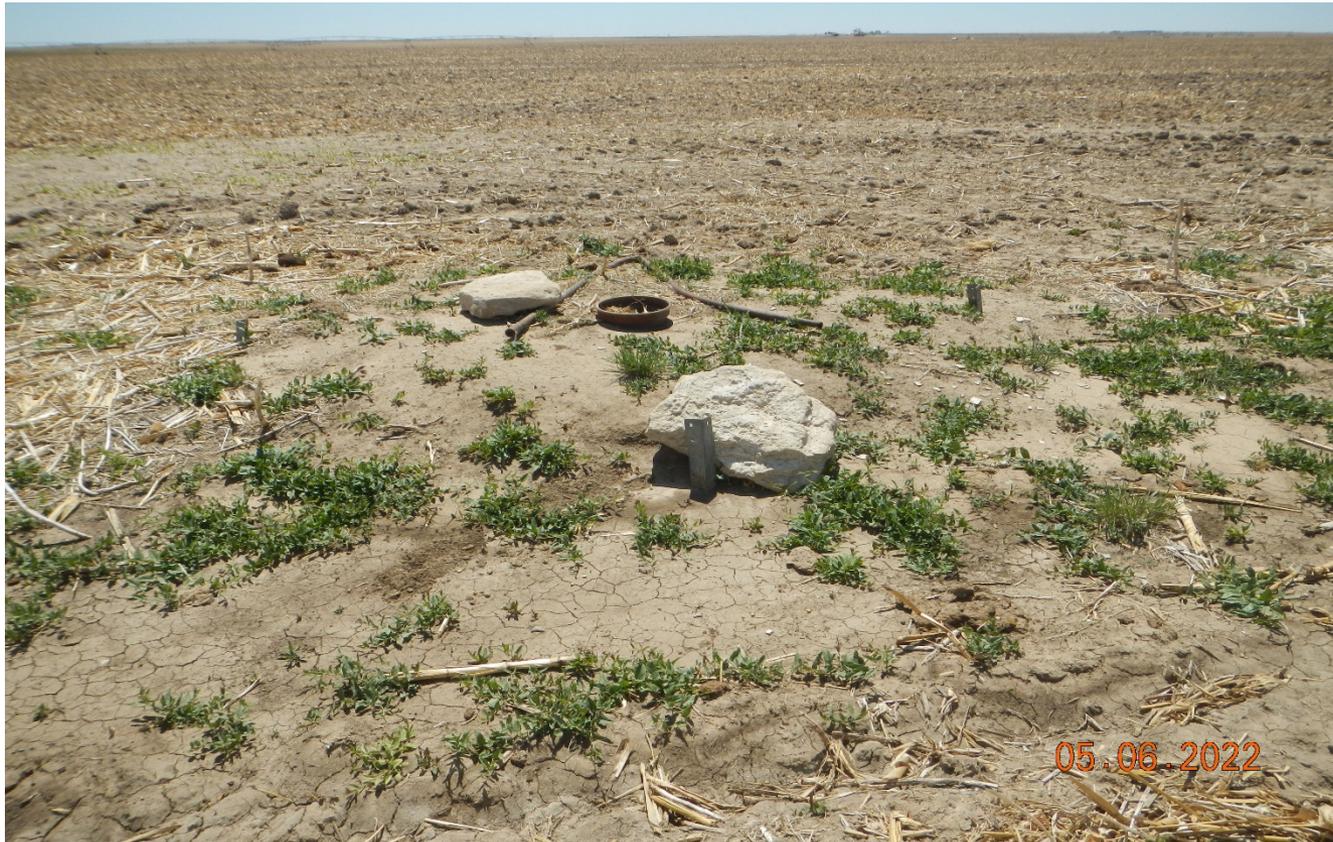
Photo 2. There is unused debris, cement blocks, and metal pipe laying on the grounding interfering with farming operations. Lat/Long:37.32092,-102.15106.

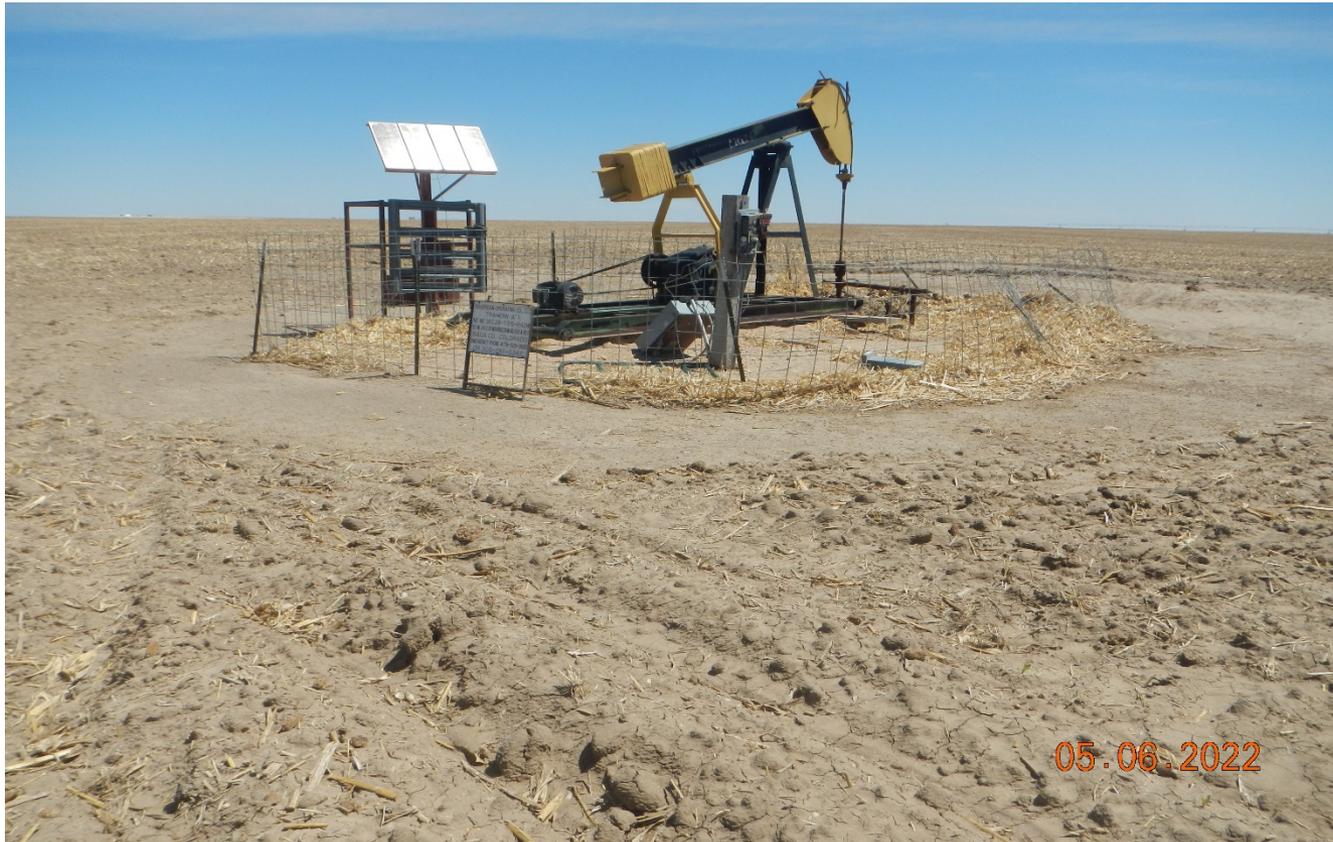
Photo 3. Facing toward the well site in cropland.

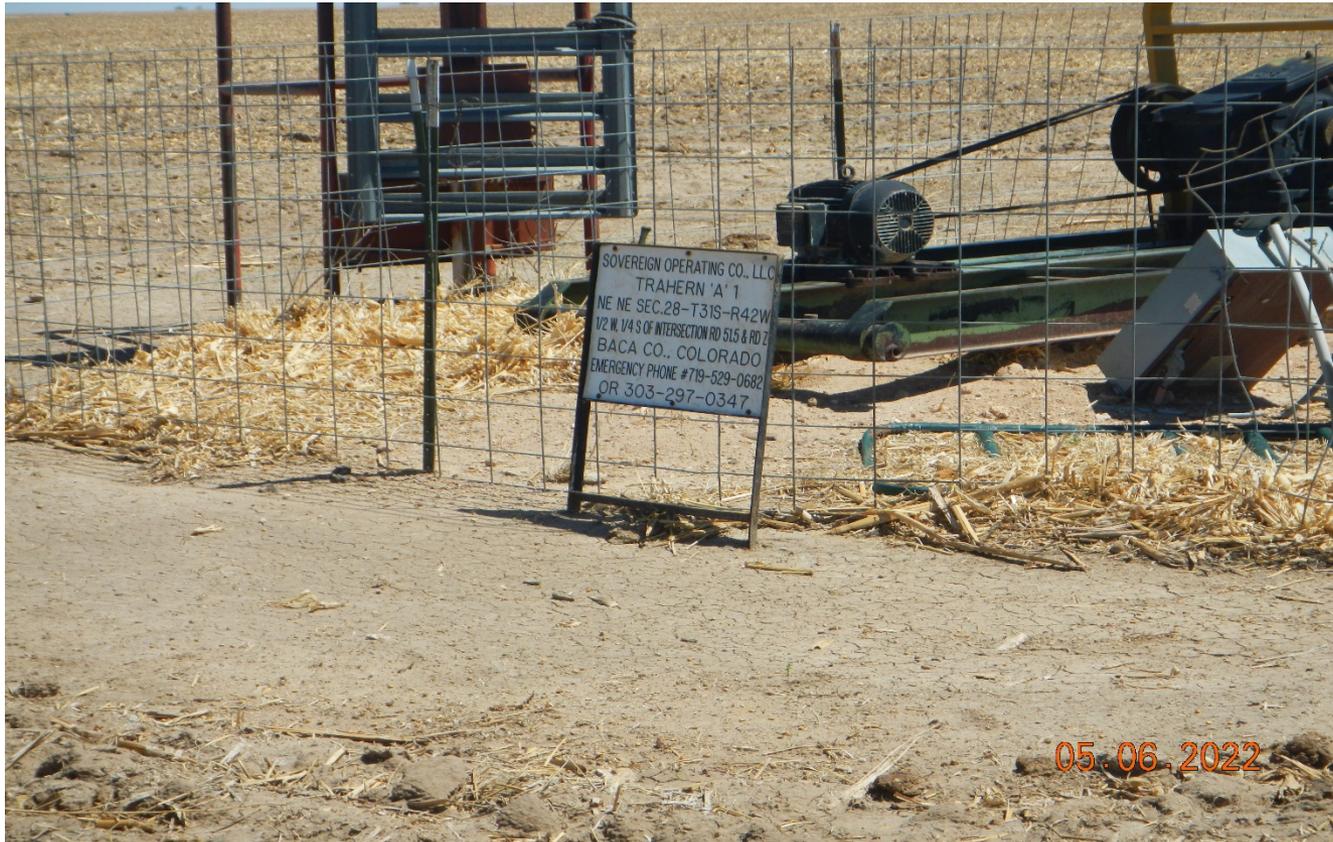
Photo 4. The well sign is inaccurate and reflects the wrong Operator info and emergency contact INFO.

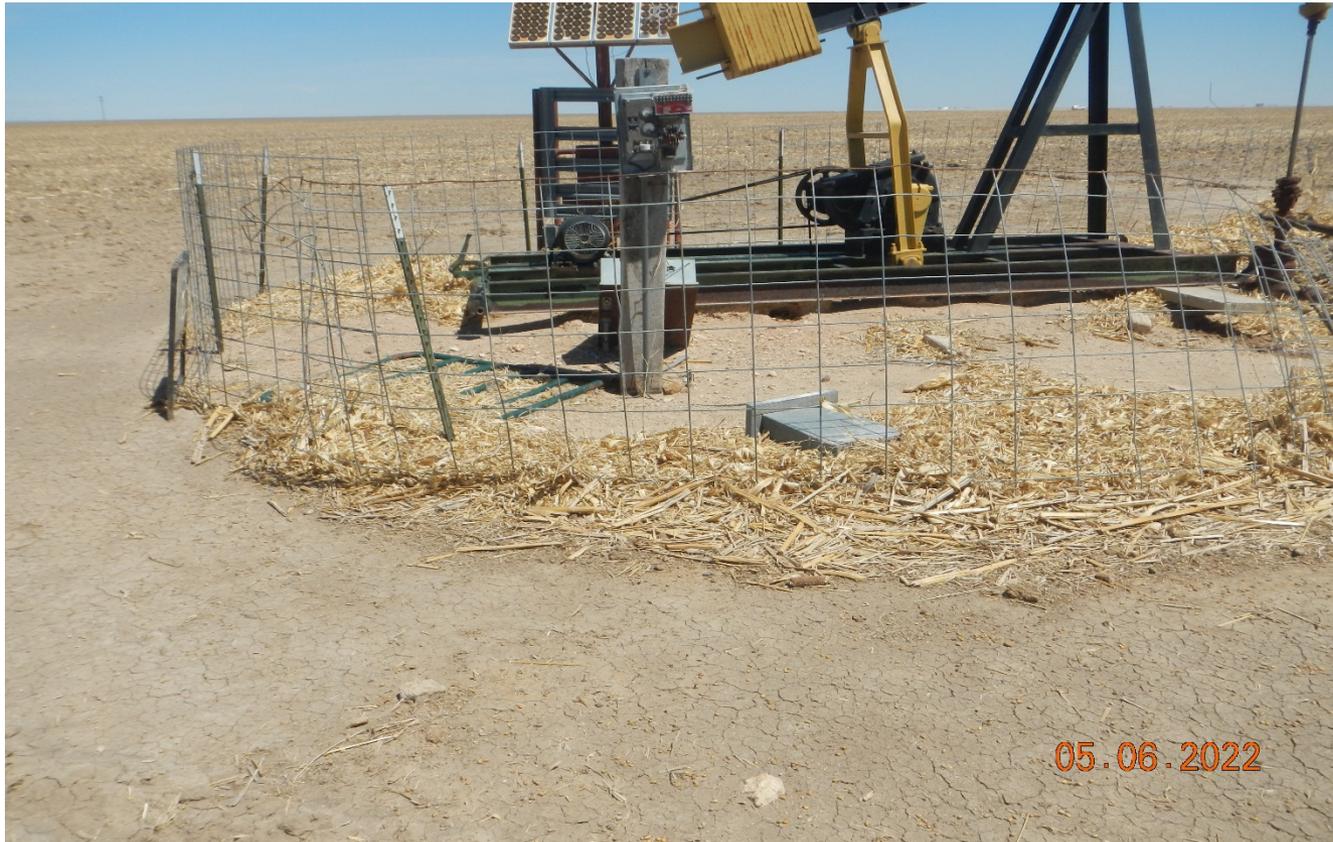
Photo 5. There is a gate and unused supplies lying on the ground. There is no cover for the electric utility which is a safety concern.
