# Inspection Photos

API: 009-06082

Operator: DOVER ATWOOD CORPORATION

Inspection Date: 5/6/2022

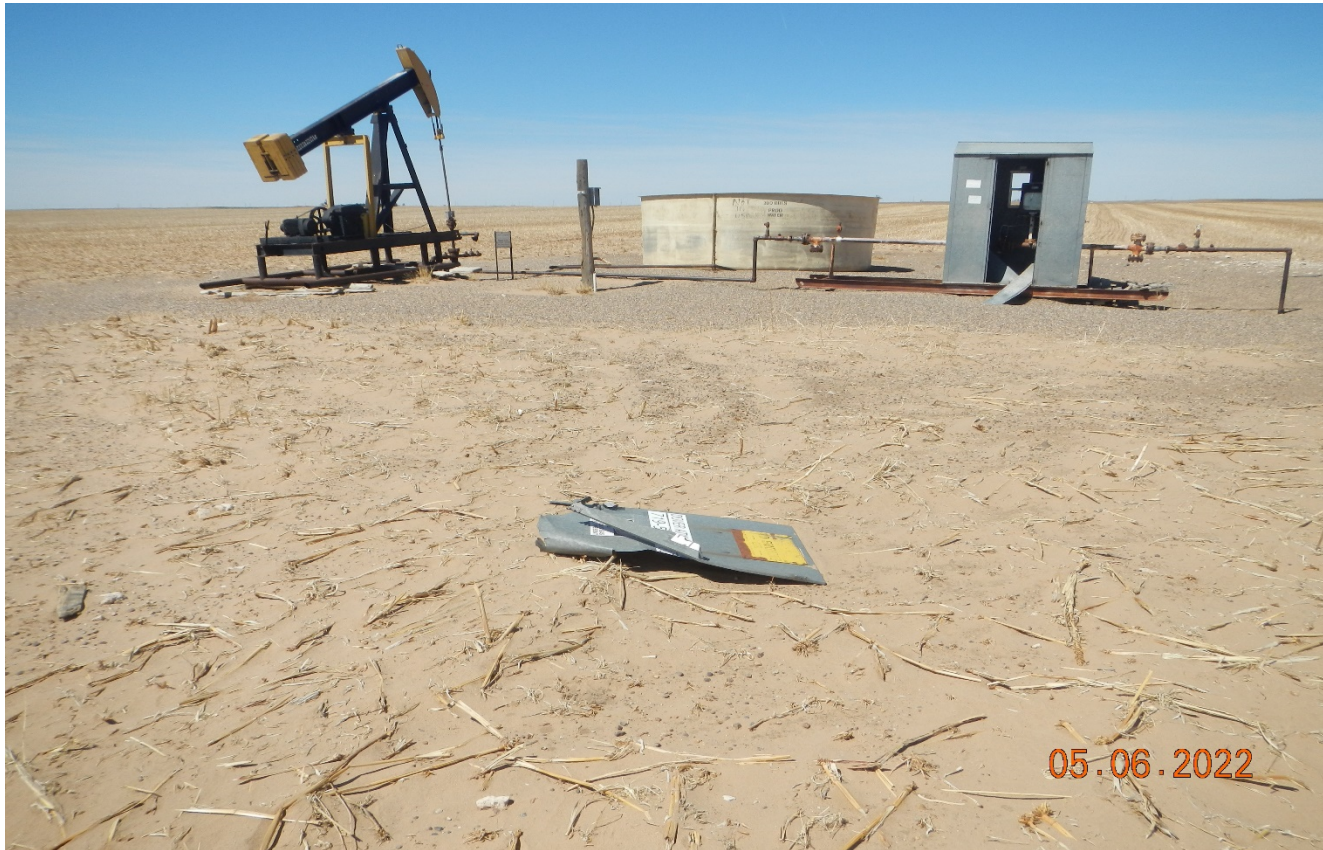
**Photo 1.** Facing east toward the location. The door to the meter shed is in disrepair and laying on the ground.

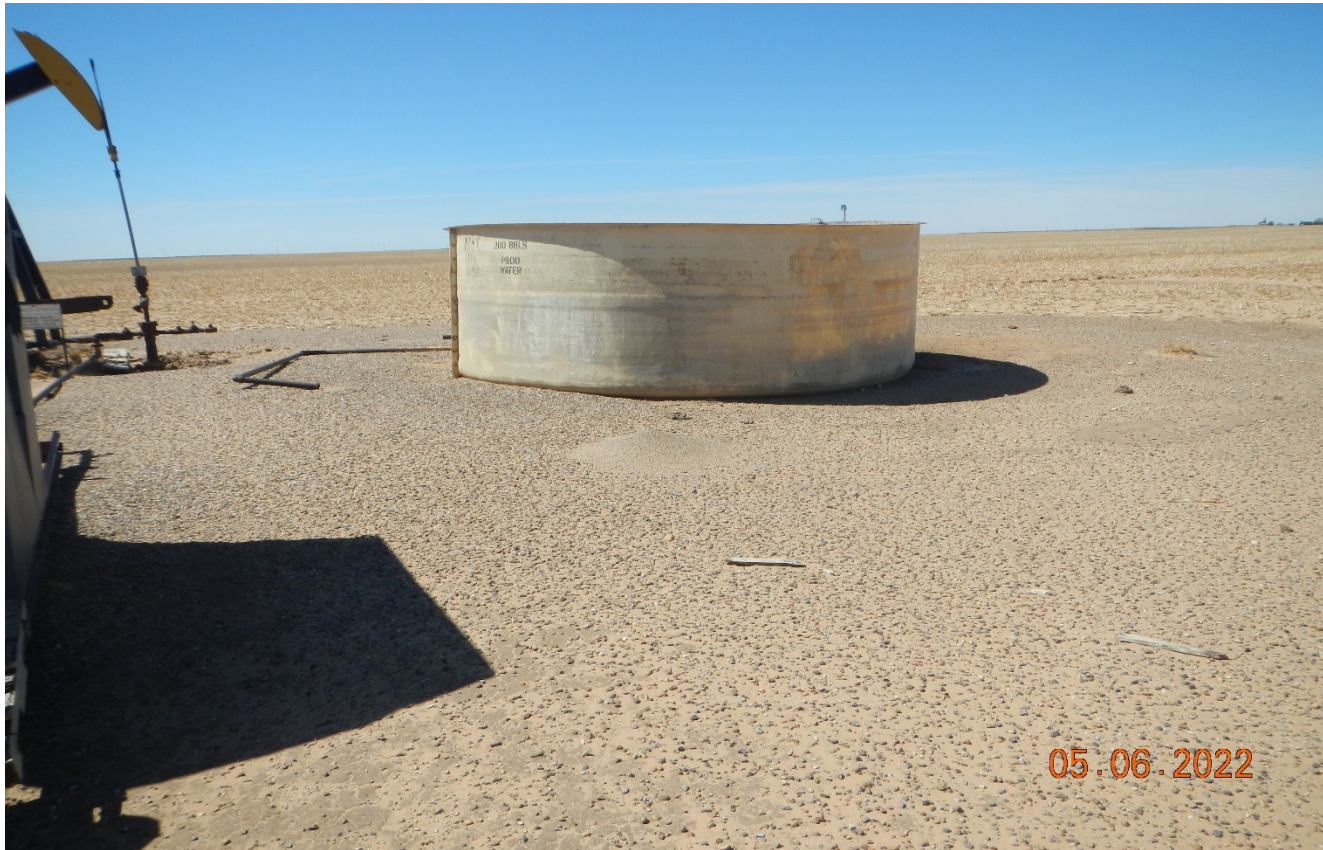
**Photo 2.** Missing tank NFPA labeling and missing INFO per 605.h.. Secondary containment is inadequate to contain 150% of the volume of the tank. Previous corrective action not completed.

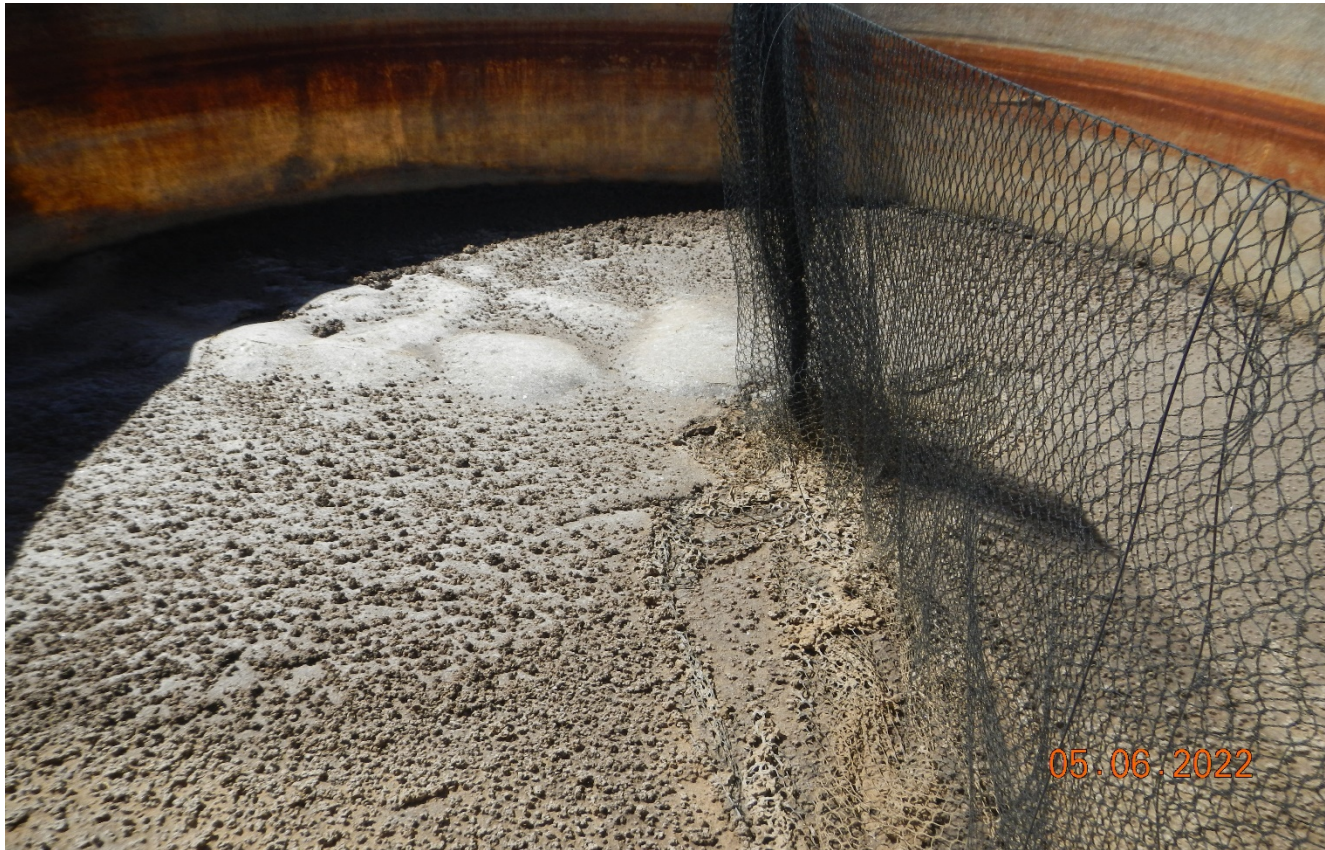
**Photo 3.** View of fluids inside the tank. Tank is labeled Produced Water. It appears to be solidified salty produced water. The netting on the tank is in disrepair. Previous corrective action not completed.

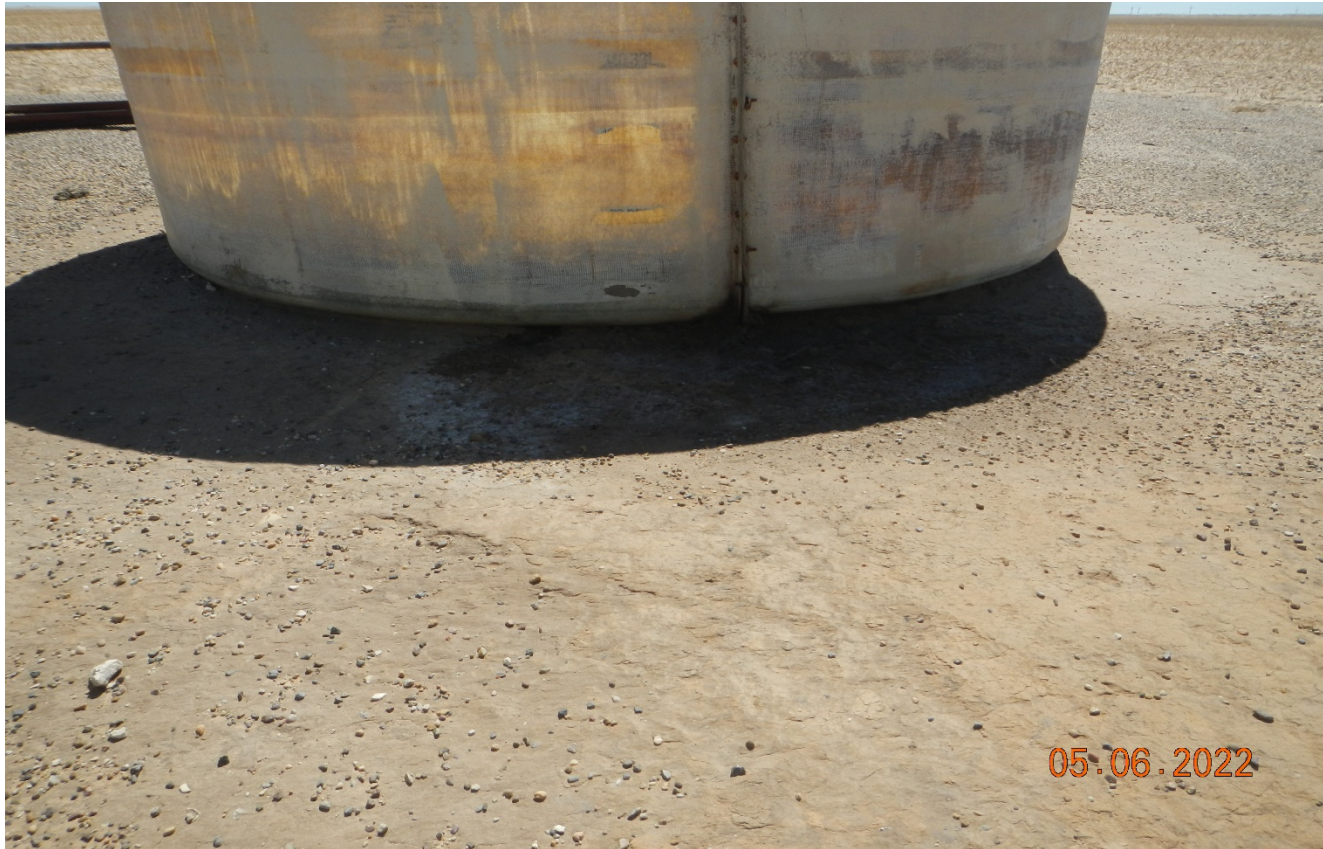
**Photo 4.** There appears to have been a leak at the tank due to stained soil in this area. If tank contains produced salty water, this can impact the soil and crop growth. Previous corrective action not completed.

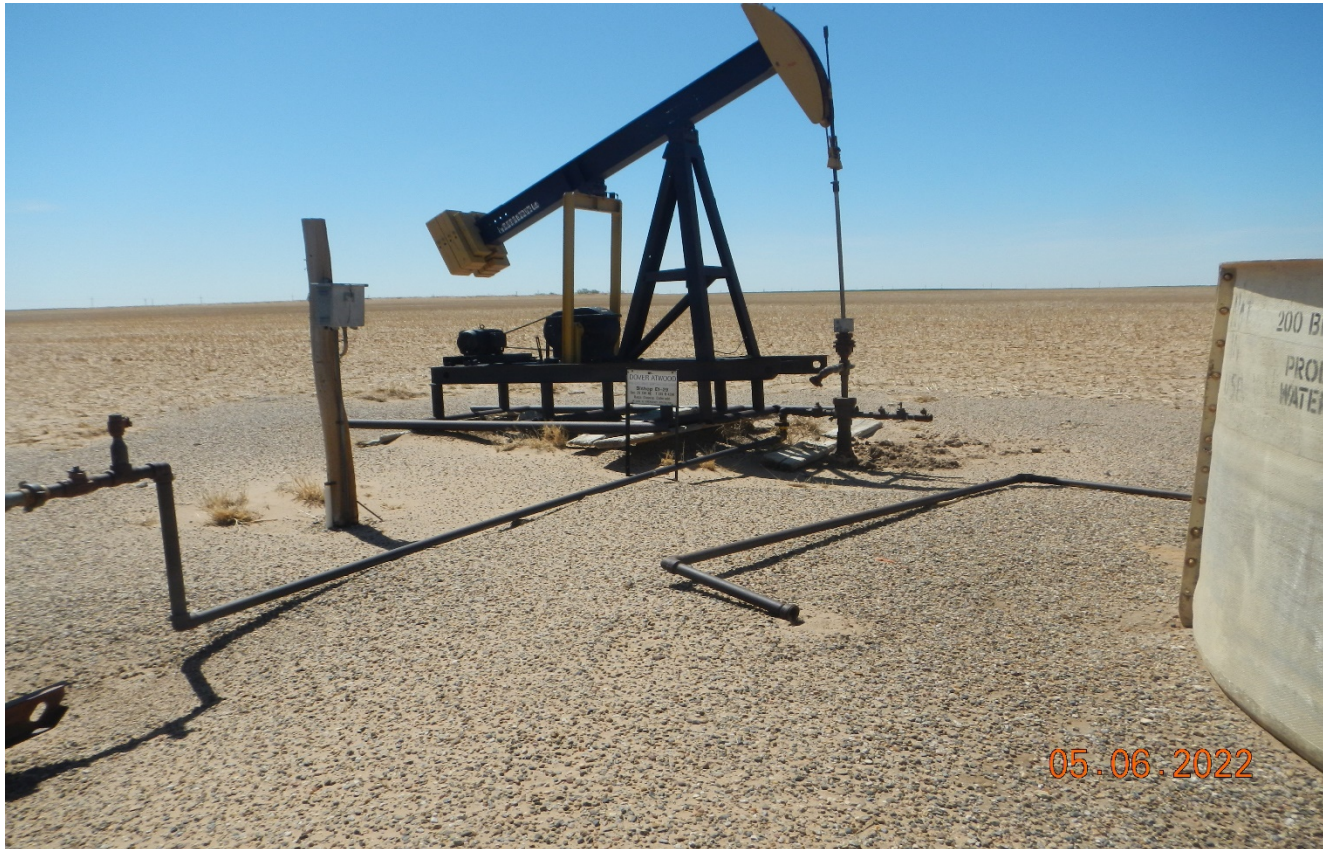
**Photo 5.** Well sign is posted at wellhead. Emergency contact number is not valid.
