Inspection Photos
Location Name: 100 WCR Group 14-11-8-61
Location ID: 425364

Inspection Photos
Location Name: Leggett 1-5H
Location ID: 428225

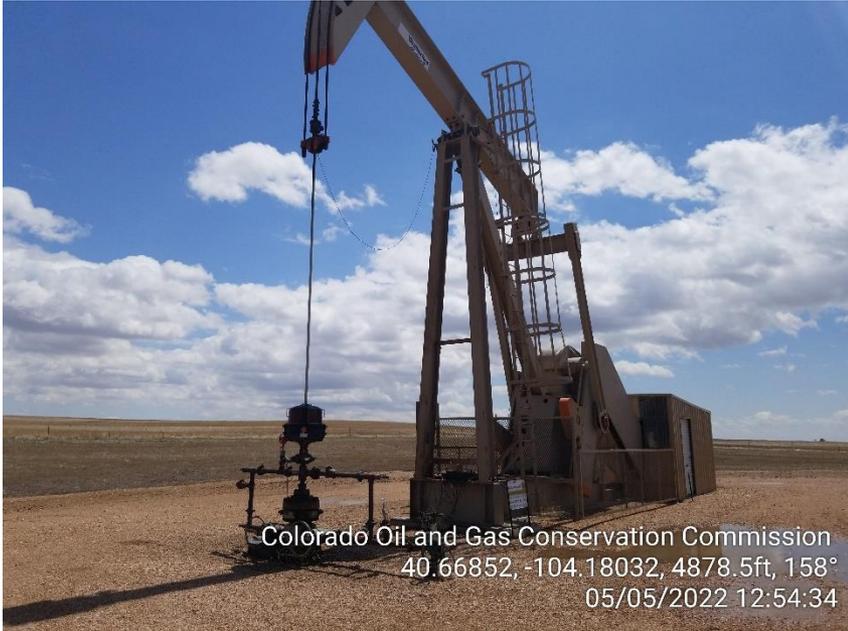
Photo 1 – Pumping Unit

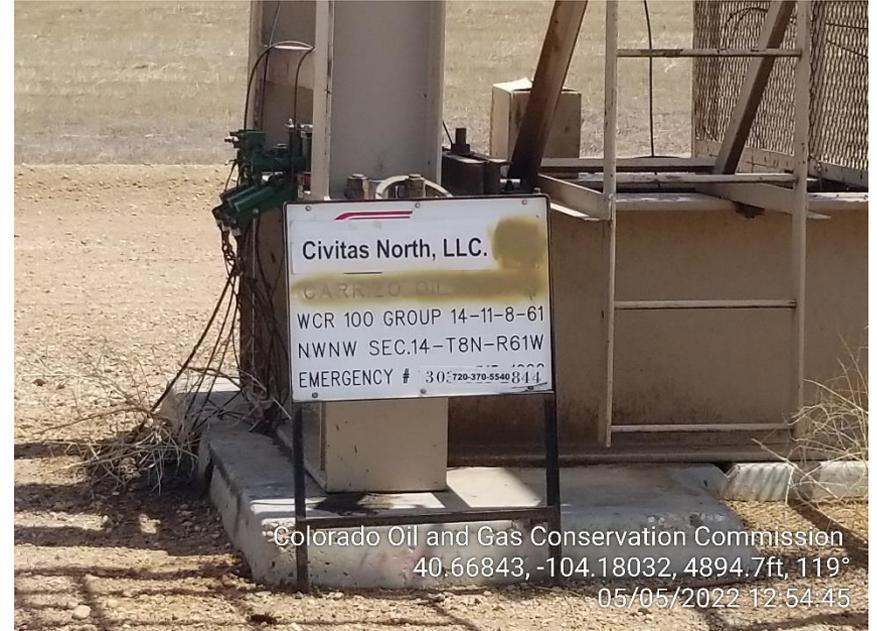
Photo 2 – Wellhead Sign

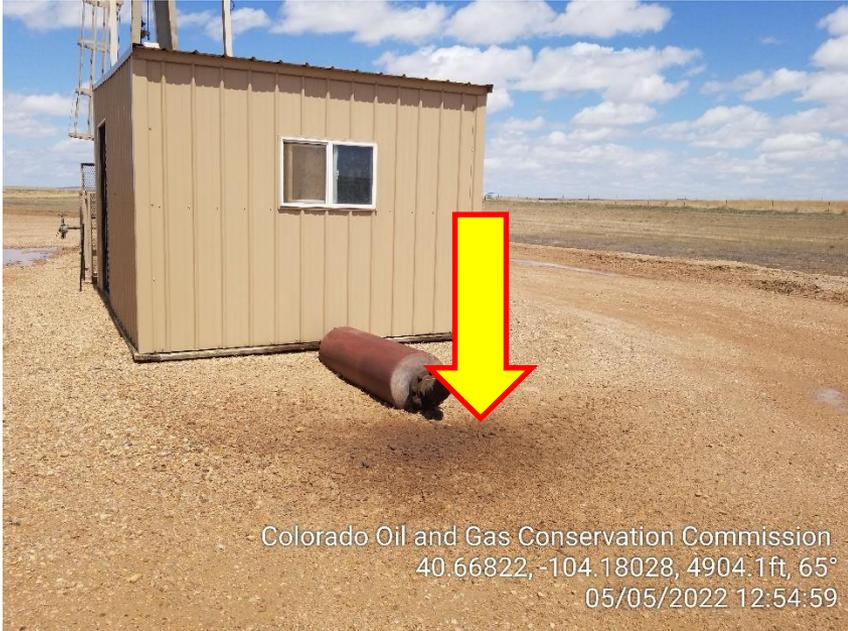
Photo 3 – Stained Soil at Exhaust

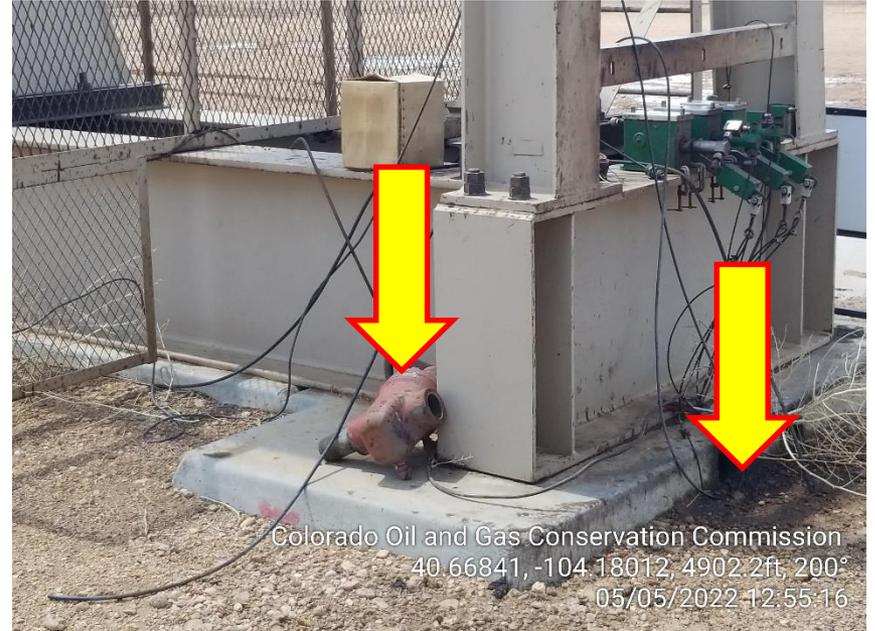
Photo 4 - Unused Valve and Stained Soil

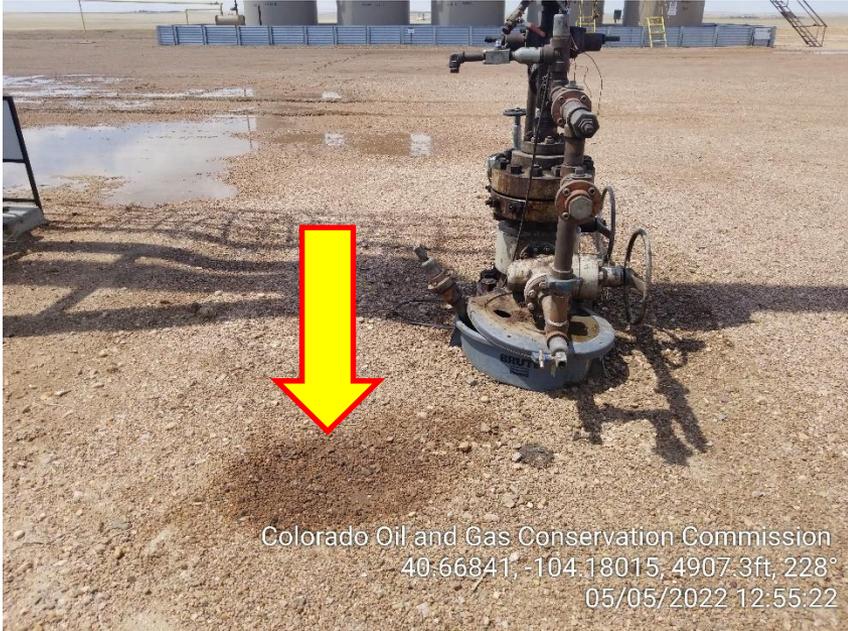
Photo 5 – Stained Soil at Wellhead

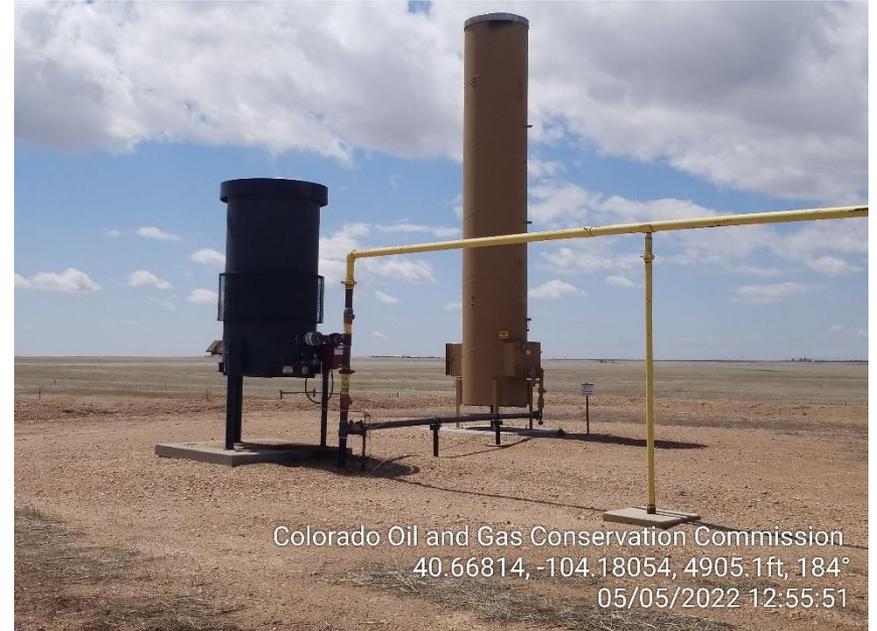
Photo 6 – ECDs

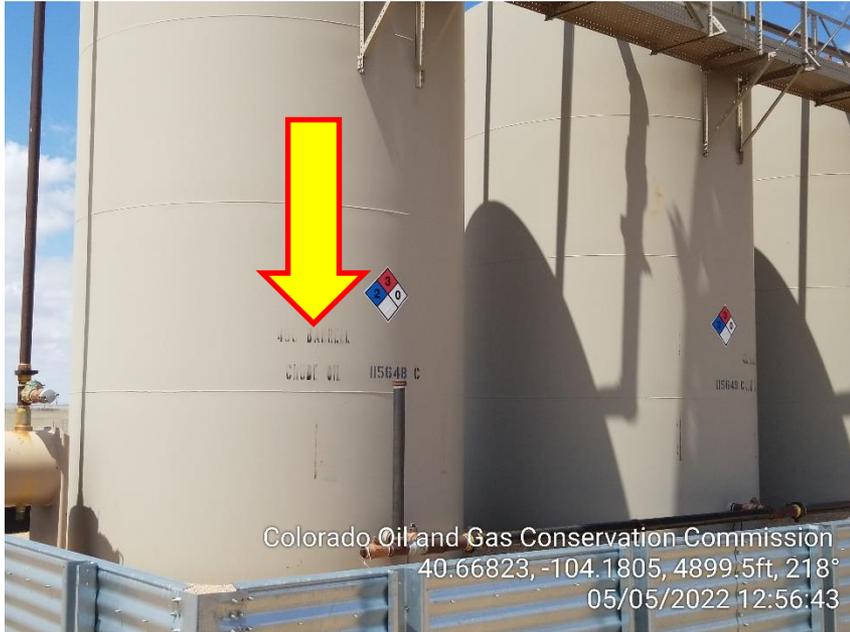
Photo 7 – Labels fading

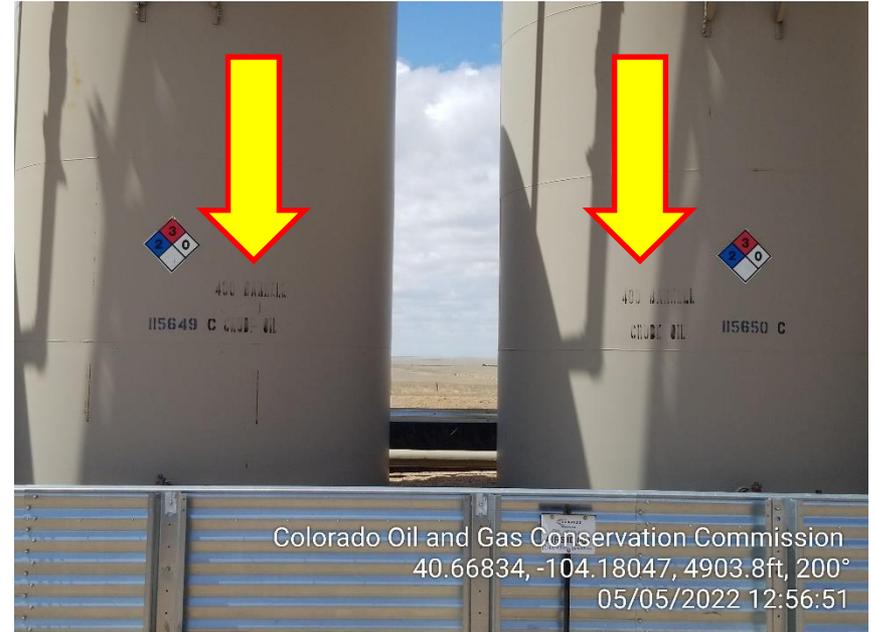
Photo 8 – Labels fading

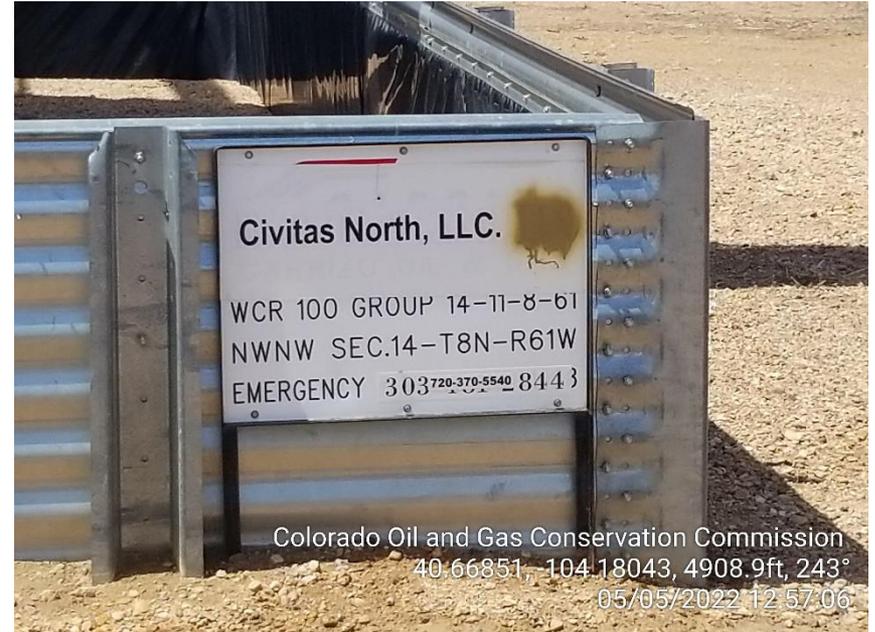
Photo 10 – Tank Battery Sign

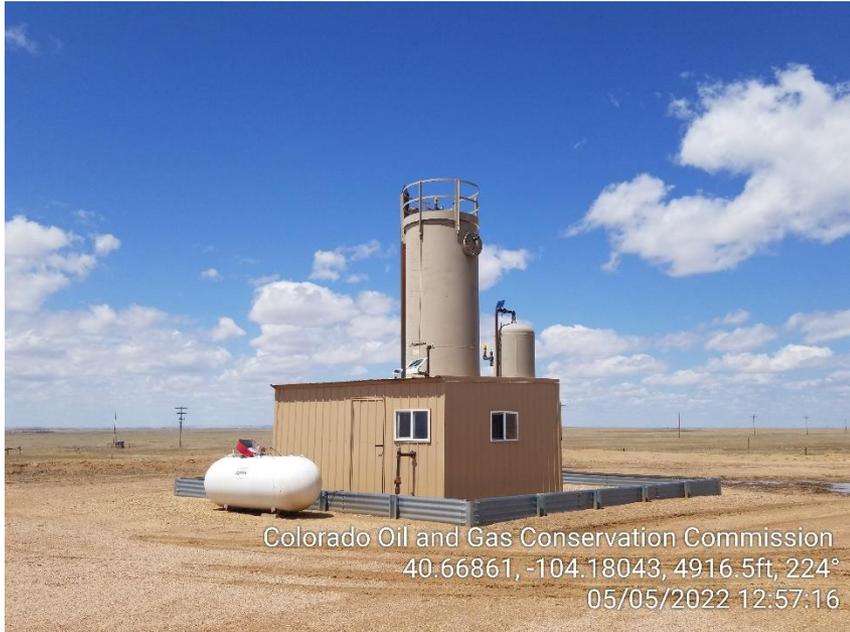
Photo 11 – Heater Treater
