Inspection Photos

5/10/2022

Operator: GORDON ENGINEERING INC -
34720

Location ID: 312560
Mesa County, CO

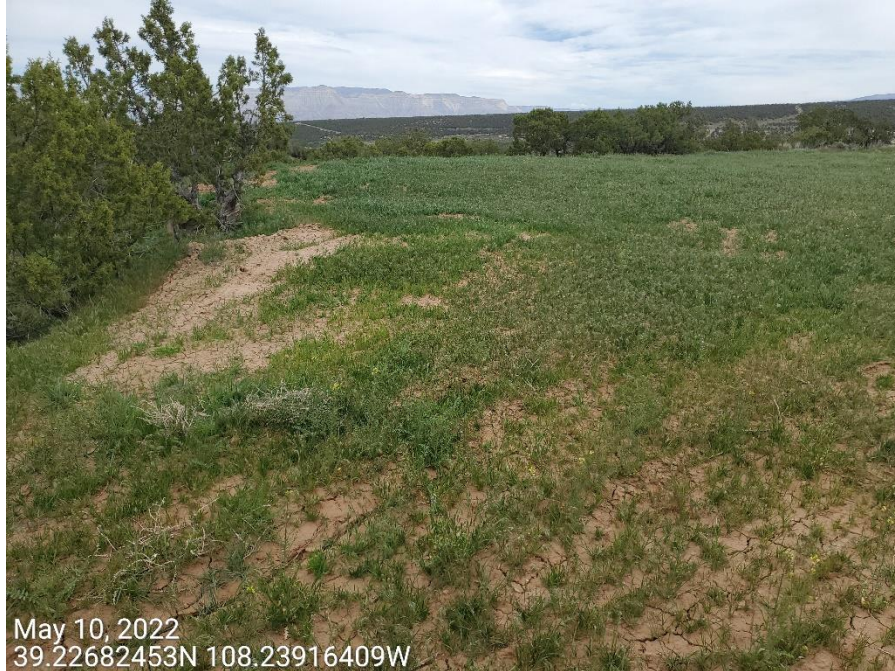
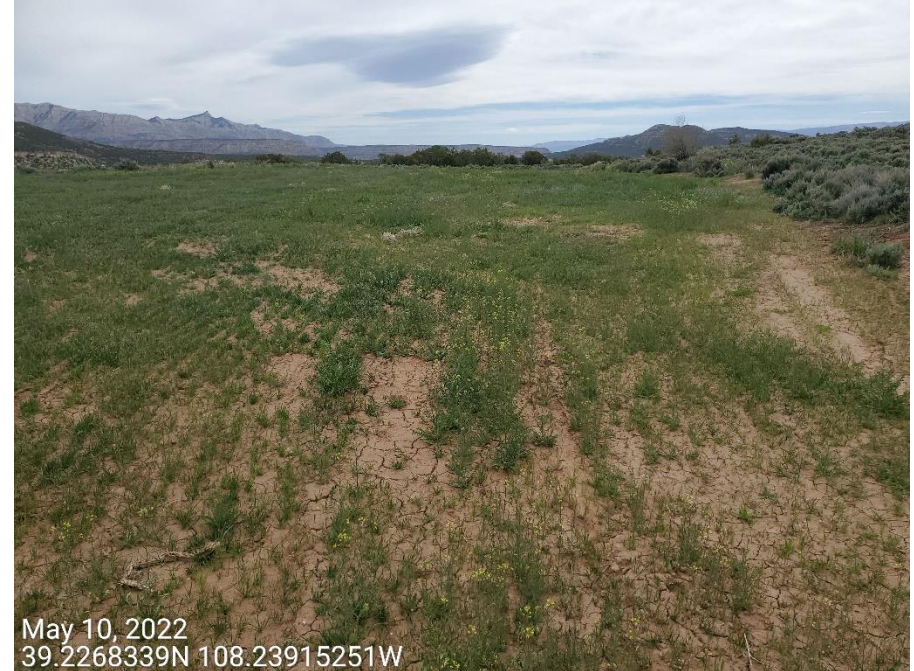
Photo 1: Photos taken from the west end of the Location, facing northeast and east. Photo provides overview of the Location. Operator appears to have conducted revegetation activities; however work including, but not limited to, compaction alleviation (cross ripping to a minimum depth of 18 inches), recontouring and regrading of the Location has not been performed in accordance with 1004 reclamation requirements. Vegetation observed in photo is predominantly undesirable and noxious plant species, such as cheat grass.

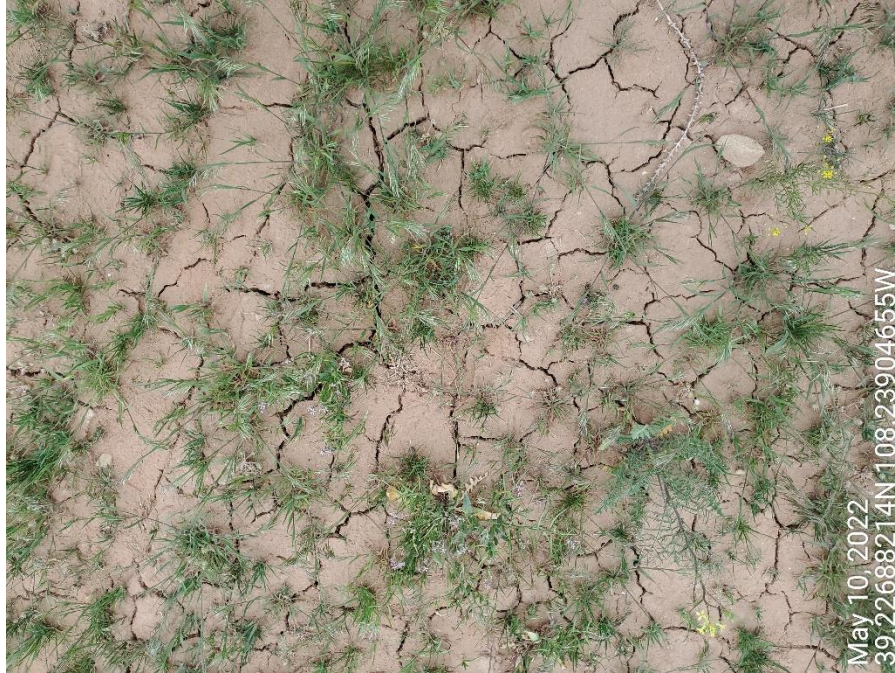
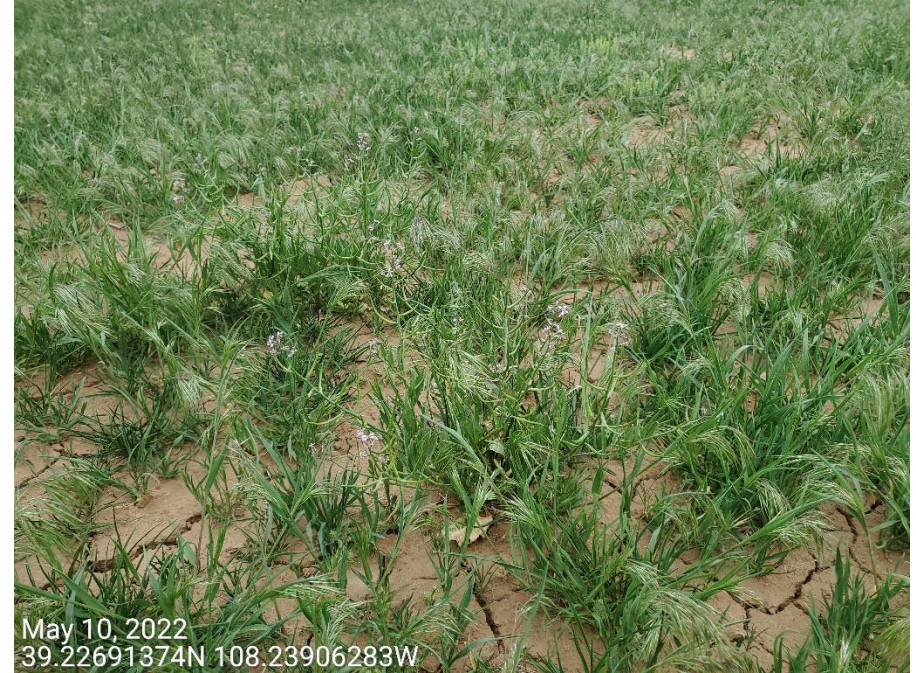
Photo 2: Photo shows example of cheatgrass vegetation establishment throughout majority of the Location.

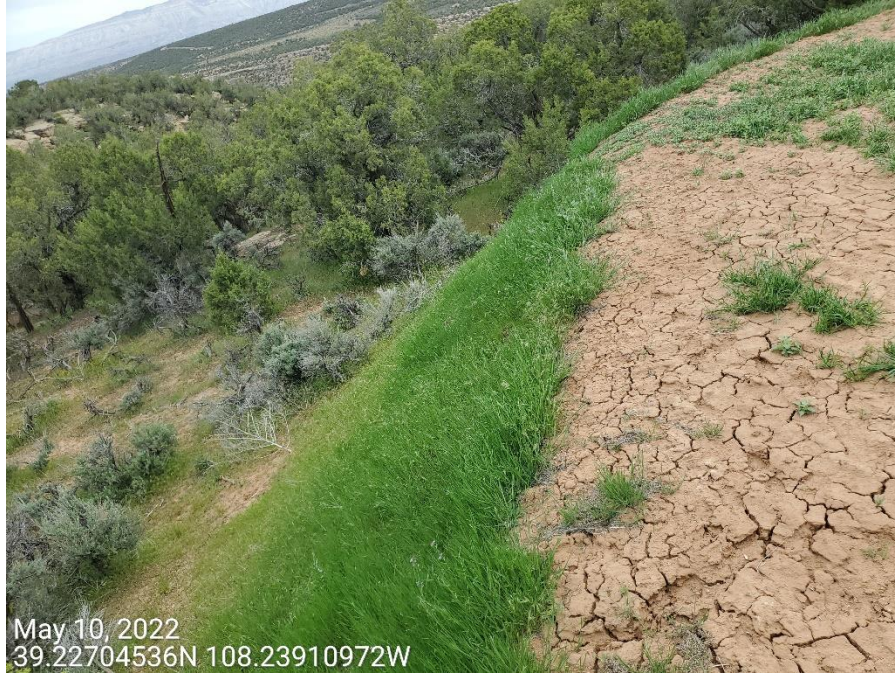
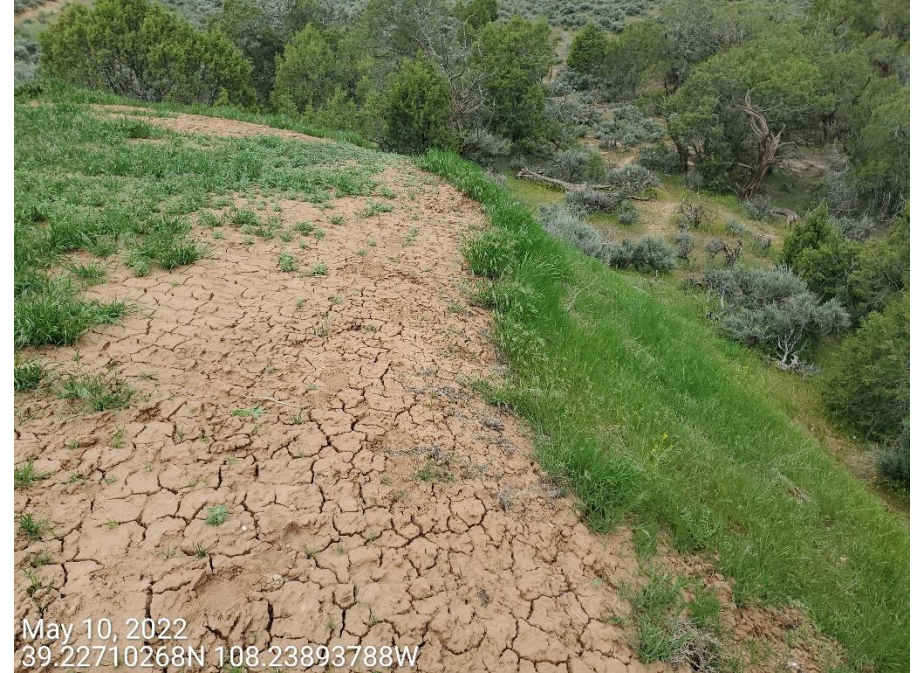
Photo 3: Photo shows fill slopes remaining; location has not been recontoured and regraded.

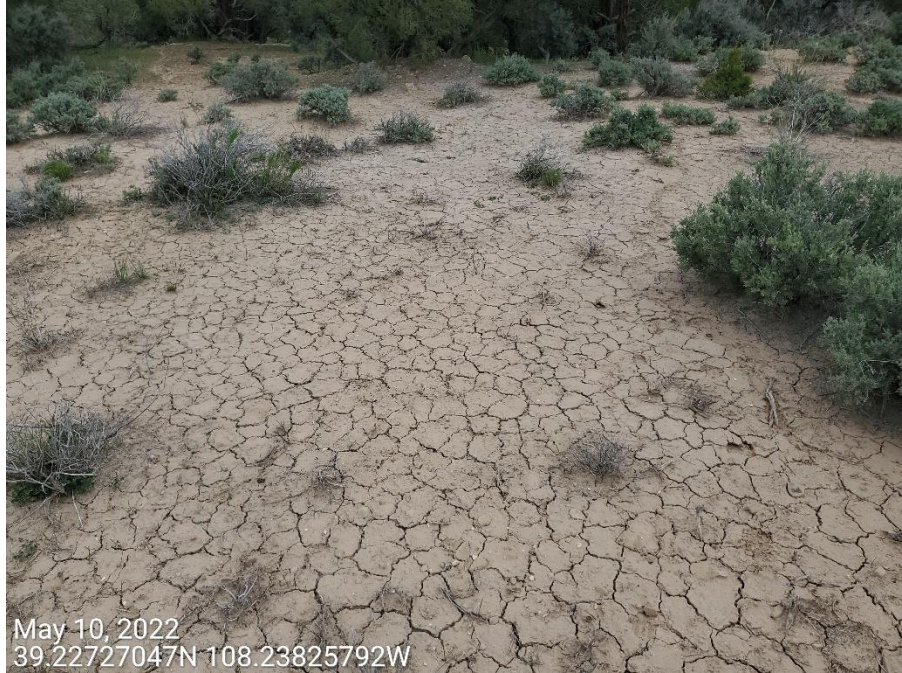
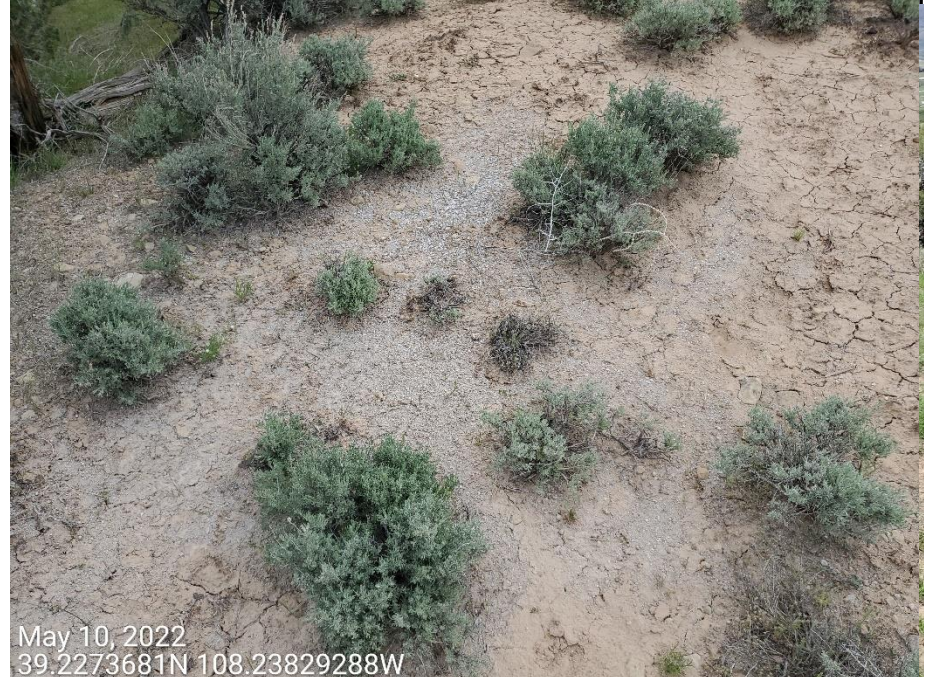
Photo 4: Photos taken from the north end of the Location where Operator was documented discharging cement waste off-site during plugging operations; unable to find evidence that cement waste was removed, and soils cleaned and areas reclaimed; cement waste remains evident; grass vegetation no longer established within areas of spill.

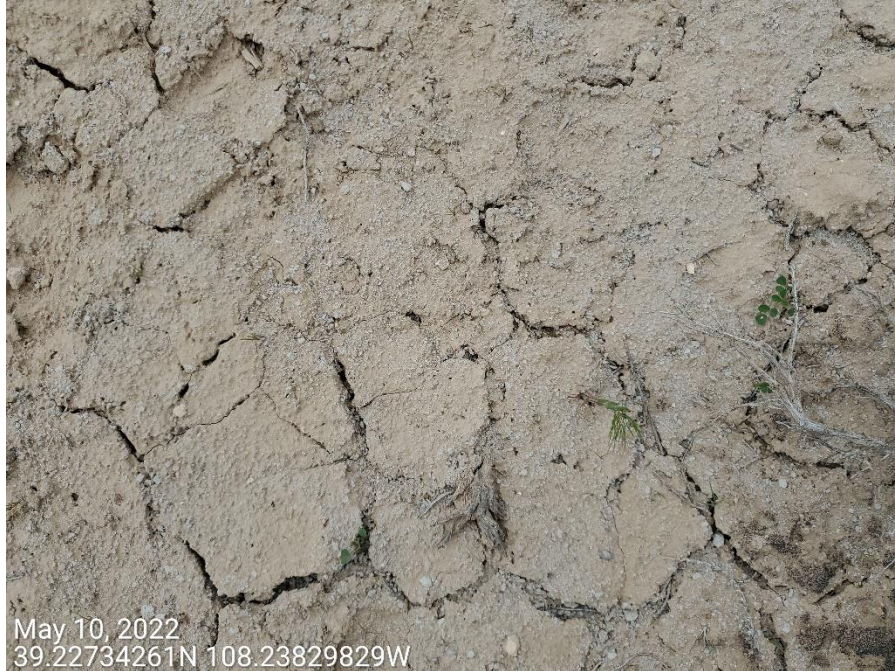
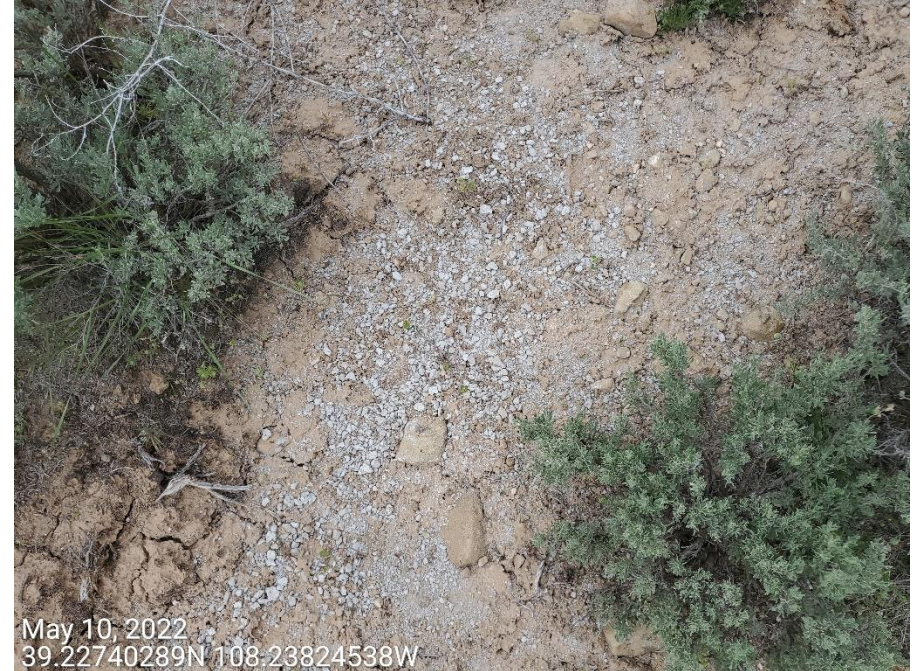
Photo 5: See comments under photo 4. Photos show soil surface within area of spill; cement waste remains evident.

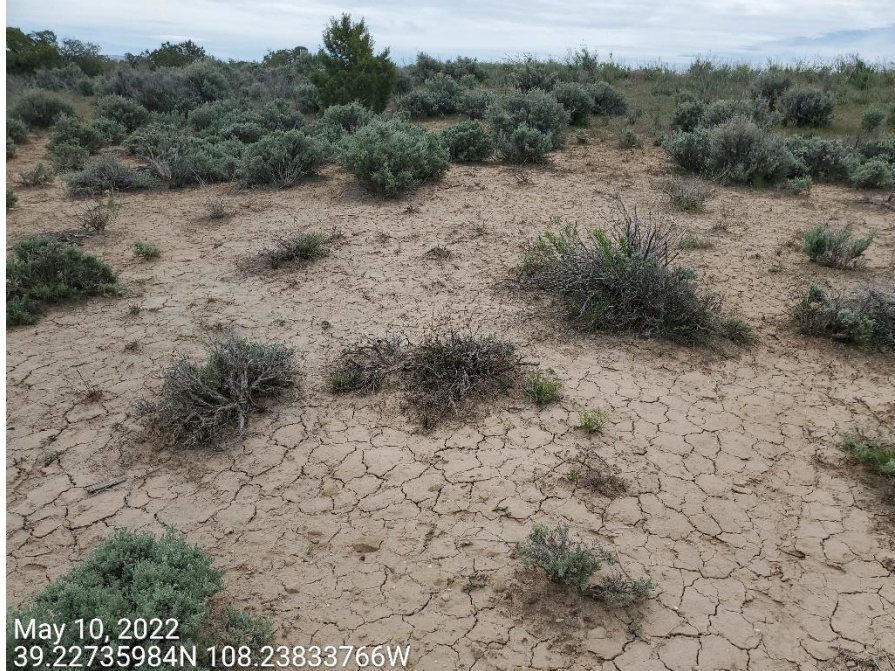
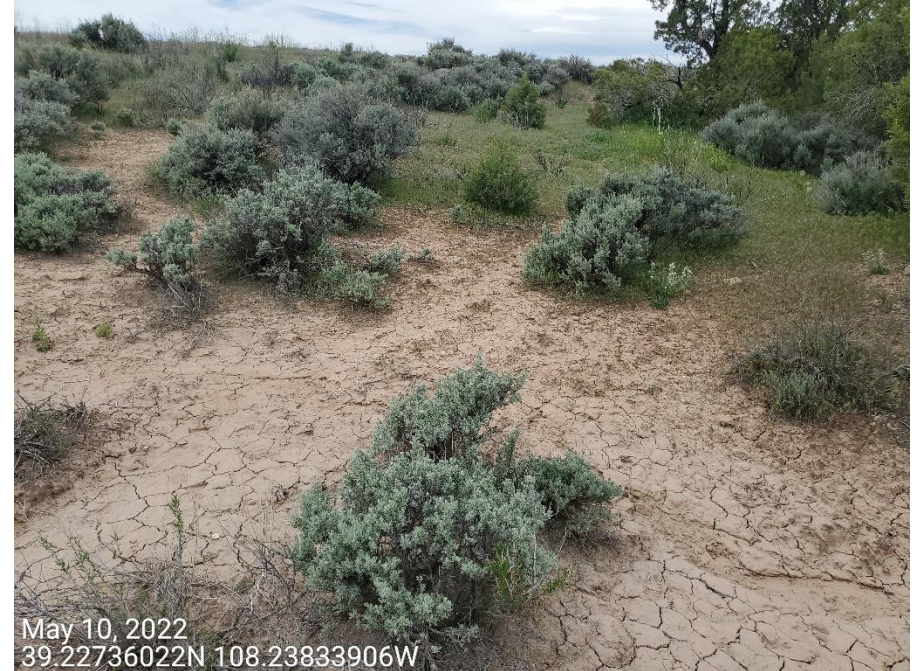
Photo 6: Photos taken from the north end of the Location where Operator was documented discharging cement waste off-site during plugging operations Photo right shows areas at the edge of the spill where vegetation remains established; grass vegetation no longer established within areas of spill.

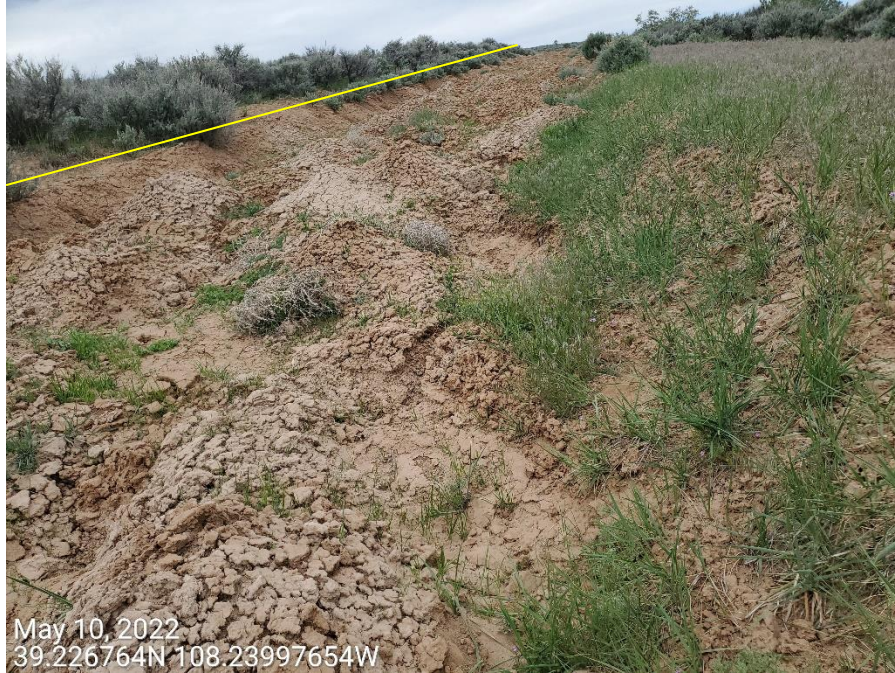
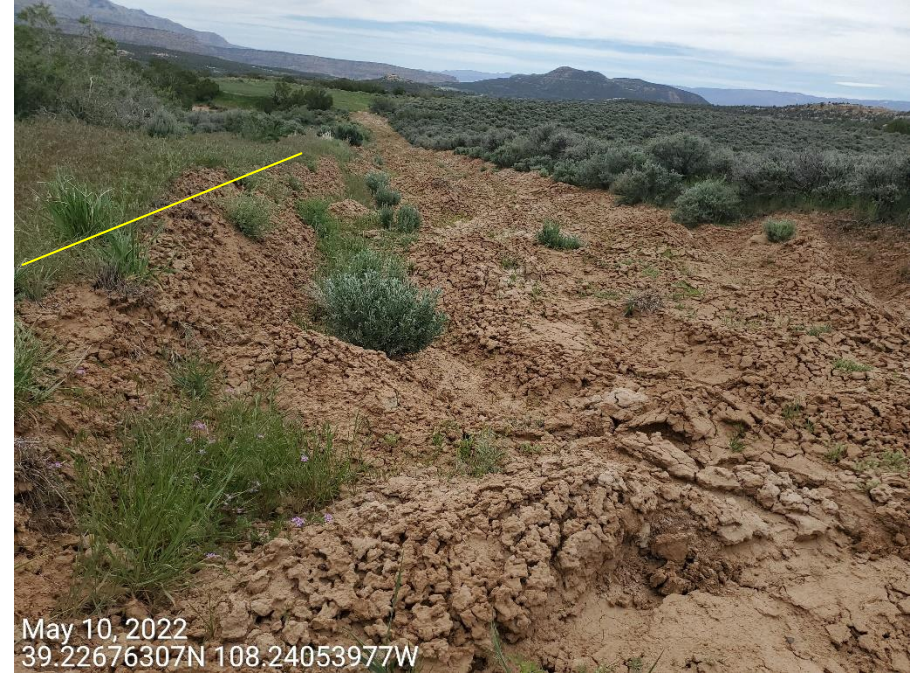
Photo 7: Photos taken from the access road. Photos show access road has not been properly recontoured/regraded to the original relative grade, and to that of the reference. Yellow line represent top grade of the adjacent areas.

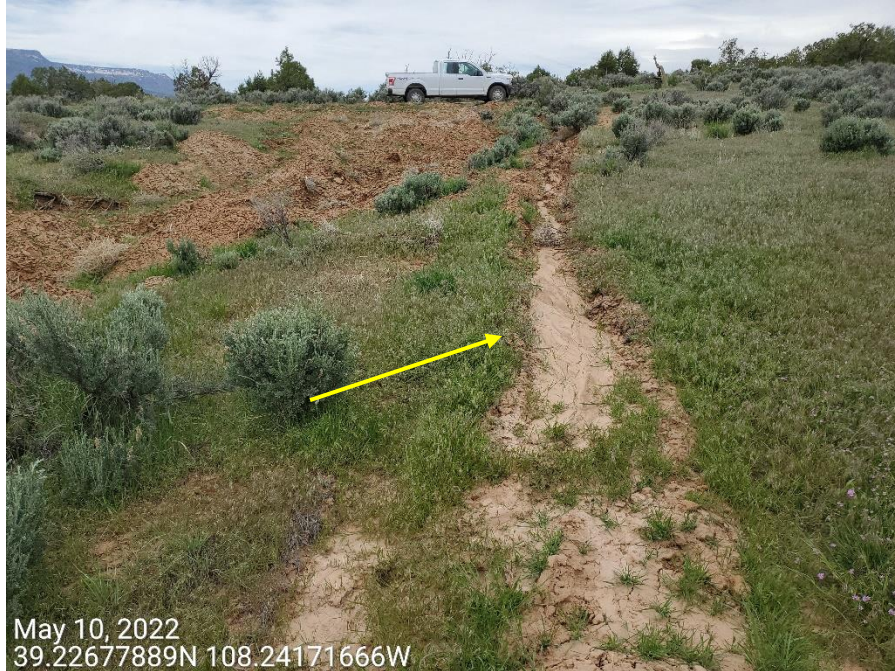
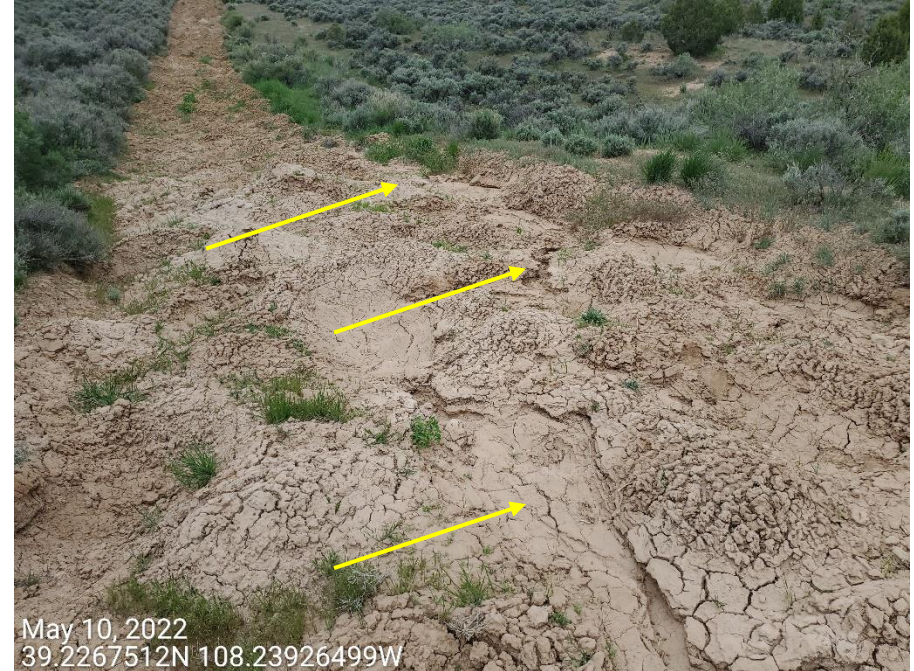
Photo 8: Photos examples of erosion degradation and sediment transport and deposition observed at access road. Stormwater and erosion control measures to minimize erosion, degradation and sediment transport and deposition (Lighter soils) at and from the access road remains missing or insufficient.

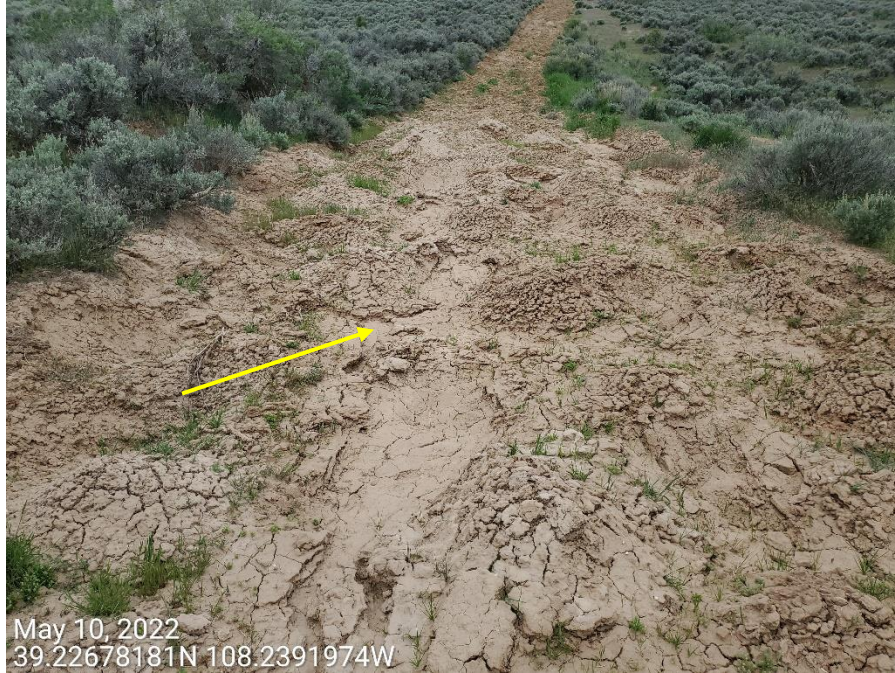
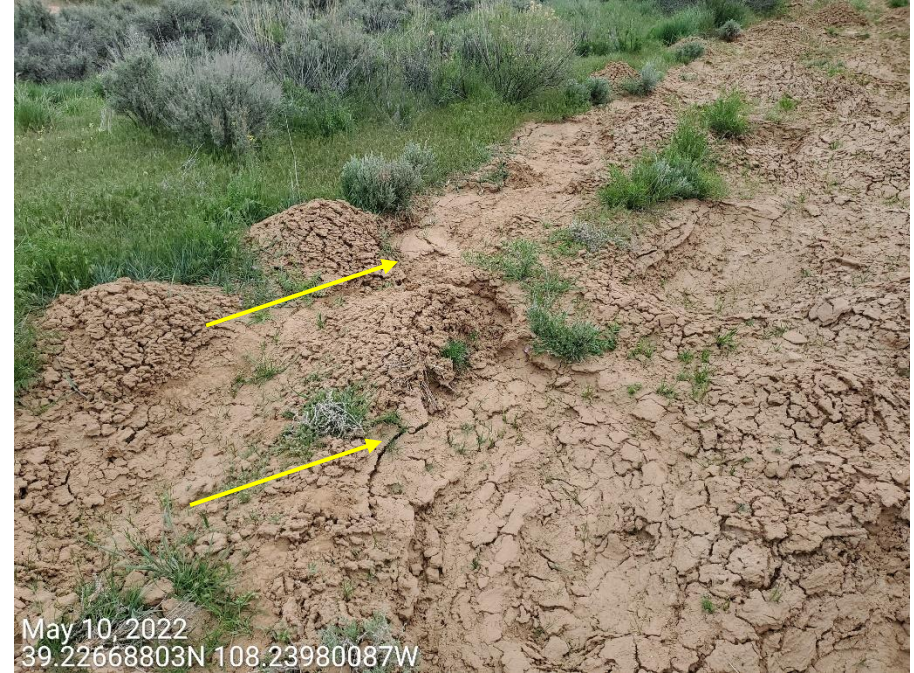
Photo 9: See comments under photo 8
