Inspection Photos

5/16/2022

Operator: CAERUS PICEANCE LLC - 10456

Location ID: 467272

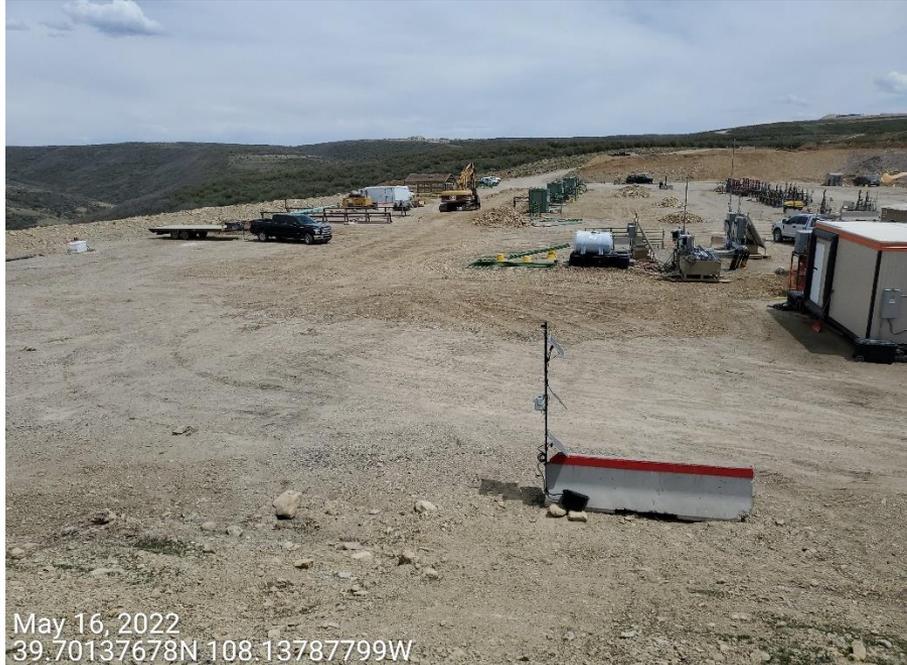
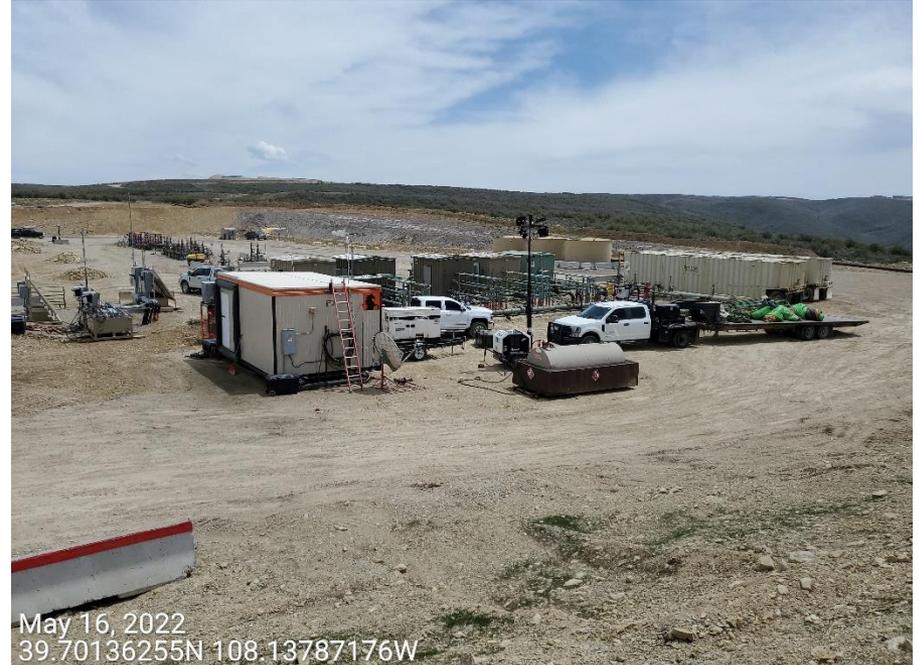
Photo 1: Photos taken from west t end of the Location, facing northeast and southeast. Photos provide an overview of the location.

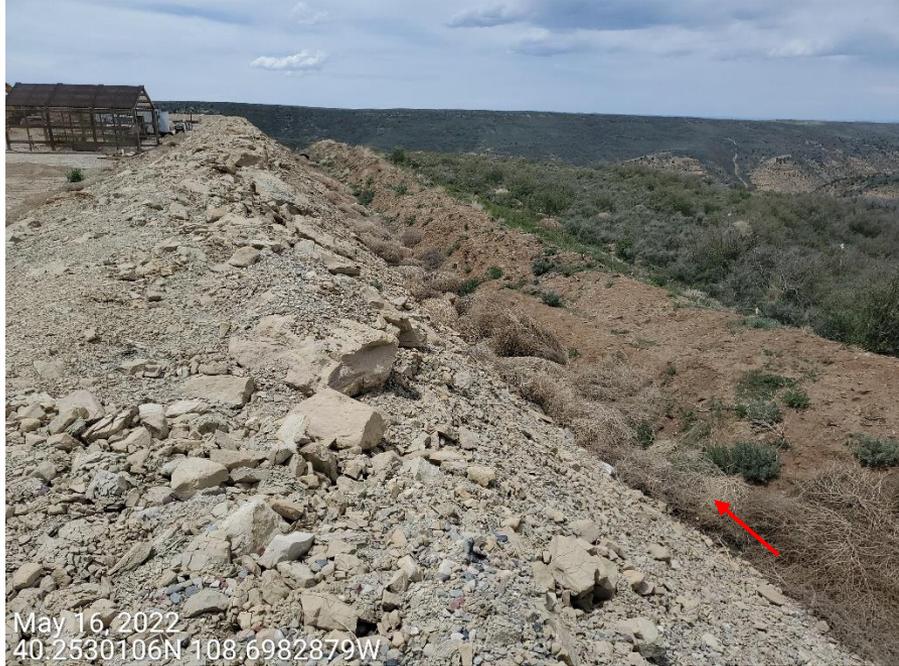
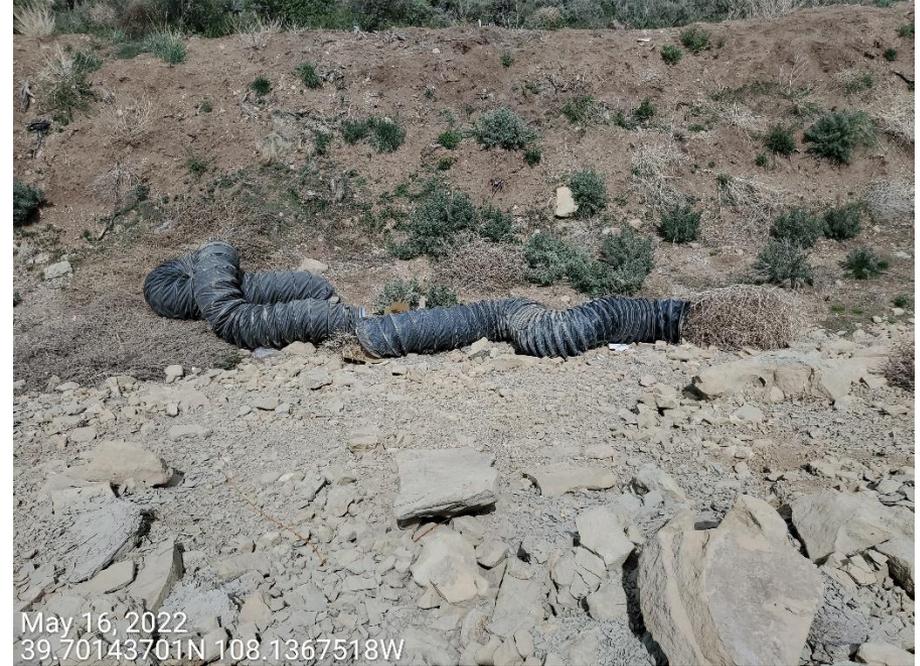
Photo 2: Photos taken from the north end of the Location. Photos example showing trash, weed debris, etc... observed on and off location.

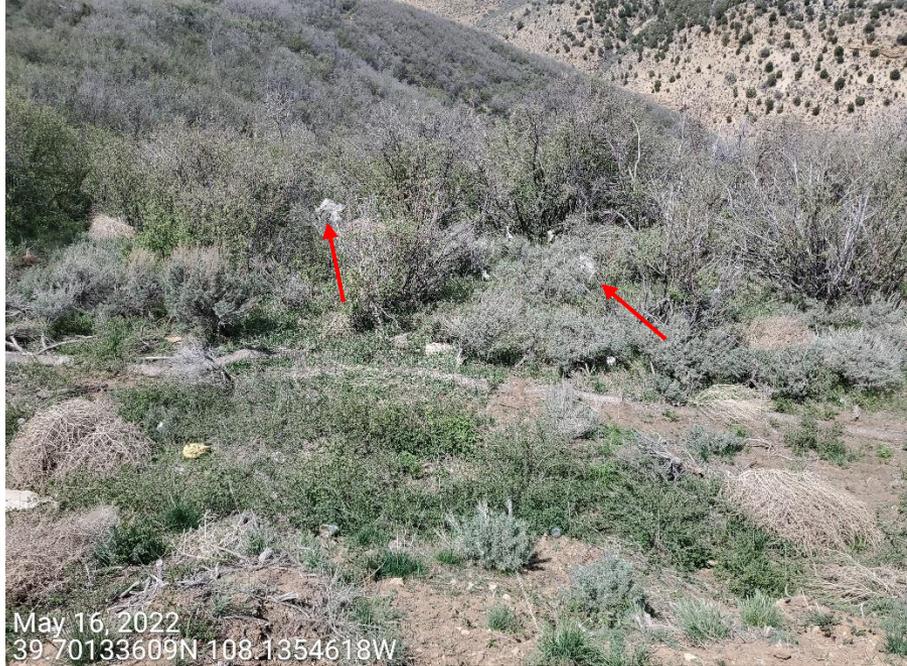
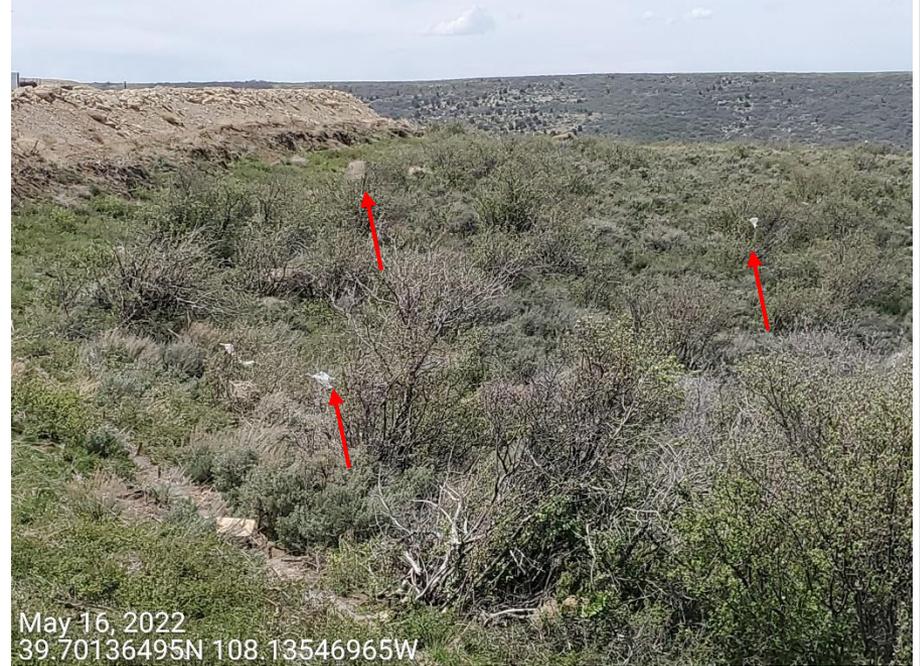
Photo 3: See comments under photo 2.

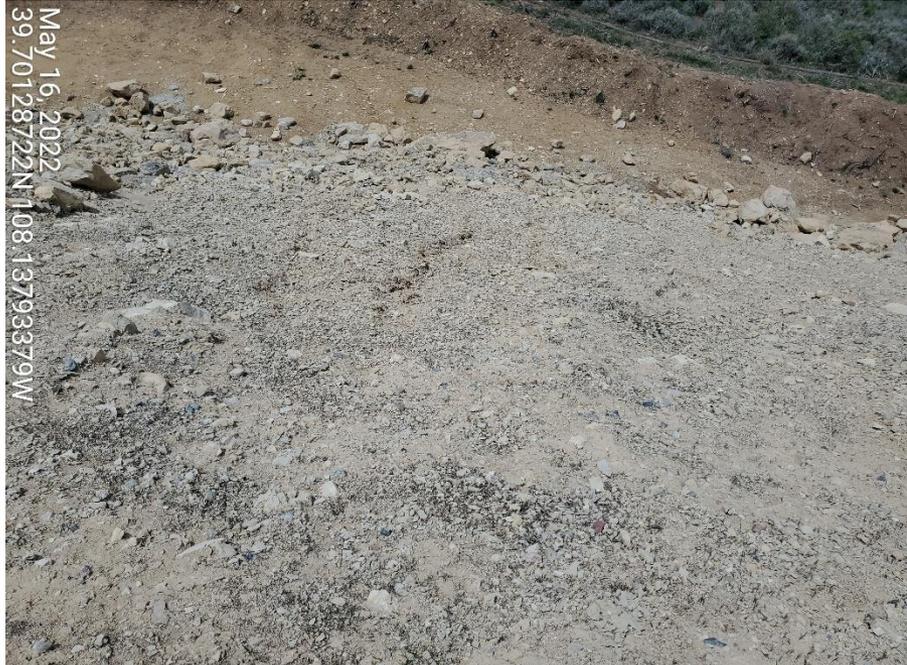
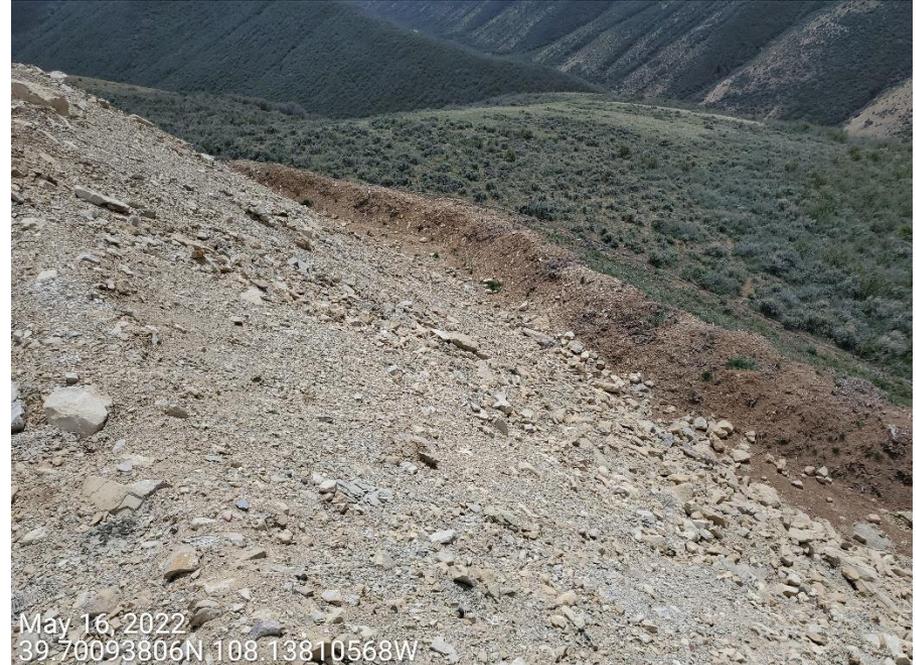
Photo 4: Photos taken from the slopes of the Location. Photos examples showing control measures to minimize erosion/degradation are missing or insufficient on the Location; slopes on locations a mixture of fine and rocky substrate; majority of the materials observed to be unconsolidated. Photos also provide examples showing how Operator has utilized topsoil at the base of the fill slopes/subsoils of the Location as a berm and sediment trap/pond to manage stormwater. Topsoil is not an appropriate material to construct stormwater control measures, and is at risk of degradation, loss and displacement due to stormwater discharge; use of topsoil as stormwater control measures does not comport with Rule 1002.b and 1002.c. Topsoil stockpiles along perimeter are predominantly bare, and at risk to erosion.

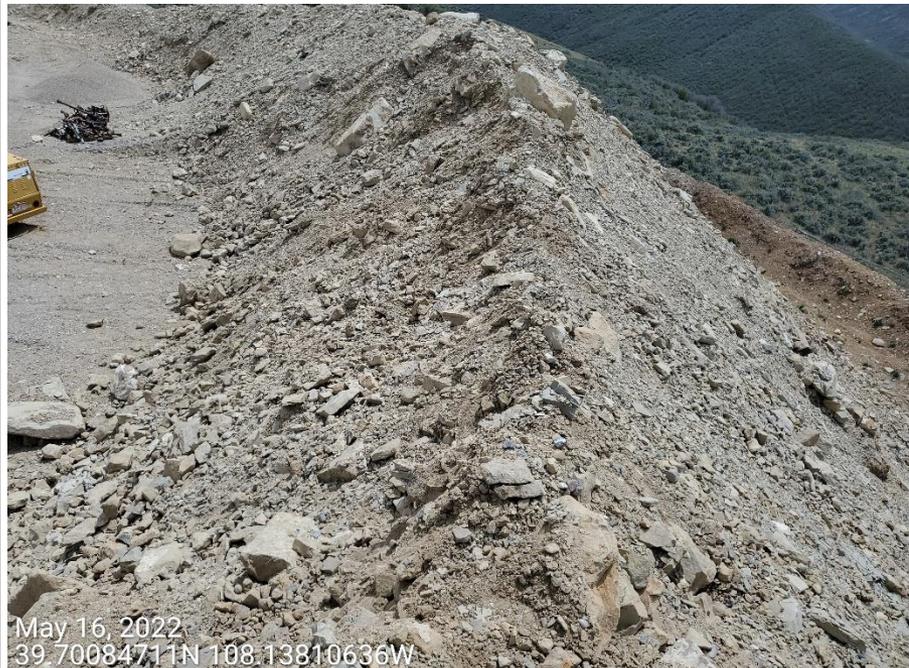
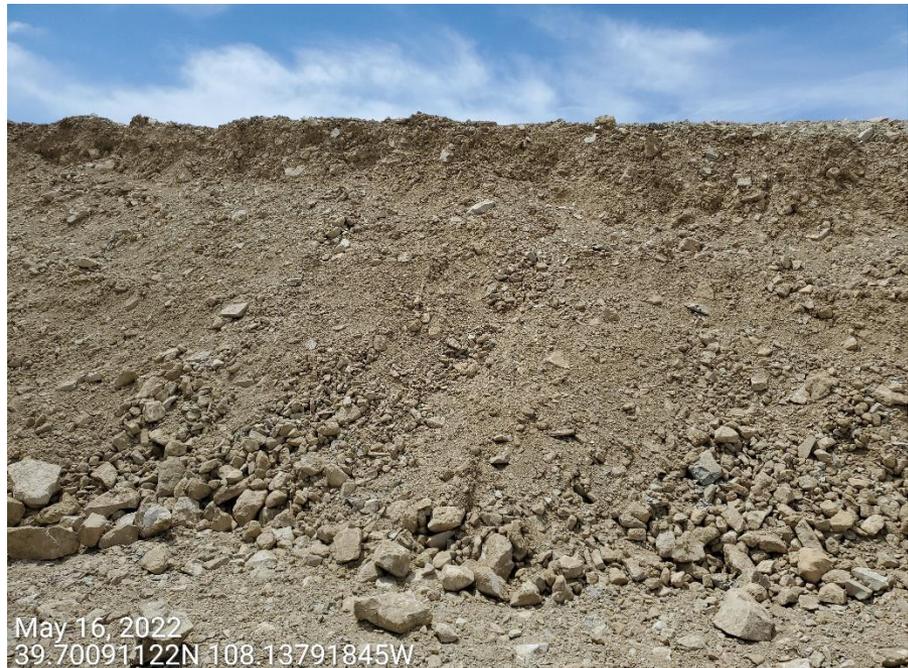
Photo 5: See comments under photo 4.

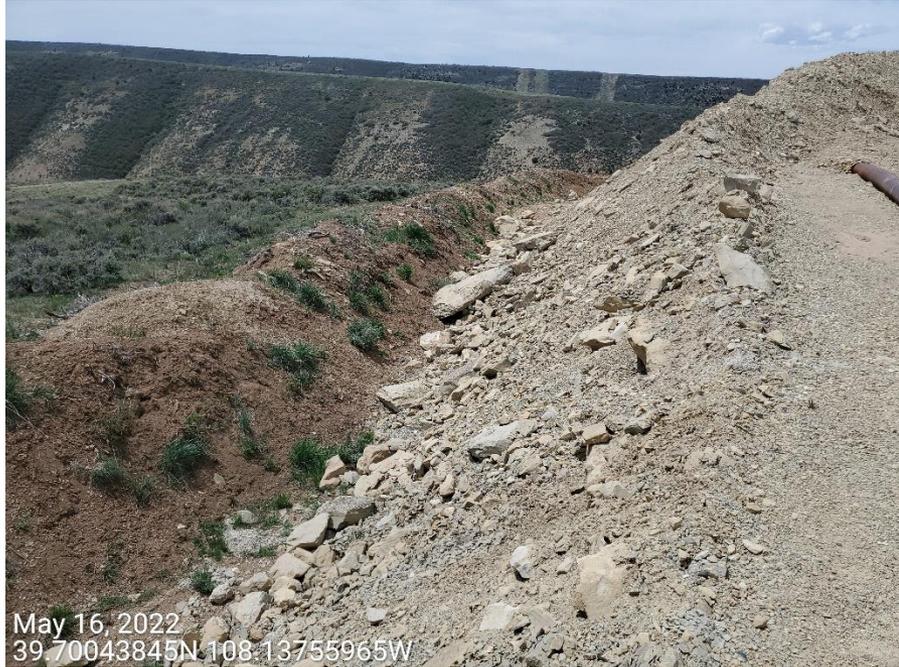
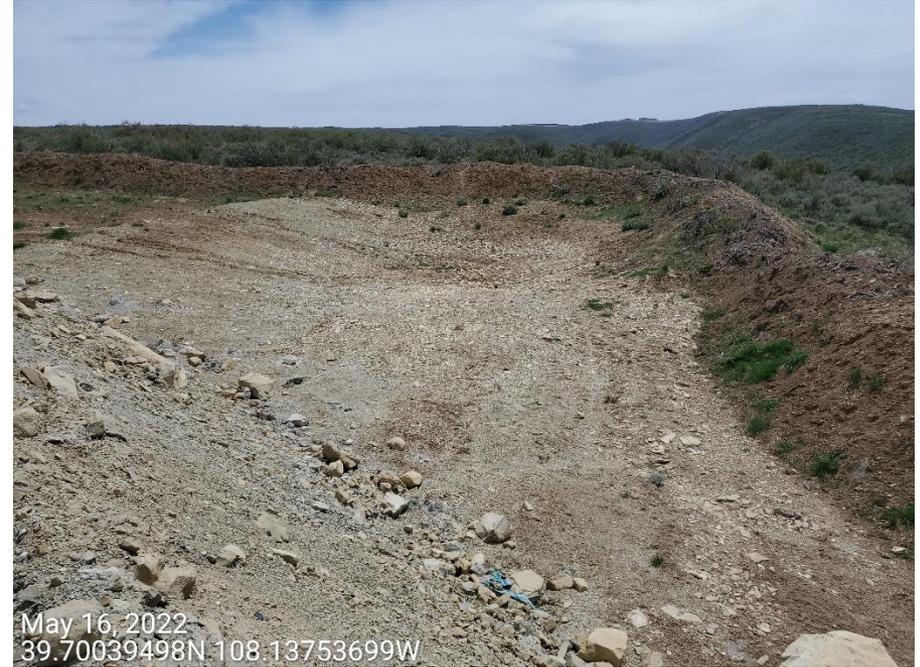
Photo 6: Photos taken from the slopes of the Location. Photos examples showing control measures to minimize erosion/degradation are missing or insufficient on the Location; slopes on locations a mixture of fine and rocky substrate; majority of the materials observed to be unconsolidated. Photos also provide examples showing how Operator has utilized topsoil at the base of the fill slopes/subsoils of the Location as a berm and sediment trap/pond to manage stormwater. Topsoil is not an appropriate material to construct stormwater control measures, and is at risk of degradation, loss and displacement due to stormwater discharge; use of topsoil as stormwater control measures does not comport with Rule 1002.b and 1002.c. Topsoil stockpiles along perimeter are predominantly bare, and at risk to erosion.

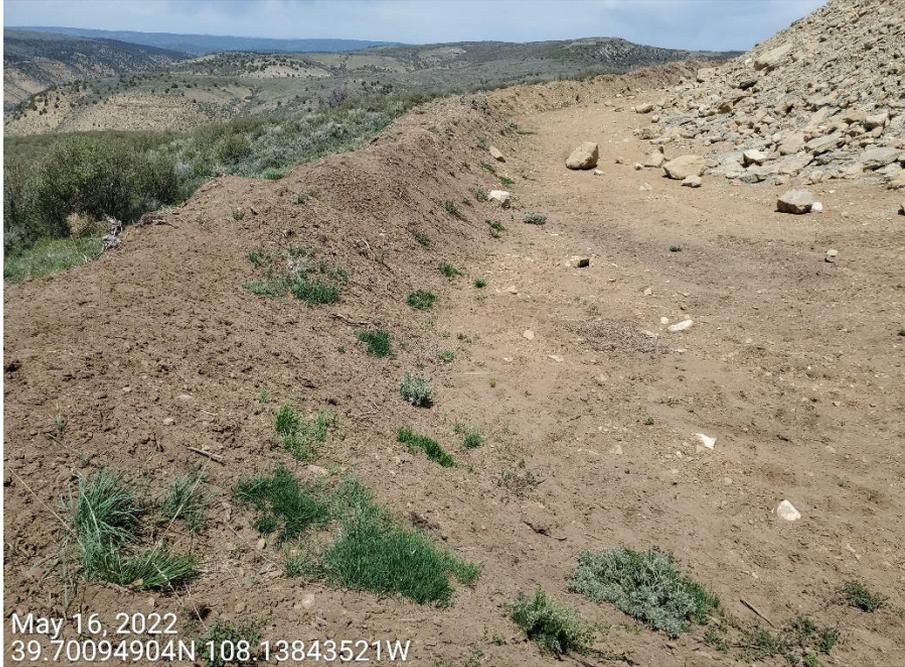
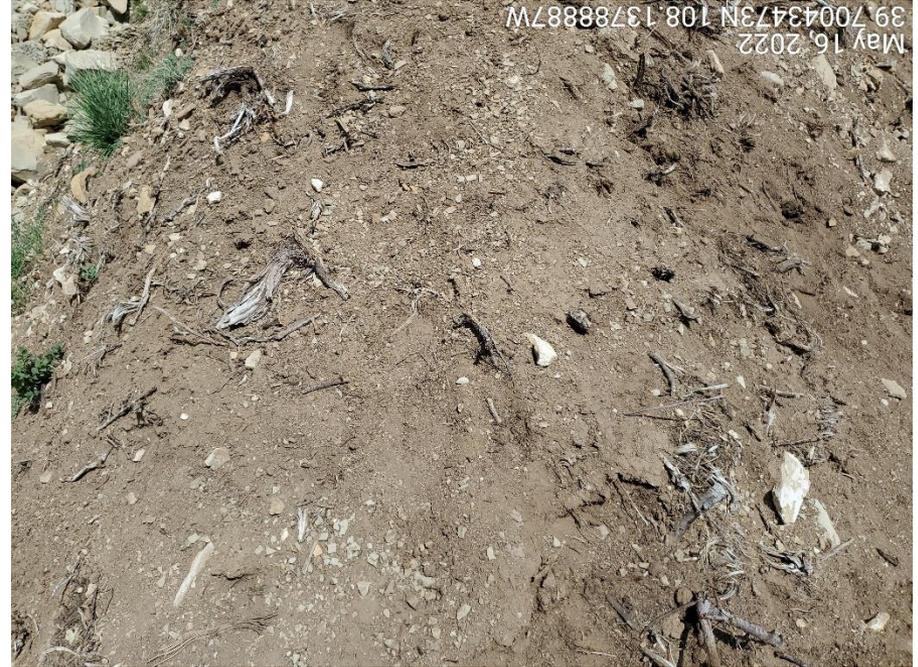
Photo 7: Photos provide examples showing how Operator has utilized topsoil at the base of the fill slopes/subsoils of the Location as a berm and sediment trap/pond to manage stormwater. Topsoil is not an appropriate material to construct stormwater control measures, and is at risk of degradation, loss and displacement due to stormwater discharge; use of topsoil as stormwater control measures does not comport with Rule 1002.b and 1002.c. Topsoil stockpiles along perimeter predominantly bare, and unvegetated, and at risk to erosion.

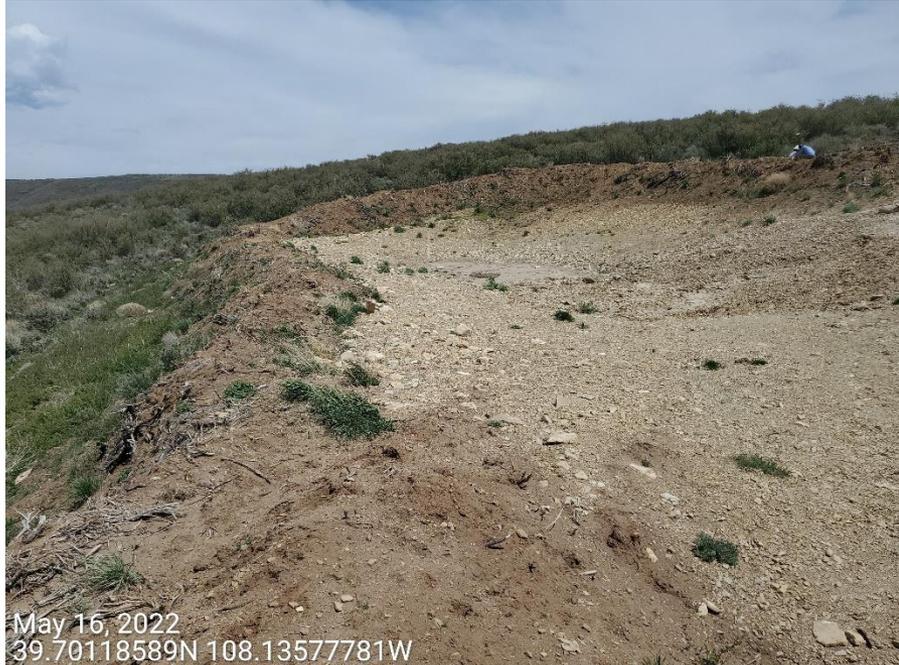
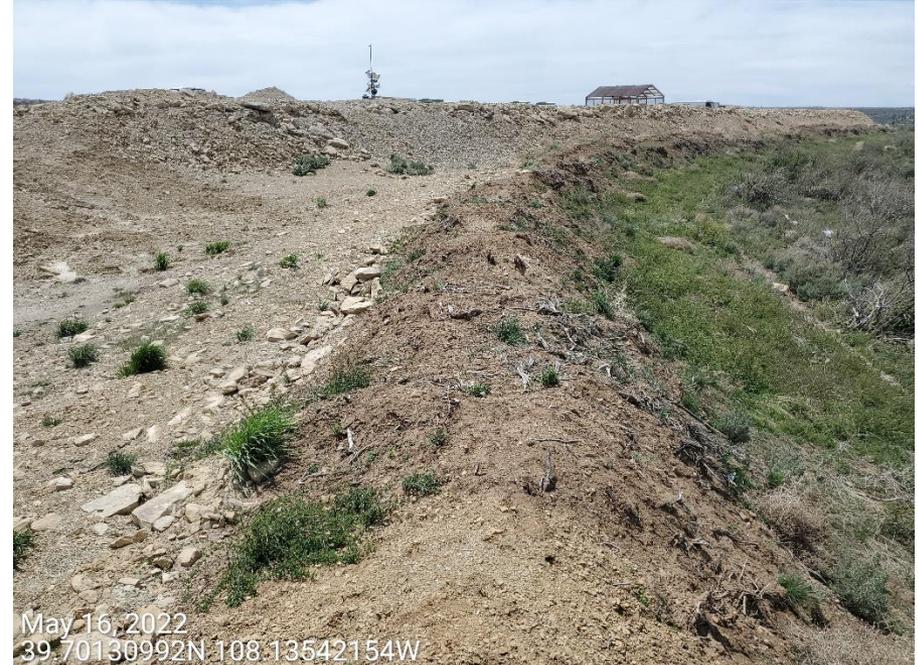
Photo 8: Photos provide examples showing how Operator has utilized topsoil at the base of the fill slopes/subsoils of the Location as a berm and sediment trap/pond to manage stormwater. Topsoil is not an appropriate material to construct stormwater control measures, and is at risk of degradation, loss and displacement due to stormwater discharge; use of topsoil as stormwater control measures does not comport with Rule 1002.b and 1002.c. Topsoil stockpiles along perimeter predominantly bare, and unvegetated, and at risk to erosion.

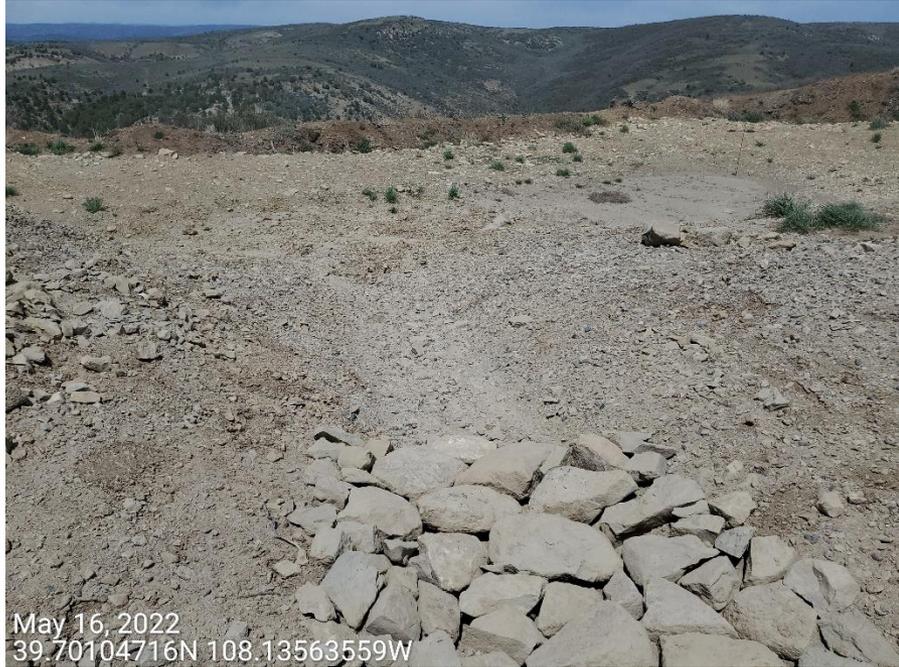
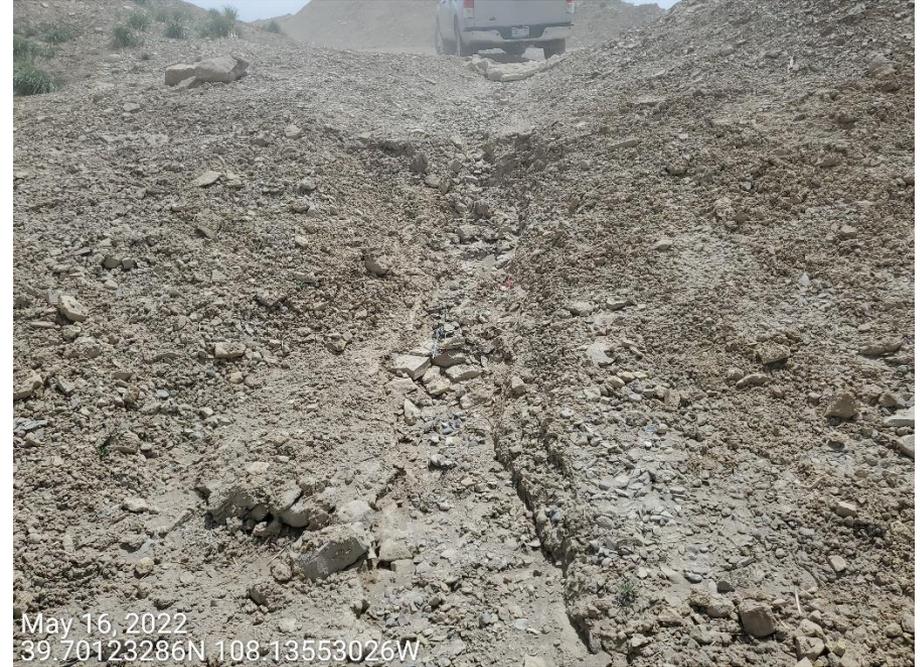
Photo 9: Photos taken from the sediment trap on the north end of the Location. Inlet at the sediment trap/pond on the north end of the Location does not appear to be properly engineered; gully erosion/degradation becoming apparent at the inlet/control.

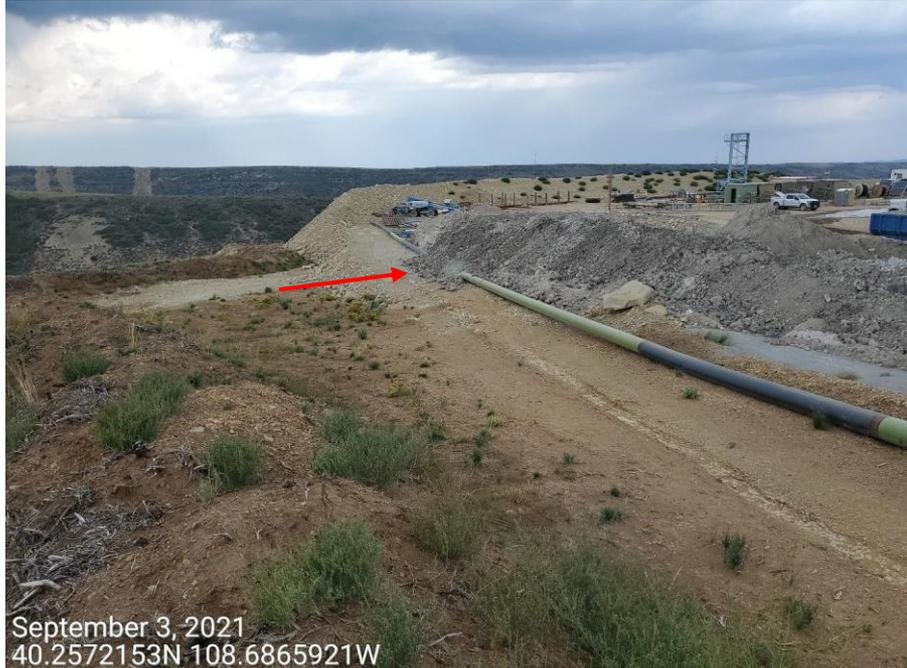
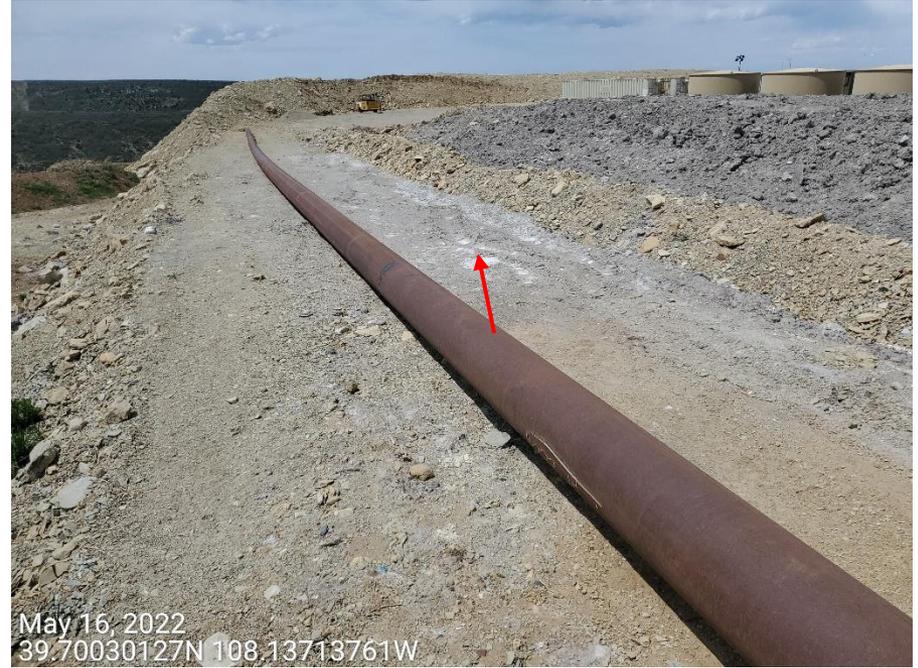
Photo 10: Photos taken from the south end of the Location. Photo on the left taken from the 9/3/2021 inspection, and shows control measures to contain drill cuttings is inadequate, resulting in a spill outside of containment. Photo right shows the containment BMP has been maintained, however impacted materials in the area of the spill is apparent (arrow). Operator does not appear to have properly cleaned spill.

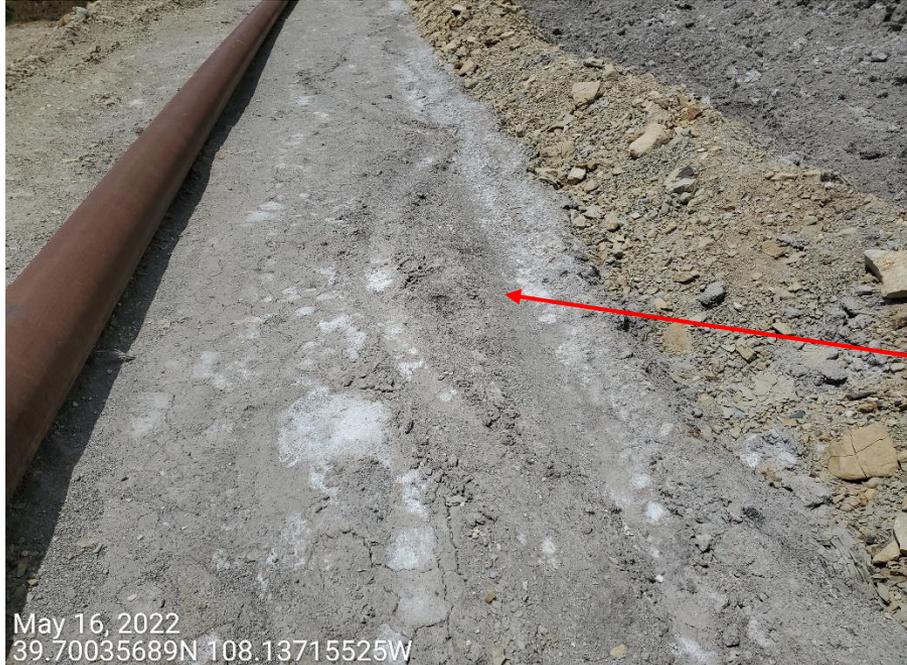
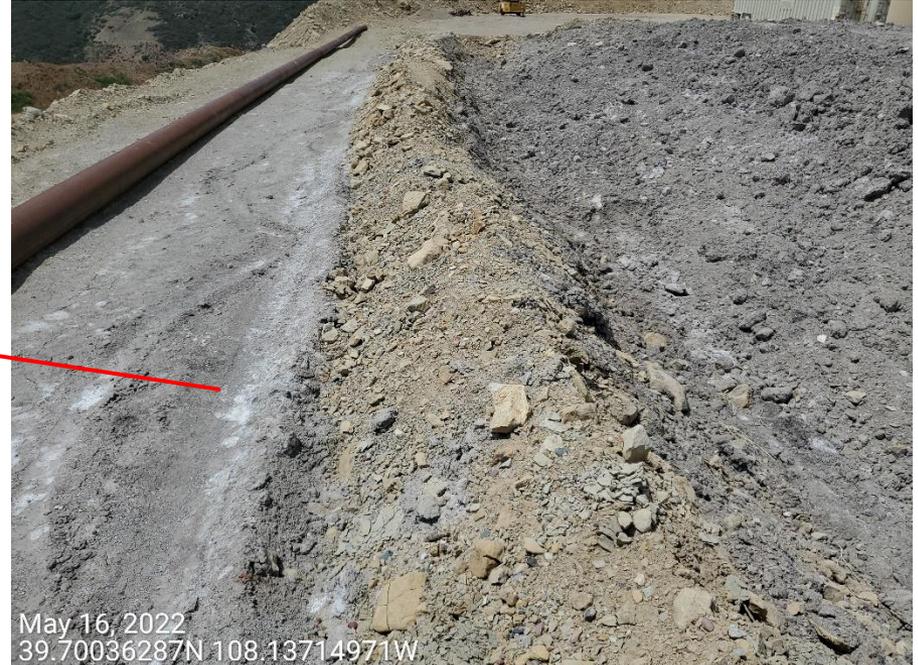
Photo 11: Continued from photo 10. Photo shows impacted materials remaining. Photo right shows cuttings right of the berm, and impacted materials left of the berm. Operator does not appear to have properly cleaned spill.

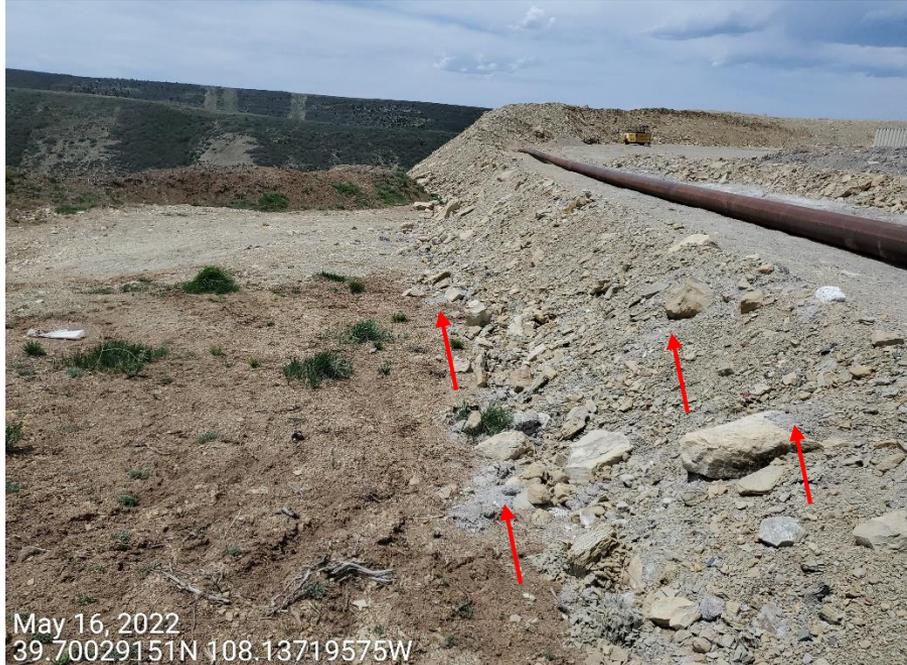
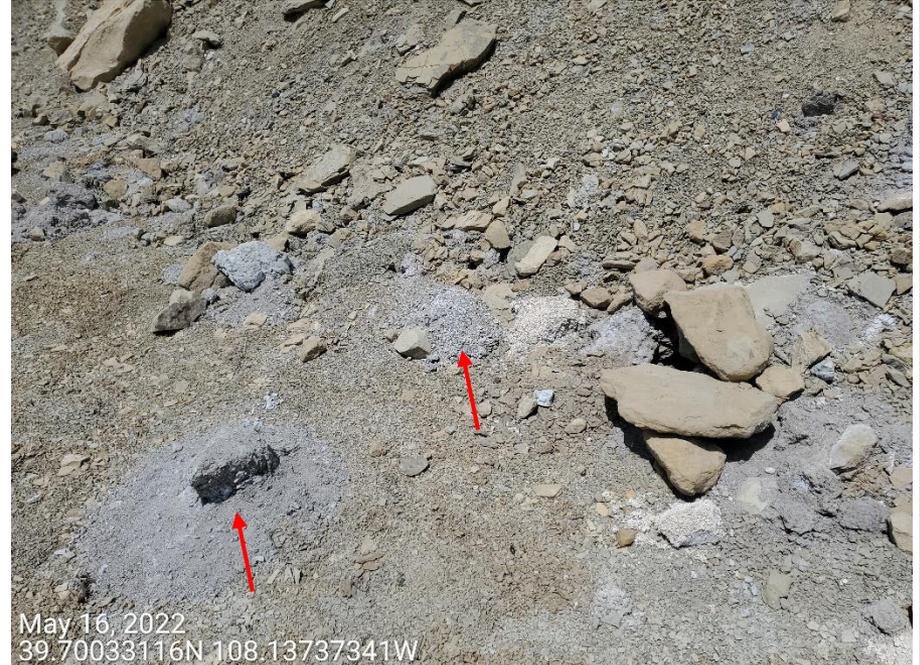
Photo 12: Continue from photo 10/11. Photo shows impacted materials observed outside of containment. Operator does not appear to have properly cleaned spill. Photo left also shows proximity of spill to the sediment trap/basin on the south end of the location, as well as the topsoil used as the berm for the trap.
