APACHE CANYON 01-12 API# 05-071-09475 – OGRIS OPERATING
OGCC OPERATOR NUMBER 10758 - DATE: MAY 19, 2022
CORRECTIVE ACTIONS COMPLETED REGARDING COGCC FIR DOCUMENT # 690201359

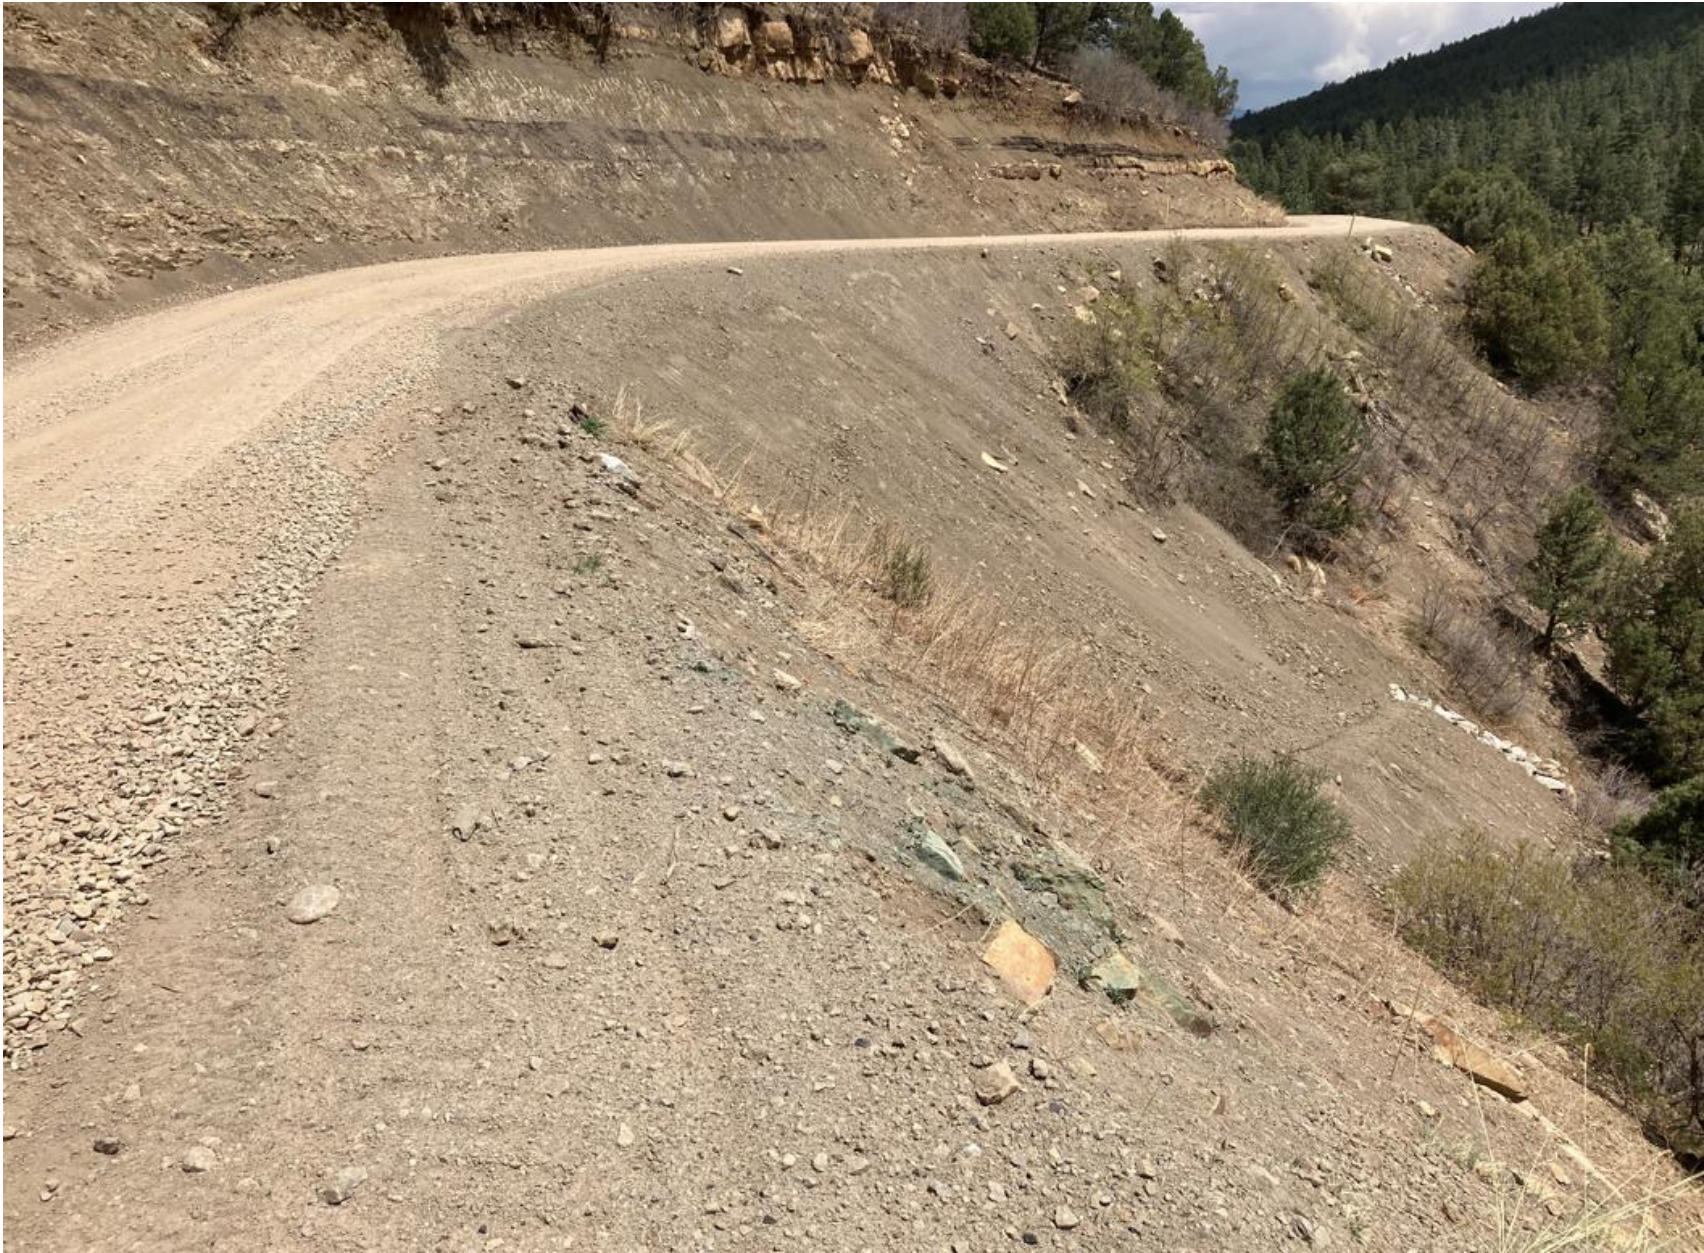
PHOTO 1: THE EROSION OF THE FILL SLOPE ON THE UPPER MAIN LEASE ROAD OF ALAMOSITO WAS REPAIRED. THE DIVERSION DITCH ALONG THE ENTIRE ACCESS HAS BEEN CLEANED OF SEDIMENT AND REDefined TO DIRECT STORMWATER TO CULVERTS. THE FILL SLOPE HAS ALSO BEEN SEEDED USING AN APPROVED CPW SEED MIX TO PROMOTE THE ESTABLISHMENT OF VEGETATION.

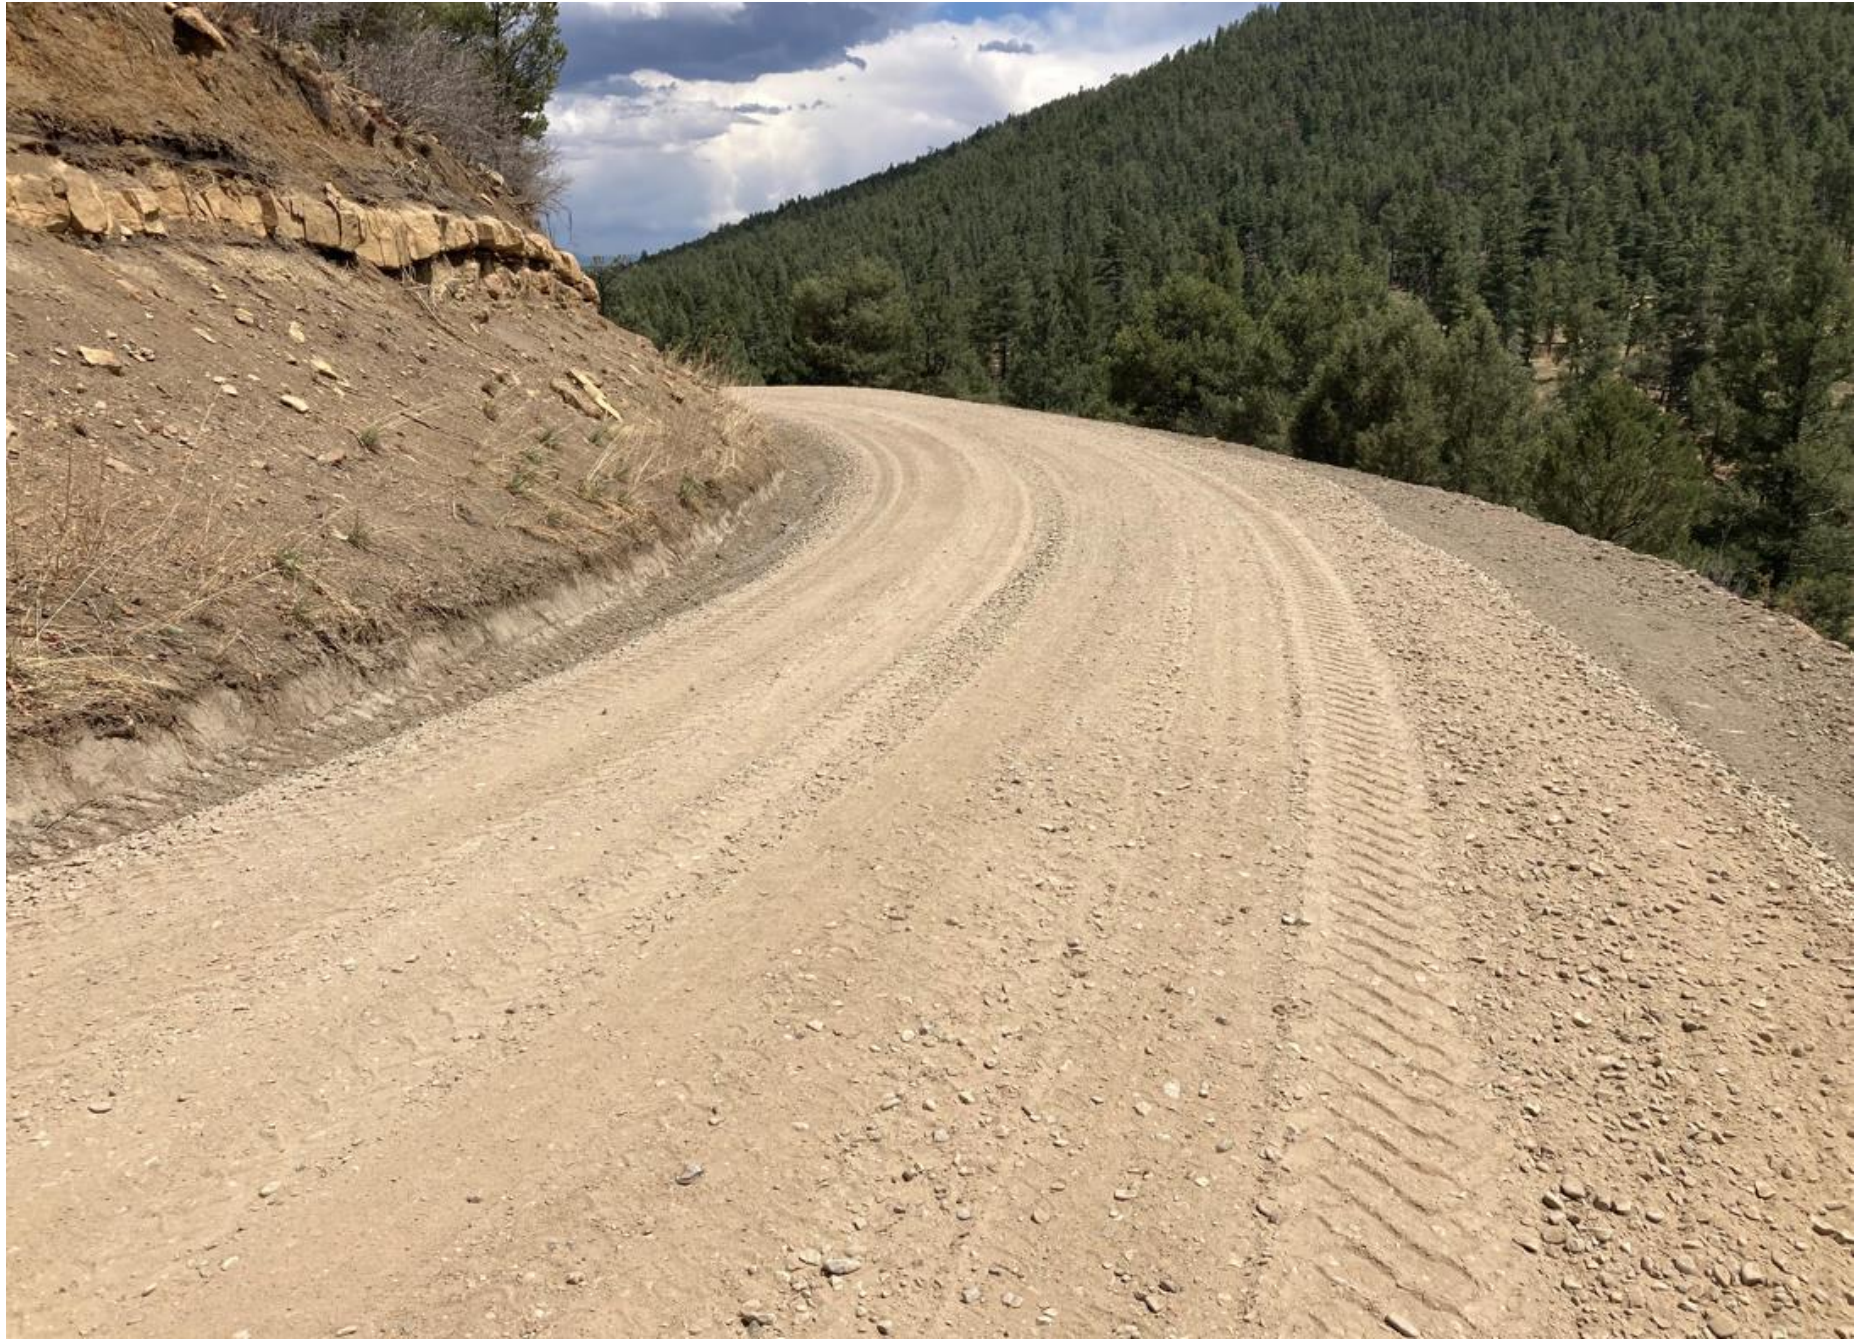
PHOTO 2: THE MAIN LEASE ROAD SURFACE WAS CROWNED TO CREATE SHEET FLOW AND ELIMINATE THE TIRE RUTS. GRAVEL WAS ADDED TO THE ROADWAY SURFACE FOR STABILIZATION.

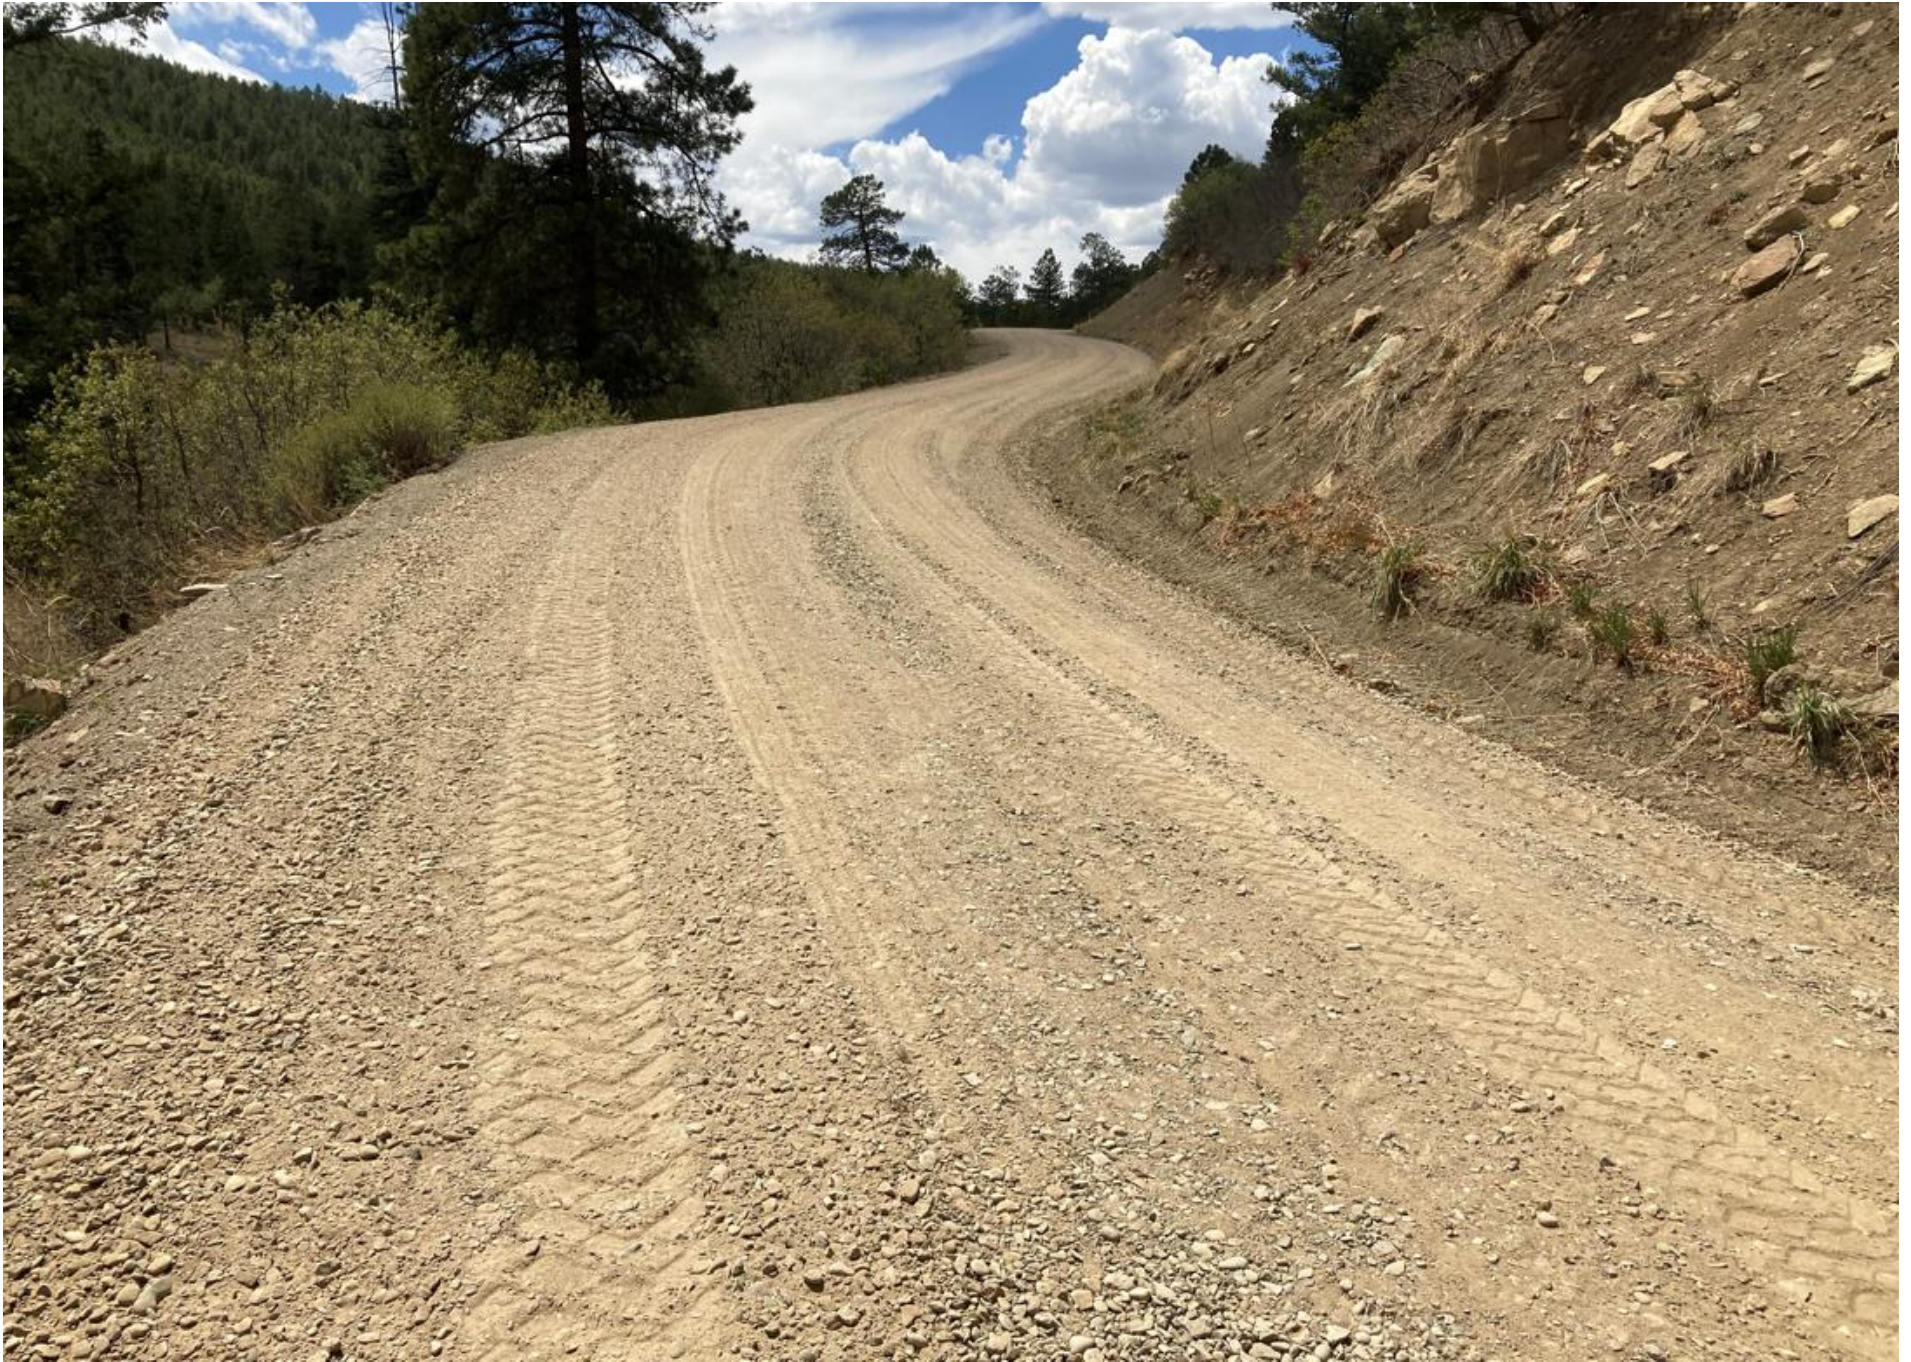
PHOTO 3: THE ROAD SURFACE WAS RE-GRADED TO ELIMINATE THE TIRE RUTS AND STABILIZED.

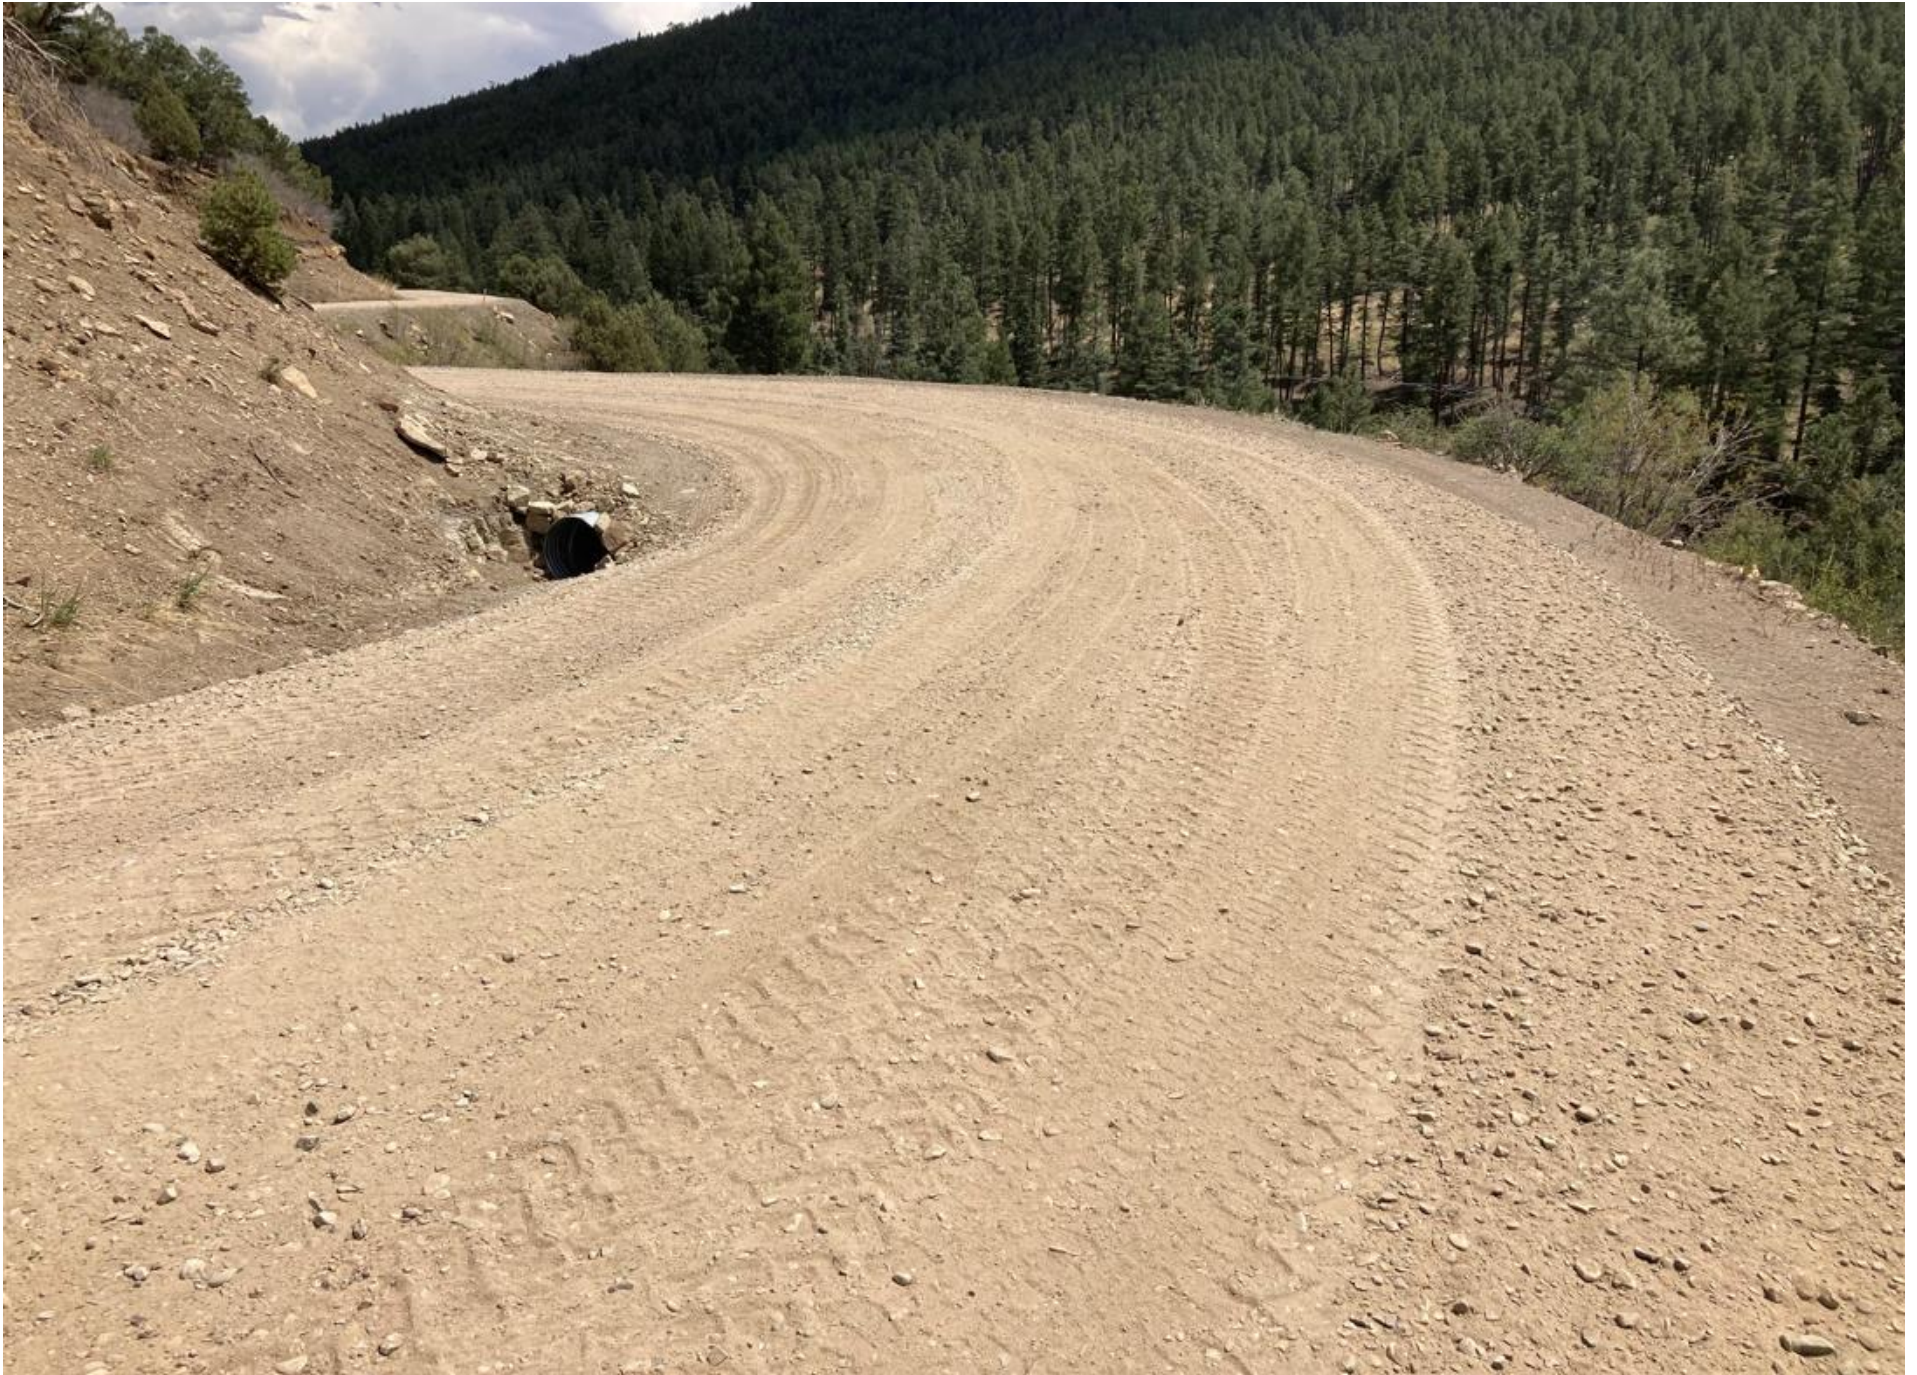
PHOTO 4: THE ROAD SURFACE WAS RE-GRADED TO ELIMINATE THE TIRE RUTS AND STABILIZED.

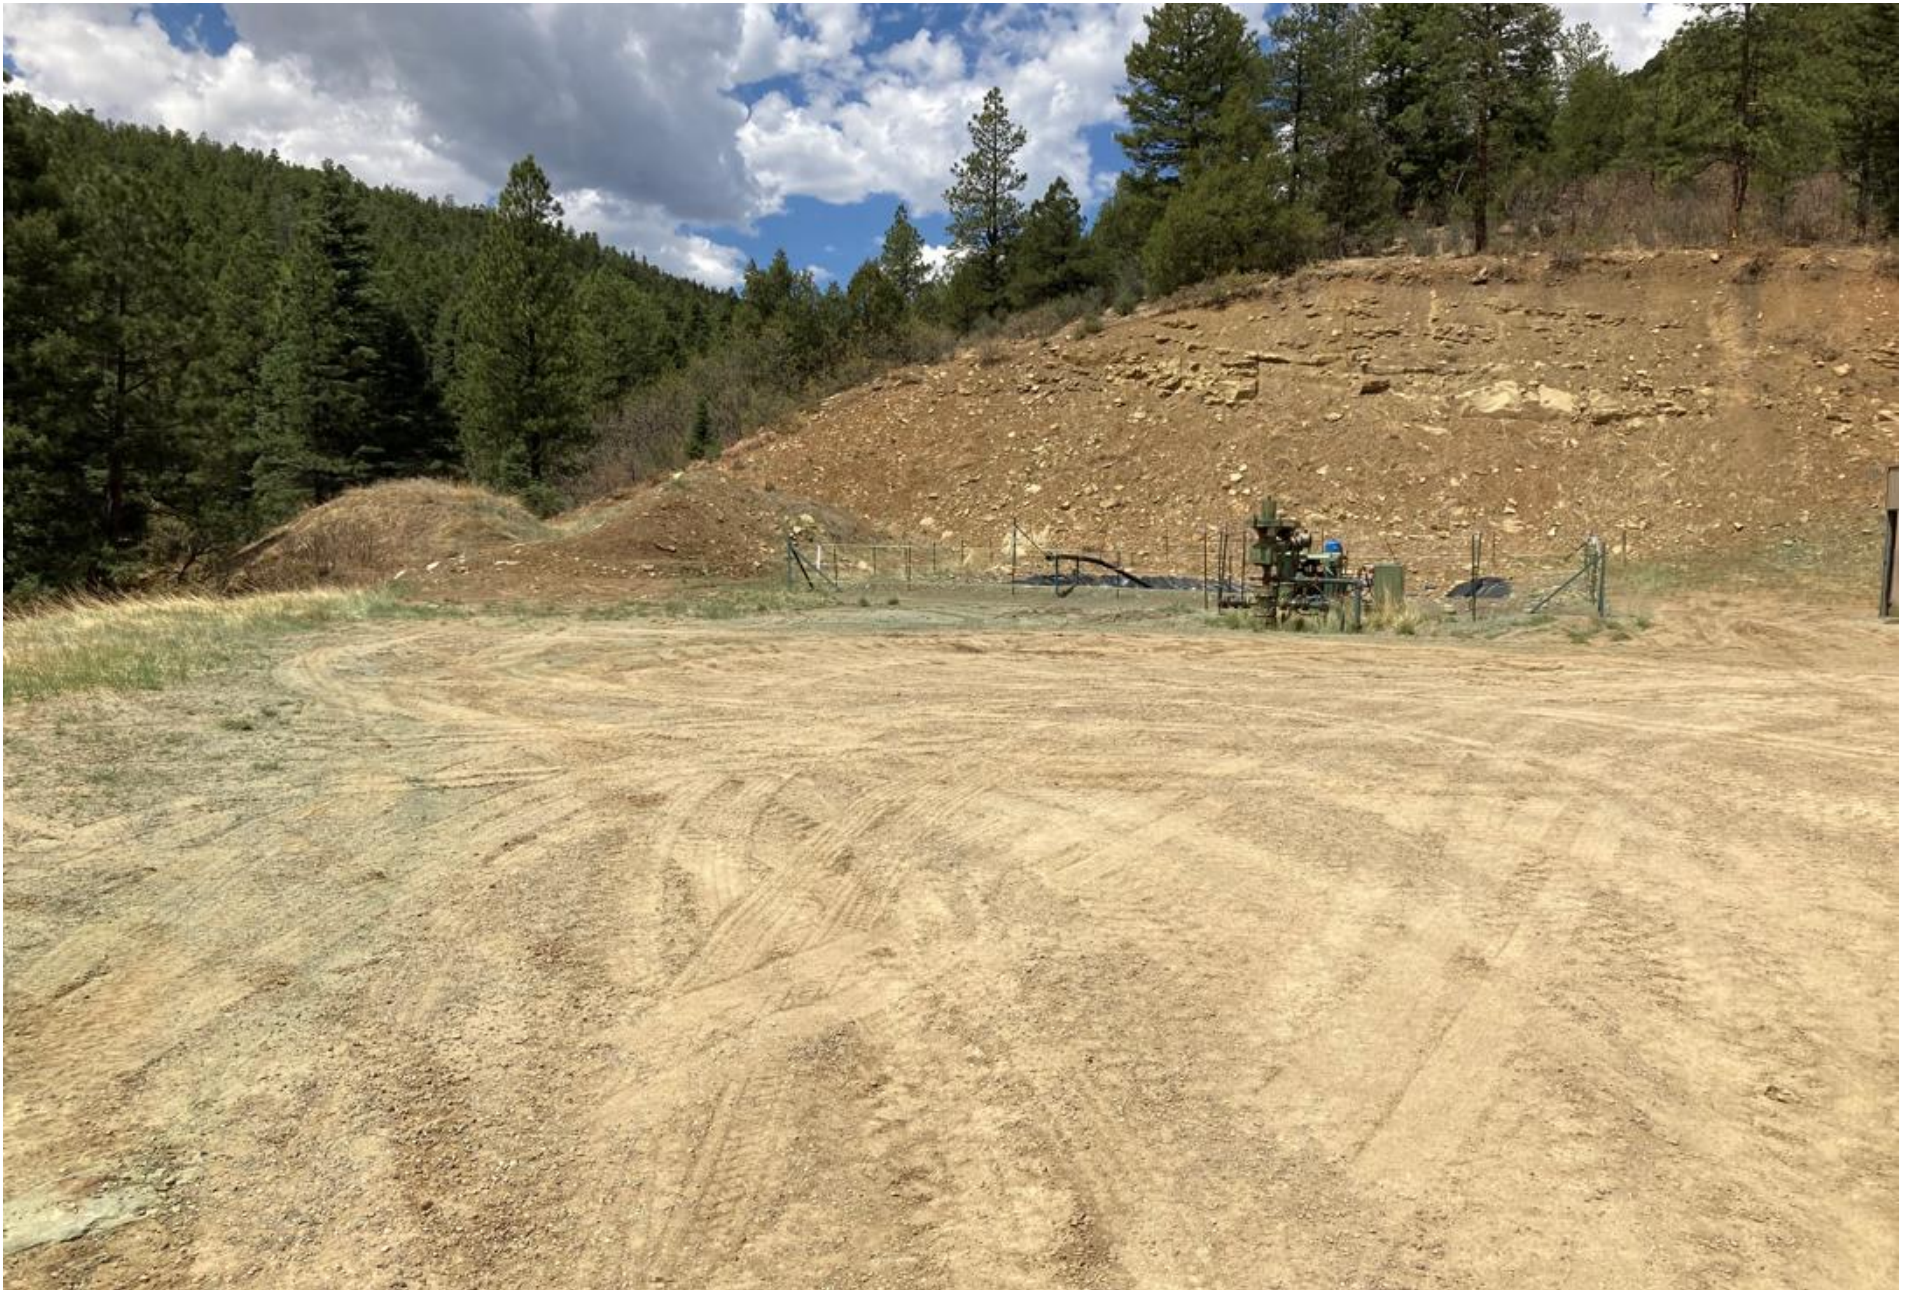
PHOTO 5: THE WELL PAD WAS REGRADED TO KNOCK DOWN THE TIRE RUTS.

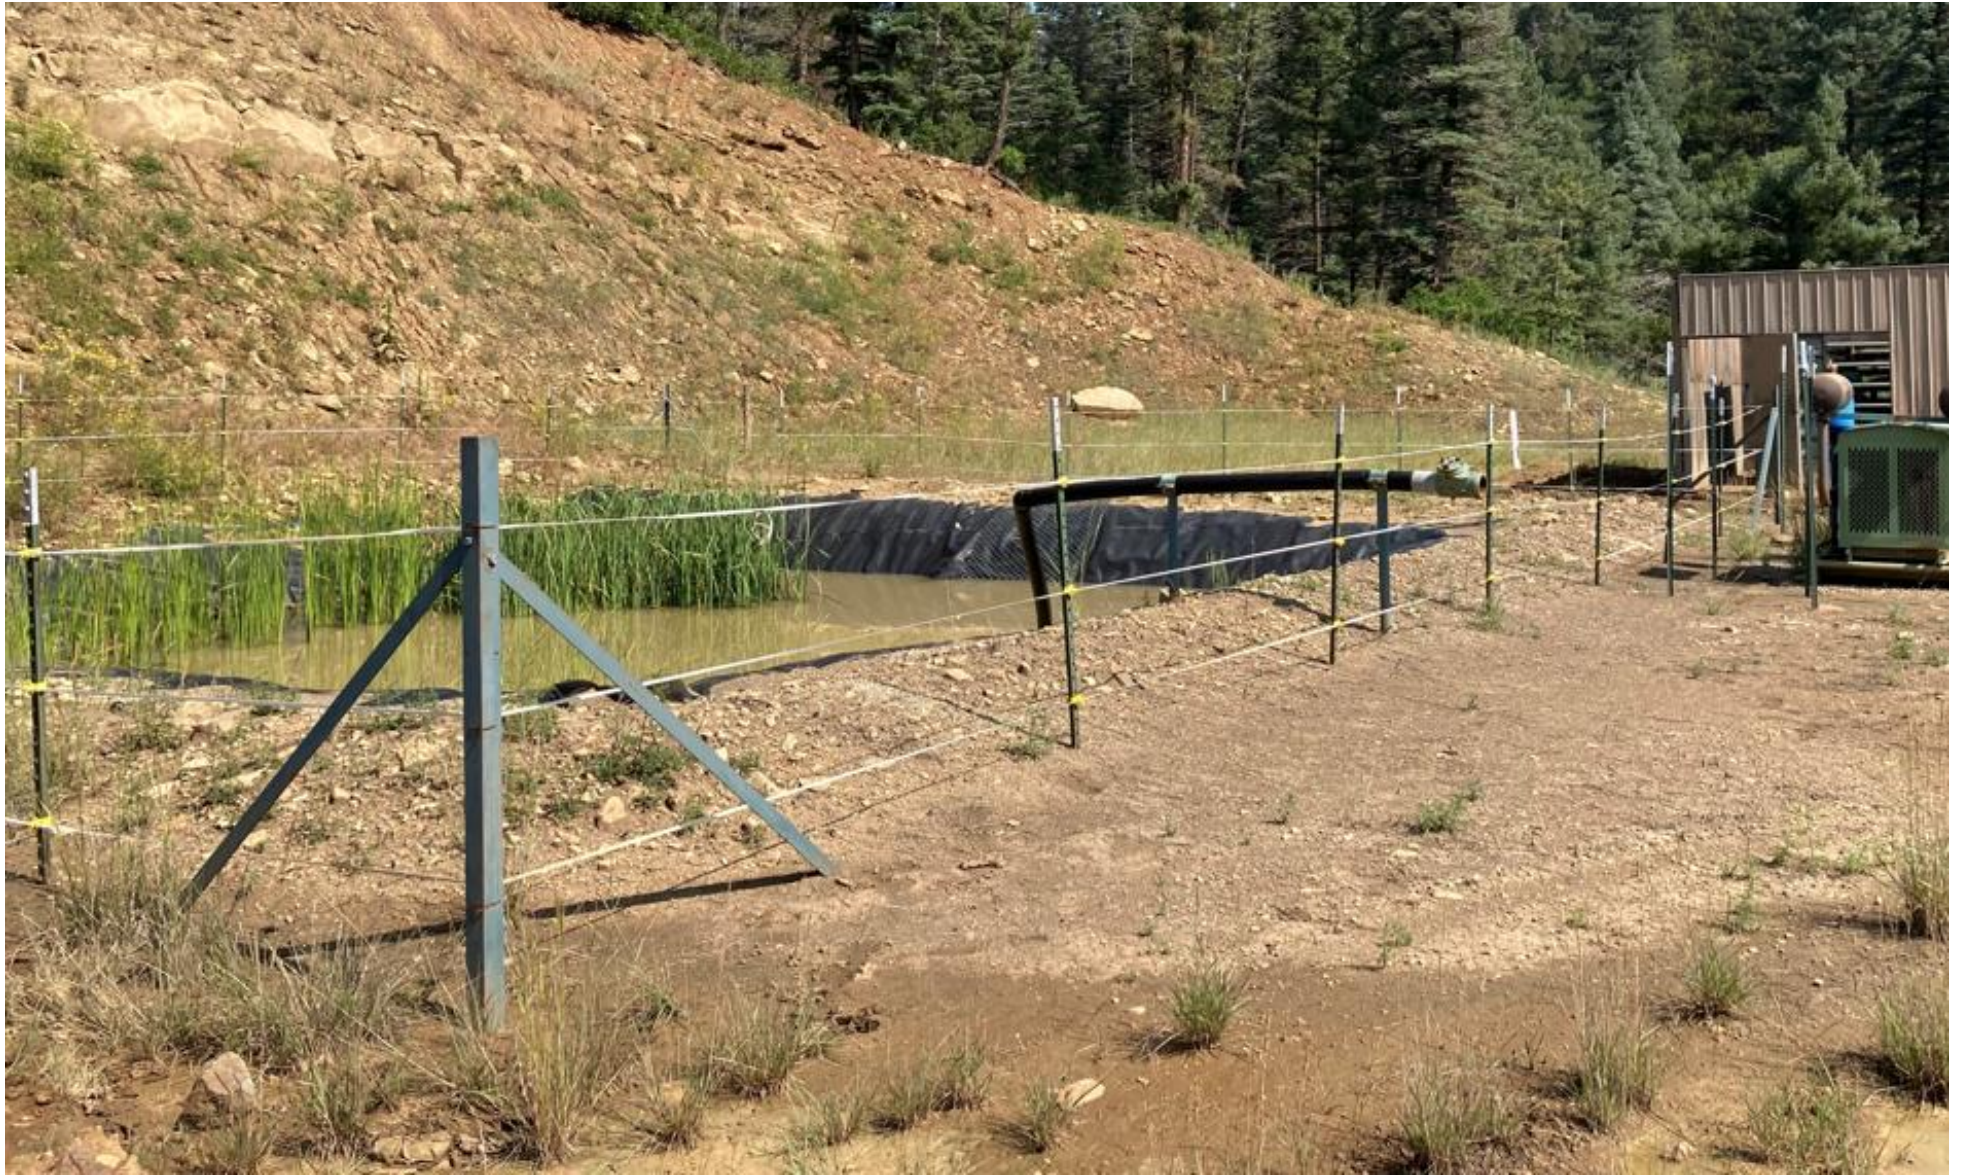
PHOTO 6: THE ELECTRIC FENCE AROUND THE PIT WAS REPAIRED.

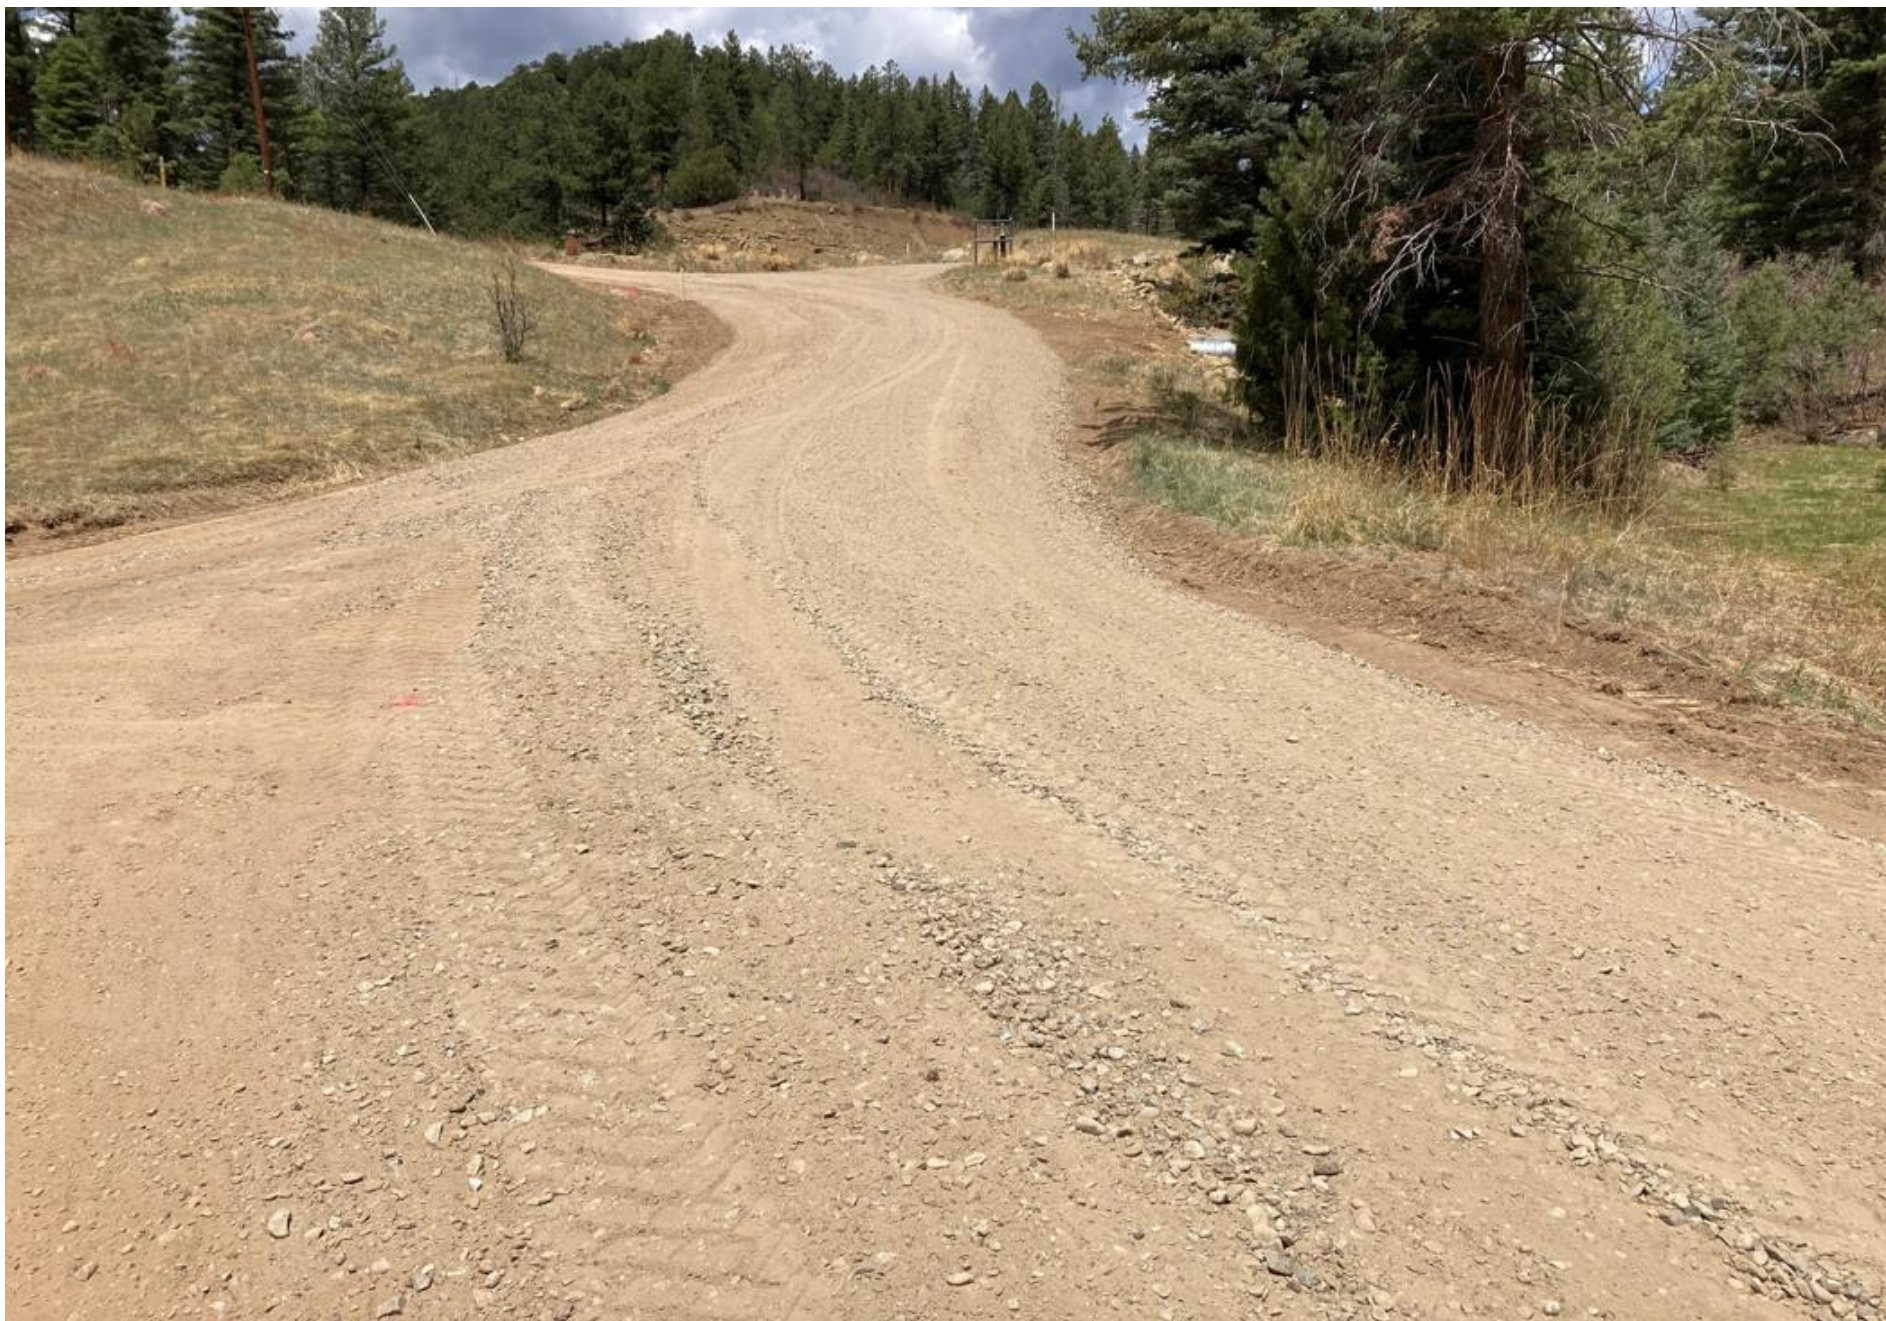
PHOTO 7: THE RUTTING ALONG THE MAIN ACCESS ROAD, AT THE INTERSECTION BELOW THE LOCATION, HAS BEEN REPAIRED AND STABILIZED.

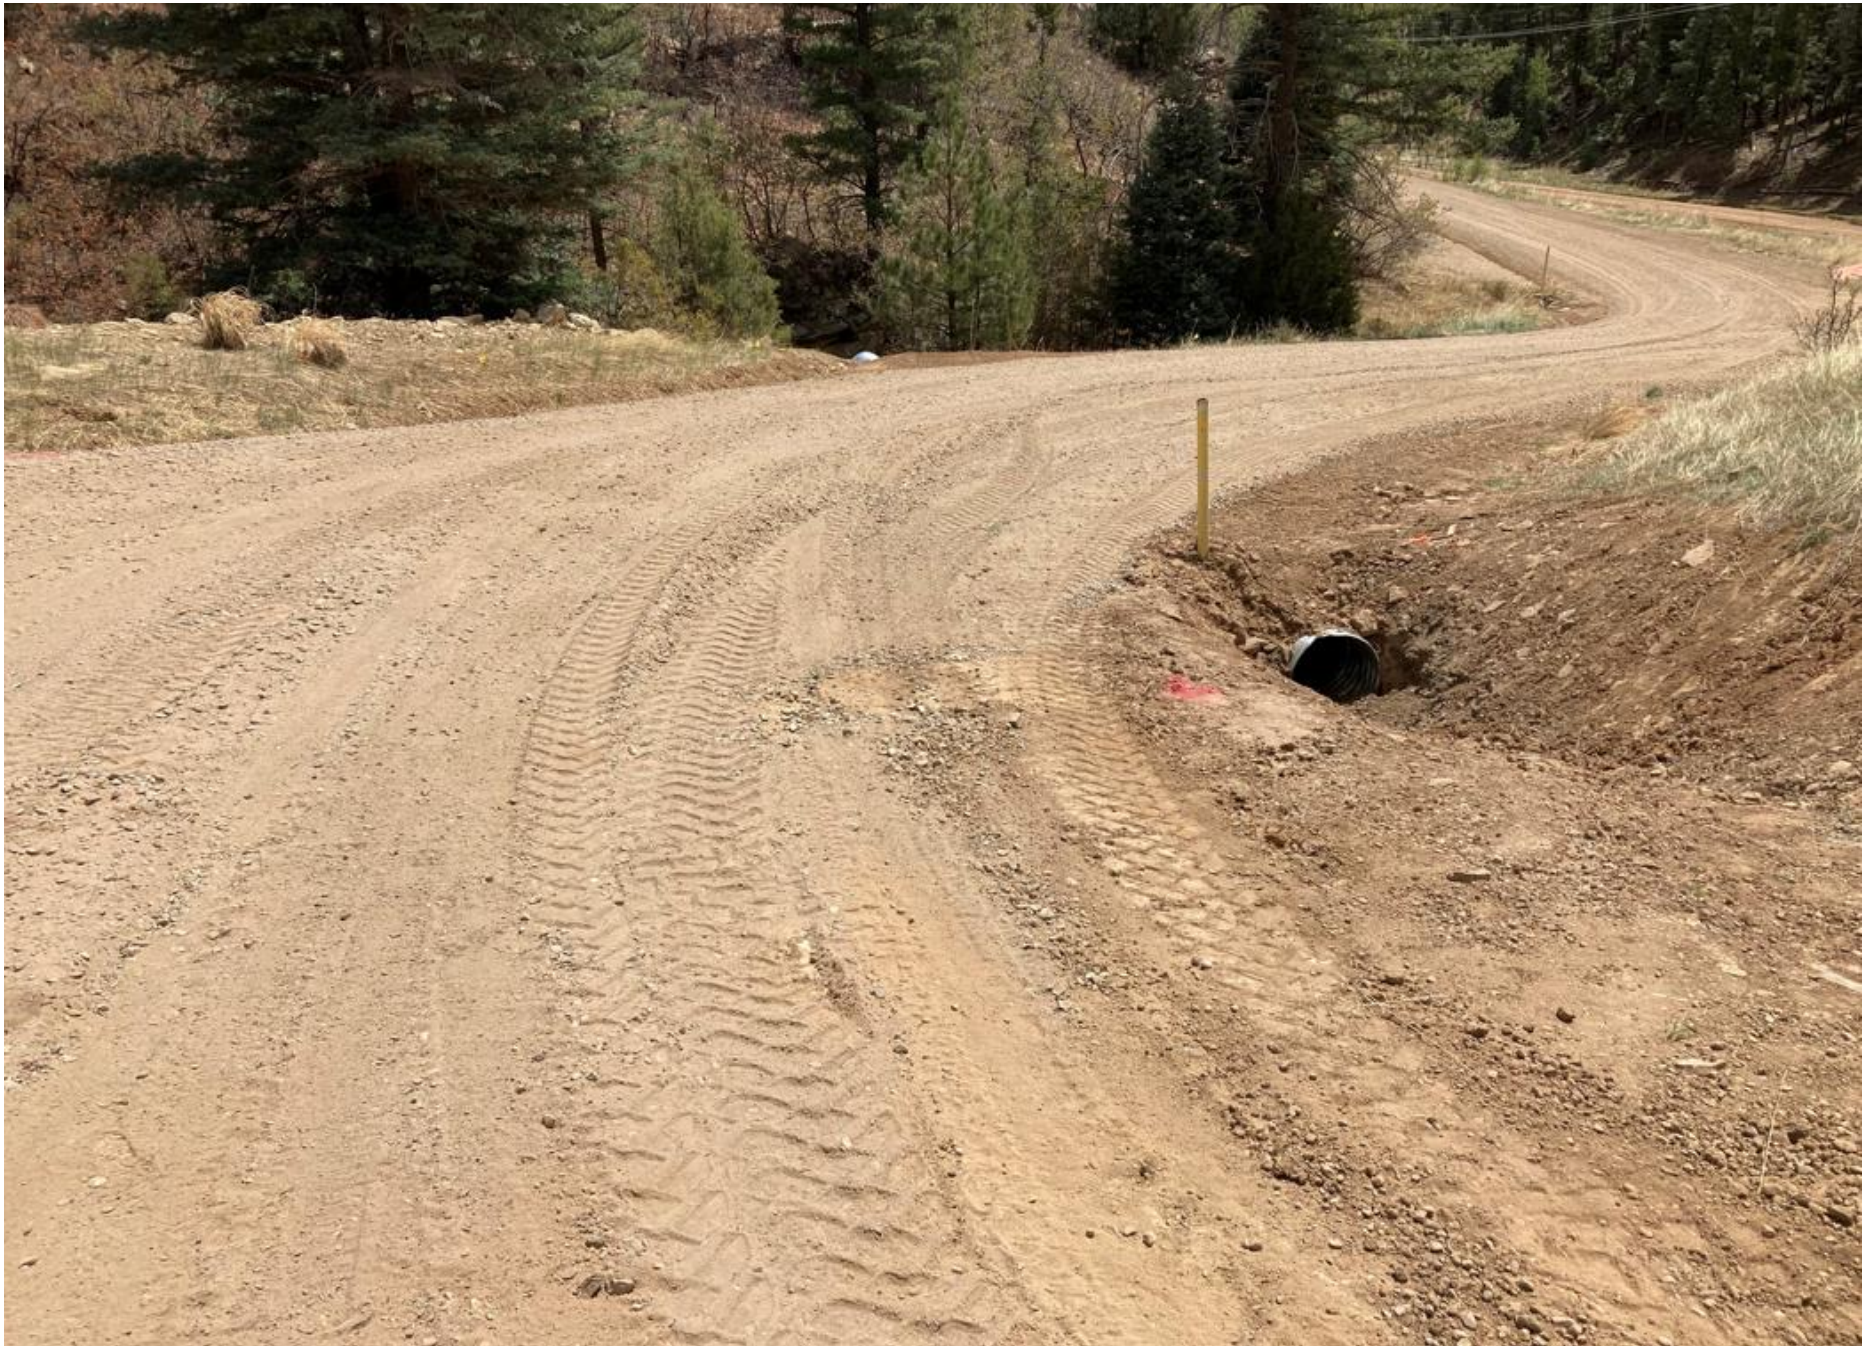
PHOTO 8: A CULVERT HAS BEEN INSTALLED AT THE INTERSECTION BELOW LOCATION. THE DIVERSION DITCH WAS DEFINED TO RECEIVE STORMWATER RUN OFF FROM THE ABOVE ACCESS ROAD AND DIRECT RUN OFF TO THE CULVERT INLET. THE ROAD SURFACE WAS CROWNED TO CREATE SHEET FLOW AND DIRECT SURFACE RUN OFF TO THE CULVERT INLET.
