## Inspection Photos

Location Name: M & M #1, #2, #3 & #4 Battery

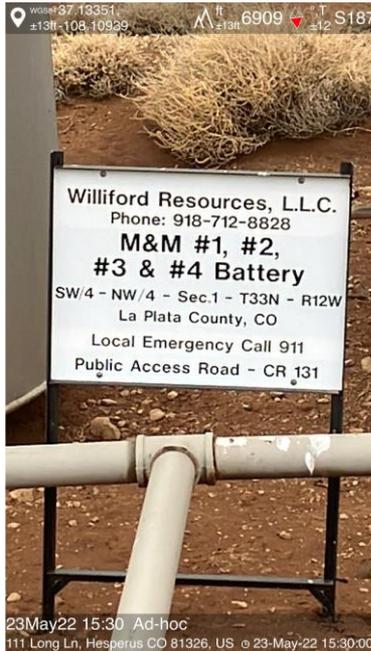
**IMG 01**  
**Well Sign**

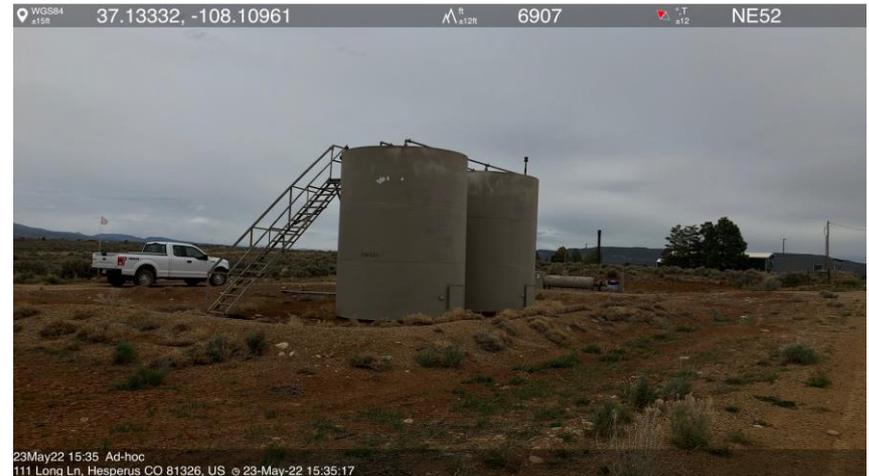
**IMG 02**  
**Site Overview**

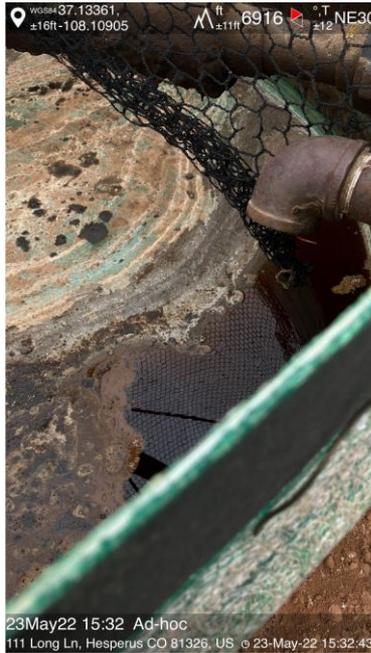
**IMG 03**

**Standing residual oily fluid In tank**

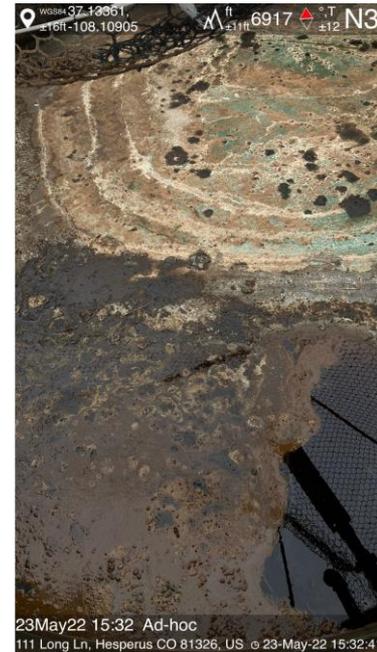
**IMG 04**

**Standing residual oily fluid In tank**

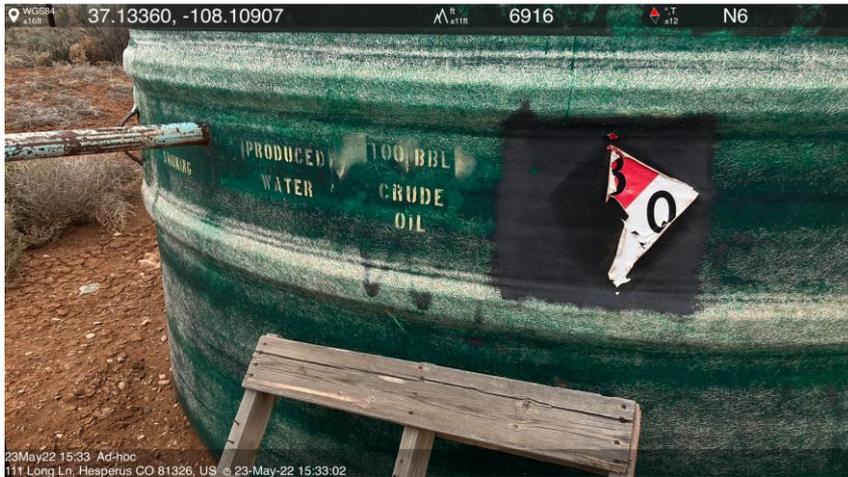
**IMG 05**

**Tank marked both as both crude and produced water, NFPA placard is deteriorated,**

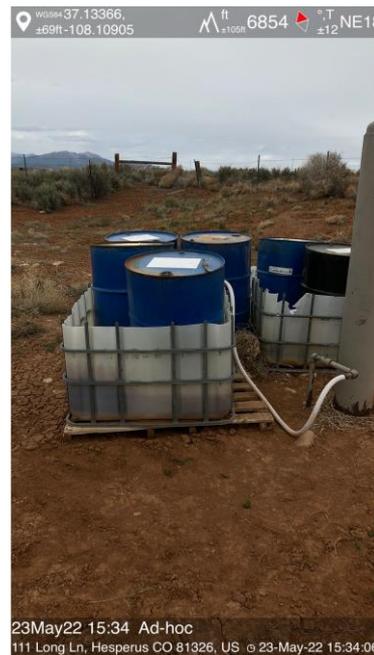
**IMG 08**  
**Empty 55 gallon drums**

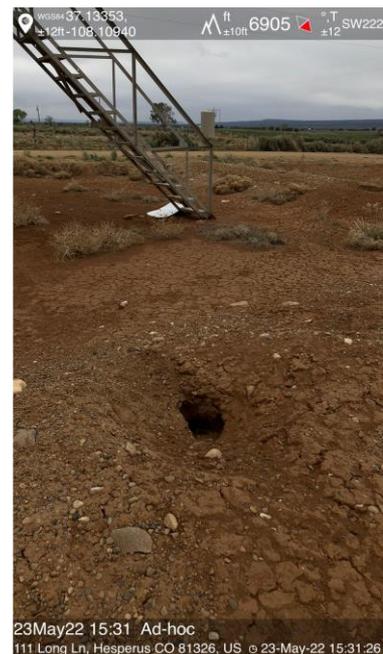
**IMG 10**  
Wildlife burrows in secondary containment berms

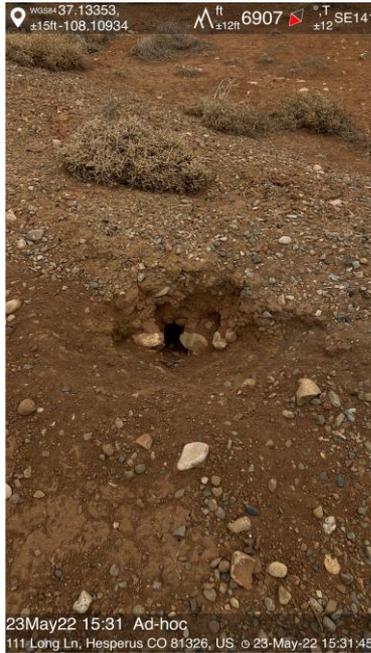
**IMG 11**

**Wildlife burrows in secondary containment berms**
