Inspection Photos
Operator: Hilcorp Energy
API: 067-05815
Date: 5/24/2022

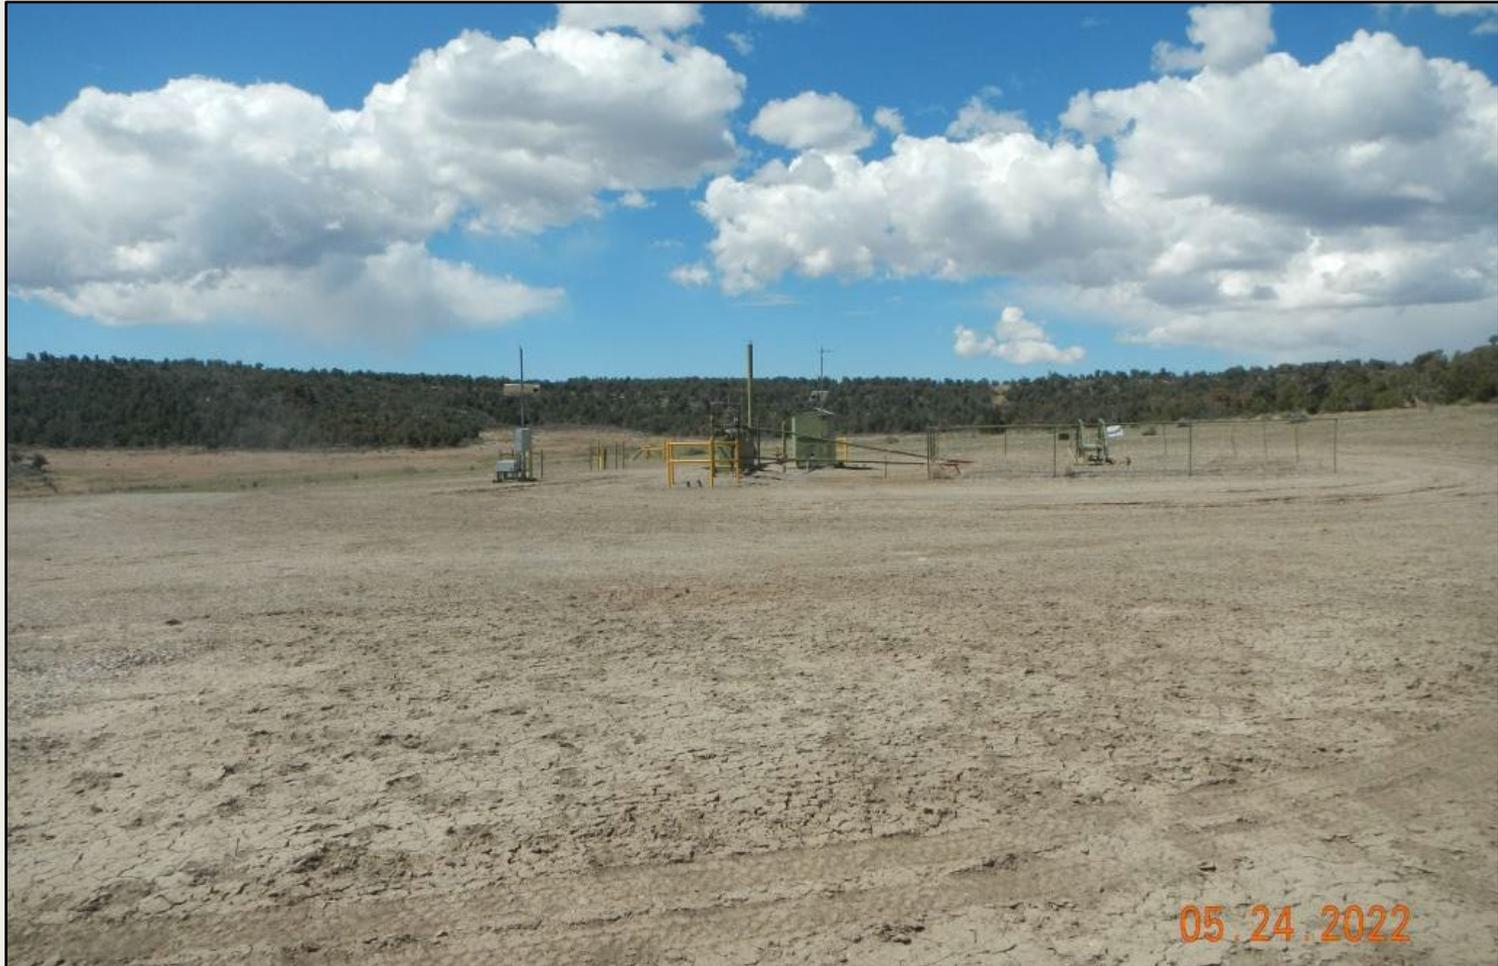
Photo 1. View of the project area from the northeastern corner facing center.

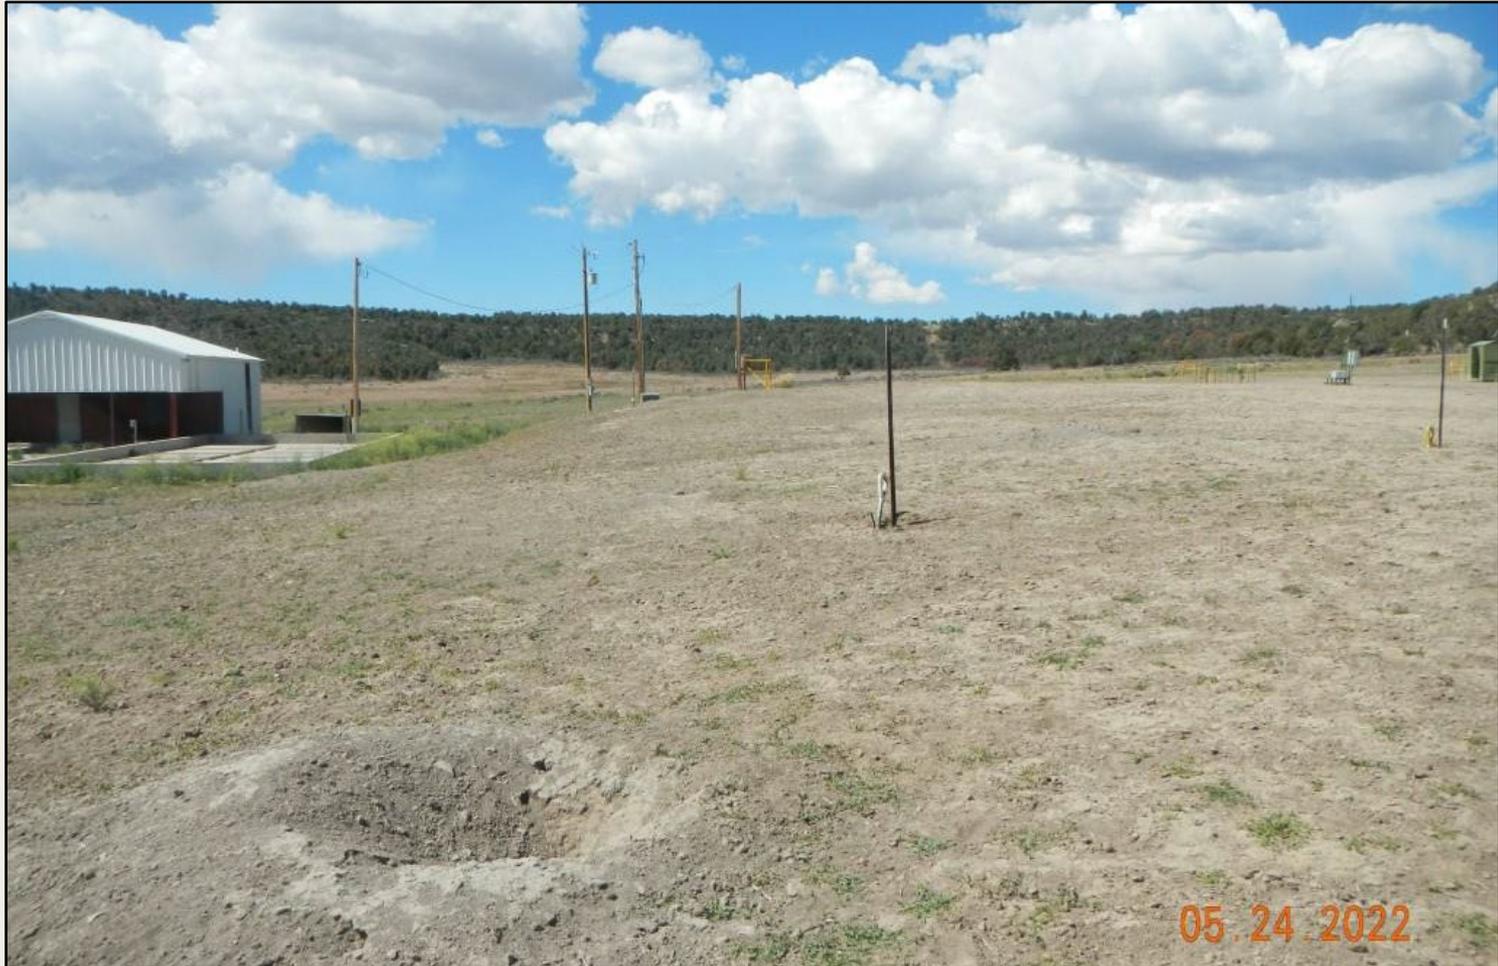
Photo 2. View of the eastern fill slope. Little desirable vegetation observed on the slope.

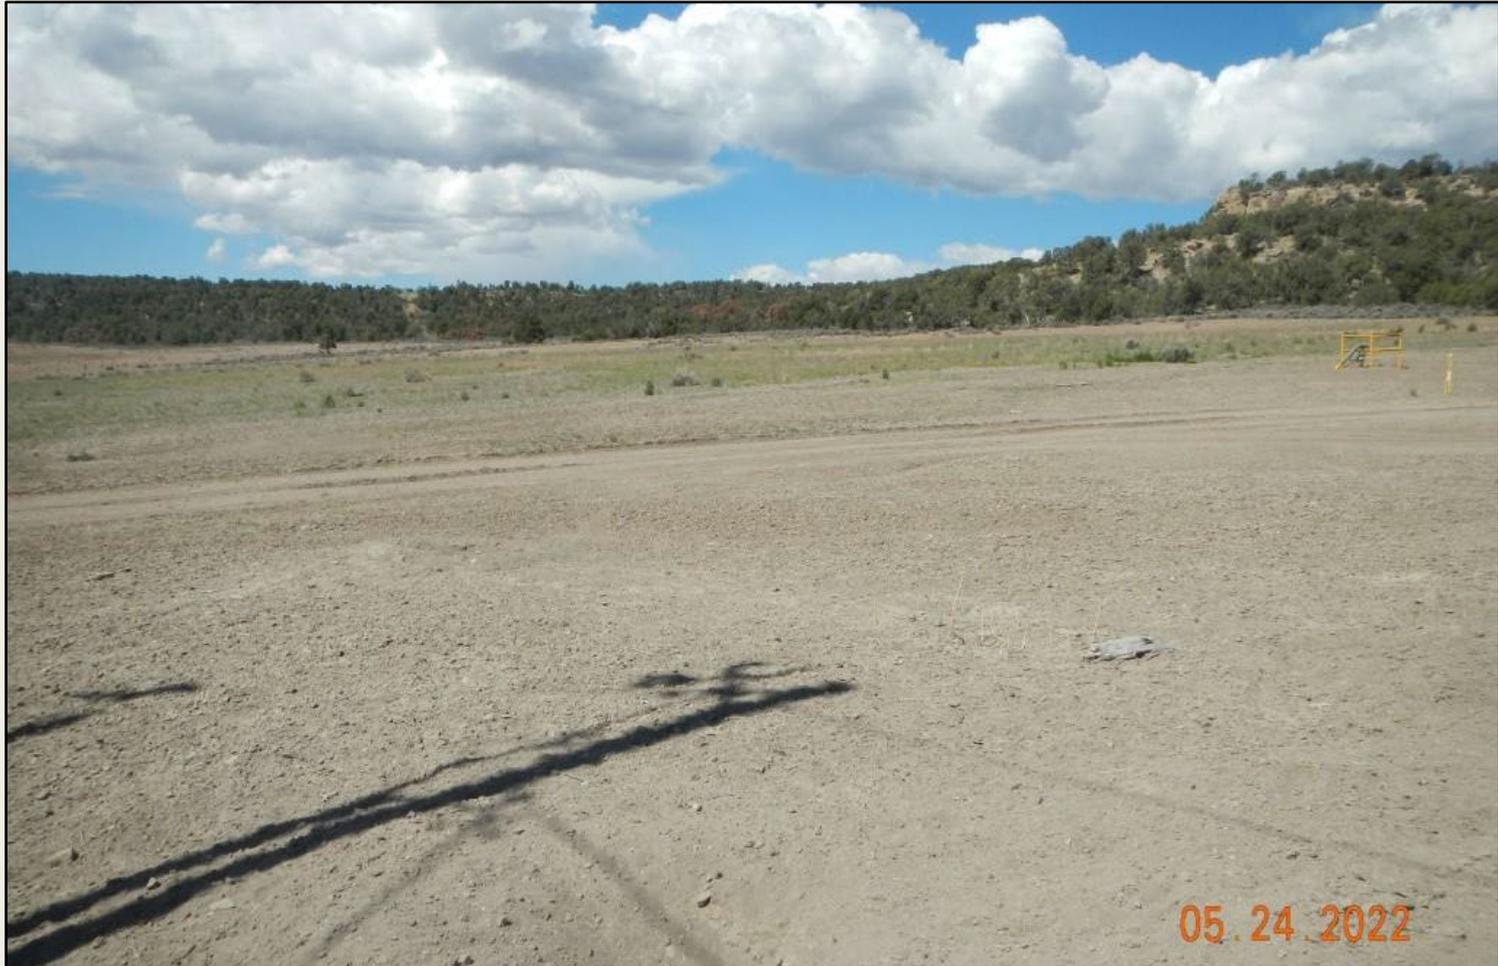
Photo 3. View of area at the well pad entrance with bare soils needing stabilization.

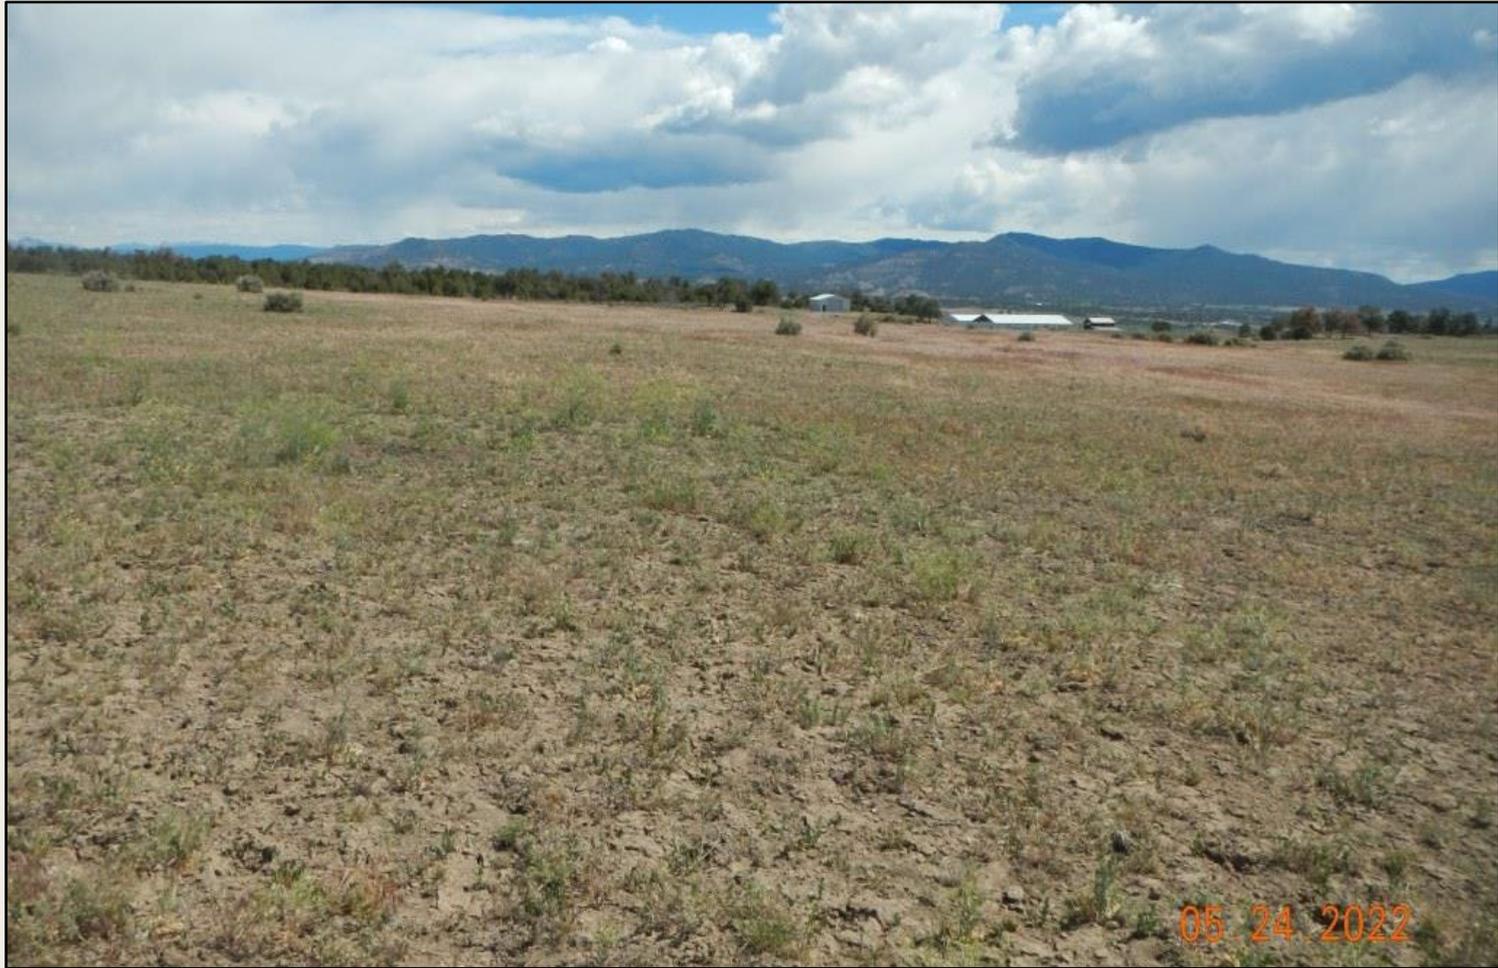
Photo 4. View of reference area vegetation comprised of open grass field with a mix of native and non-native grasses and forbs such as western wheatgrass, purple mustard, and flixweed.
