Inspection Photos
Operator: Hilcorp Energy
API: 067-08186
Date: 5/24/2022

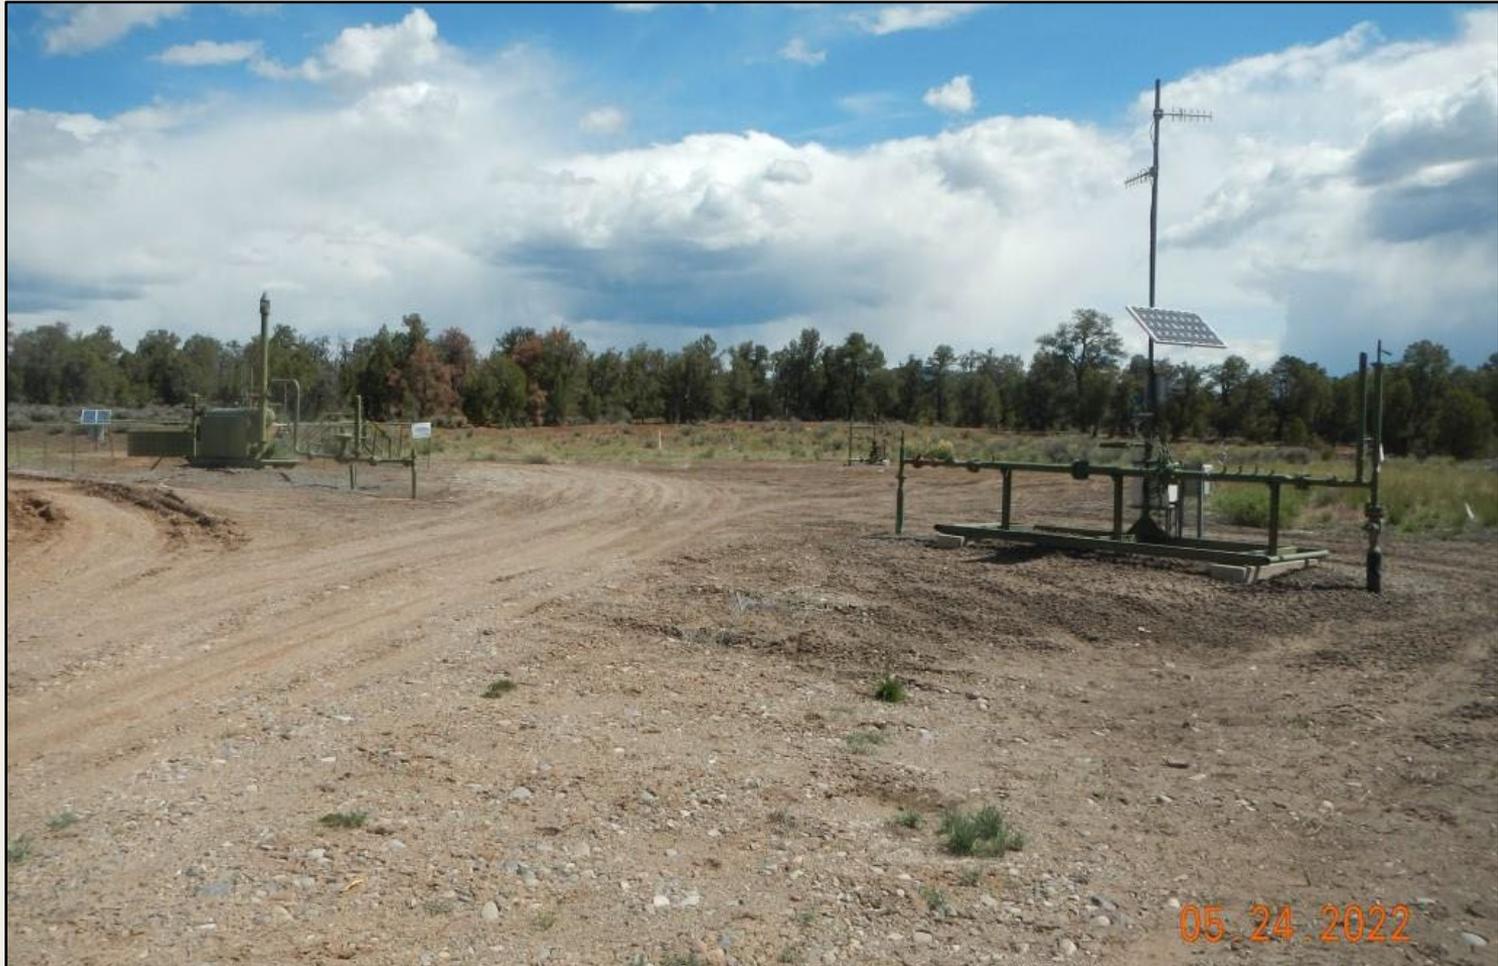
Photo 1. View of the project area from the well pad entrance facing center.

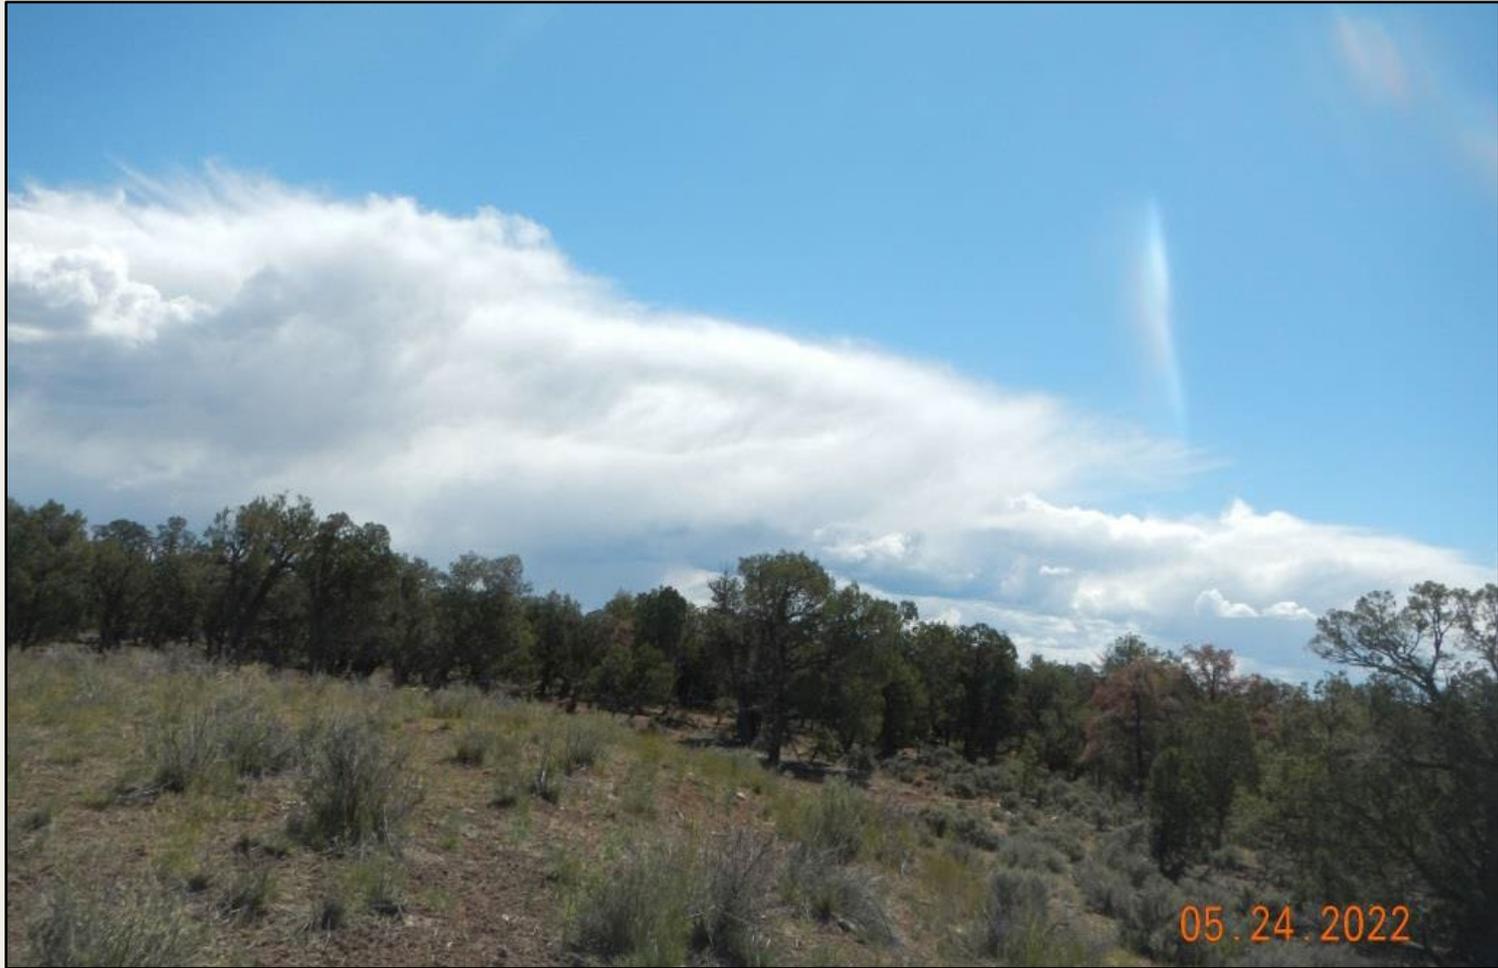
Photo 2. View of the southern project area from the southwestern corner facing eastward. Revegetation is progressing within crested wheatgrass, smooth brome, western wheatgrass, and rubber rabbitbrush.

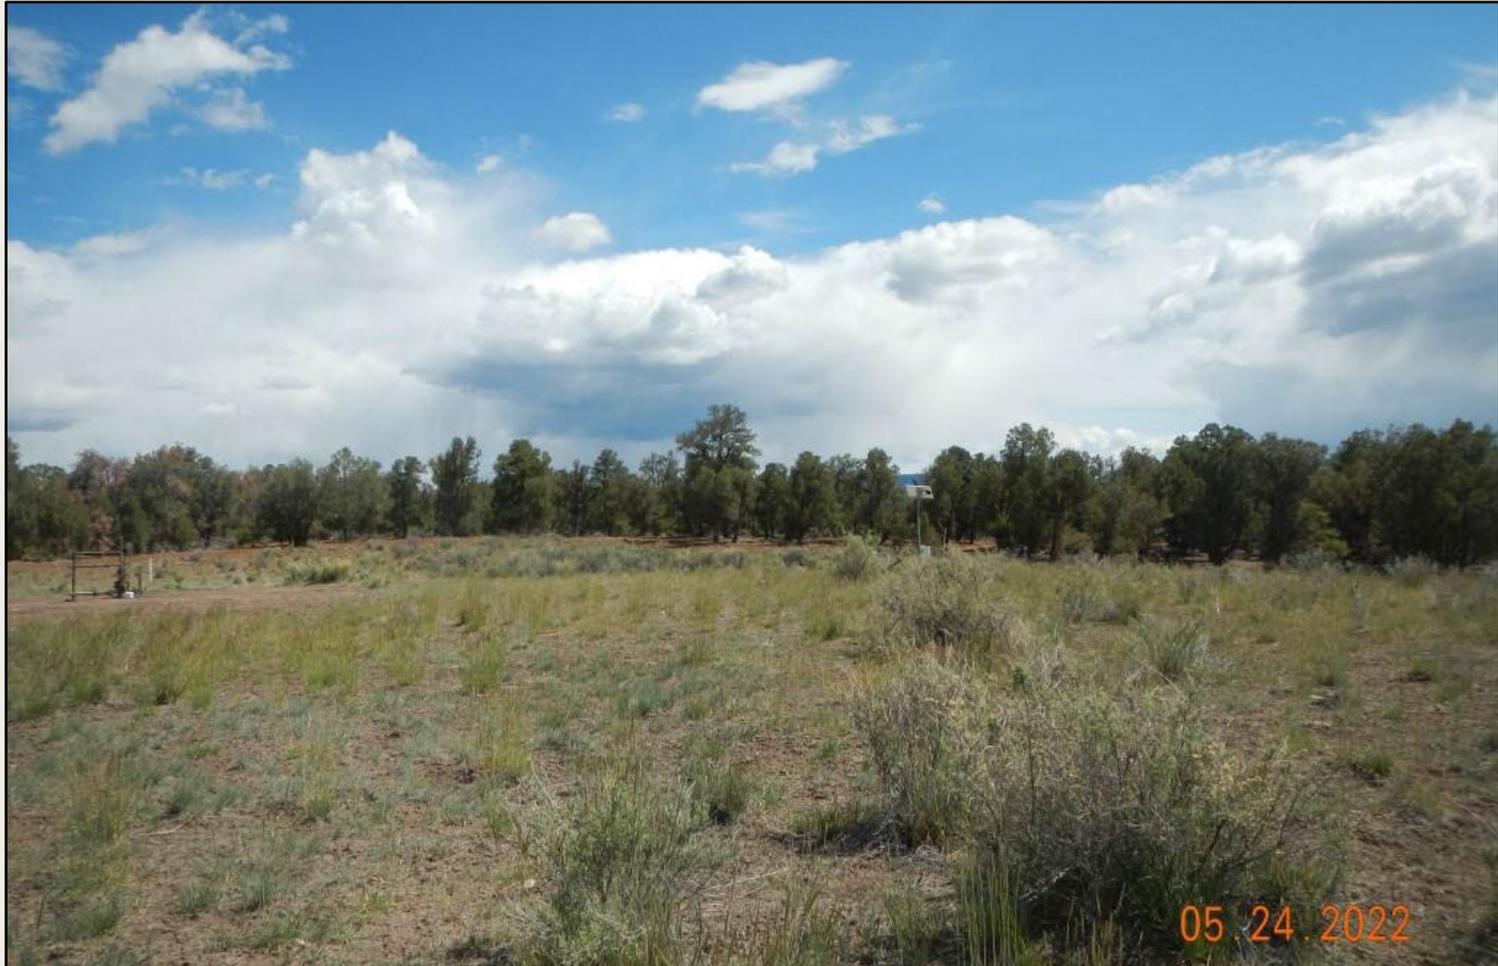
Photo 3. View of the eastern project area from the southeastern corner facing northward.

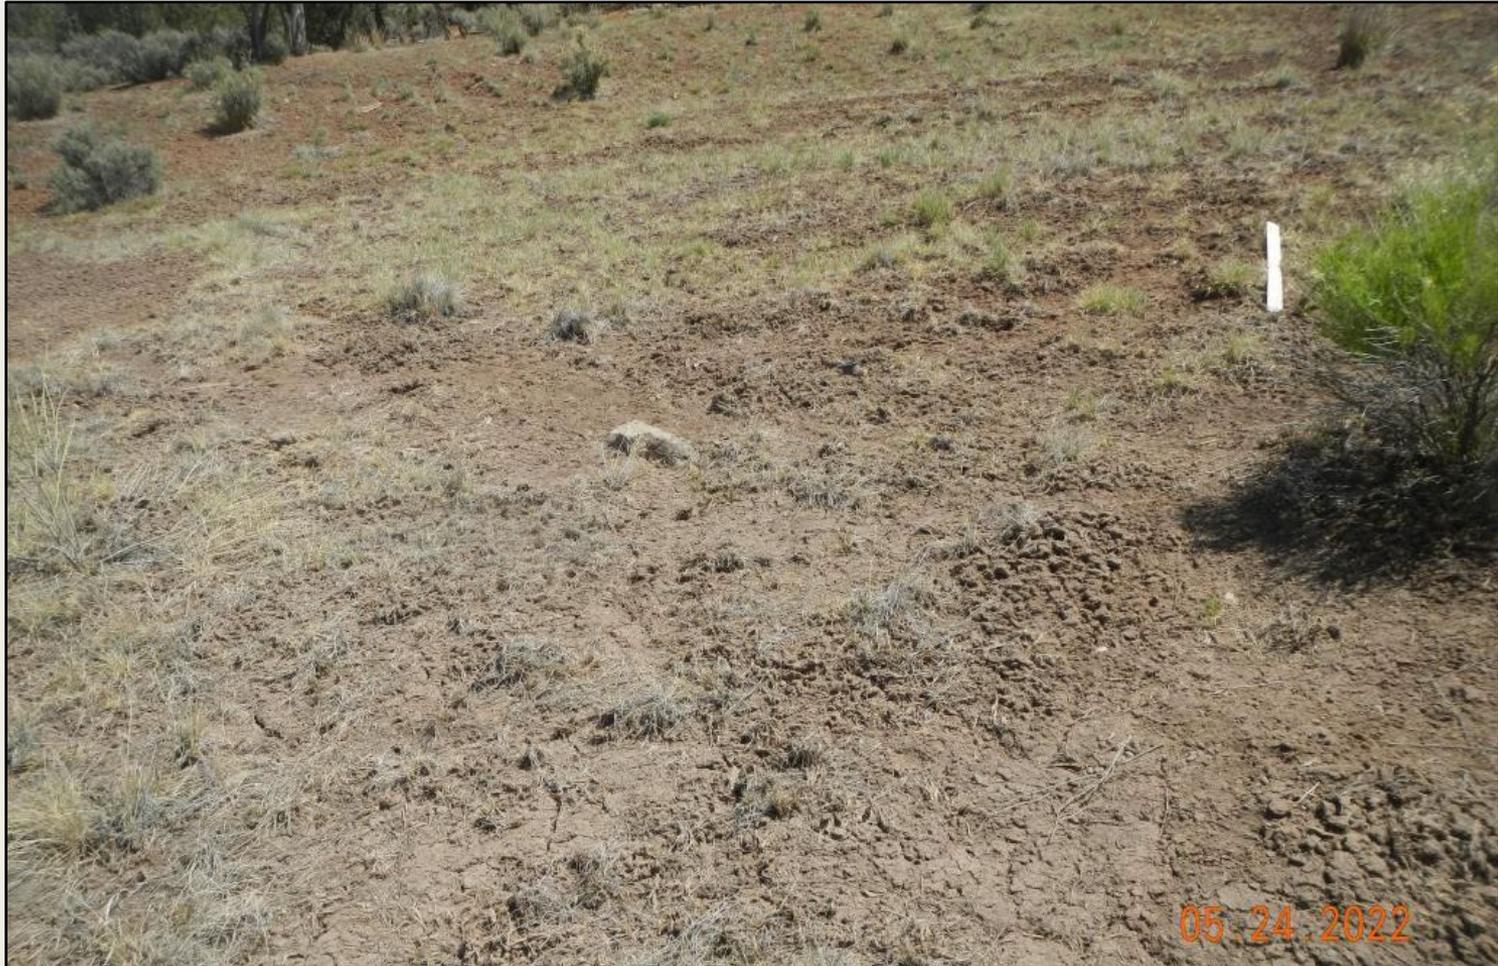
Photo 4. View of area within the northern interim reclamation area where tire tracks observed and are resulting in site degradation.

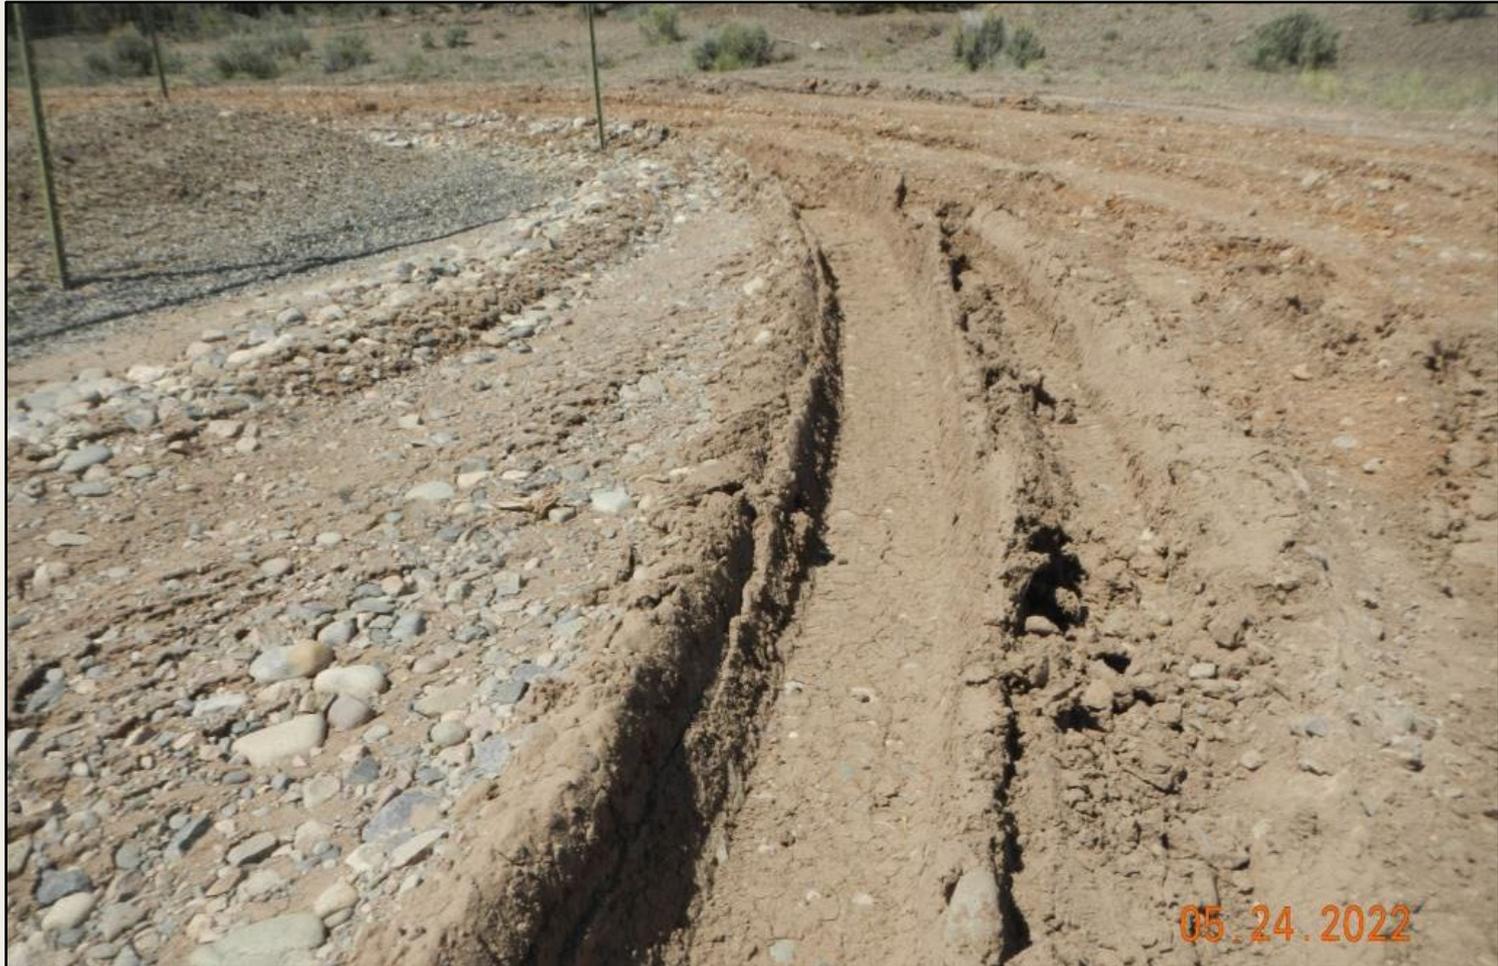
Photo 5. View of rutting, approximately 12 to 18 inches deep on the well pad surface. Additional stabilization is needed here.

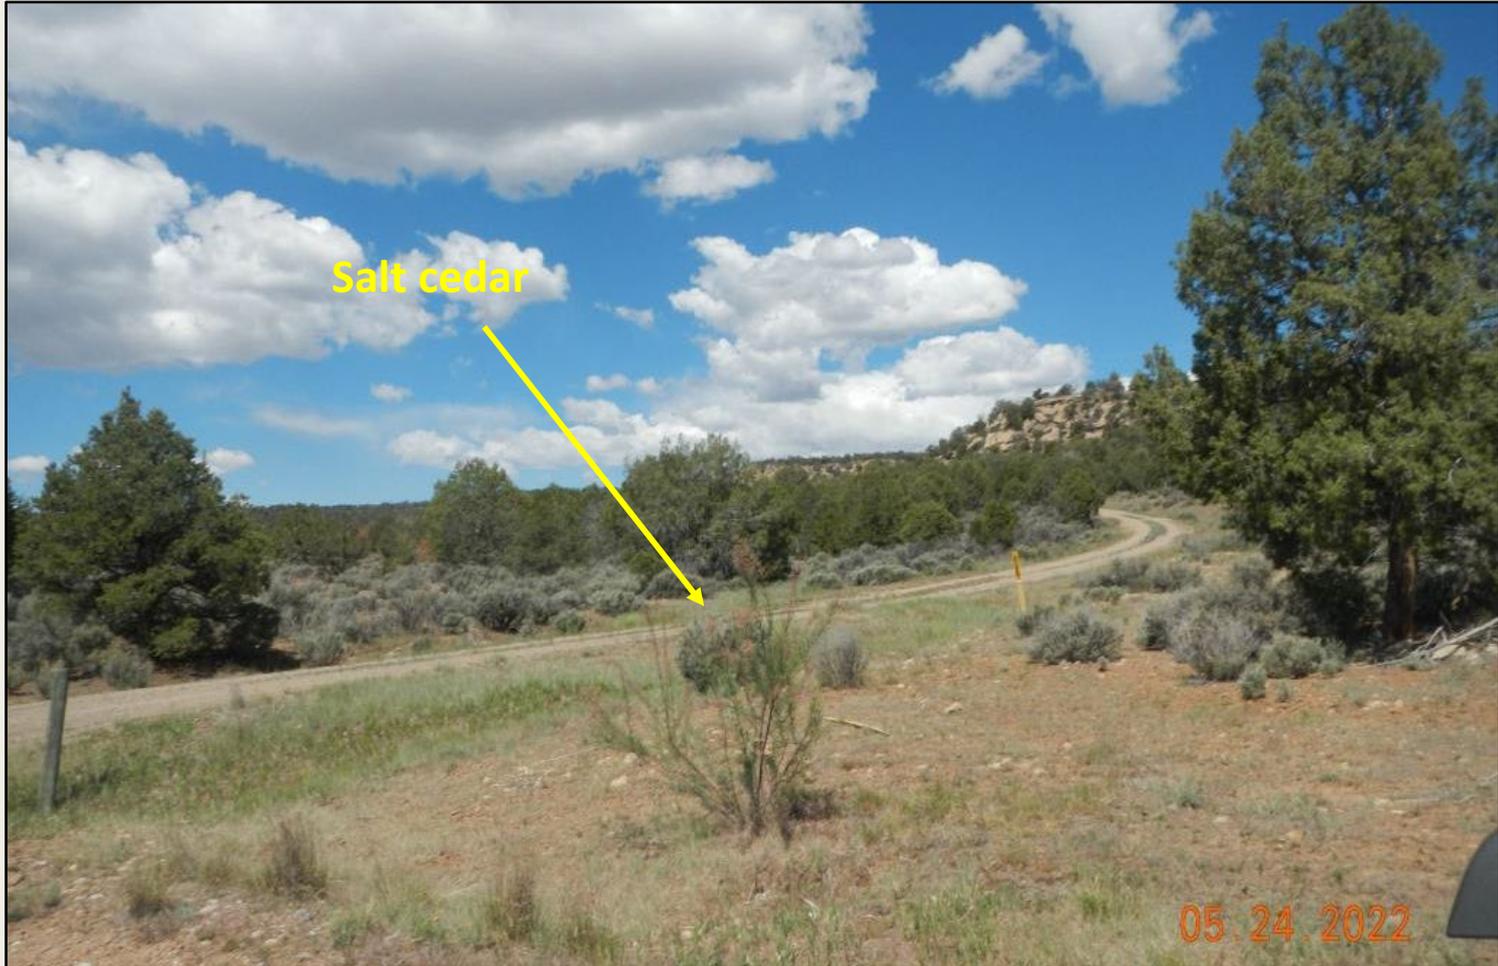
Photo 6. View of salt cedar at the entrance to the access road need to be removed and controlled.

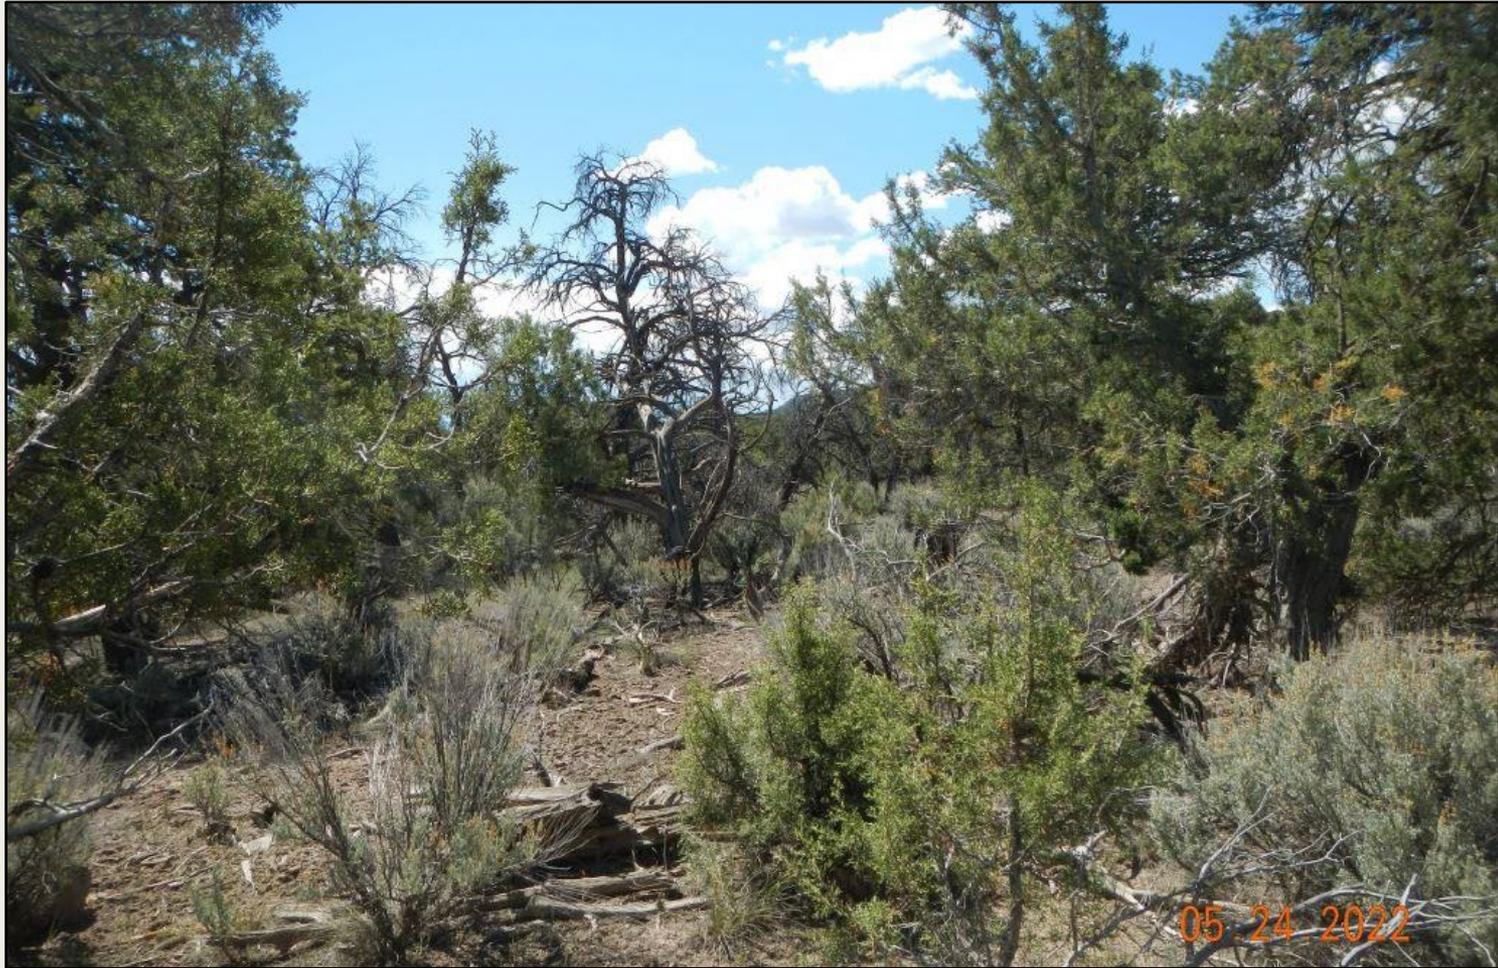
Photo 7. View of reference area comprised of pinyon and juniper woodland with sagebrush, Indian ricegrass, antelope bitterbrush, mountain mahogany, and sulfur flower.
