Inspection Photos

Operator: Hilcorp Energy
API: 067-08350
Date: 5/24/2022

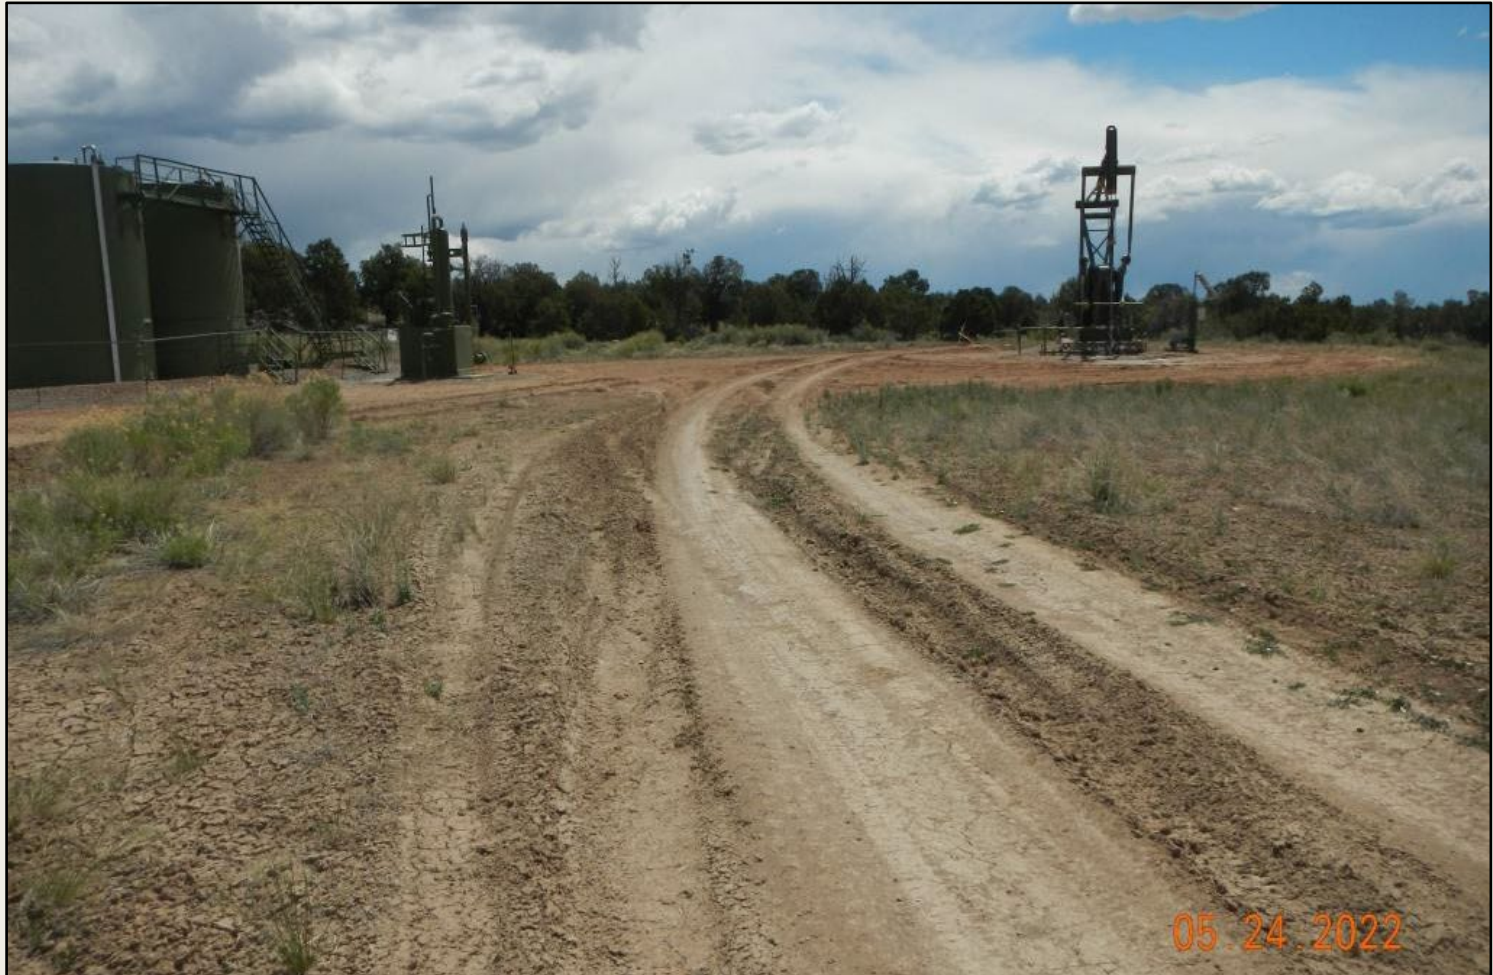
Photo 1. View of the project area from the western entrance facing center. .

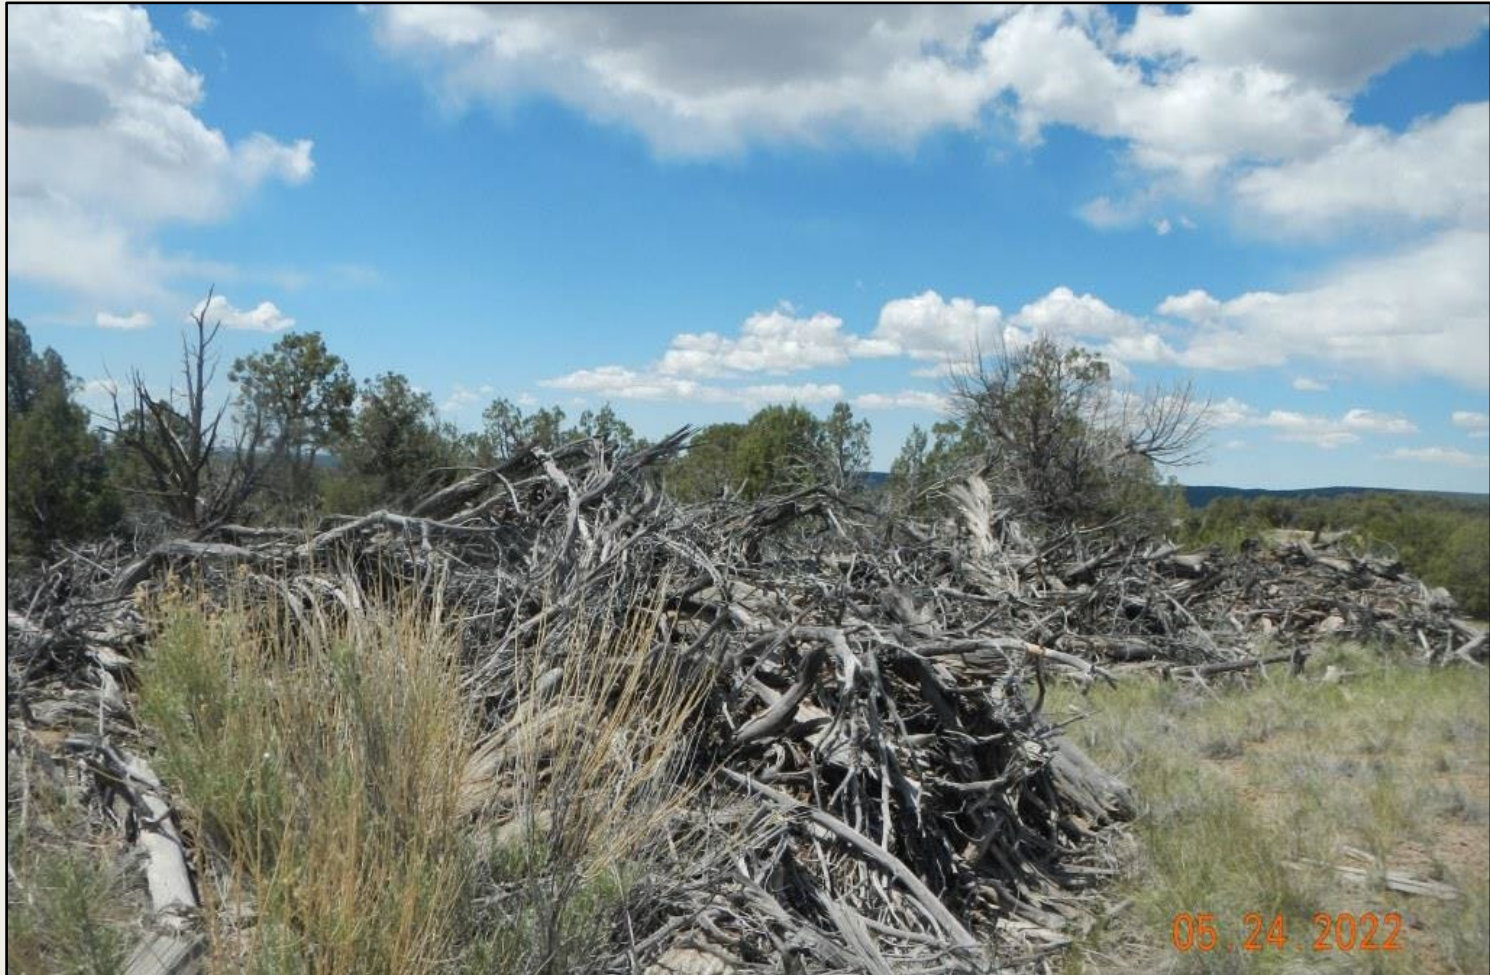
Photo 2. View of the northern project area from the northeastern corner facing westward. Revegetation is progressing within crested wheatgrass, smooth brome, western wheatgrass, and rubber rabbitbrush.

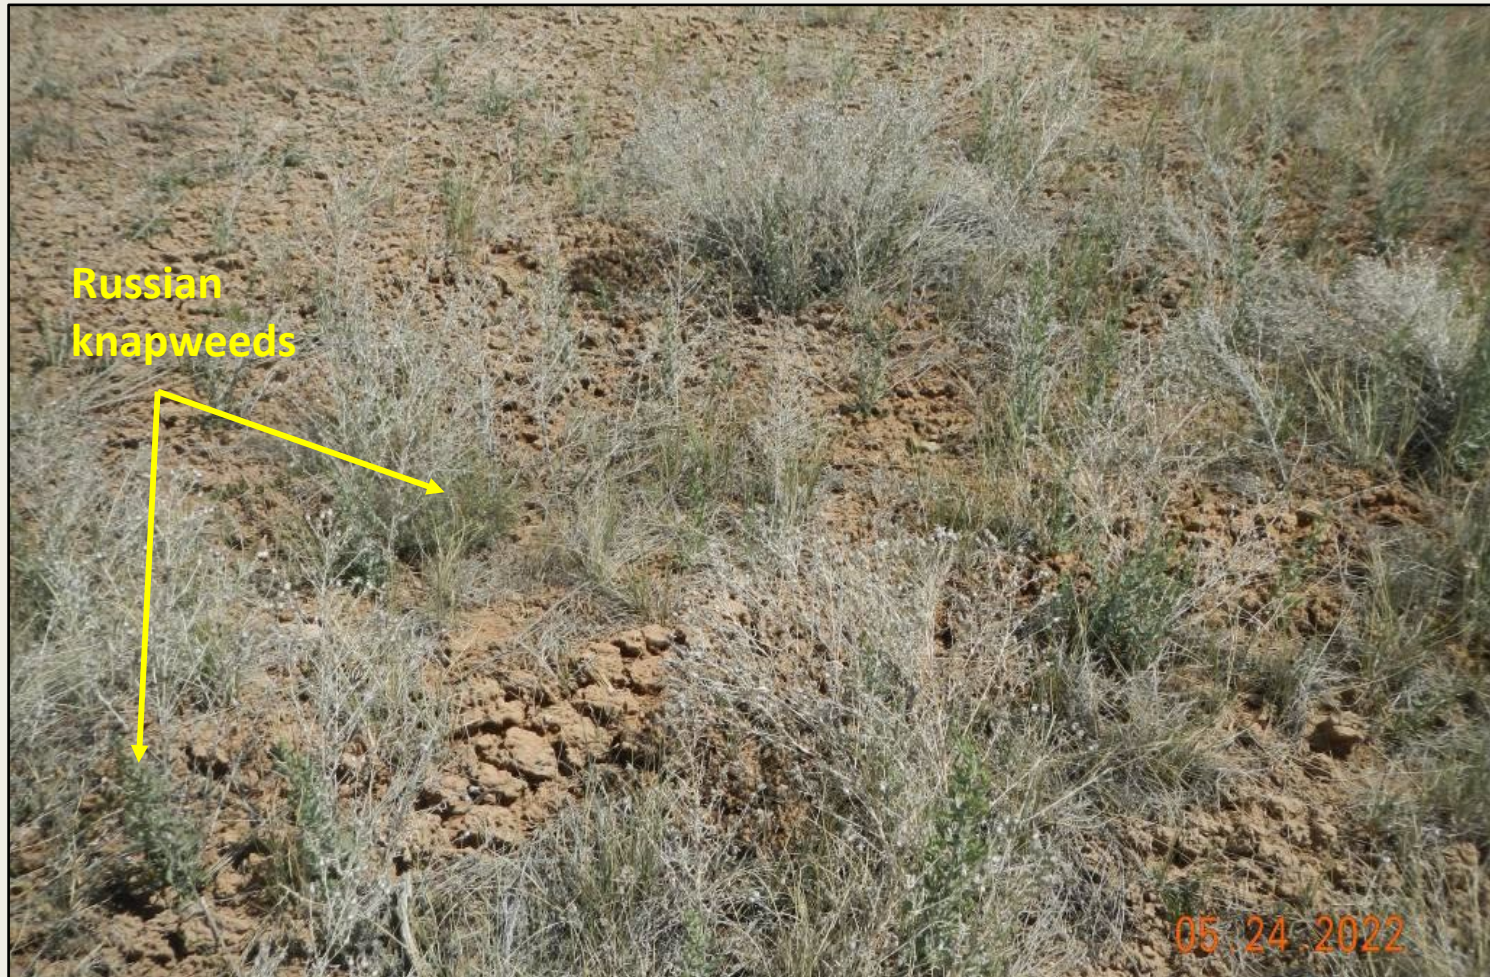
Photo 3. View of dense Russian knapweeds observed along the western access and throughout the interim reclamation areas. Thousands of individuals observed.

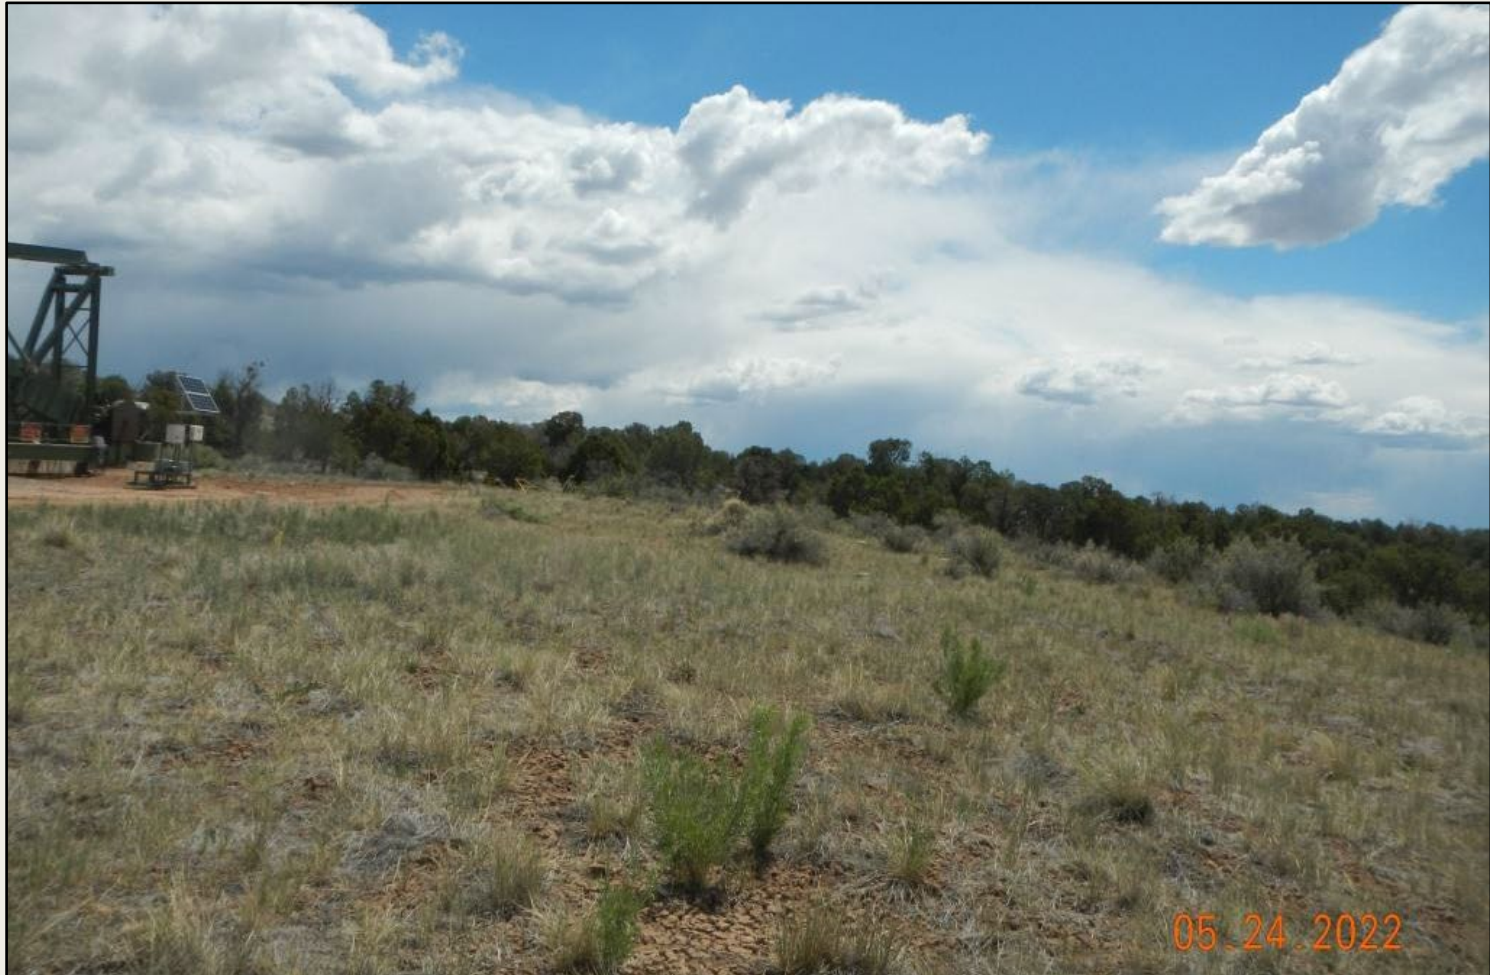
Photo 4. View of the southern project area from the southwestern corner facing eastward. Revegetation is progressing in non-weedy portions with western wheatgrass, and crested wheatgrass.

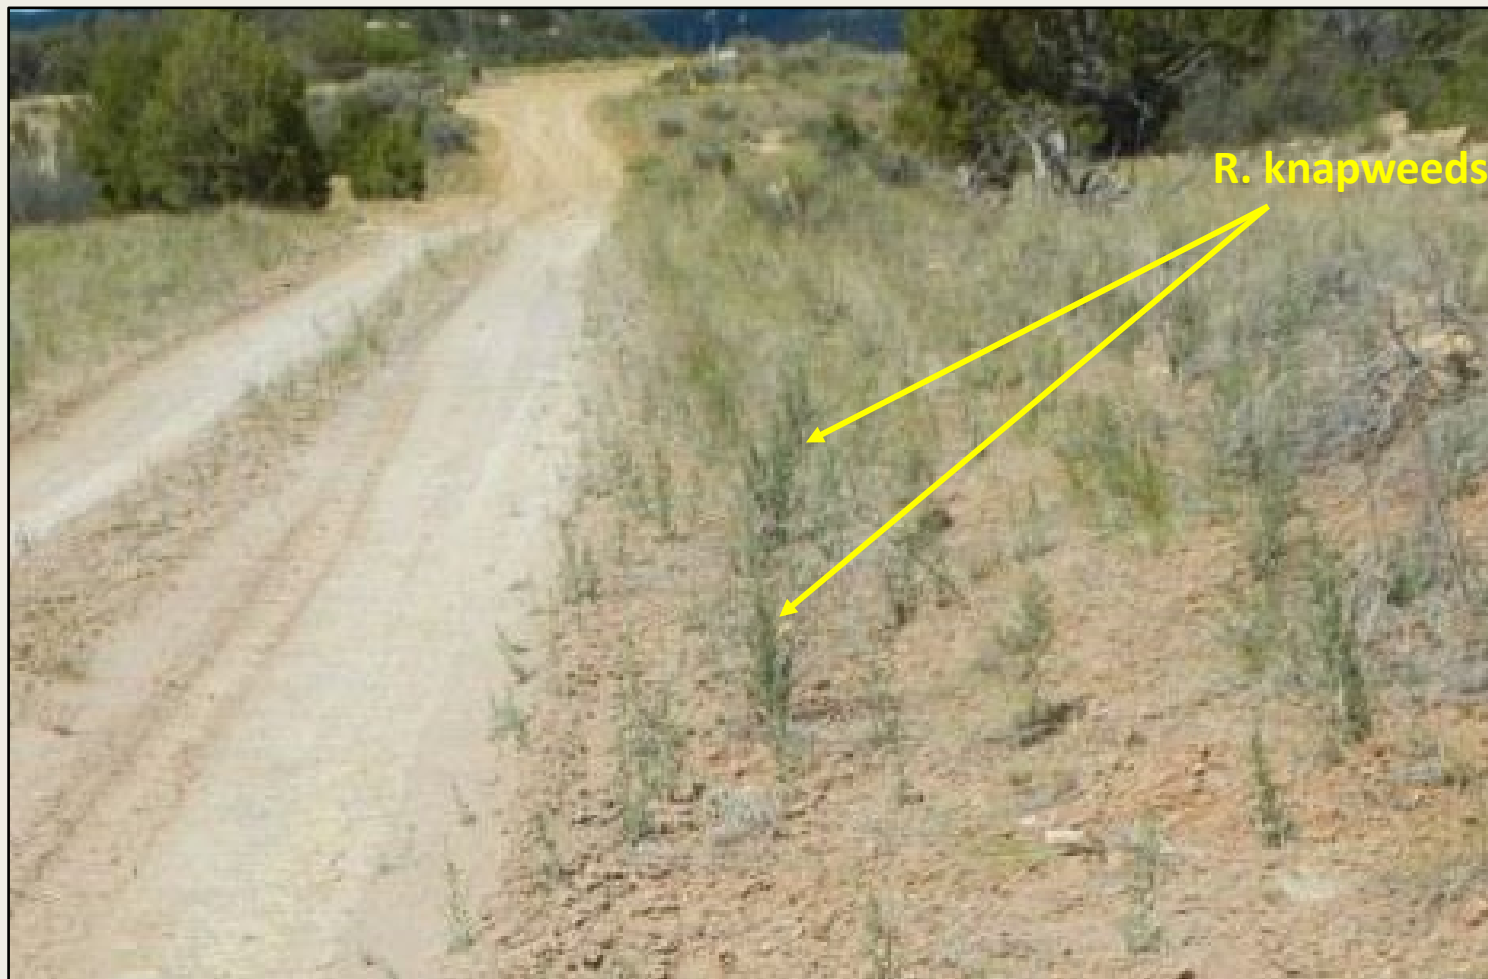
Photo 5. Another view of Russian knapweeds, this is along the western access road.

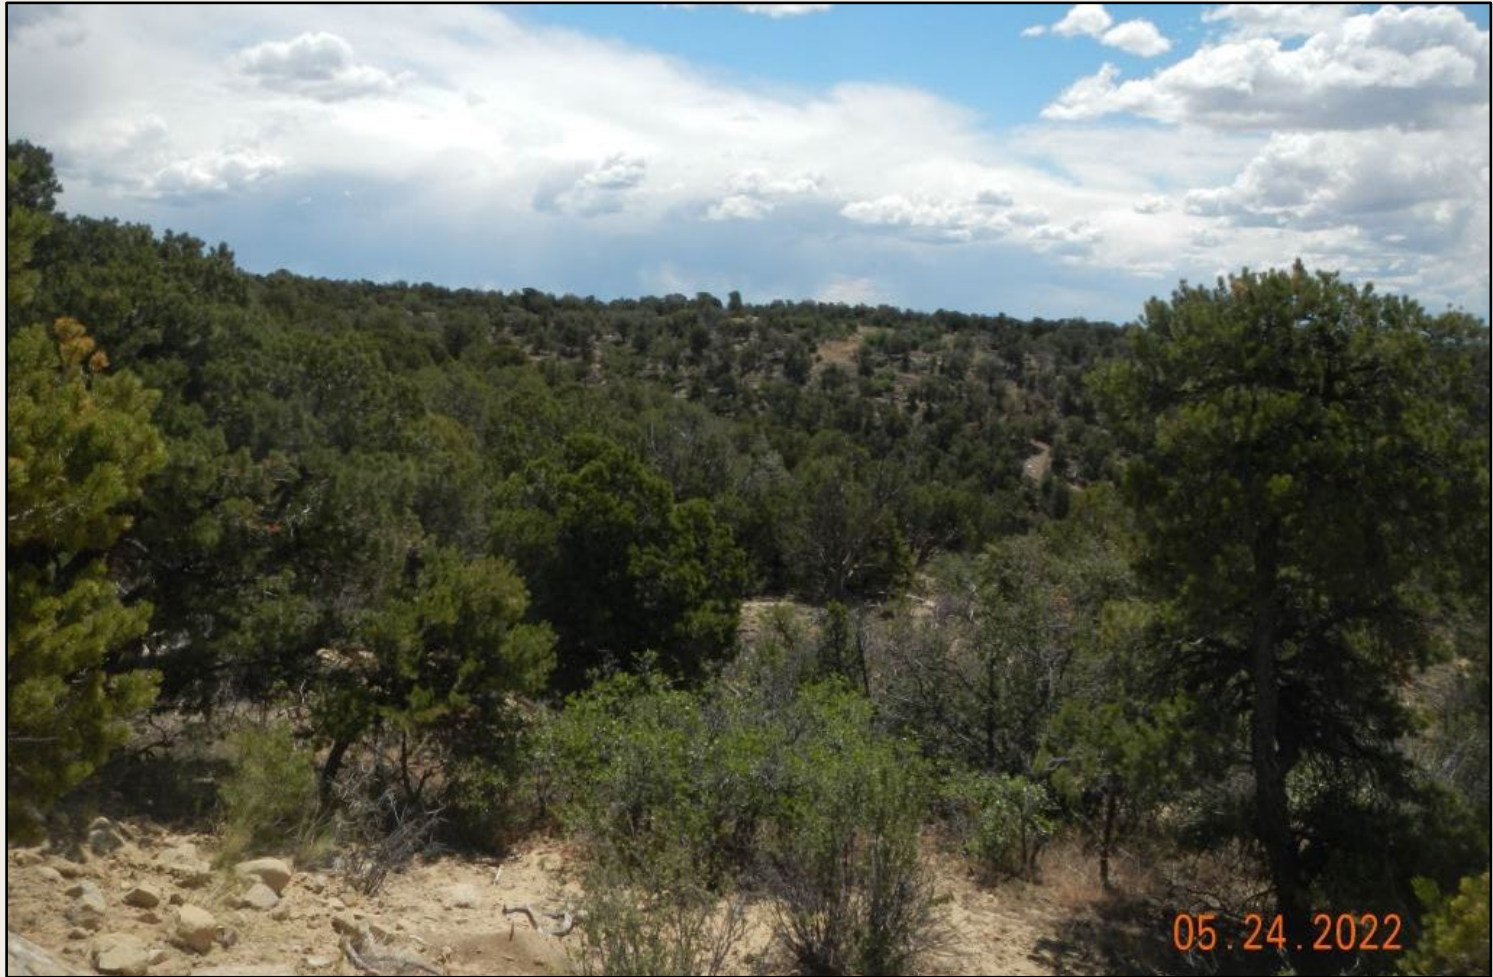
Photo 6. View of reference area comprised of pinyon and juniper woodland with gambel oak, Indian ricegrass, antelope bitterbrush, mountain mahogany, and sulfur flower.
