Inspection Photos
Operator: Hilcorp Energy
API: 067-08223
Date: 5/24/2022

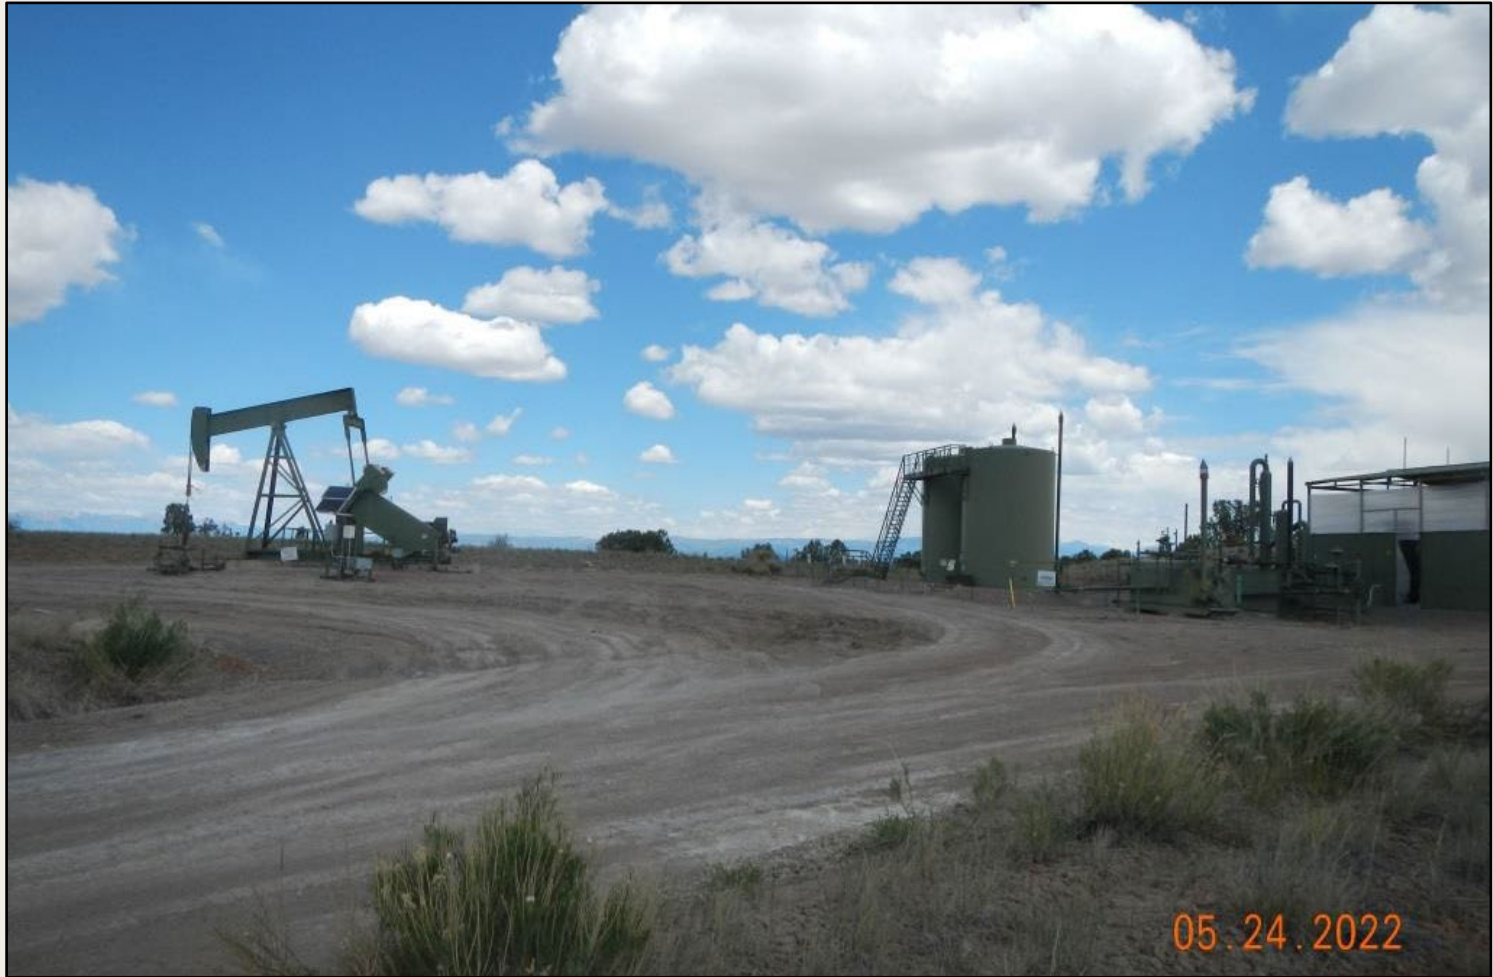
Photo 1. View of the project area from the southeastern entrance facing center. .

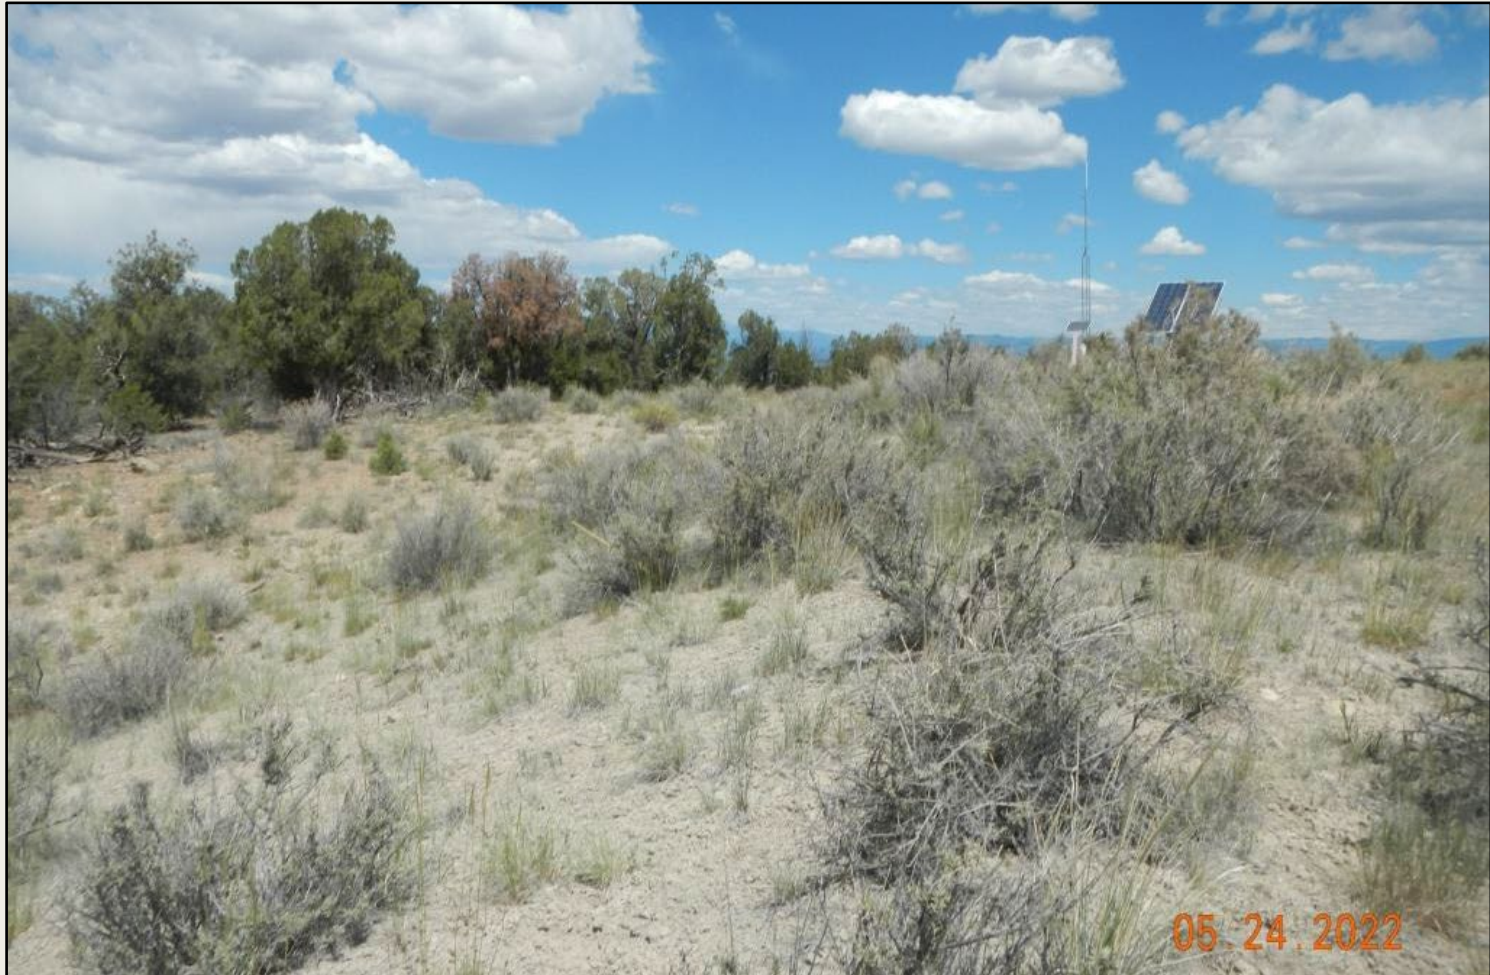
Photo 2. View of the southern project area from the southeastern corner facing westward. Revegetation is progressing within crested wheatgrass, western wheatgrass, and rubber rabbitbrush.

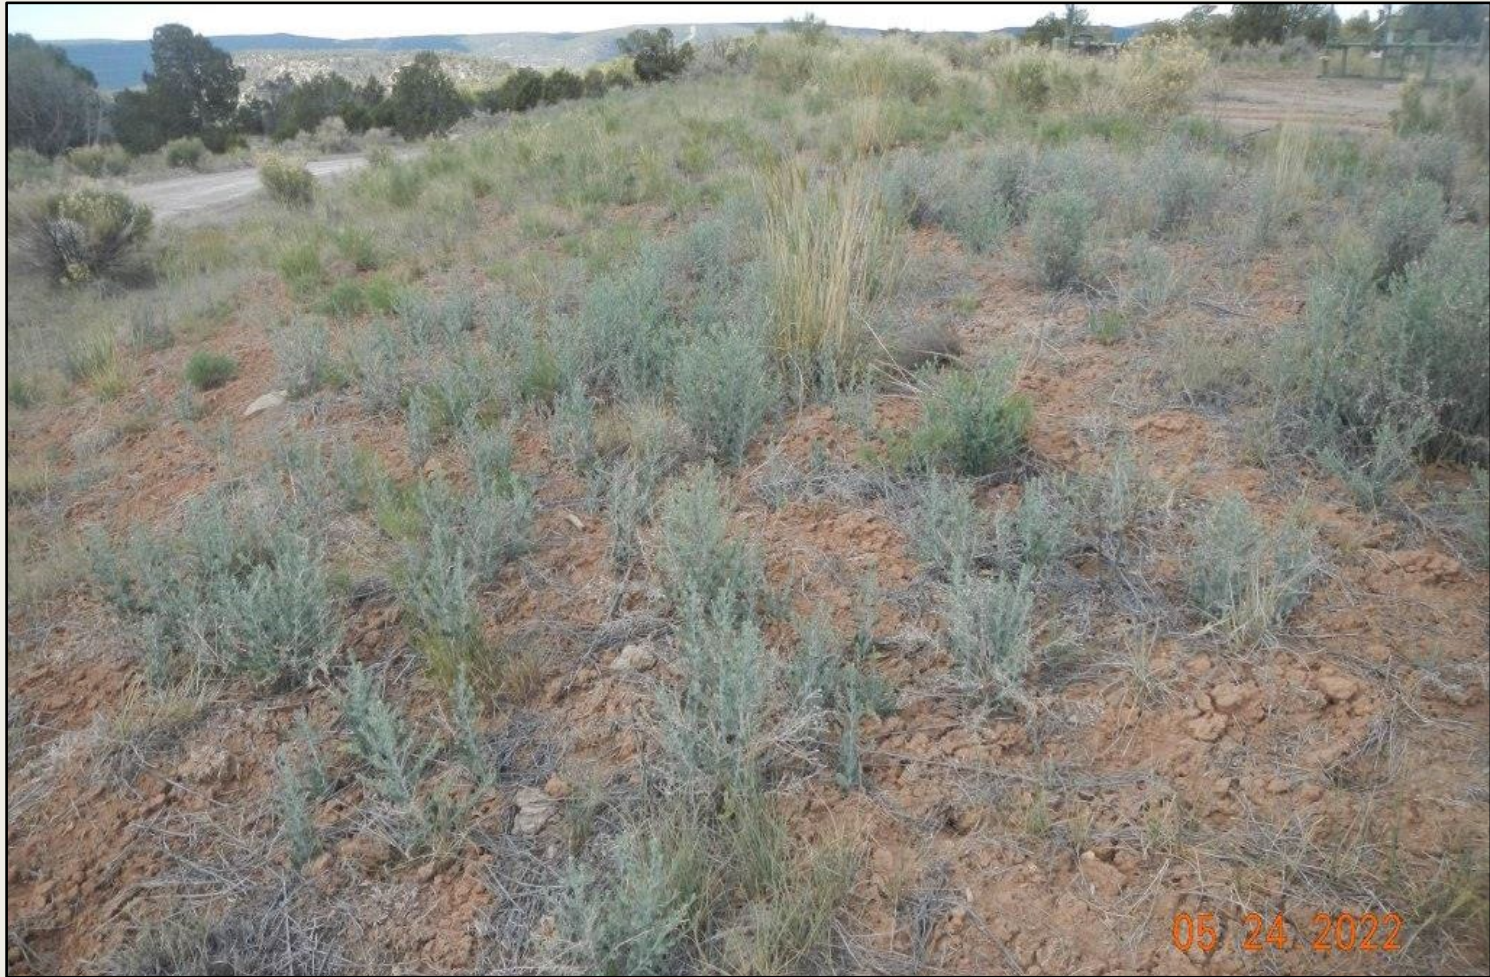
Photo 3. View of dense Russian within the southern project area. Approximately 2000 individuals observed.
