Inspection Photos

Location Name: TEP ROCKY MOUNTAIN LLC UNION ENERGY MINING DIV.-66S96W /33NESE

Location ID: 335267

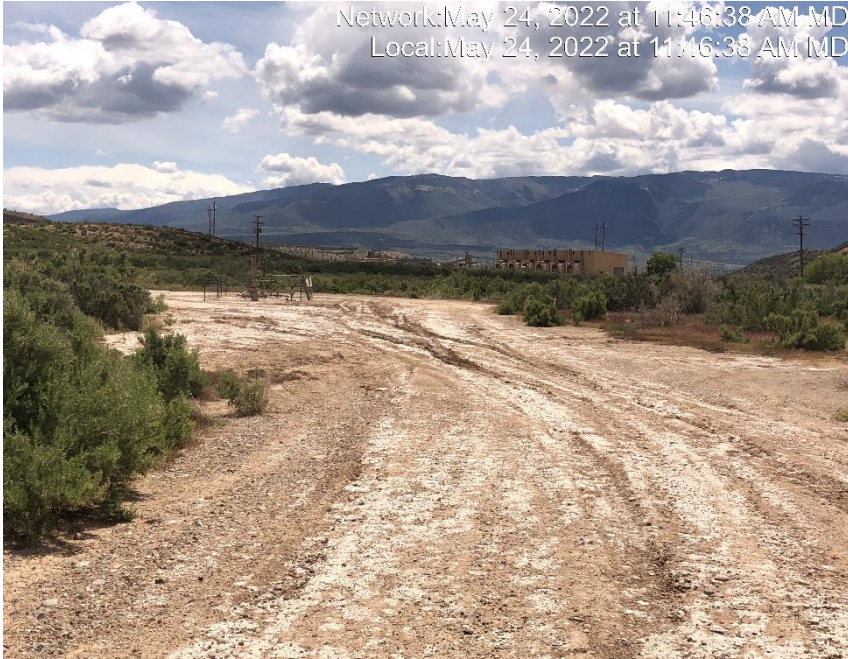
Photo #6794 from entrance to location.

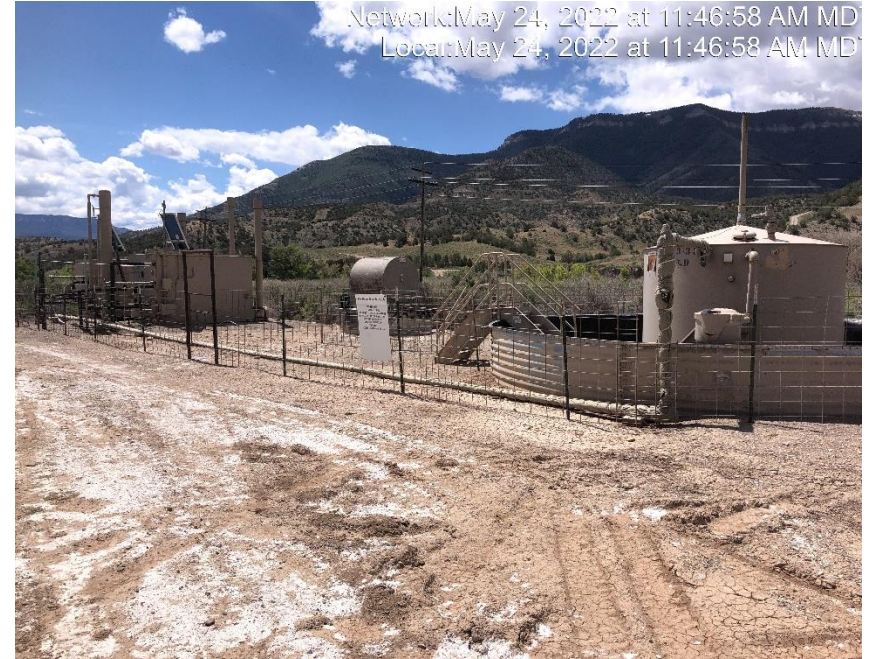
Photo #6795 from entrance to location.

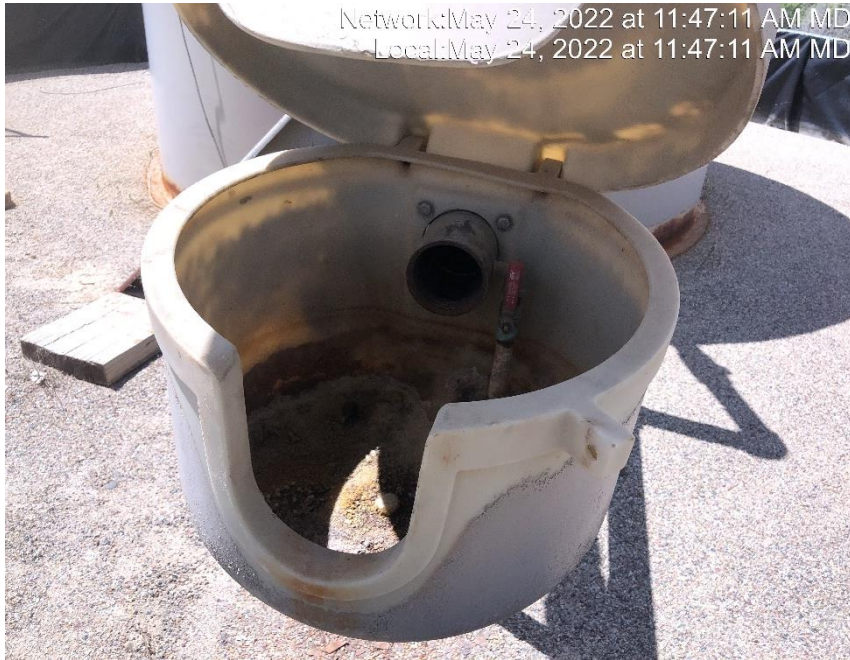
Photo #6796 Loadline open ended.

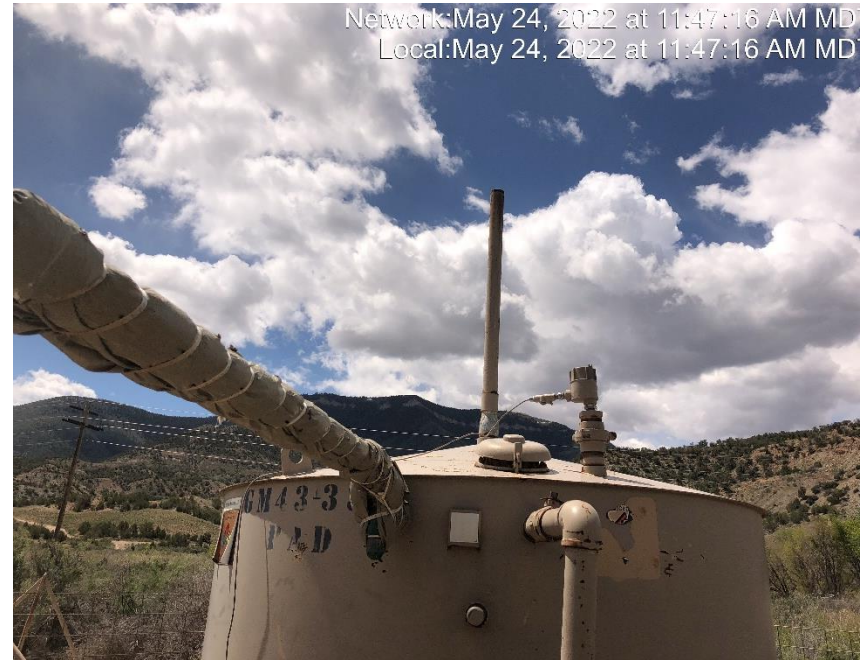
Photo #6797 Vent pipe open ended.

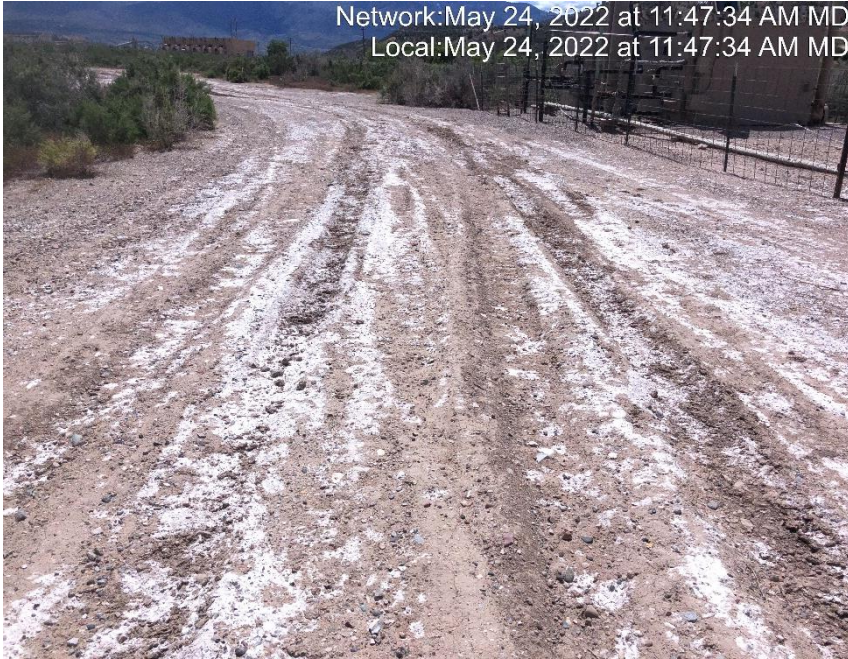
Photo #6798 Location lacks stabilization.

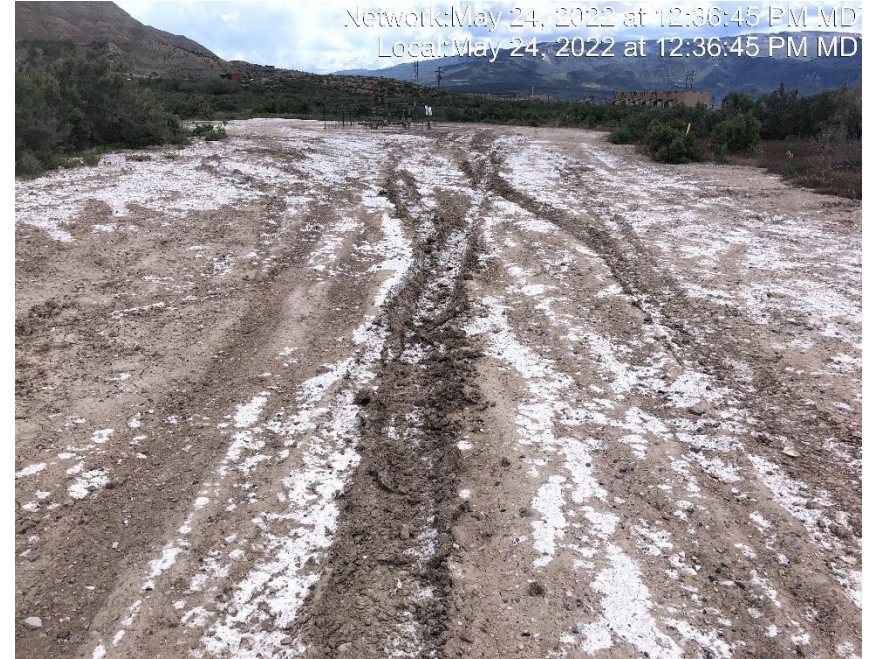
Photo #6799 Location lacks stabilization.

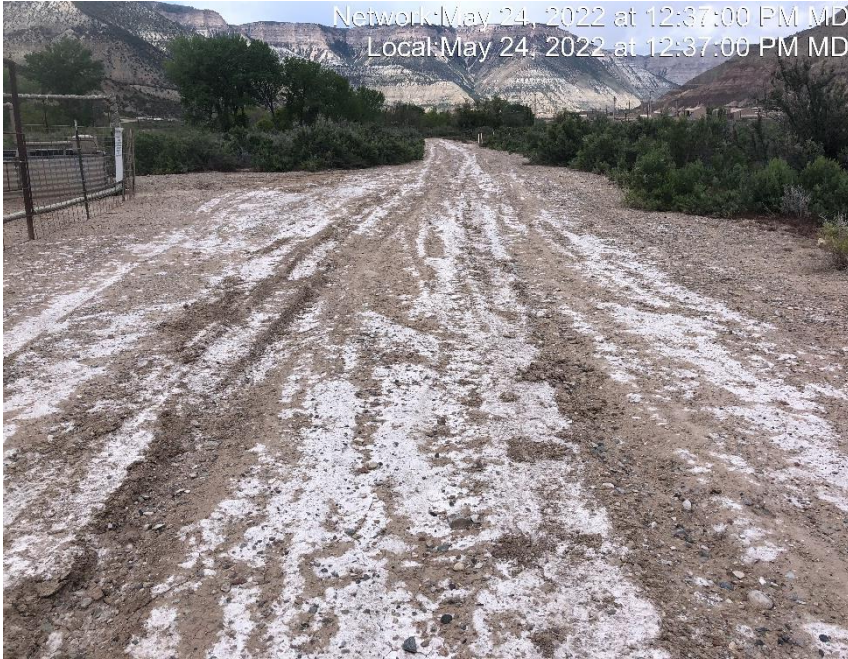
Photo #6800 Insufficient tracking BMP located at the entrance to location.
