Inspection Photos

Location Name: TEP ROCKY MOUNTAIN LLC WILLIAMS-66S96W /33NENE

Location ID: 335435

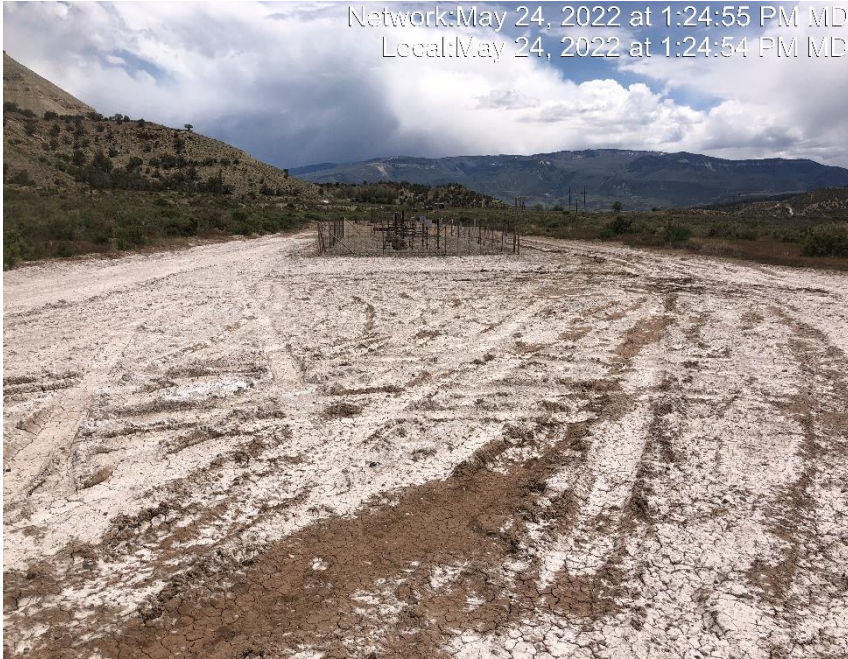
Photo #6807 from entrance to location.

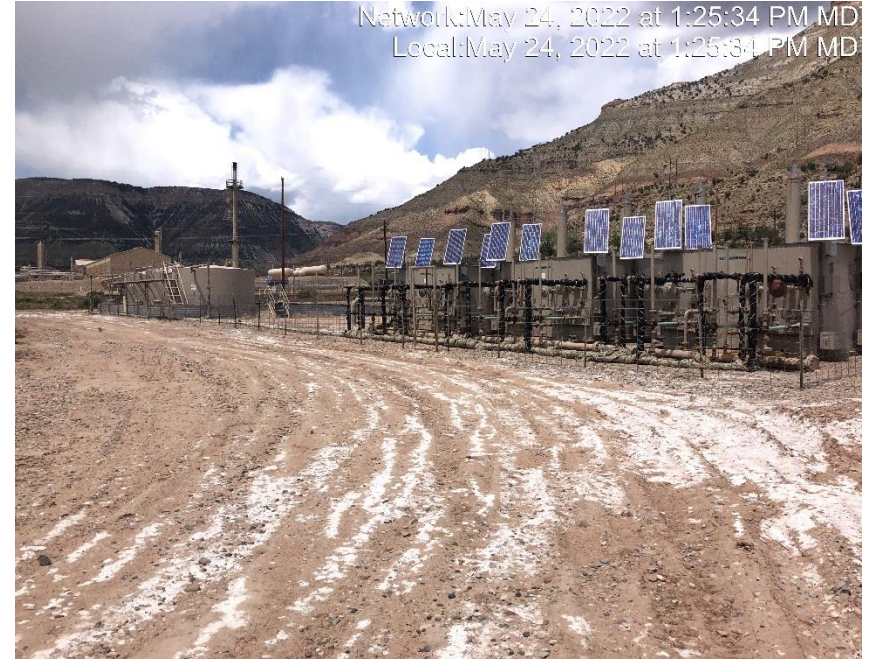
Photo #6809 from entrance to location.

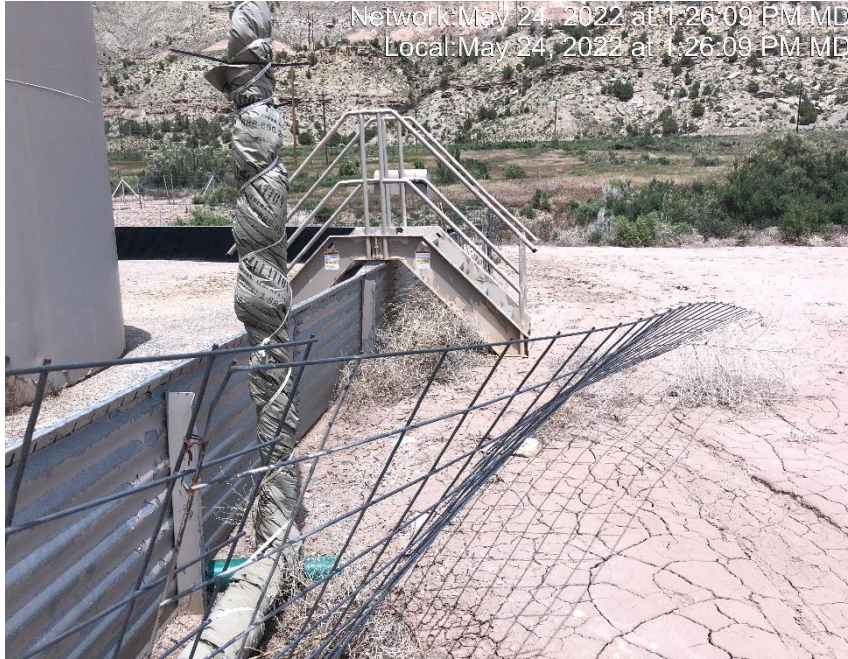
Photo #6810 Debris on location.

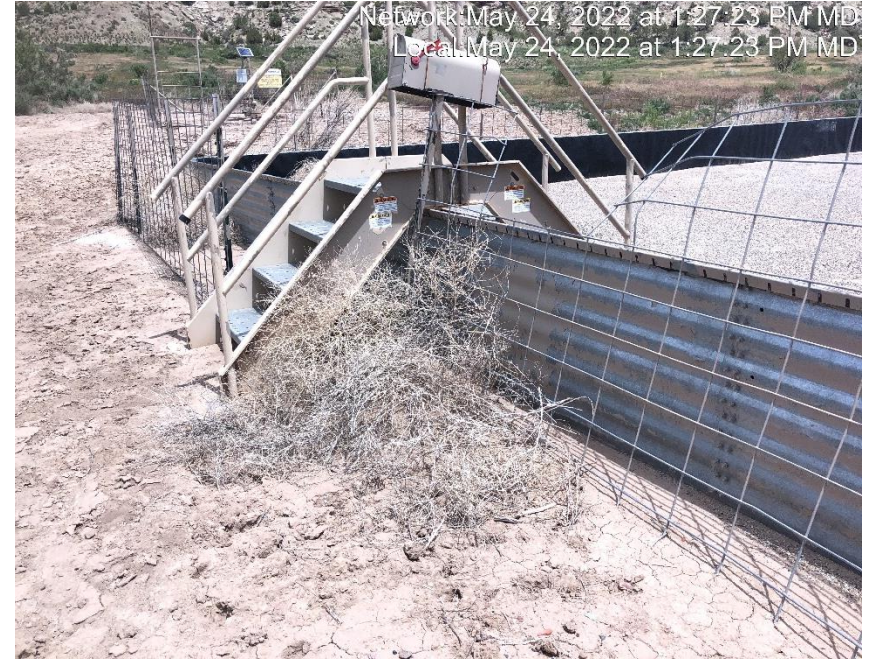
Photo #6813 Debris on location.

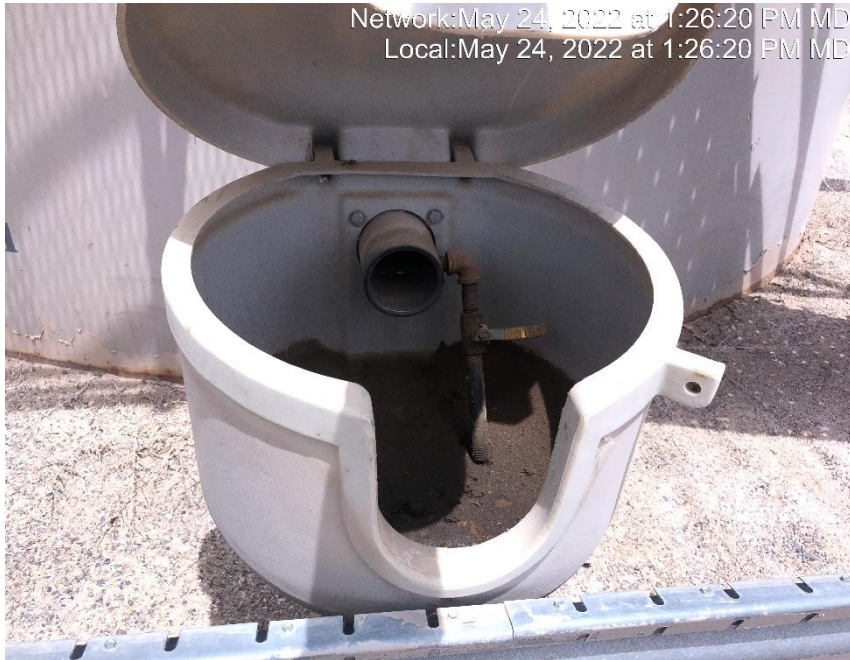
Photo #6811 Loadline open ended.

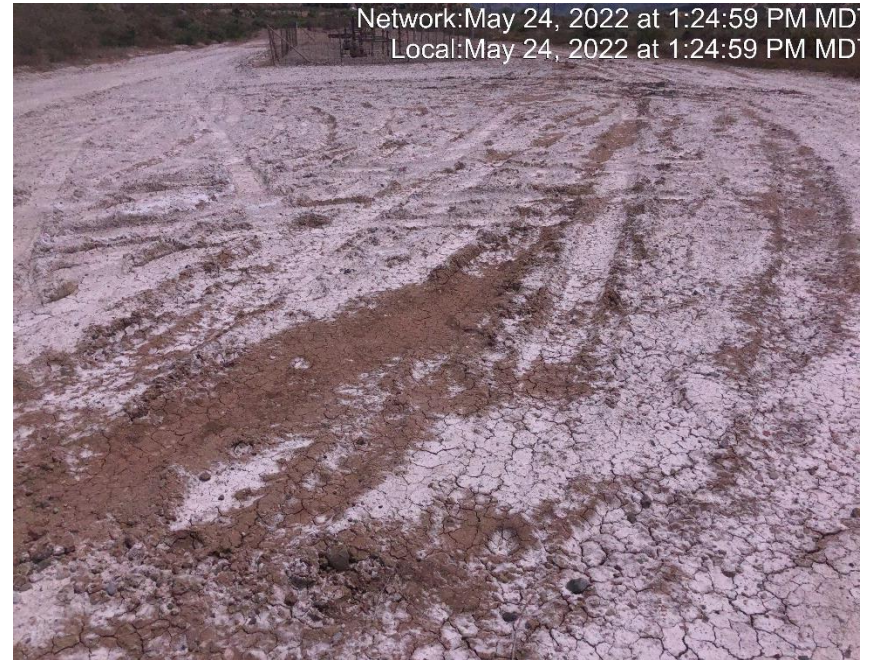
Photo #6808 Location lacks stabilization.

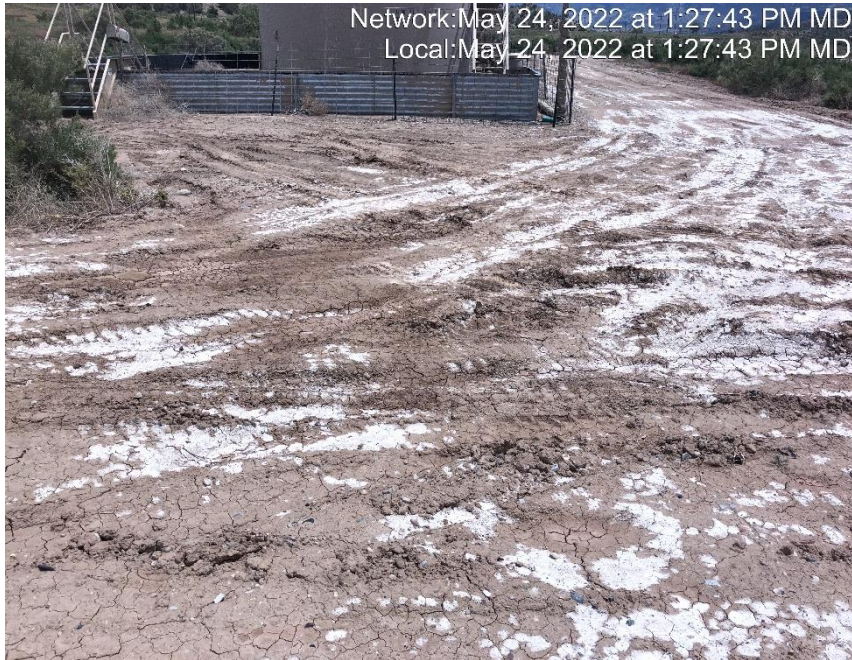
Photo #6814 Location lacks stabilization.

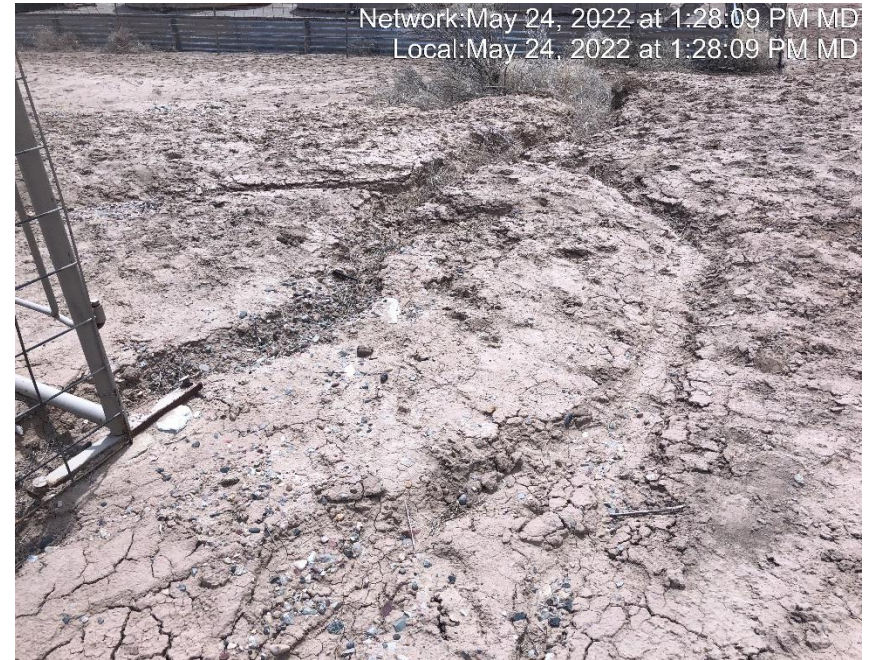
Photo #6815 Rill erosion occurring on location.

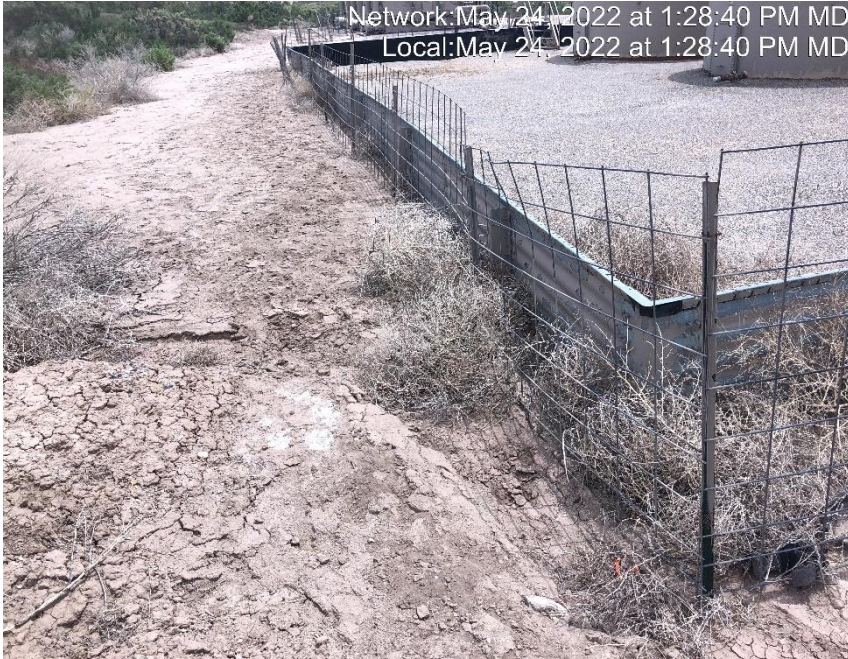
Photo #681 Sediment encroaching on tank containment.
