TEP
Gentry
Location # 311695

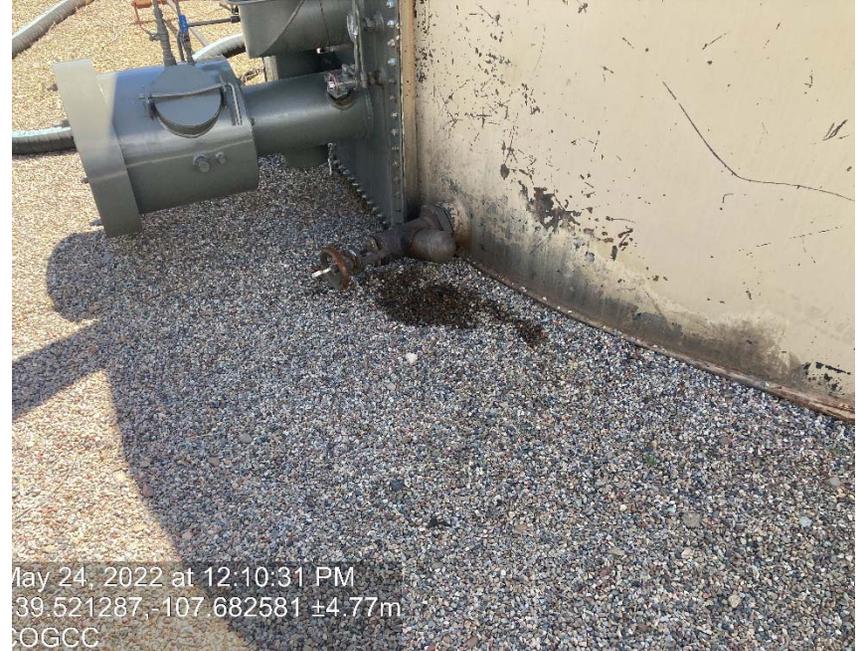
Staining

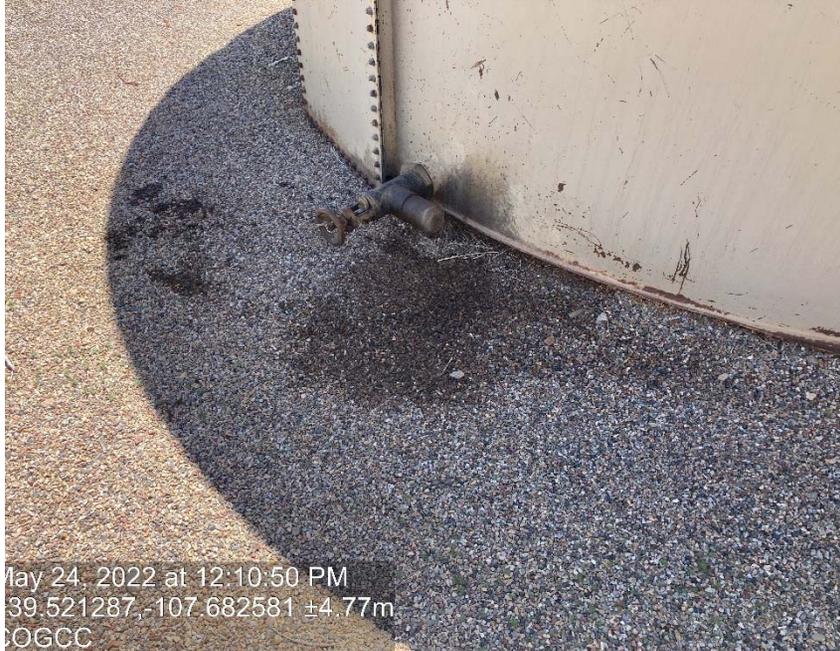
Staining

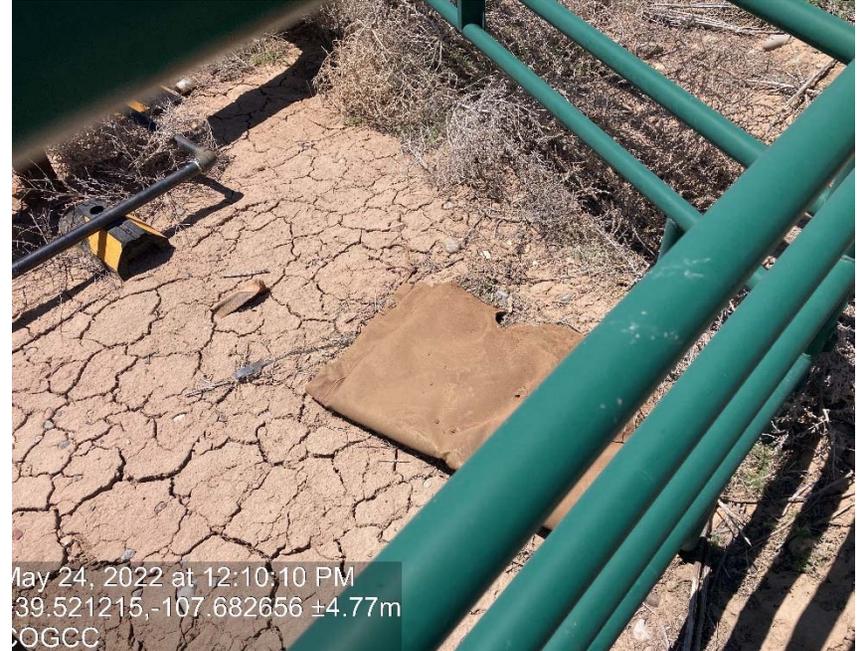
Debris

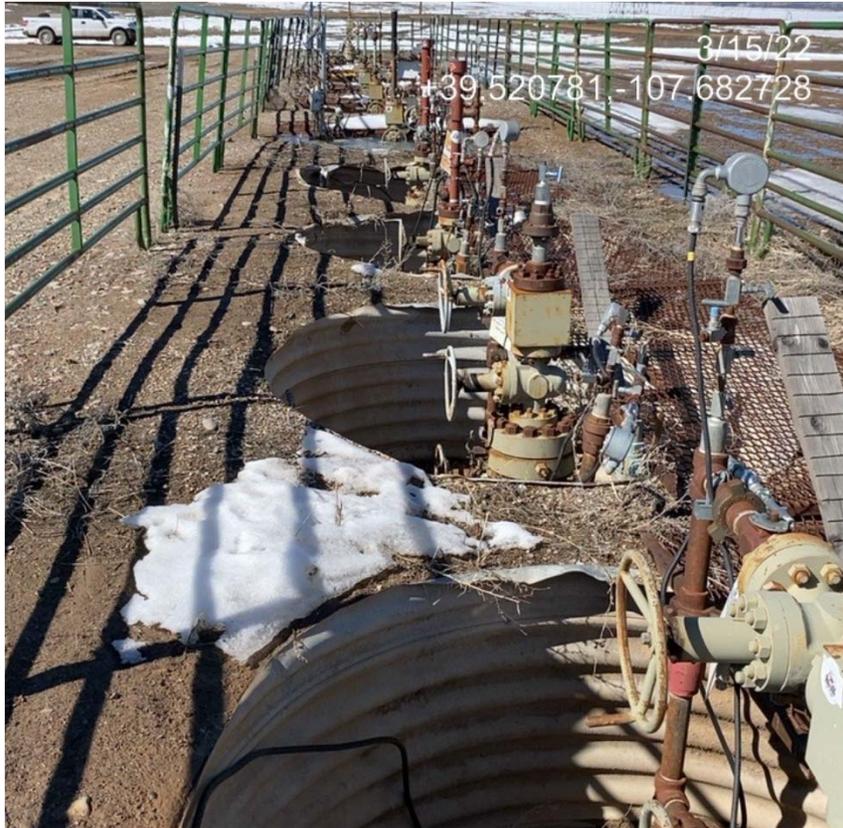
Previous inspection photo taken from the well equipment facing west shows BMPs to prevent wildlife access to the well cellars were missing or insufficient.

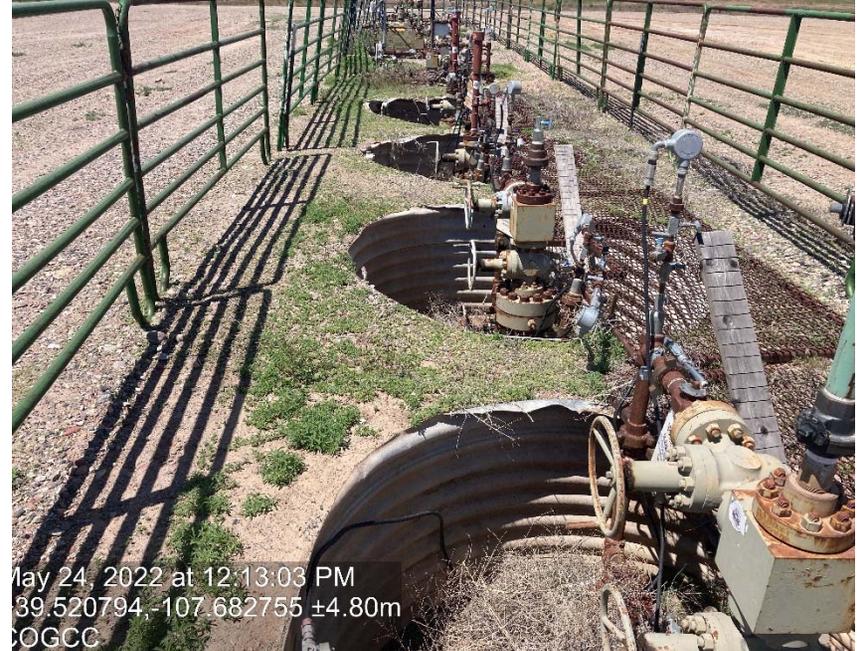
Recent photo show C/A has not been completed

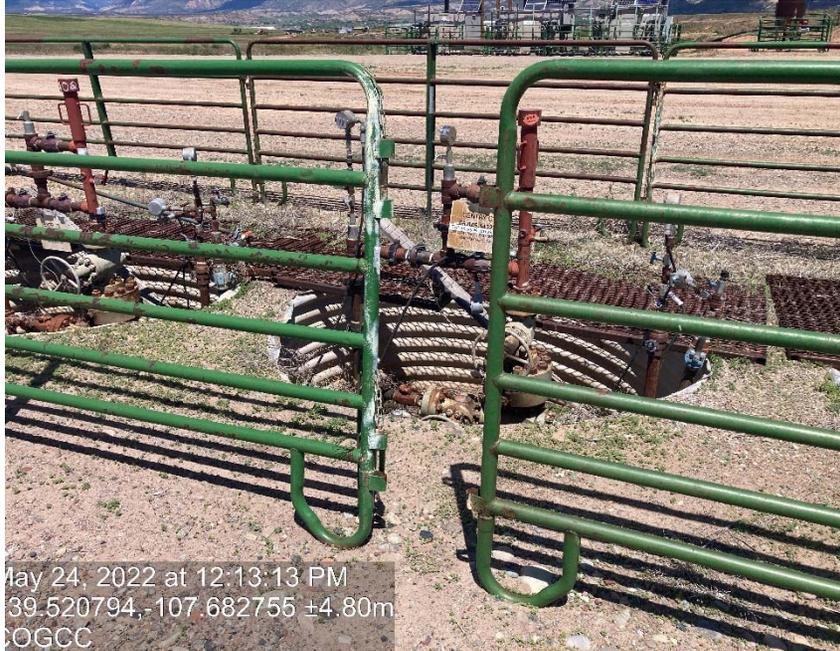
Fencing is also open to well heads

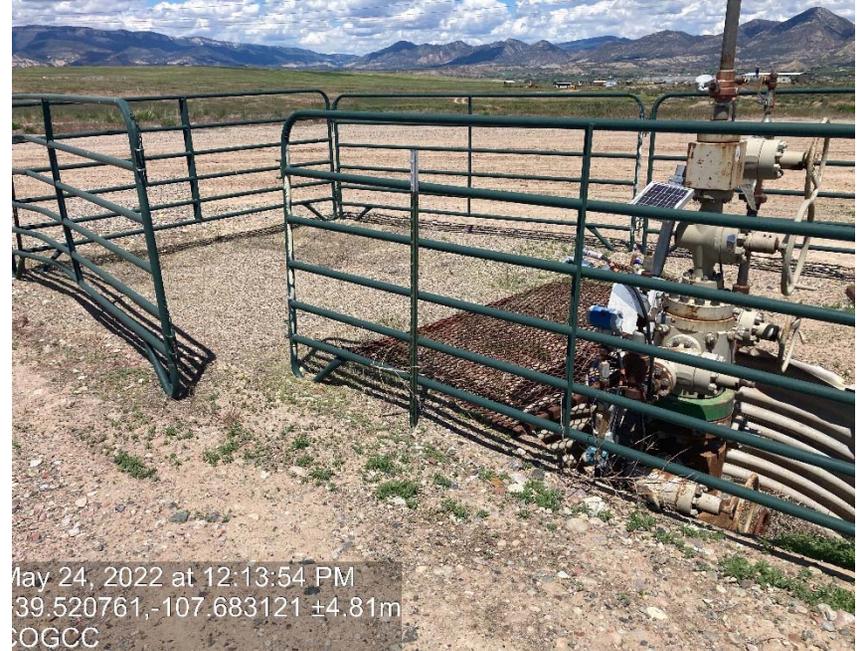
Fencing is also open to well heads

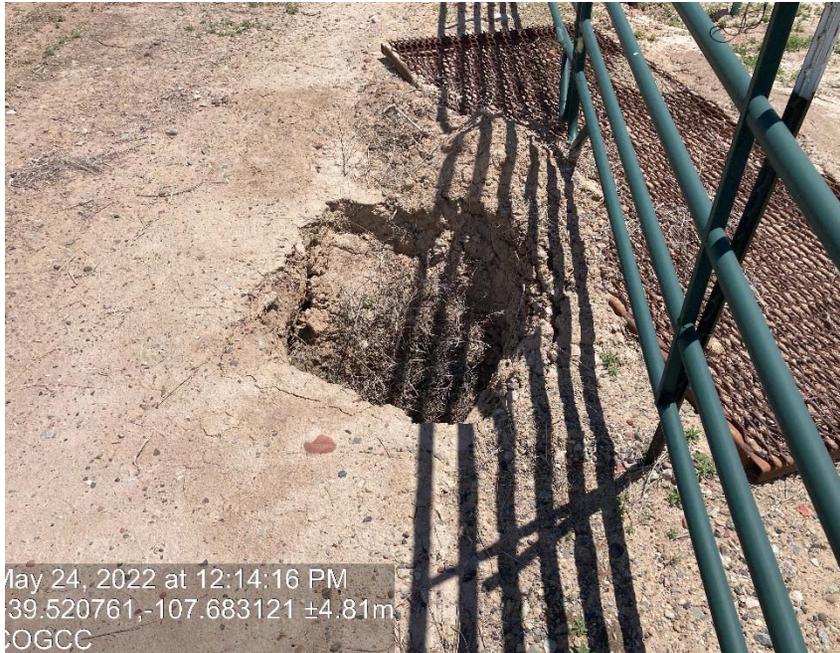
Pot hole trench is showing subsidence

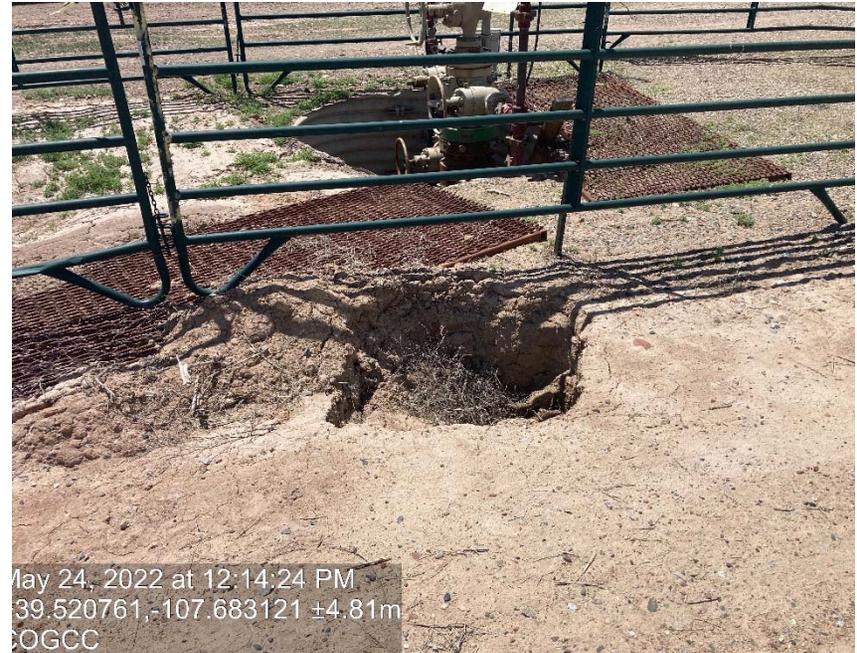
Pot hole trench is showing subsidence

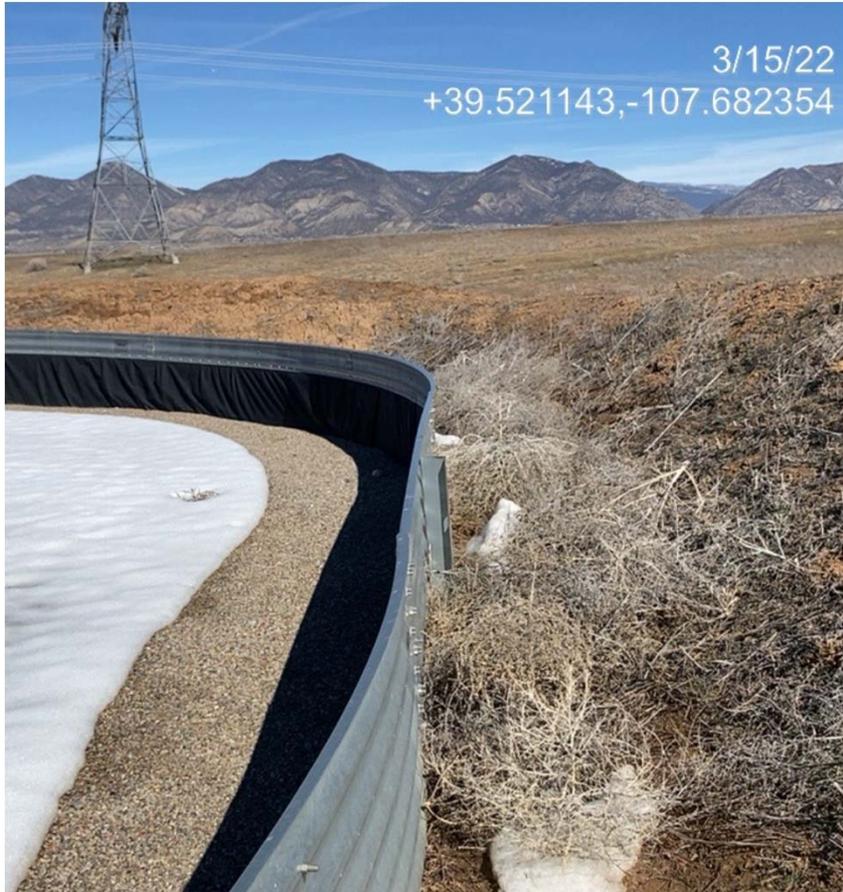
Previous inspection photo taken from the north of the Location facing north shows undesirable plant species/weed debris accumulating in production areas. Photo from reclamation inspector

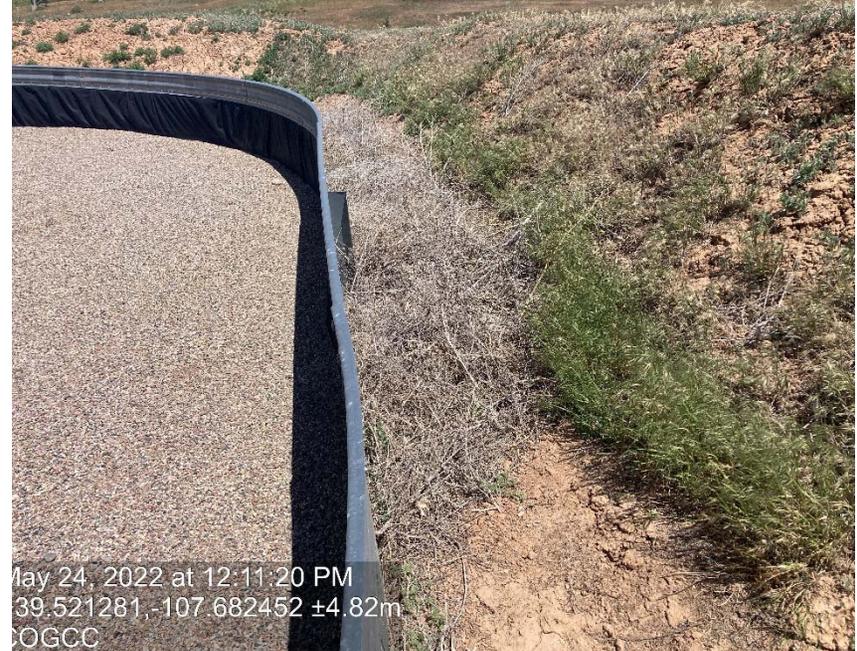
Recent inspection show C/A has not been completed

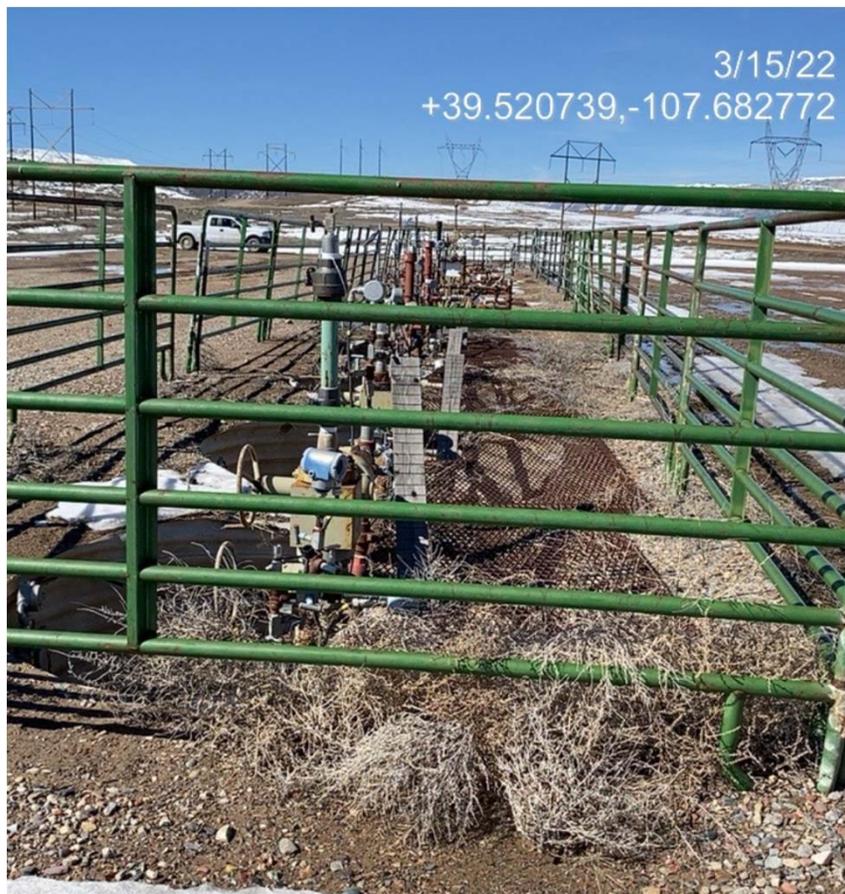
Photo taken from the well equipment facing west shows undesirable plant species/weed debris accumulating in production areas. Photo from reclamation inspector

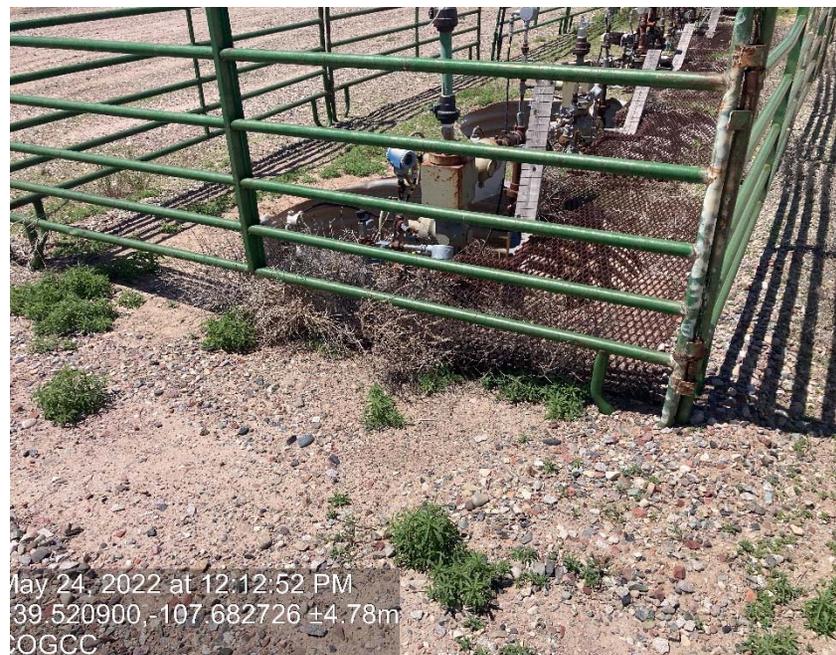
Recent inspection show C/A has not been completed

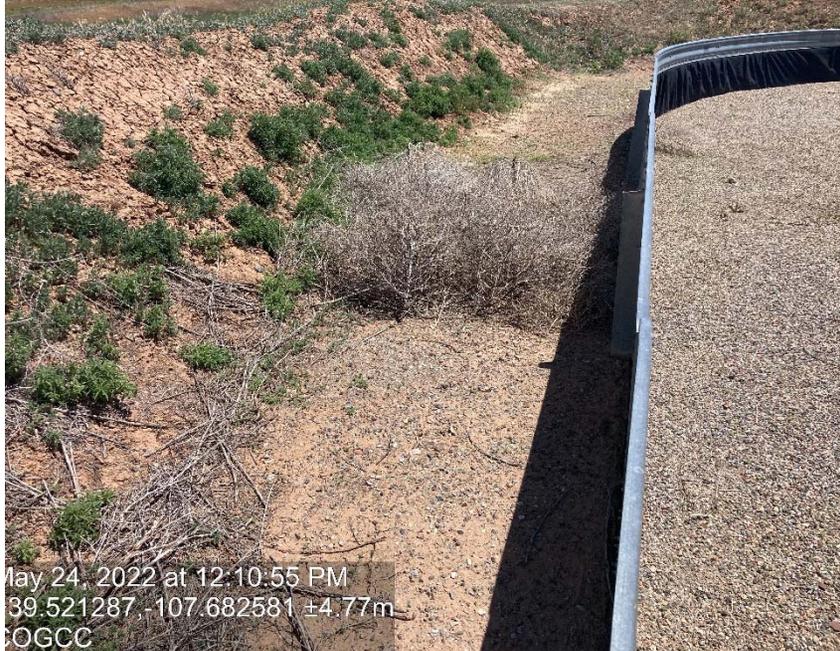
Debris

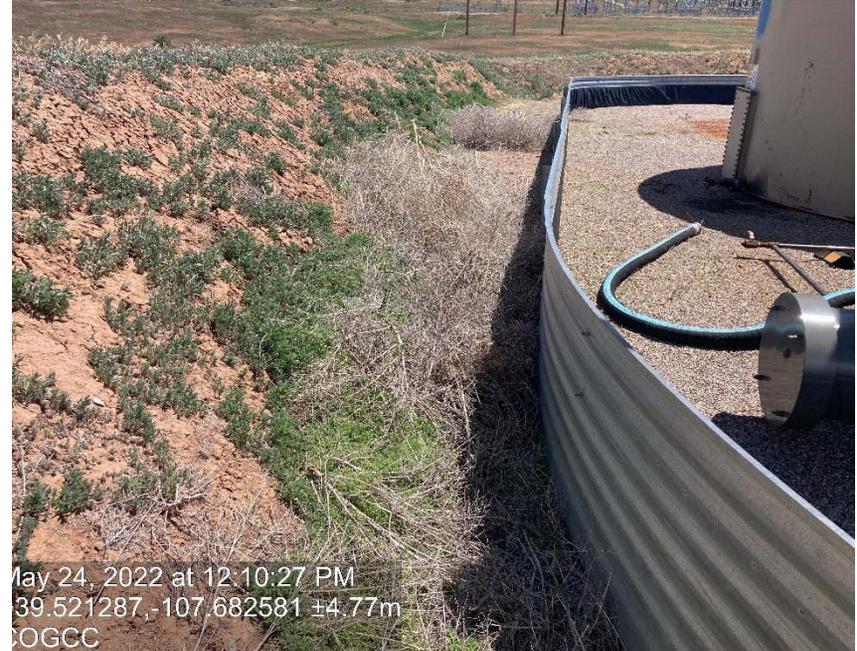
Debris

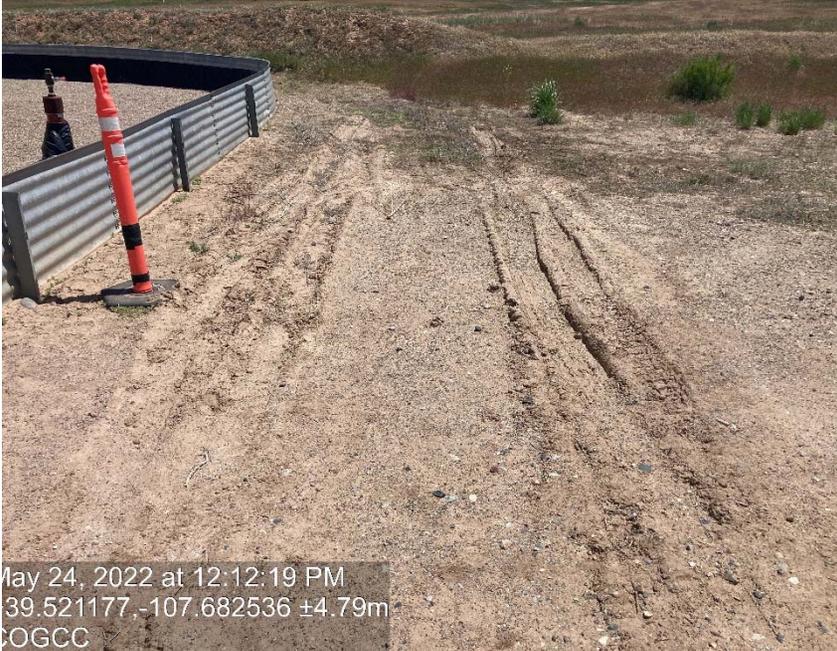
Lack of stabilization/compaction

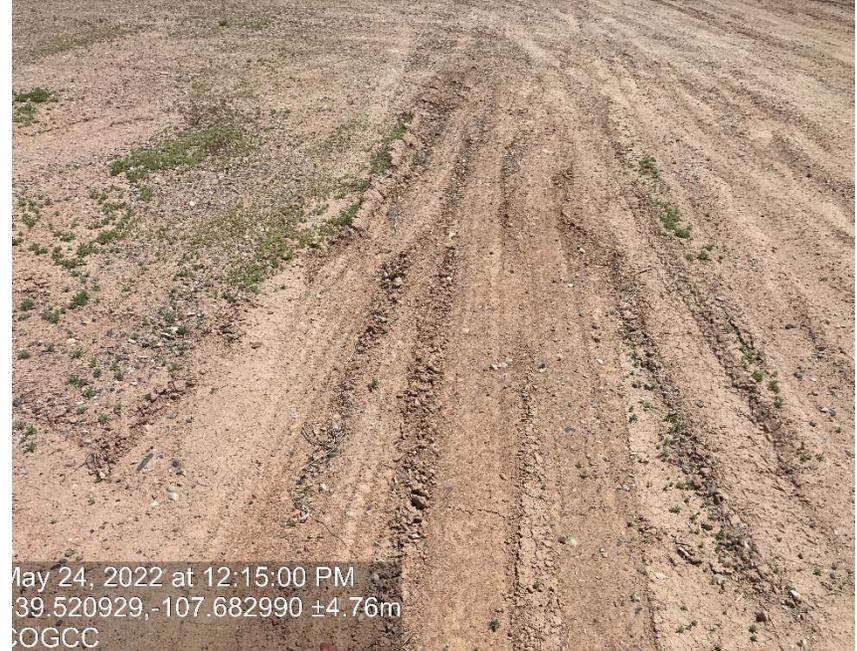
Lack of stabilization/compaction

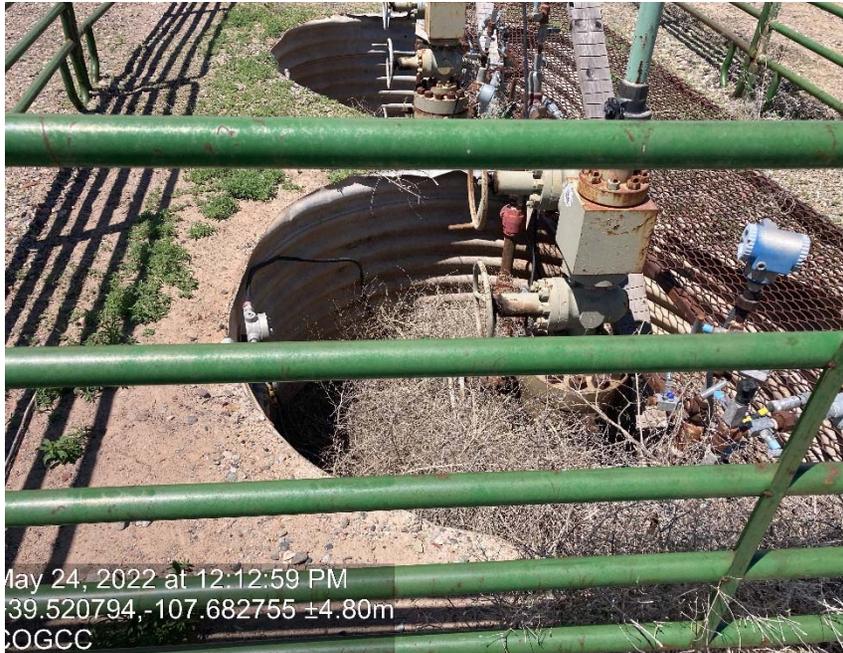
Debris
