Interim Reclamation and Stormwater Inspection

Operator: EDGE ENERGY II LLC- #10671

Location ID: 456286

Inspection Photos
Location Name: Deporter /29-A Pad
Location ID: 456286

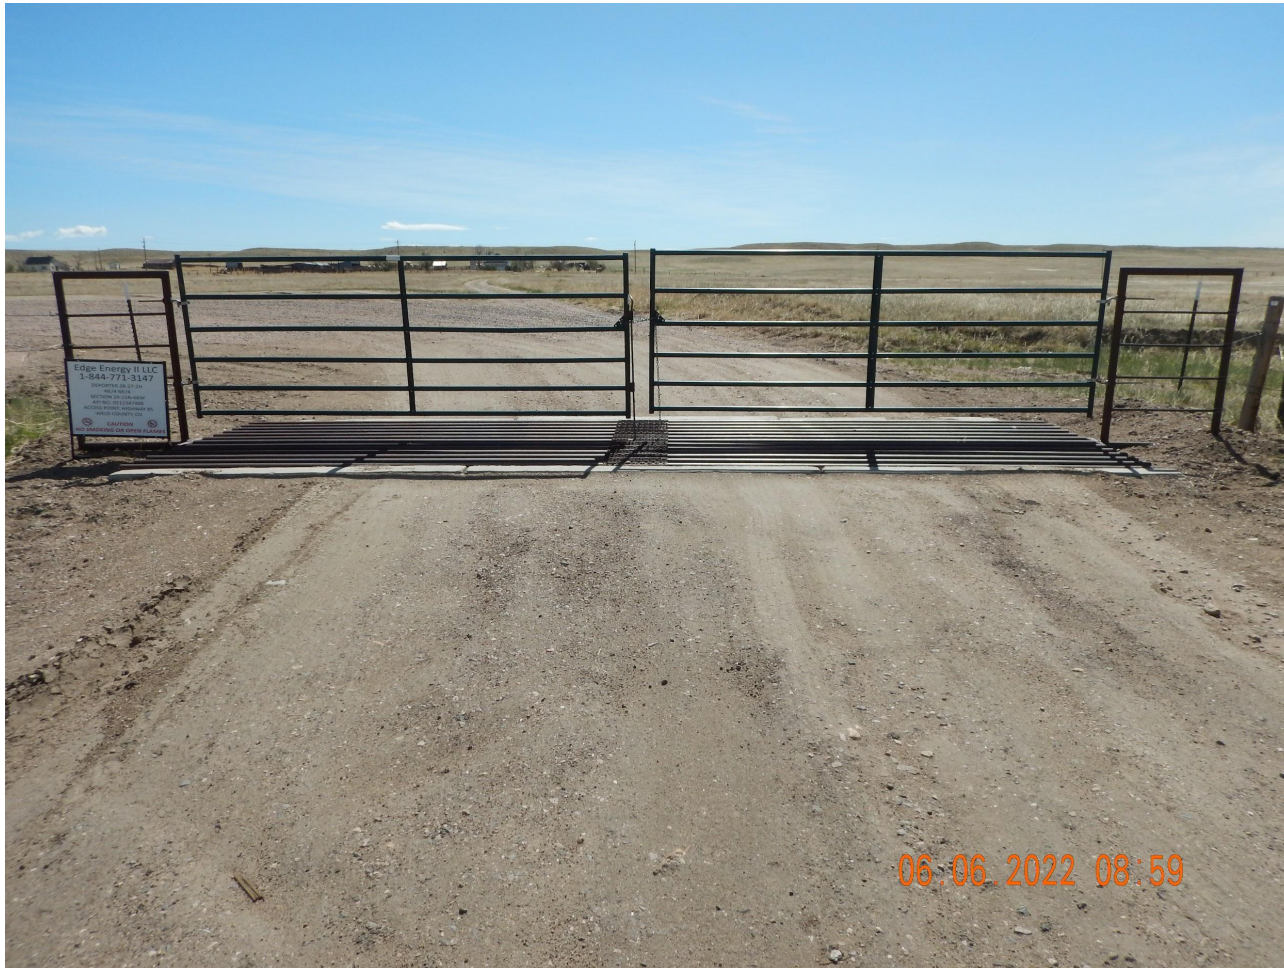
Photo 1. Photo taken from the entrance of location, facing East. Photo illustrates Operator has replaced the cattle guard and installed new gates.

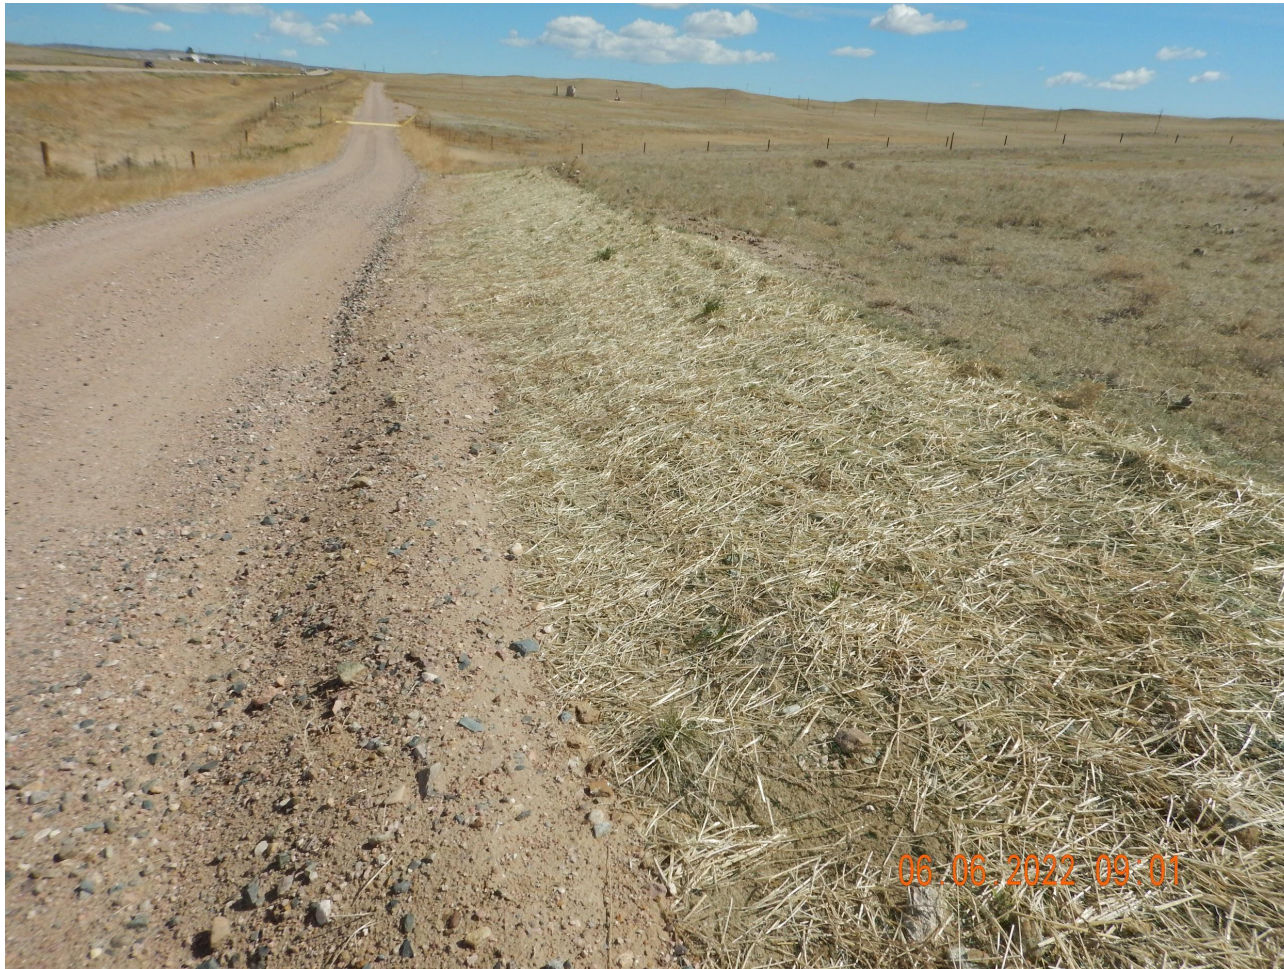
Photo 2. Photo taken from a portion of the southern access road, facing North. Photo illustrates the cut slope has been stabilized with erosion control matting and desirable species establishment was observed.

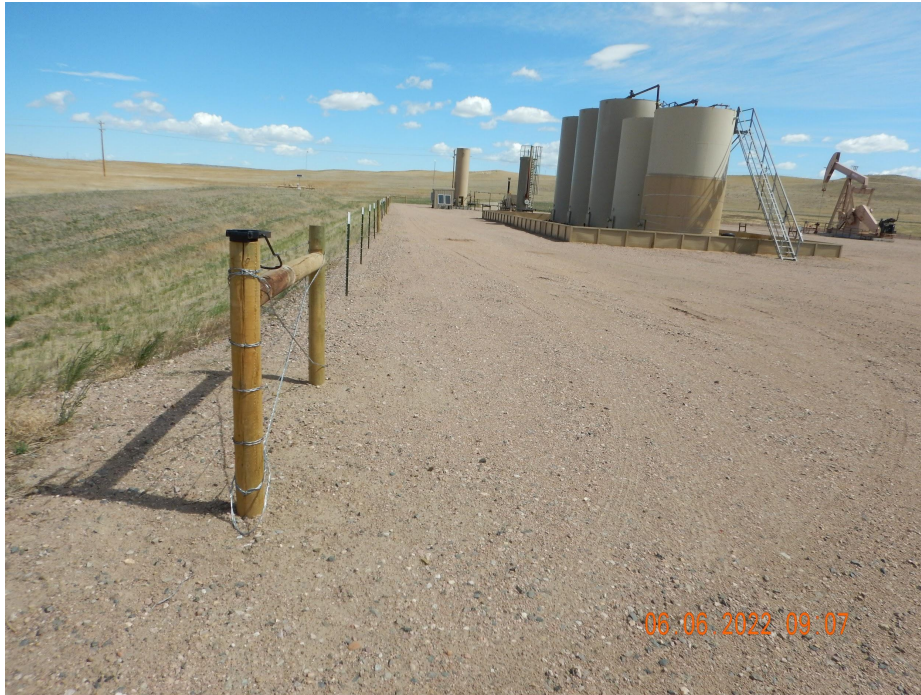
Photo 3. Photo taken from the southwestern well location, facing North. Photo illustrates Operator has installed fencing around the well location to exclude cattle.

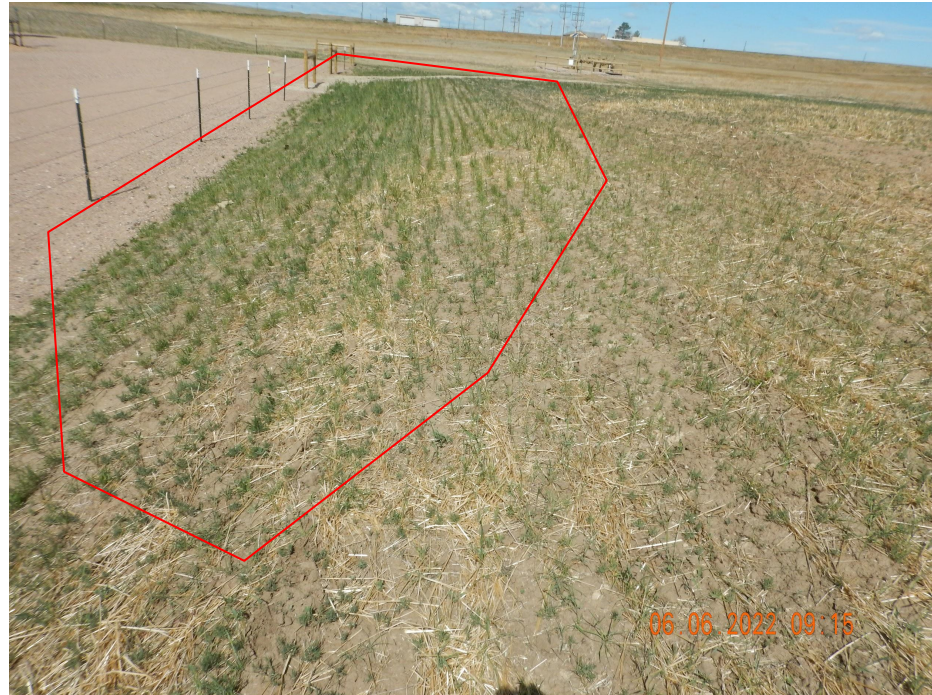
Photo 4. Photo taken from the northwestern location, facing West. See comments under Photo 3.

Note: the majority of the green vegetation is that of Common rye.

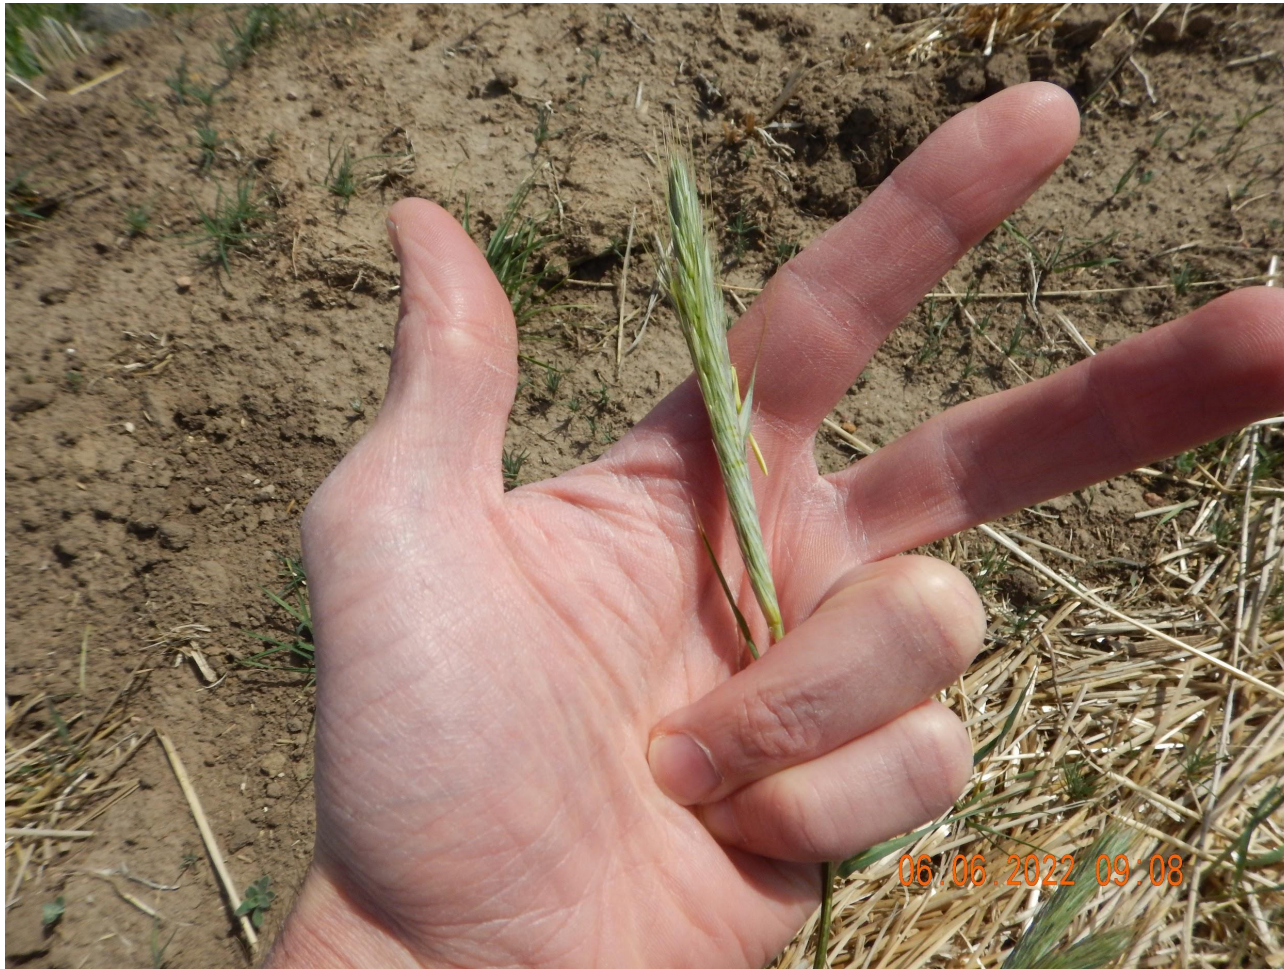
Photo 5. Photo taken from the southwestern interim reclamation area along the fill slope. Photo illustrates Common rye starting to flower.

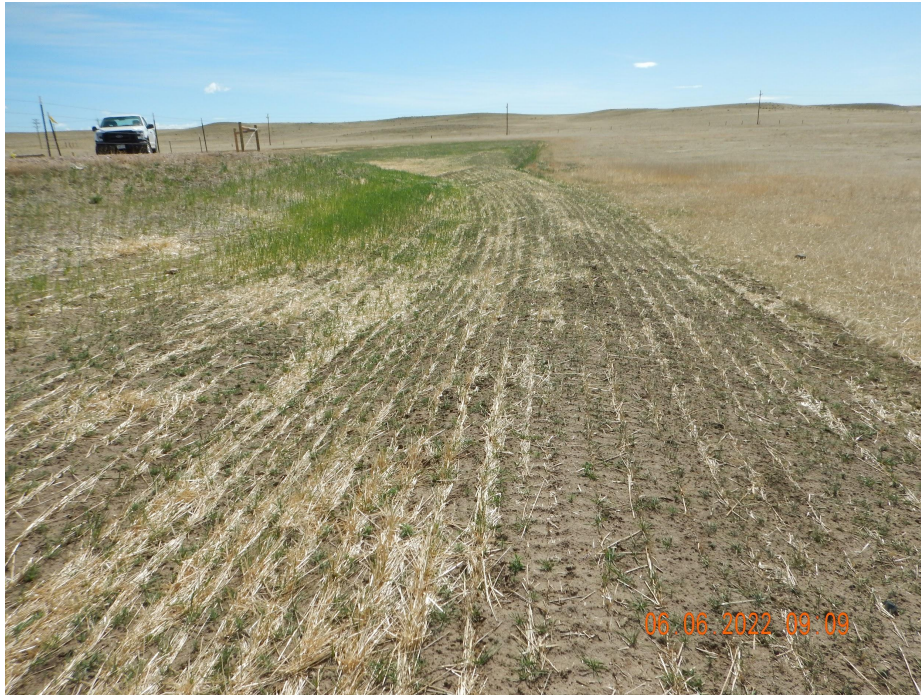
Photo 6. Photo taken from the southwestern interim reclamation area, facing East. Photo illustrates Operator has performed additional interim reclamation and desirable vegetation establishment was observed.

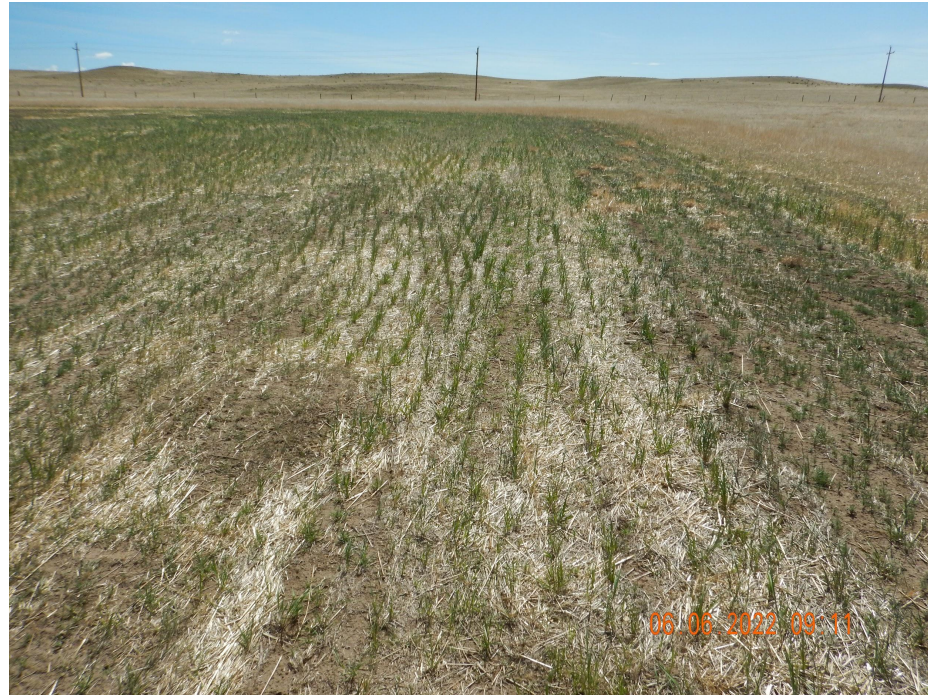
Photo 7. Photo taken from the southern interim reclamation area, facing East. See comments under Photo 6.

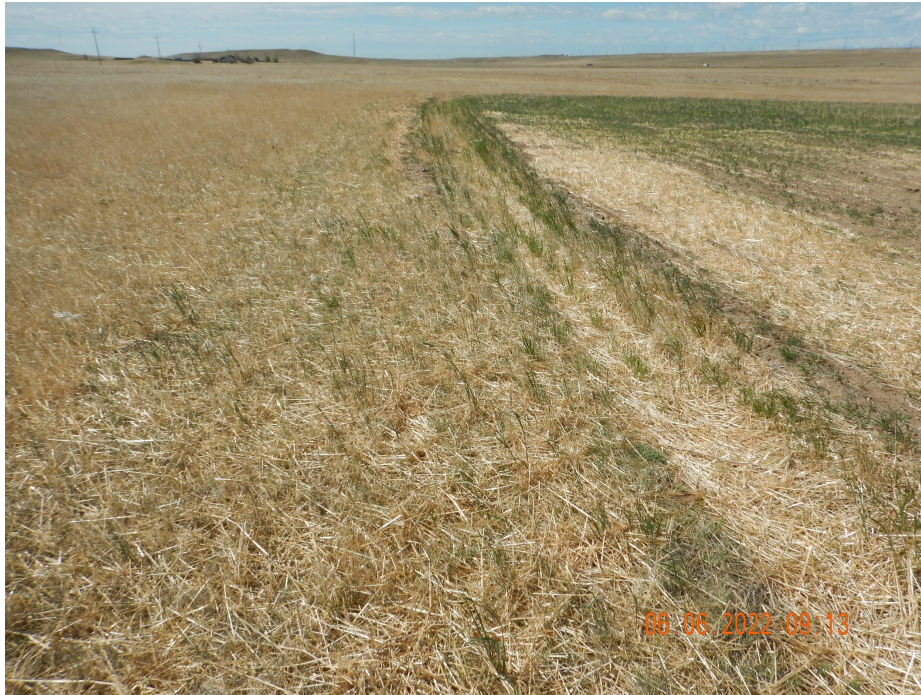
Photo 8. Photo taken from the eastern interim reclamation area, facing South. Common rye was observed along the perimeter of location.

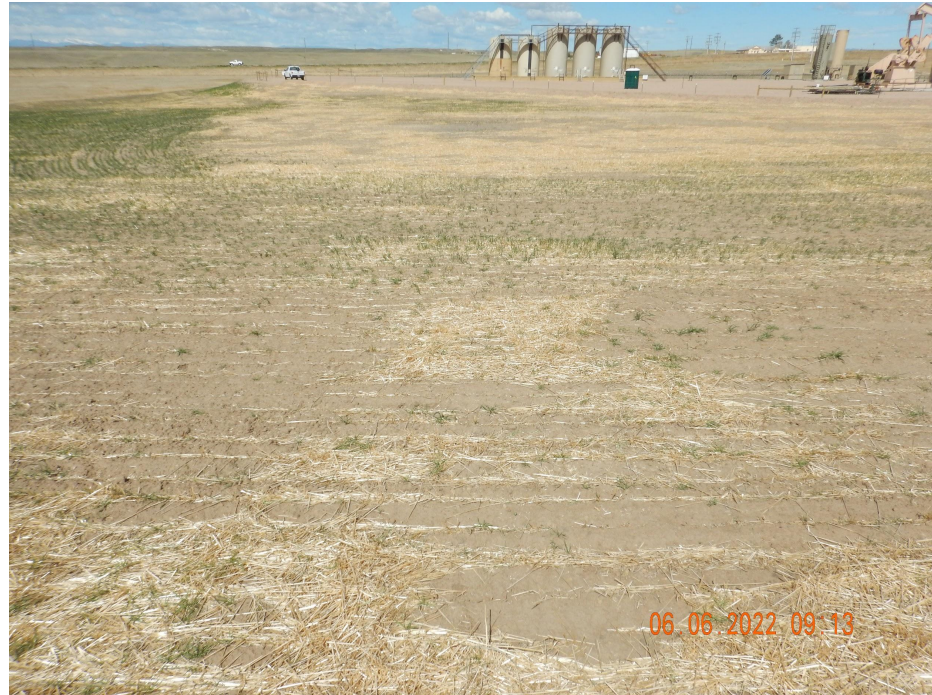
Photo 9. Photo taken from the eastern interim reclamation area, facing West. See comments under Photo 6.
