# Inspection Photos and Issue Report

Operator: GORDON ENGINEERING INC

Location ID: 312560

Mesa County, CO

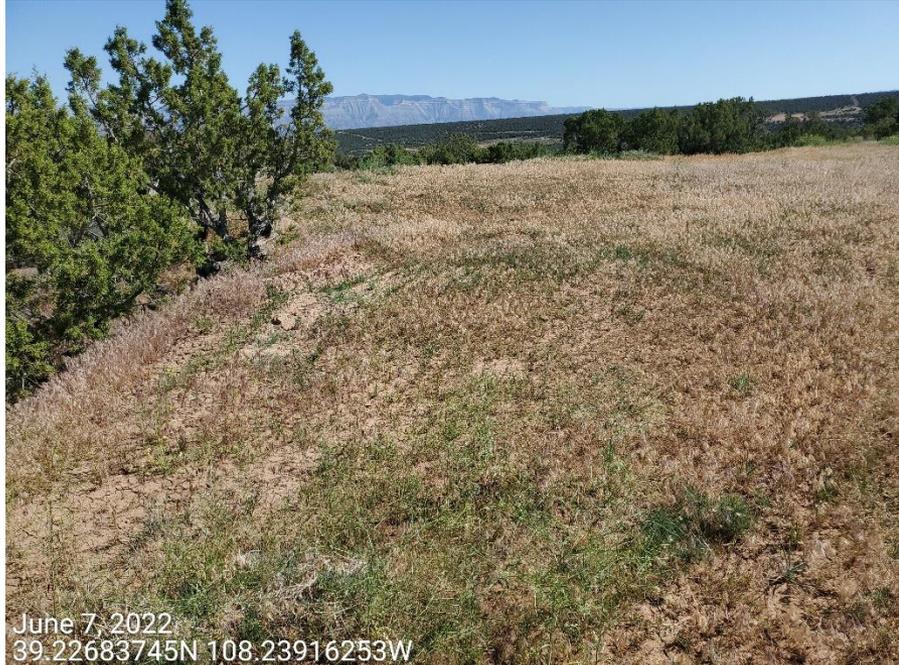
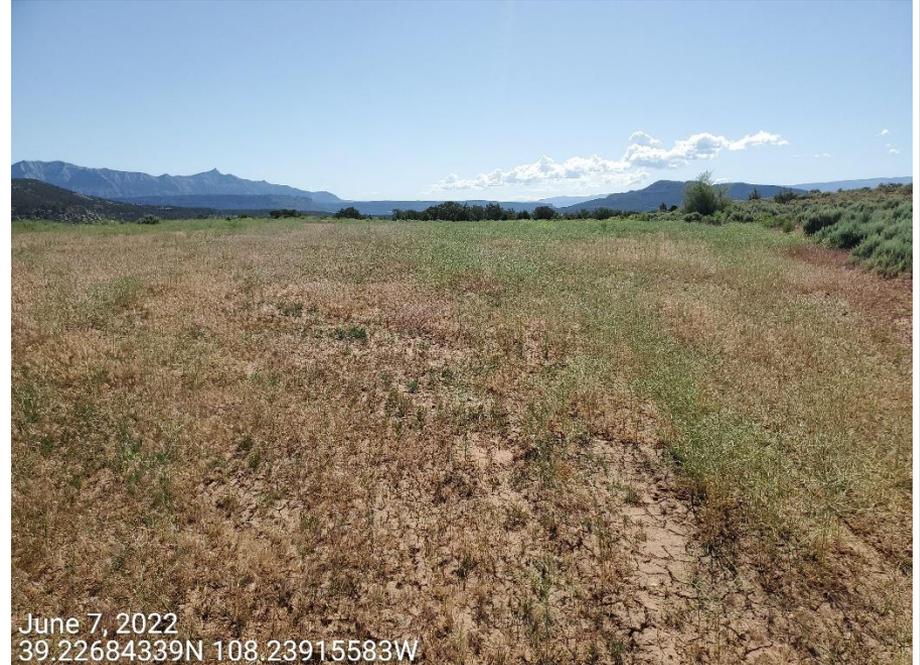
**Photo 1:** Photos taken from the west end of the Location, facing northeast and east. Photos provide an overview of the Location. Photos shows cheatgrass has established throughout the entire Location. Photo shows final reclamation has not been completed; work including, but not limited to, compaction alleviation (cross ripping to a minimum depth of 18 inches), recontouring /regrading and reclamation

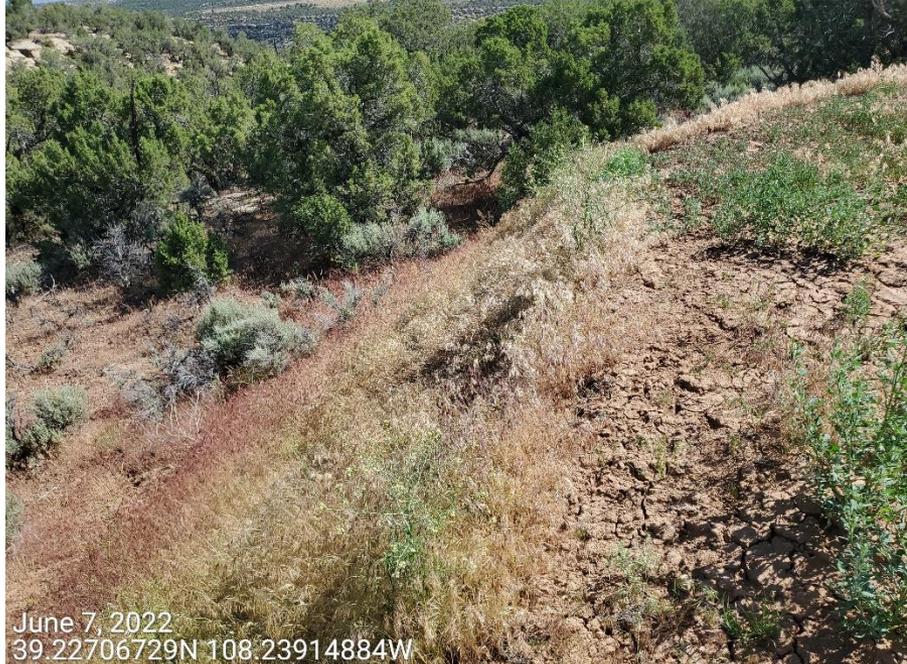
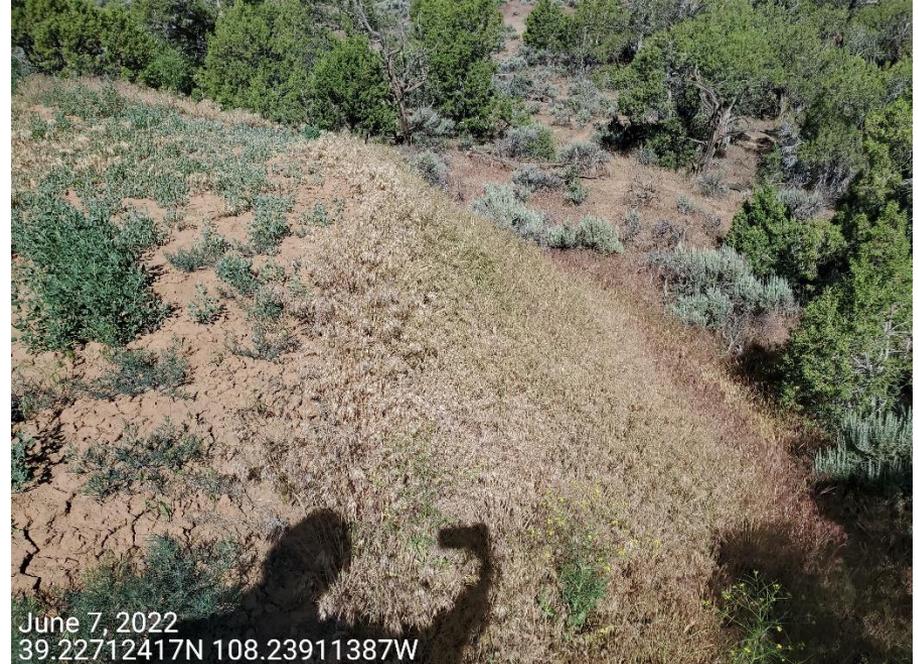
**Photo 2:** Photos show fill slopes remaining; location has not been recontoured and regraded

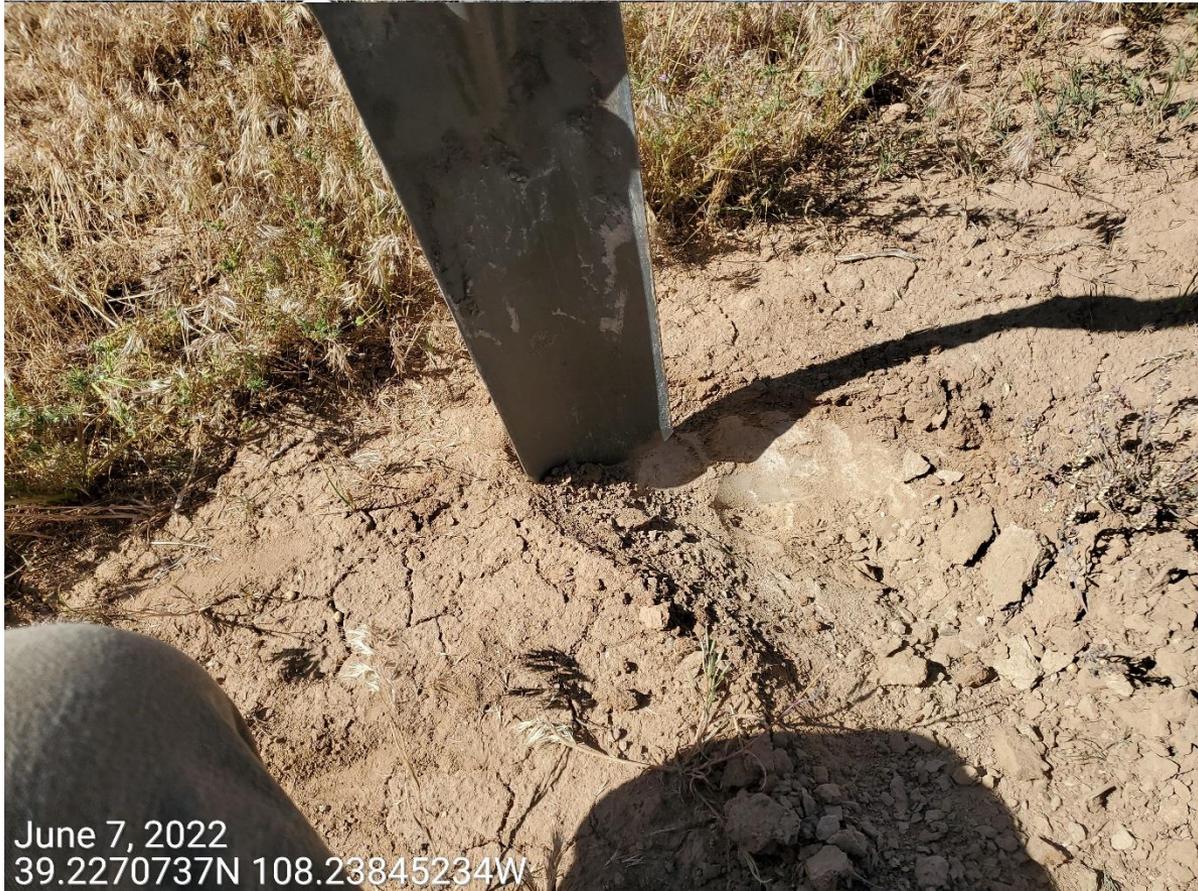
**Photo 3:** Photo shows compaction issues are evident; Location has not been decompacted.

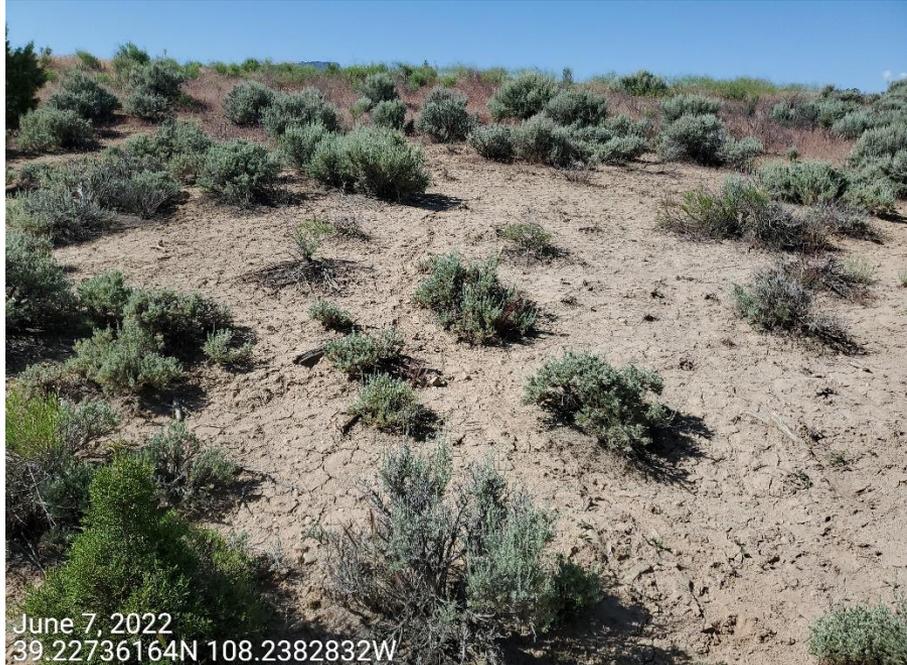
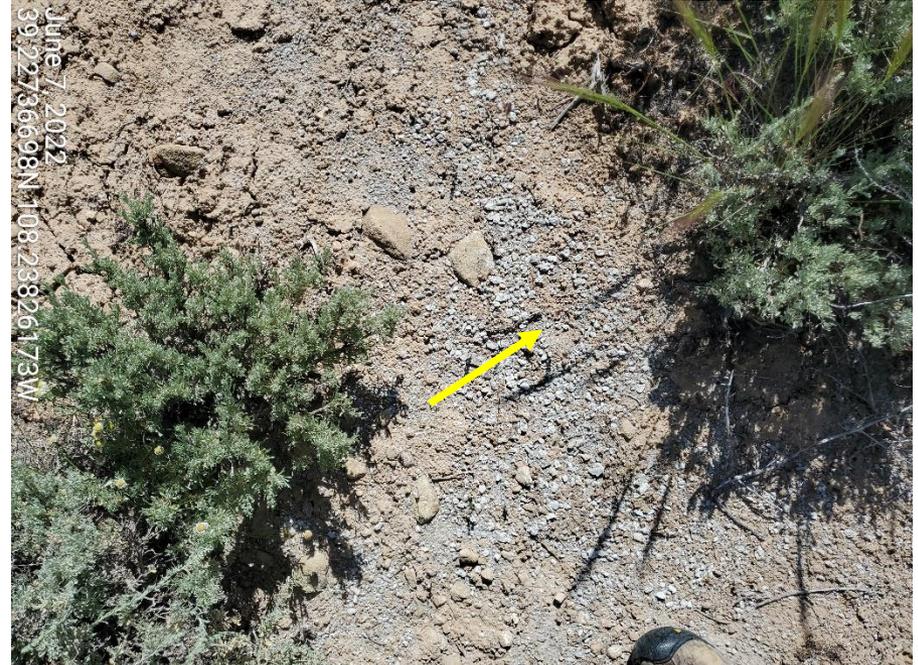
**Photo 4:** Photos taken from the north end of the Location where Operator was documented discharging cement waste off-site during plugging operations; cement waste remains evident. Areas of the spill devoid of grass vegetation. Spill has not been cleaned/remediated, and area reclaimed.

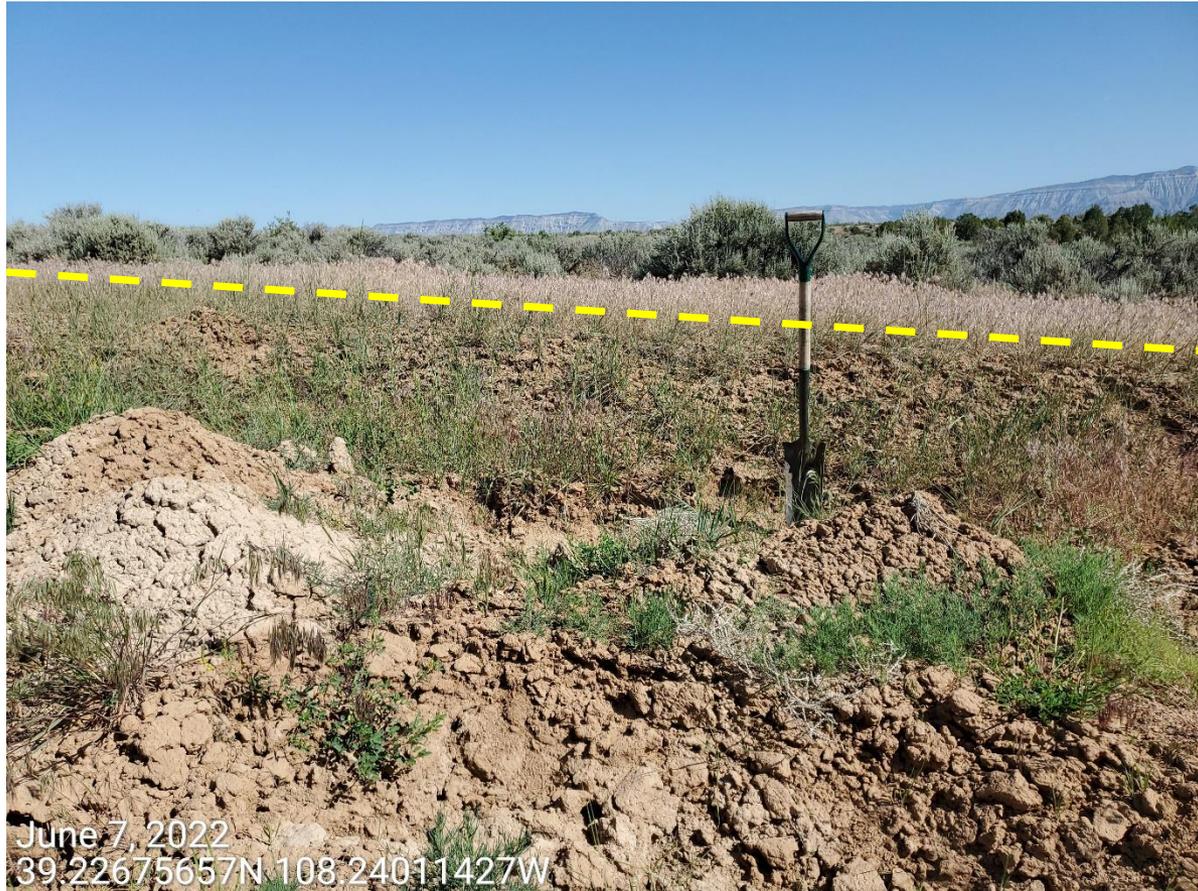
**Photo 5:** Photo taken from the access road. Photo example showing access road has not been properly recontoured/regraded to the original relative grade, and to that of the reference. Yellow line represents top grade of the adjacent area. Shovel used for scale.

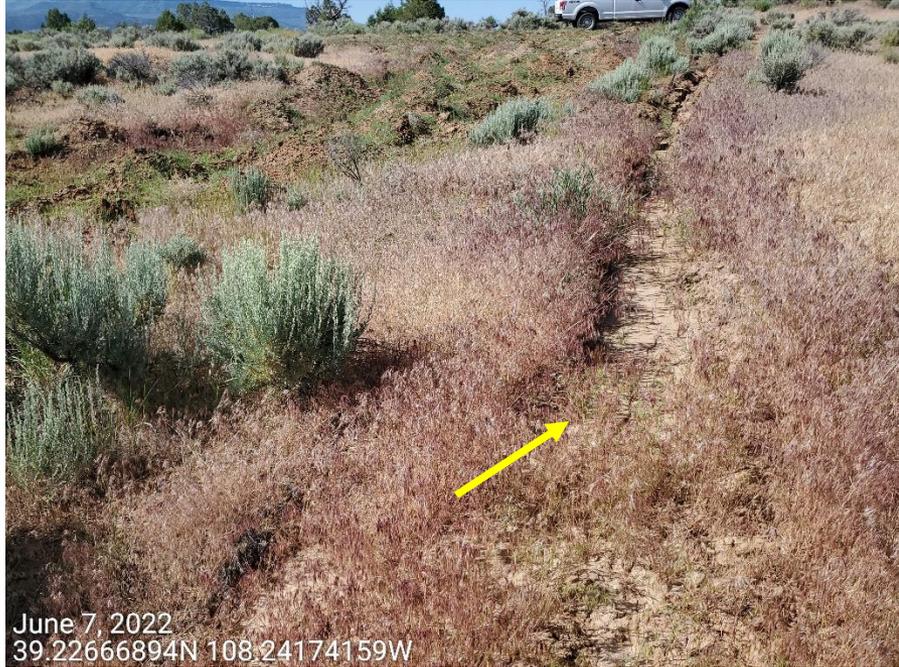
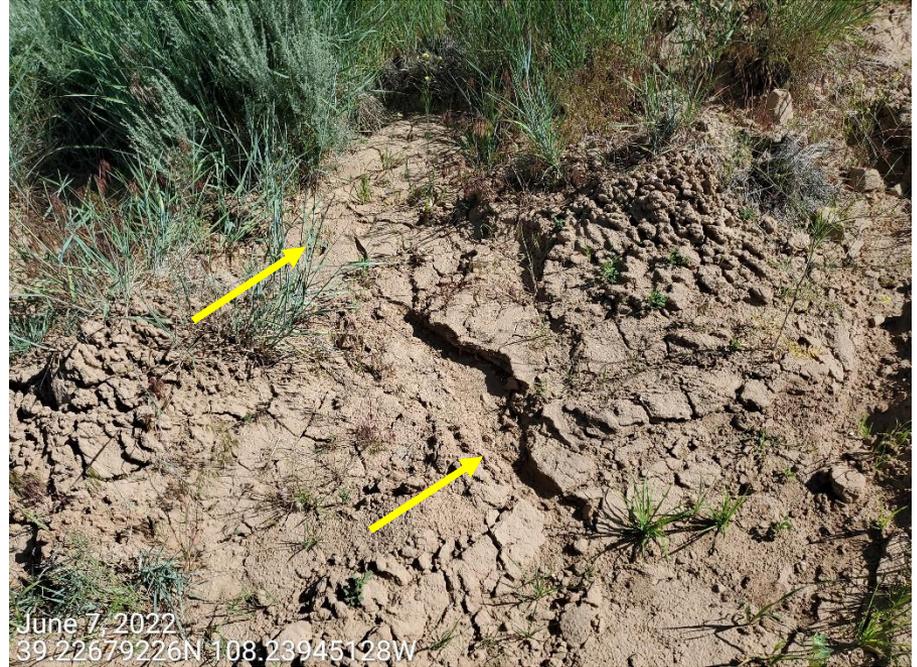
**Photo 6:** Photos provide examples of erosion degradation and sediment transport and deposition observed at access road. Stormwater and erosion control measures to minimize erosion, degradation and sediment transport at and from the access road remains missing or insufficient.
