Inspection Photos

API: 055-06190

Operator: EVERGREEN NATURAL RESOURCES

Inspection Date: 6/7/2022

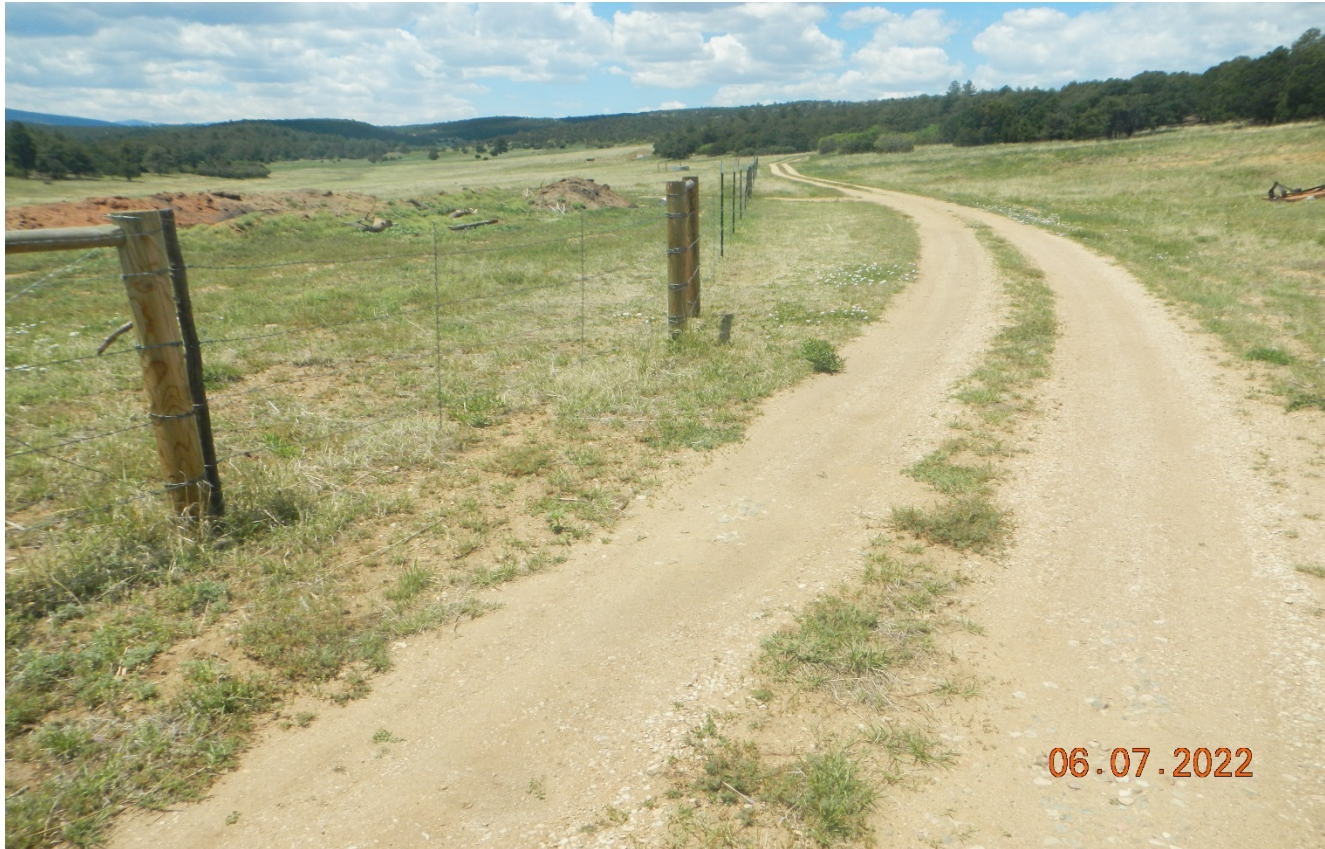
Photo 1. Facing west toward the location. The road travels thru the center of the location.

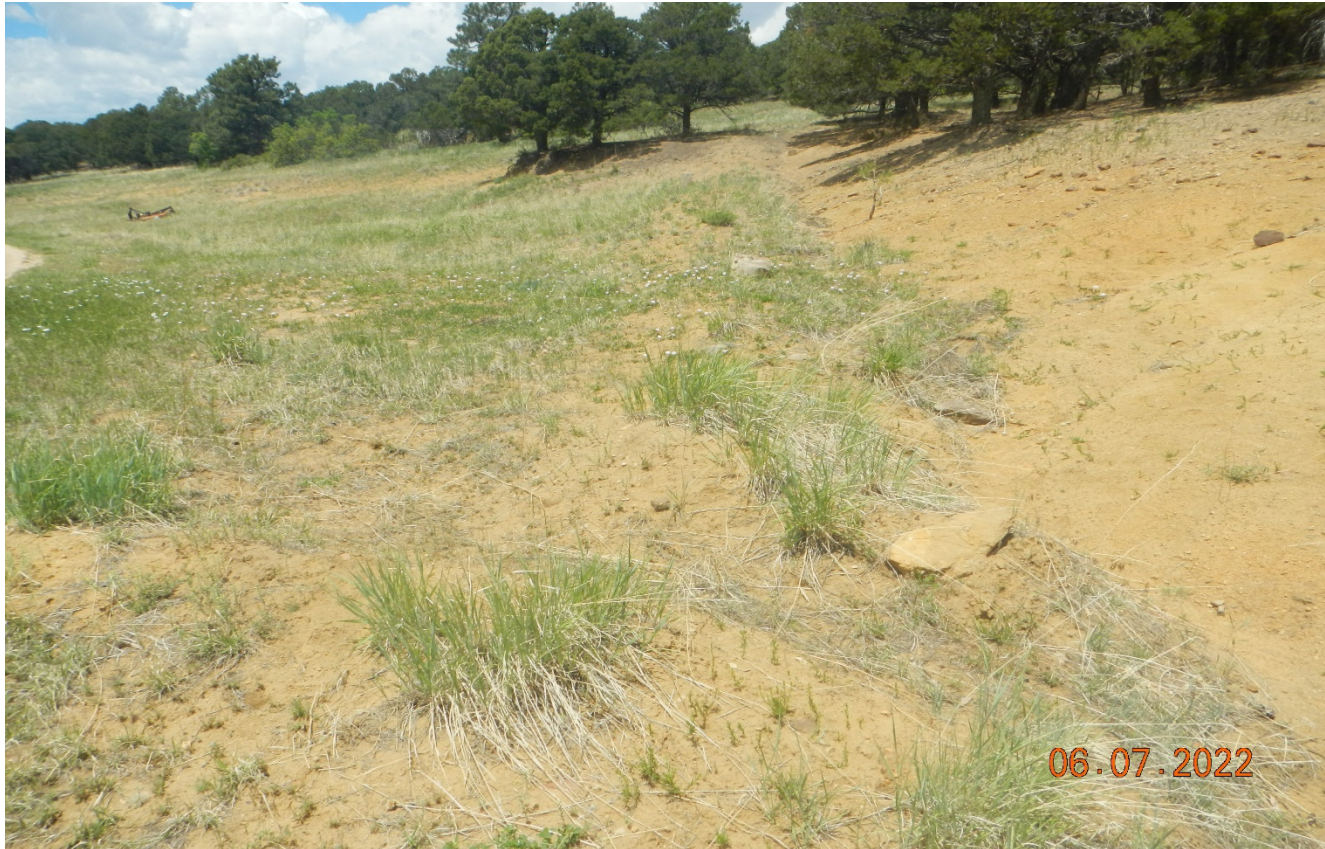
Photo 2. Facing northwest toward the location. The cut slope of the location is visible along the right side of photo and a run-on ditch. This area shown in right portion of the photo is not stabilized.

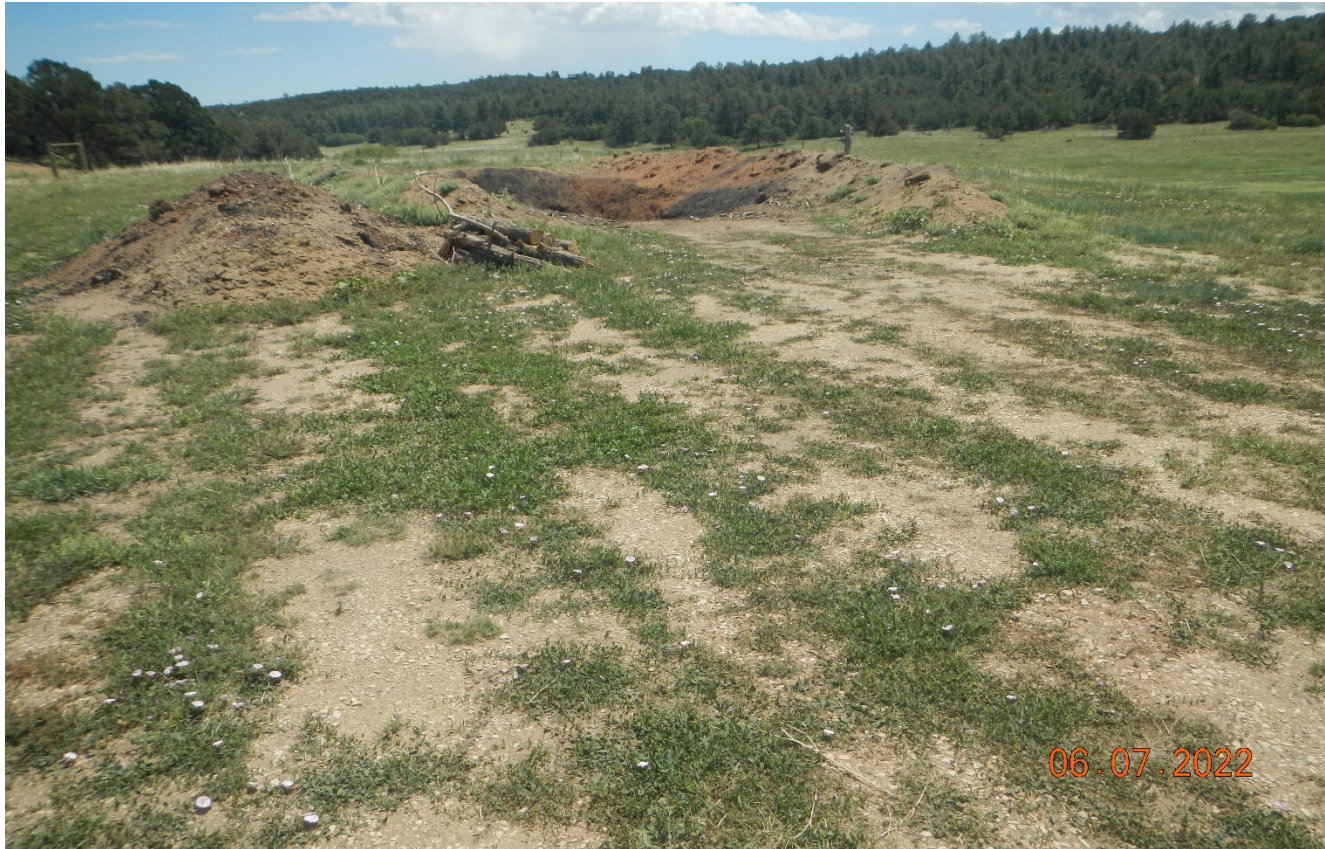
Photo 3. Facing southeast at the location. The surface owner is using the location for a debris burn pit.

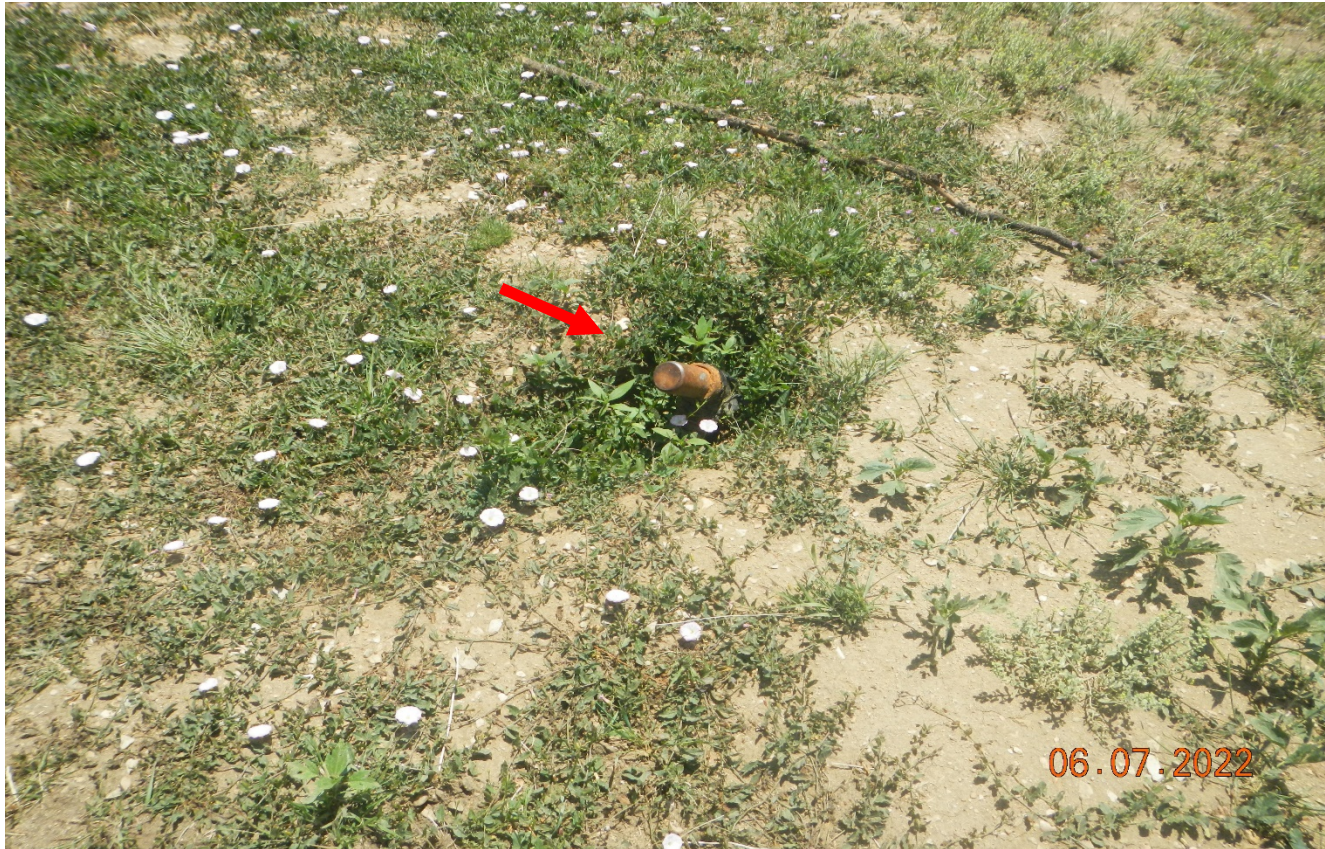
Photo 4. There is a pipe riser that remains at the surface of the location that needs to be properly abandoned.

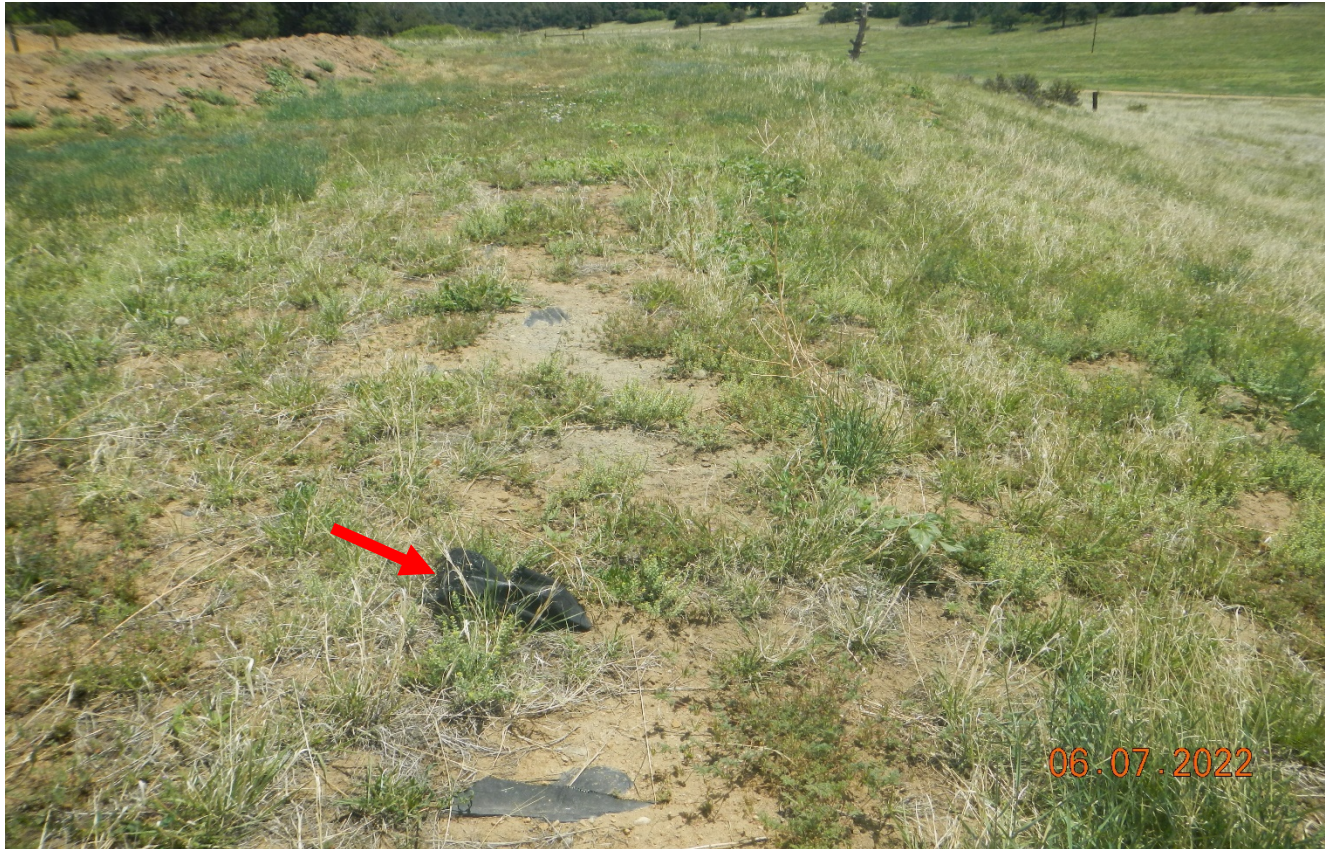
Photo 5. There appears to be liner debris at the surface at the southwest side of the pad.

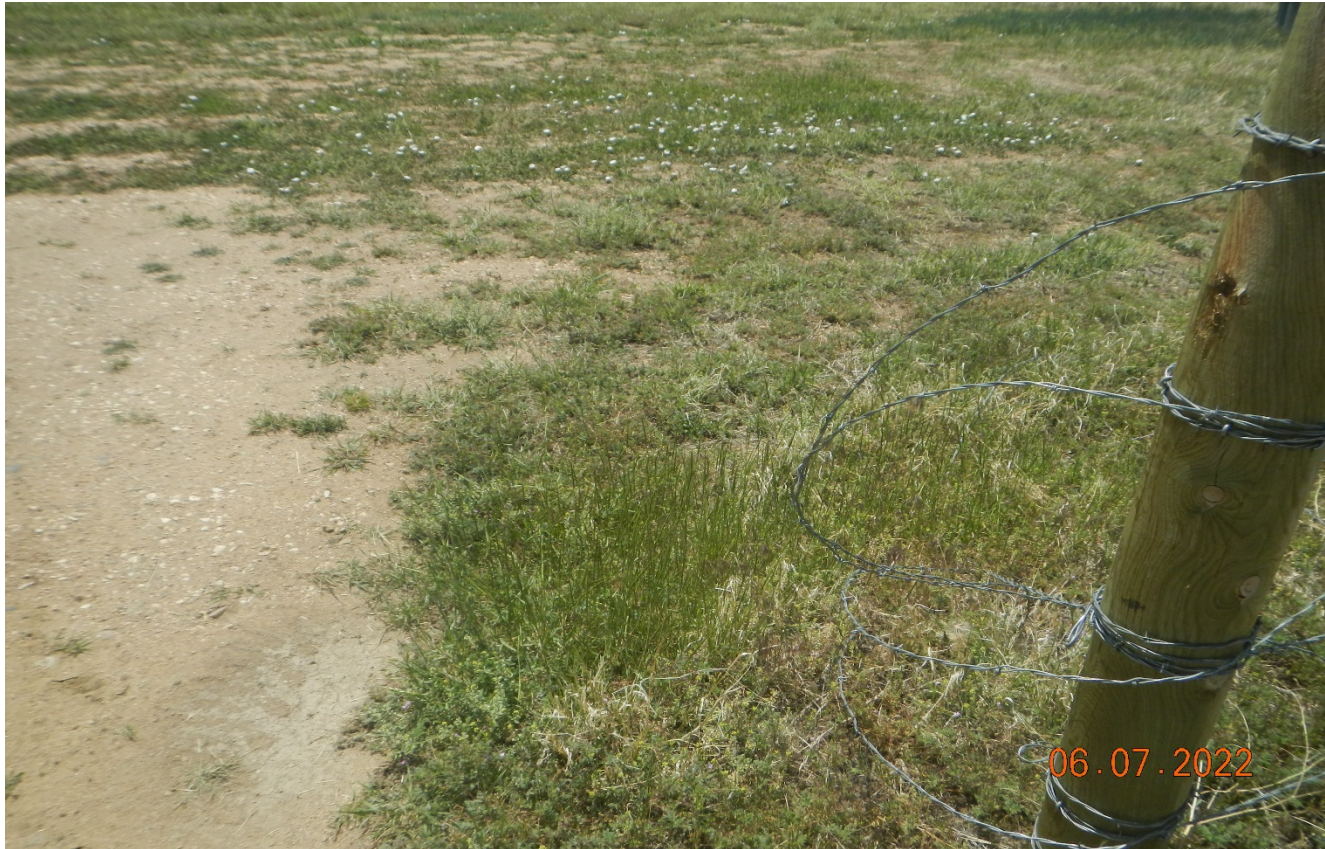
Photo 6. There are noxious weeds at the location which include Cheat grass, Red stem filaree, Field bind weed, and Jointed Goat grass.

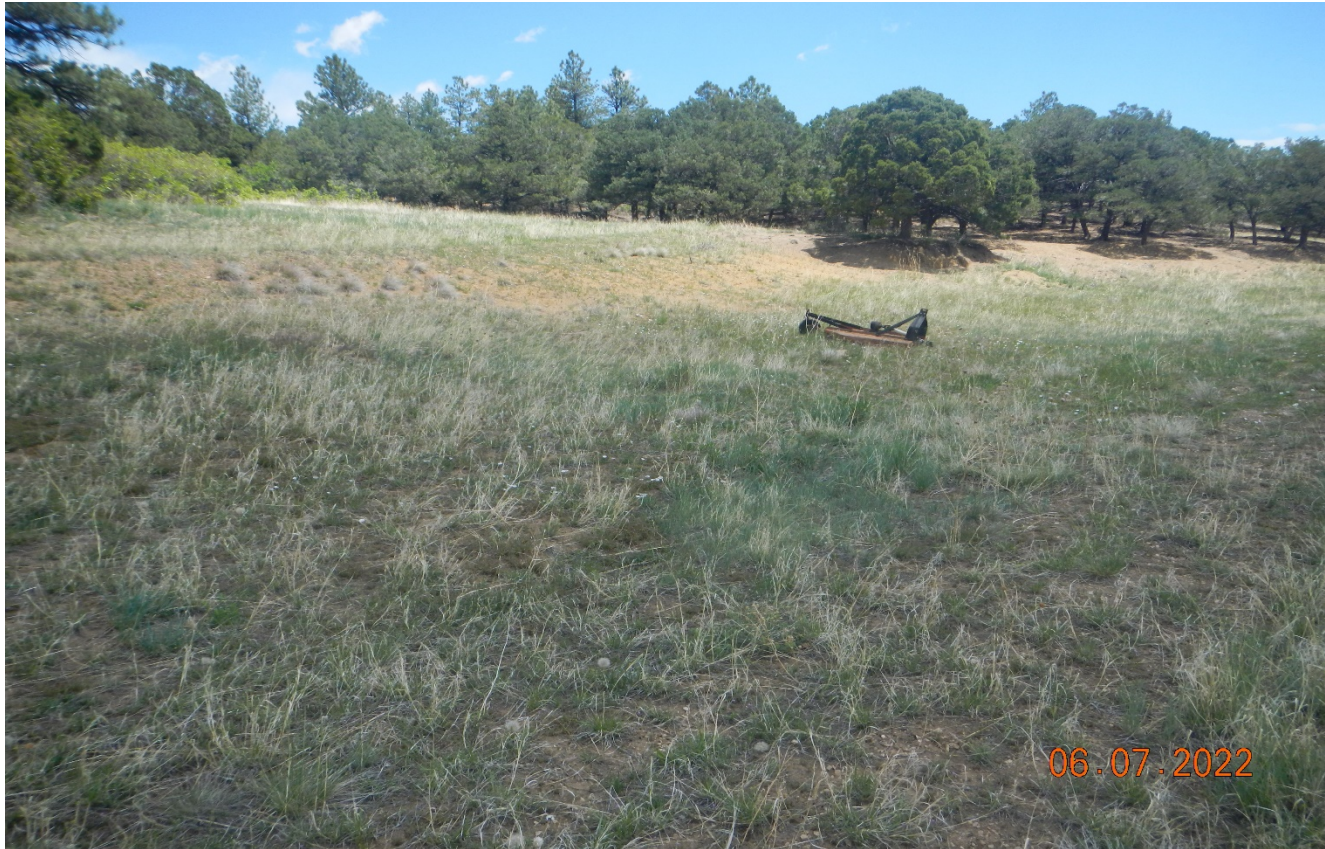
Photo 7. Facing northeast toward the location. The cut slope of the location is visible along the center of photo and a run-on ditch.
