# Inspection Photos

API: 055-06276

Operator: EVERGREEN NATURAL RESOURCES

Inspection Date: 6/7/2022

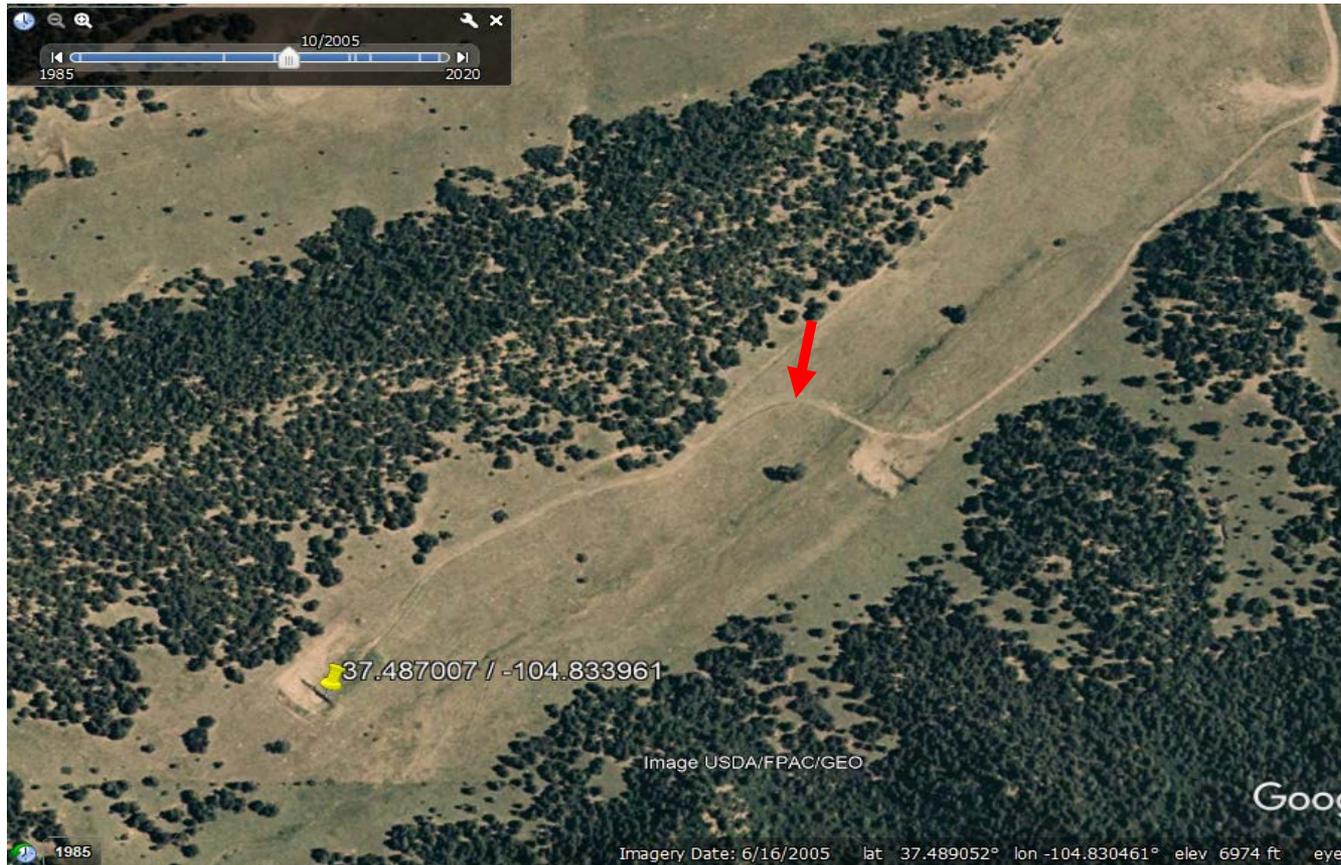
**Photo 1.** 2005 aerial image showing the access road and location. Red arrow points to area at photo #2. The remainder of the access road to the northeast was not inspected but needs to be evaluated for possible reclamation maintenance.

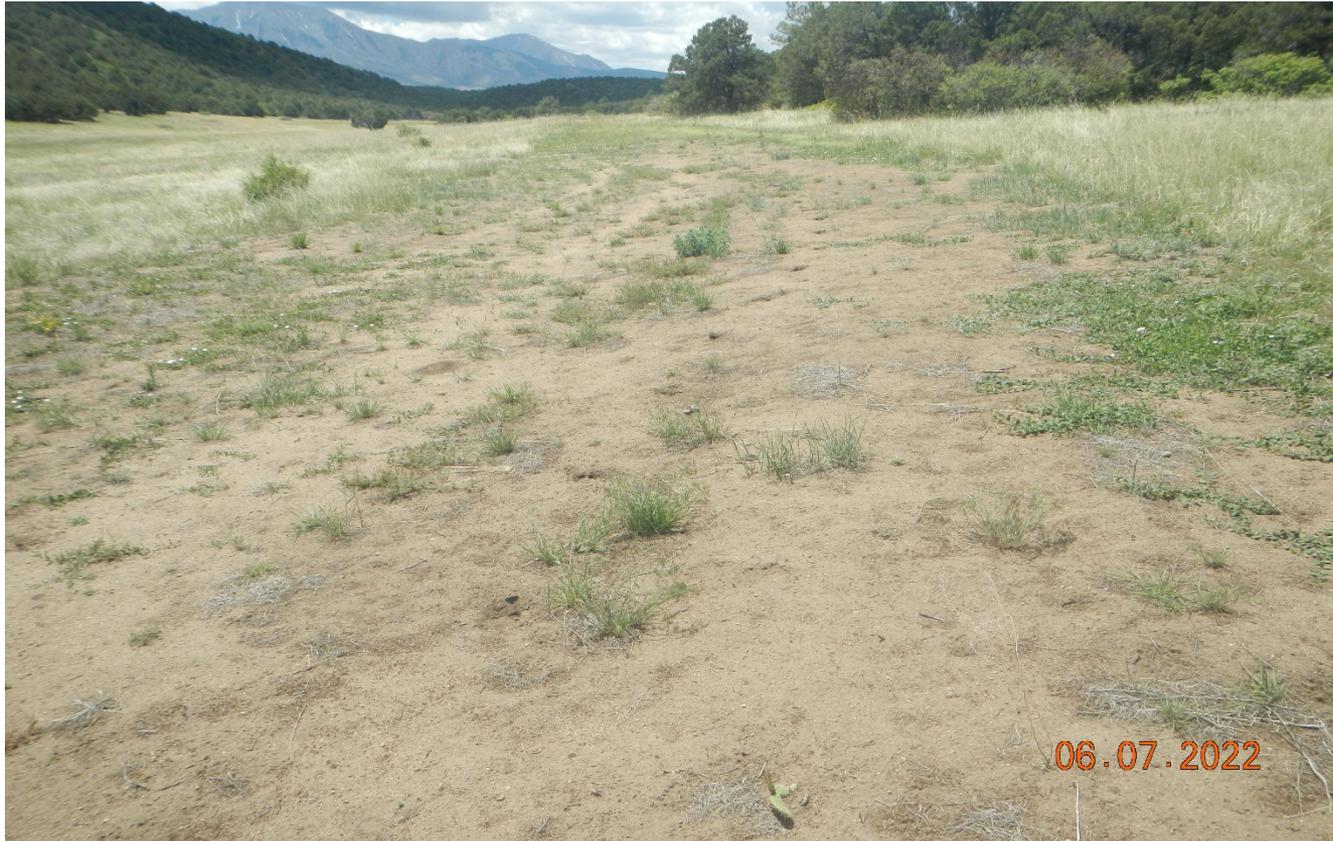
**Photo 2.** This area of the former access road has not re-established vegetation and consists of weeds. Lat/Long:37.48927, -104.83009

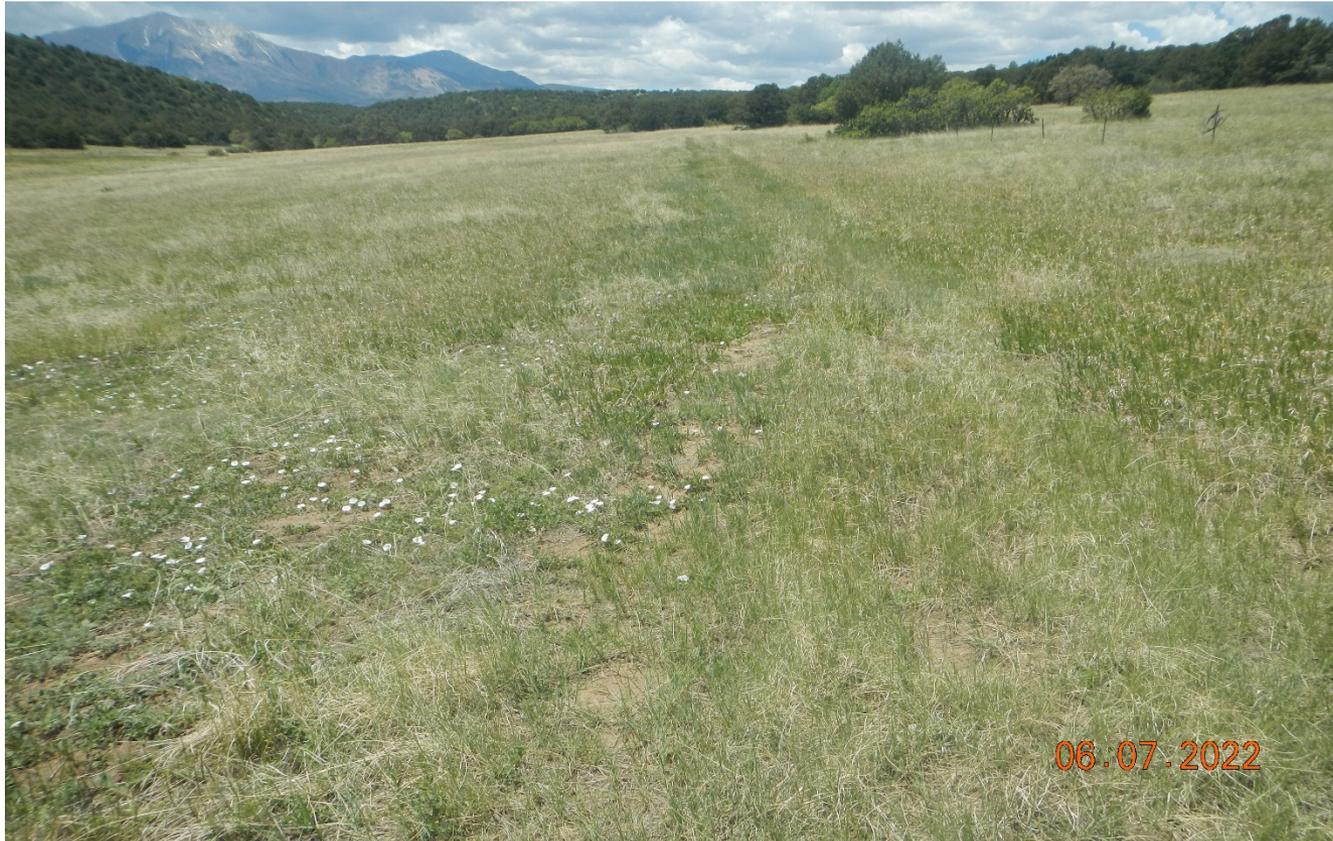
**Photo 3.** Facing southwest along the former access road. The remainder of the road has re-established perennial vegetation. There are some areas with Field bind weed which needs to be controlled.

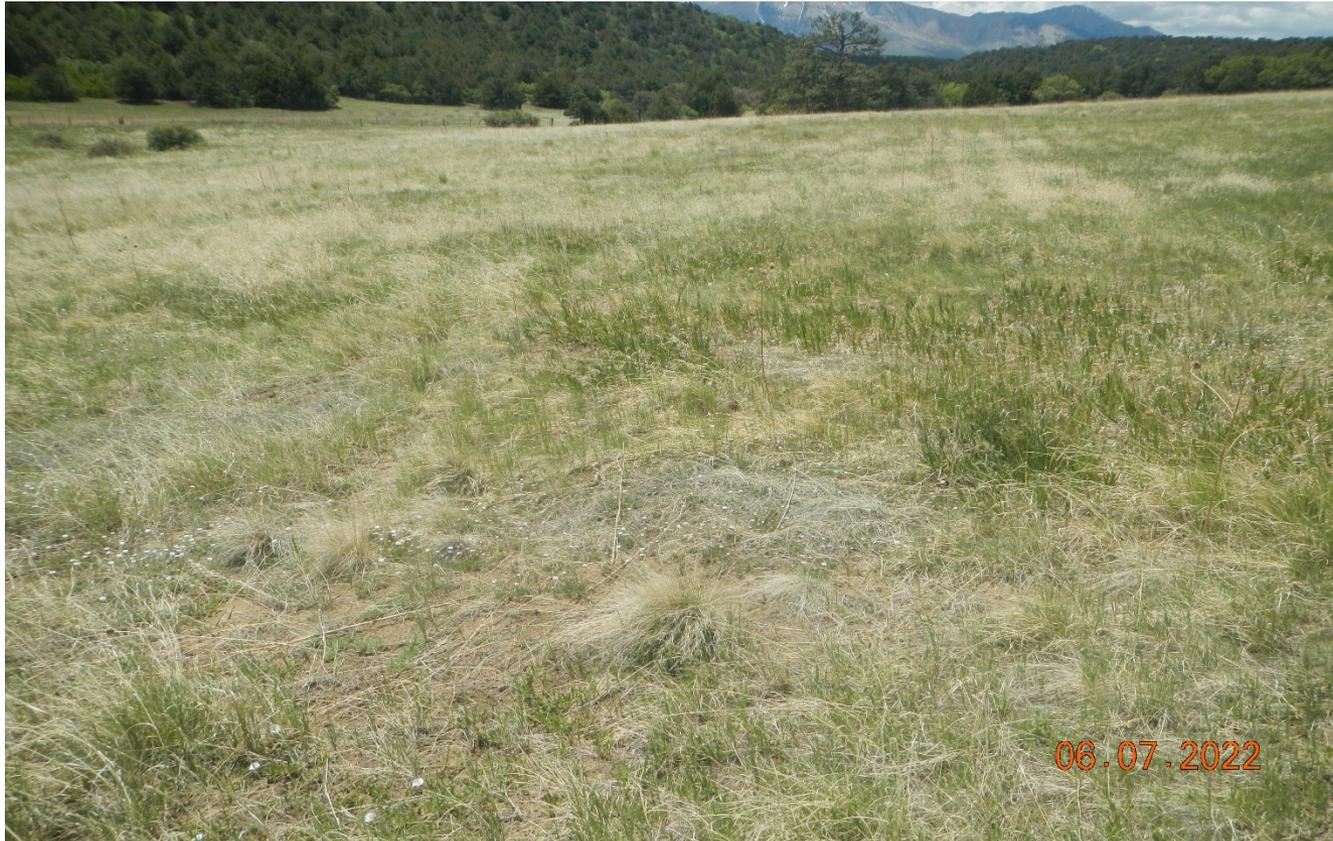
**Photo 4.** Facing southwest toward the location which was recontoured and reclaimed. There is desirable vegetation established throughout most of the location.

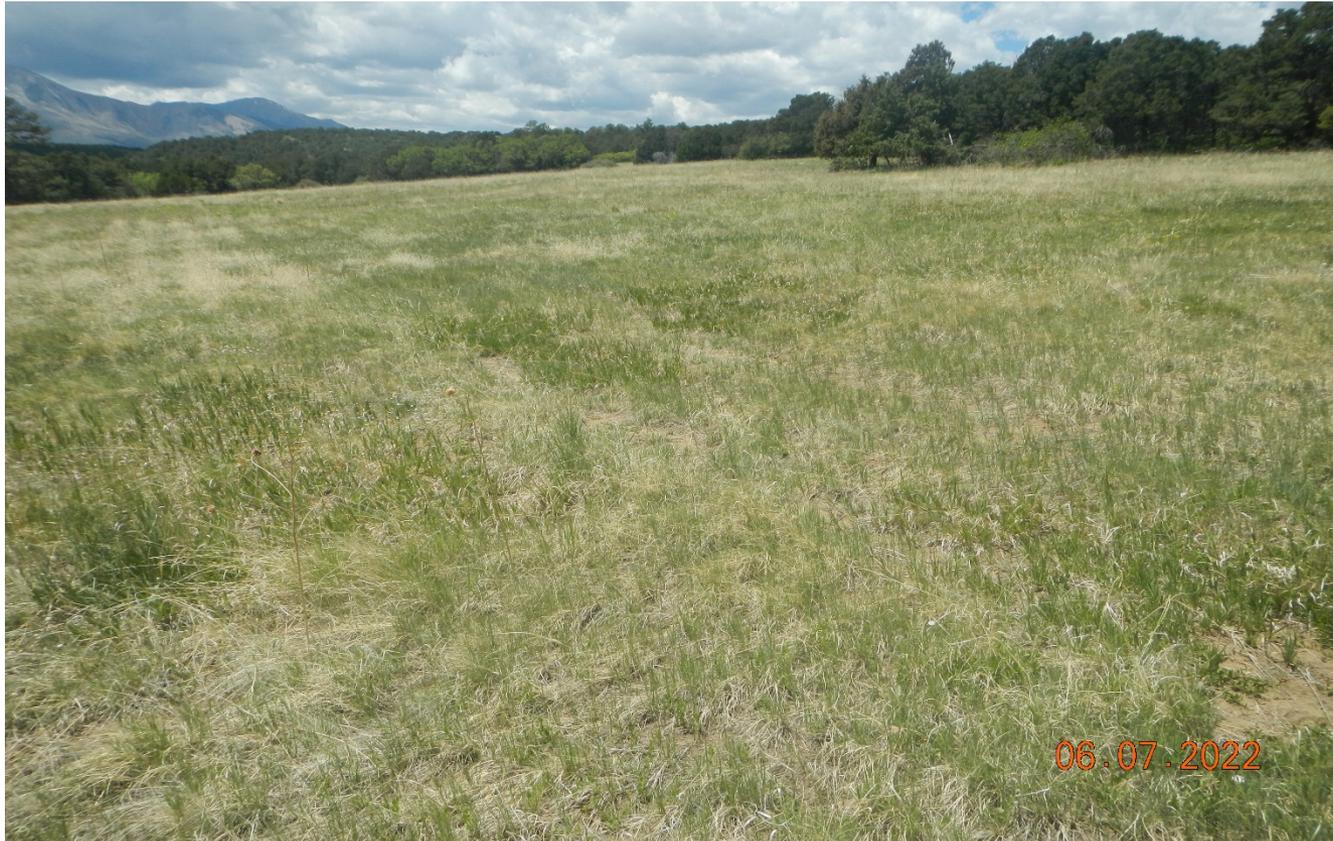
**Photo 5.** Facing west toward the location which was recontoured and reclaimed. There is desirable vegetation established throughout most of the location.
