# Inspection Photos

API: 055-06306

Operator: MANZANO LLC

Inspection Date: 6/7/2022

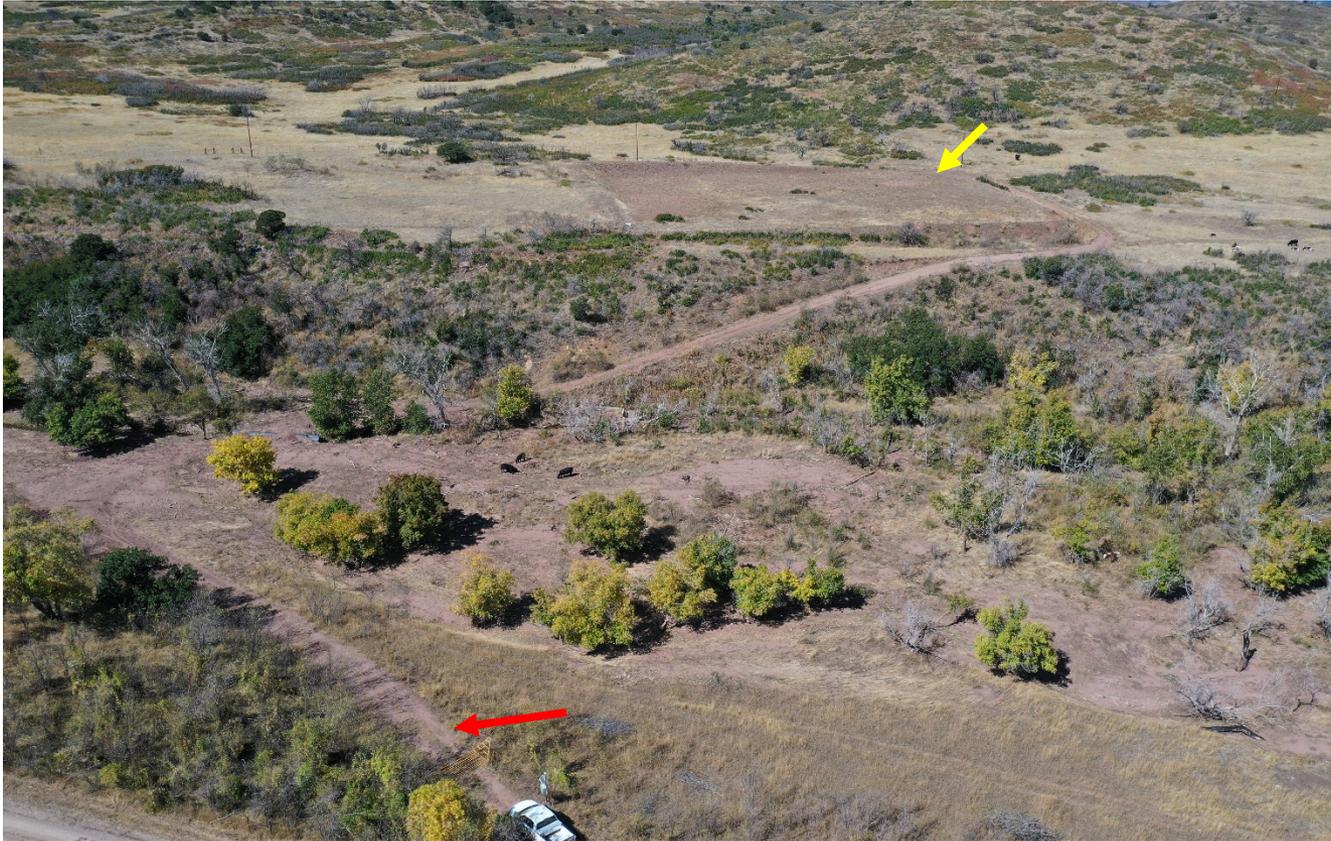
**Photo 1.** Drone aerial photo facing northwest toward the access road and the location. Red arrow points the the access road and yellow arrow points to the location which have not been reclaimed per rule 1004. Photo taken on 10/5/2021

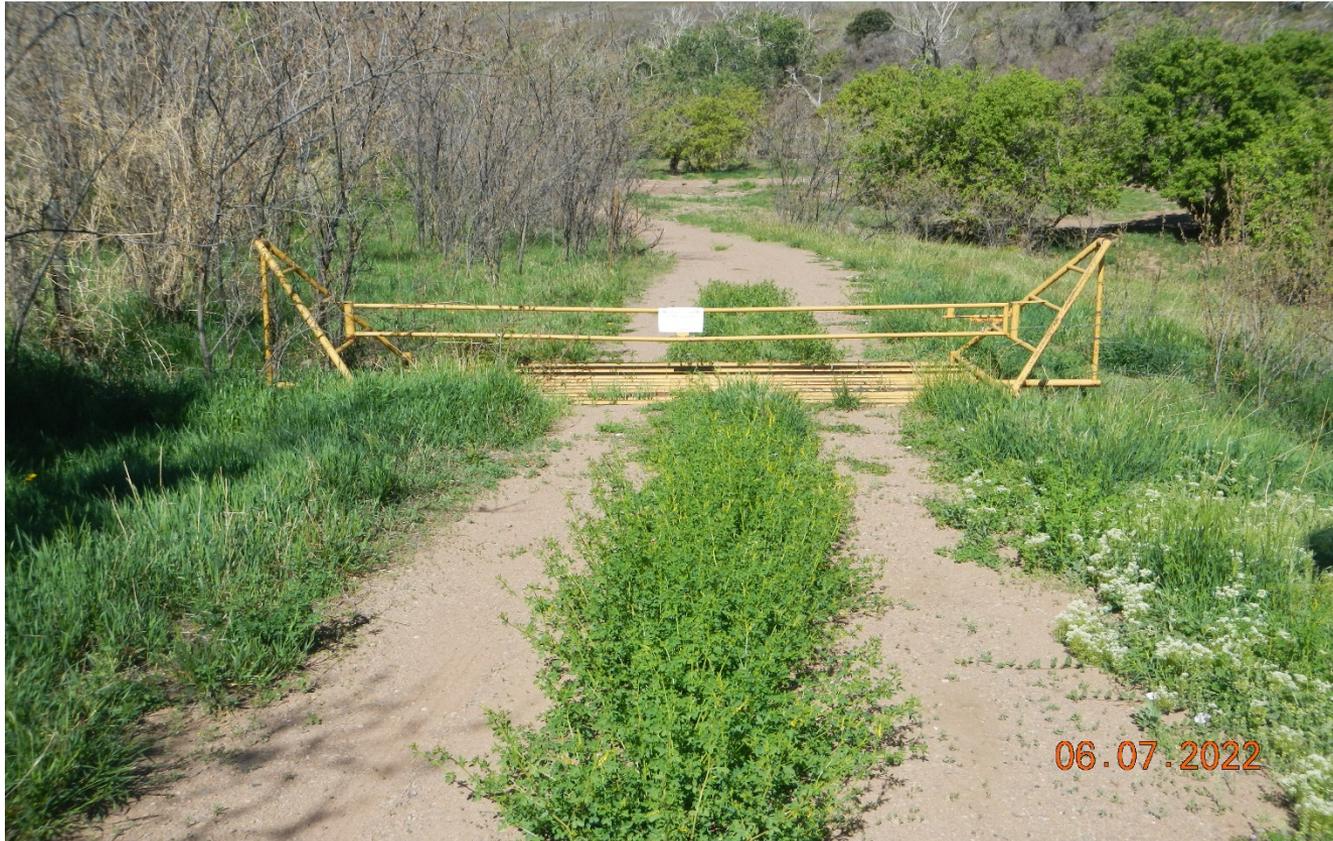
**Photo 2.** Facing toward the access road the beginning of the access road. The cattleguard remains and the road has not been reclaimed.

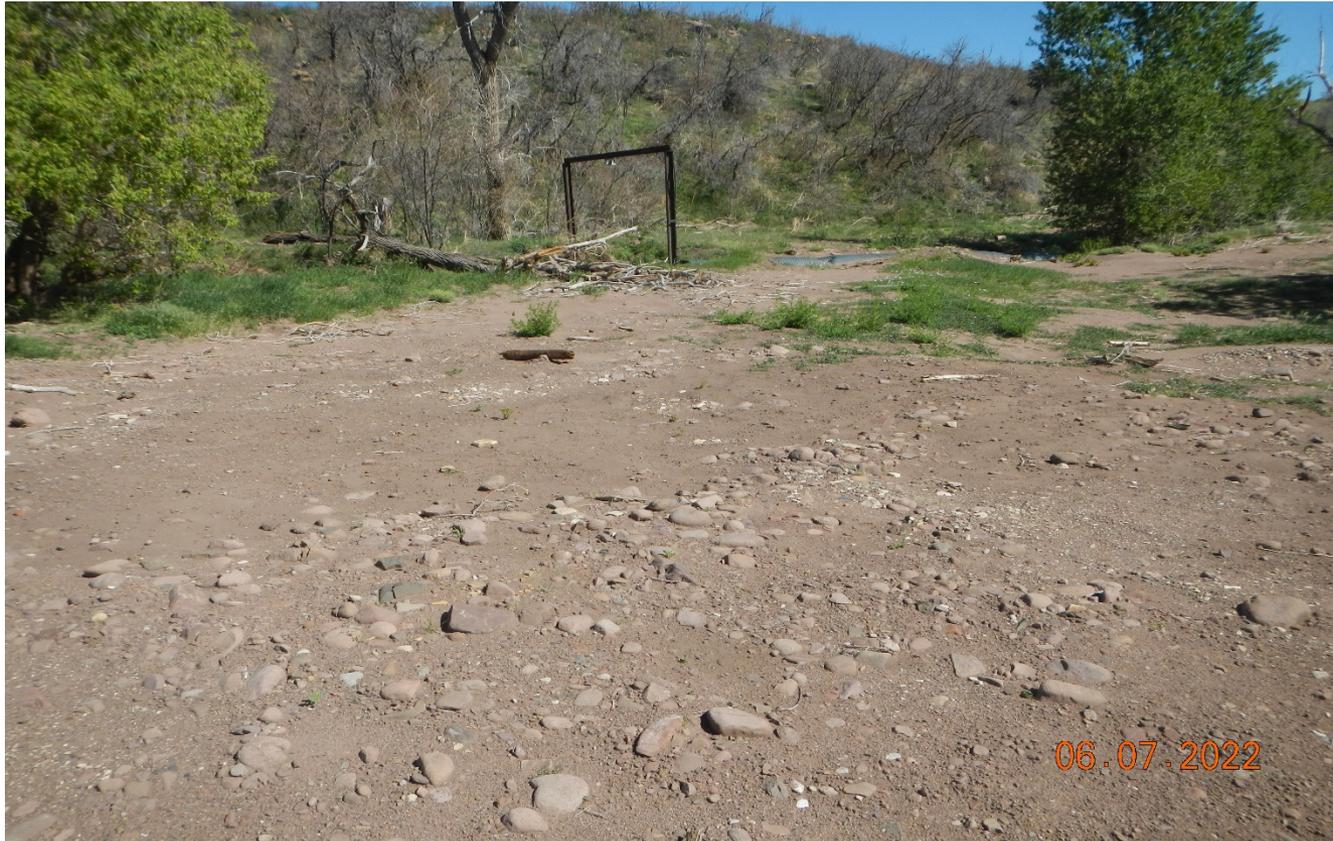
**Photo 3.** There has been erosion of the road near the stream crossing which has not been repaired.

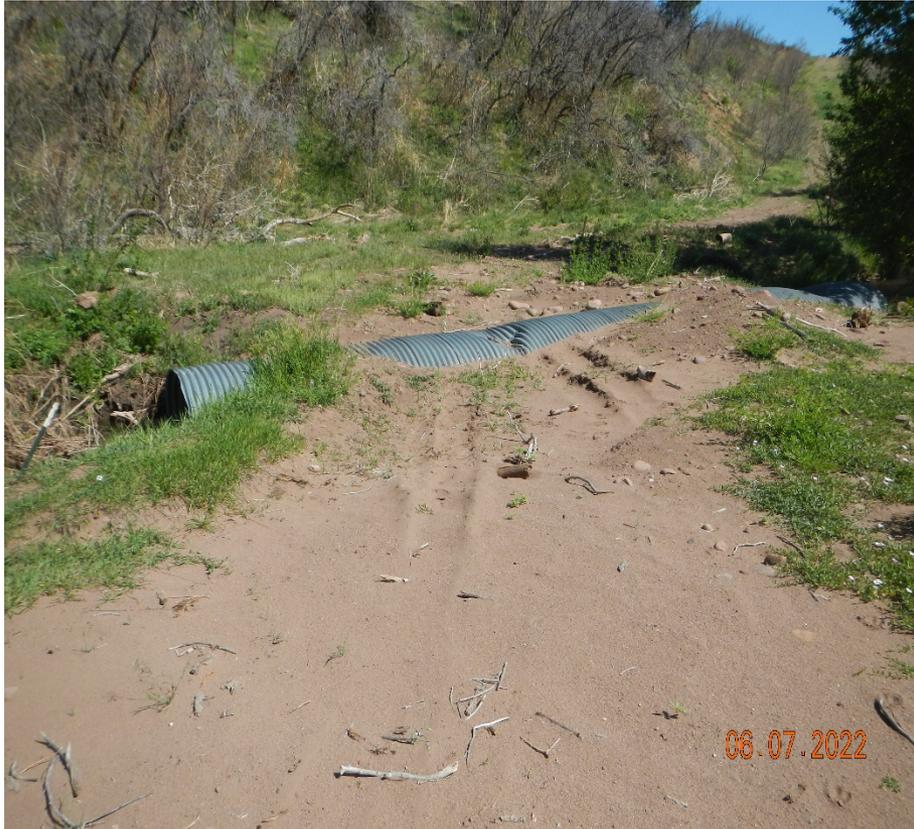
**Photo 4.** Facing toward the culvert at the stream crossing. The culvert has become exposed due to erosion and has not been repaired.

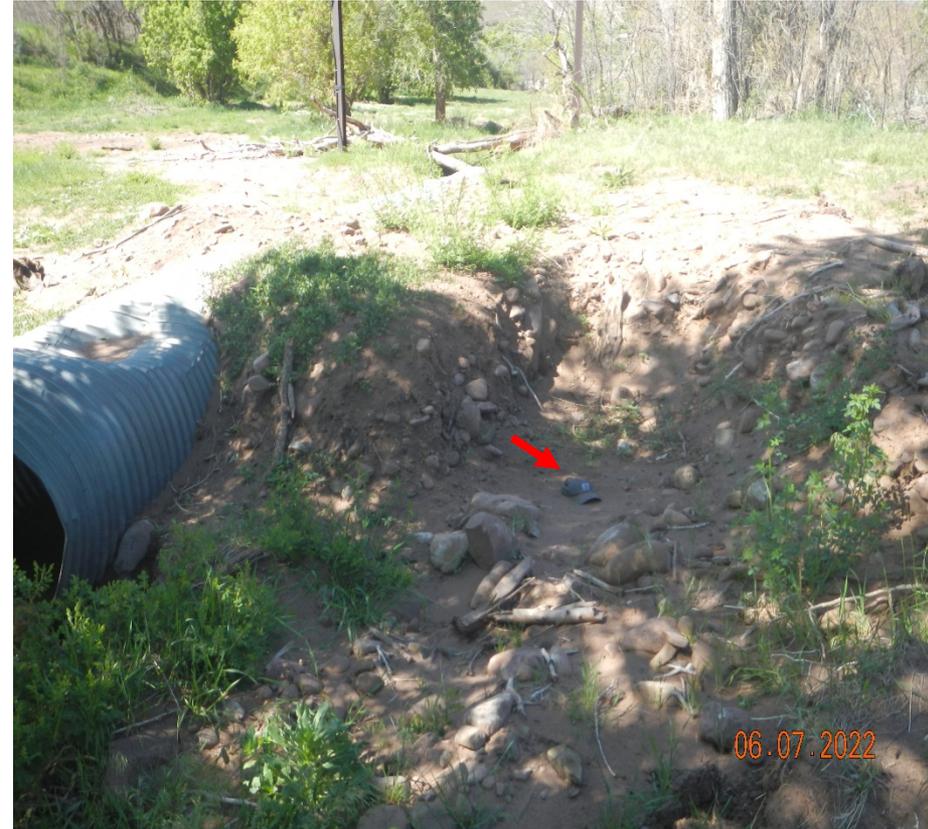
**Photo 5.** Facing toward the culvert outlet. An erosion gully has formed at the stream crossing of the access road. Red arrow points to a hat for scale.

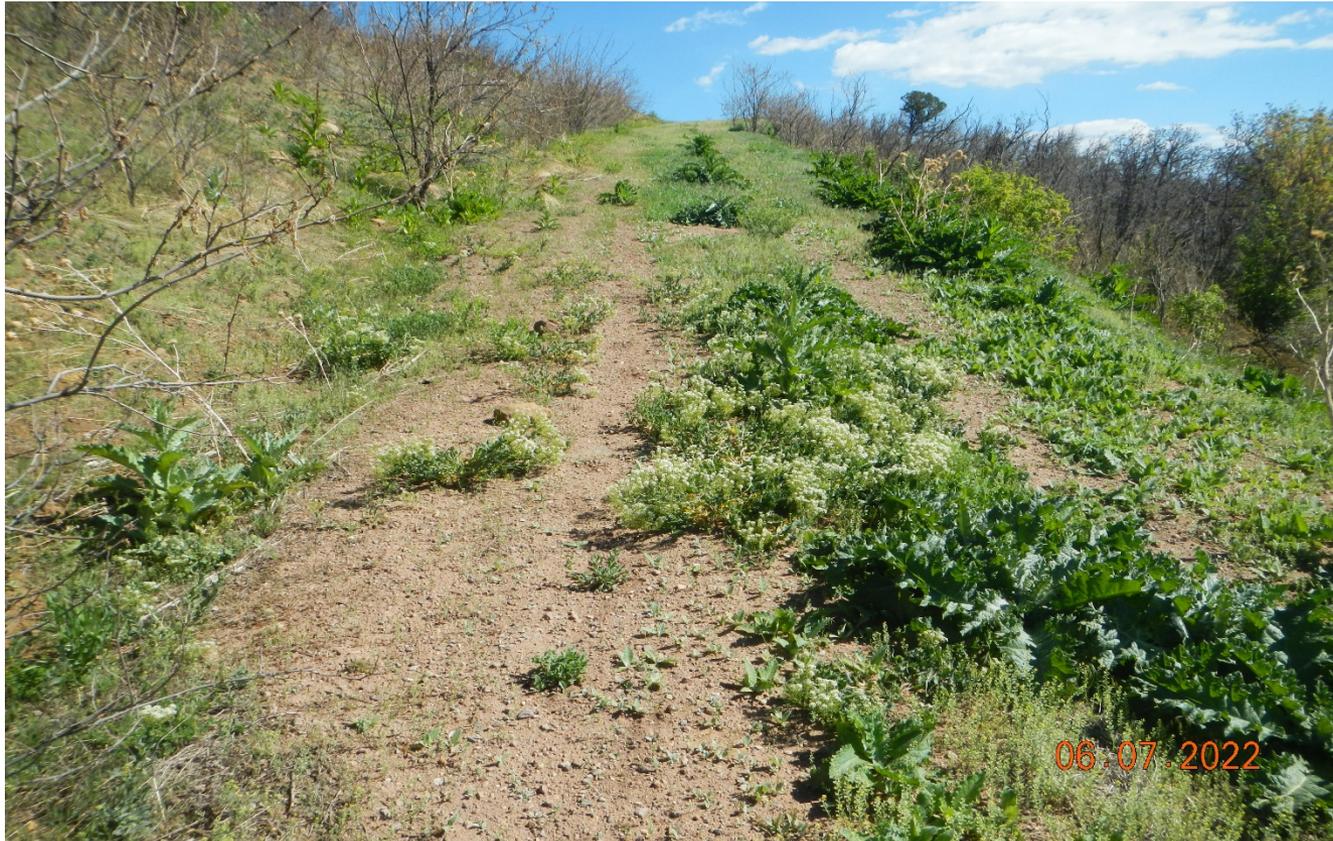
**Photo 6.** Facing north along the access road which has not been recontoured and reclaimed. There are numerous noxious weeds along the road. Noxious weeds shown in this area is Hoary crest and Scotch thistle.

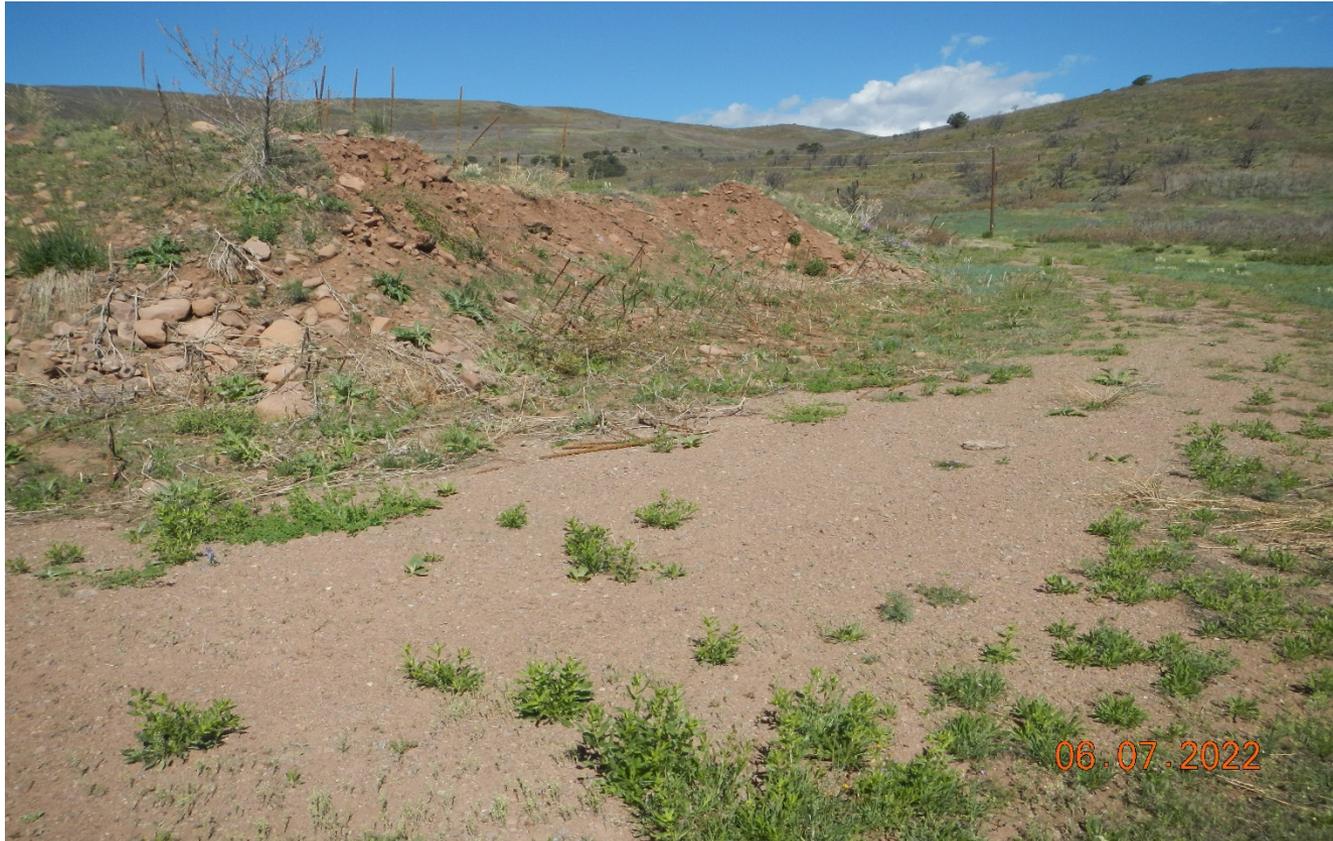
**Photo 7.** Facing northwest toward the fill slope of the location approximately 10 ft. in height. There are numerous noxious weeds growing along the fill slope of the location.

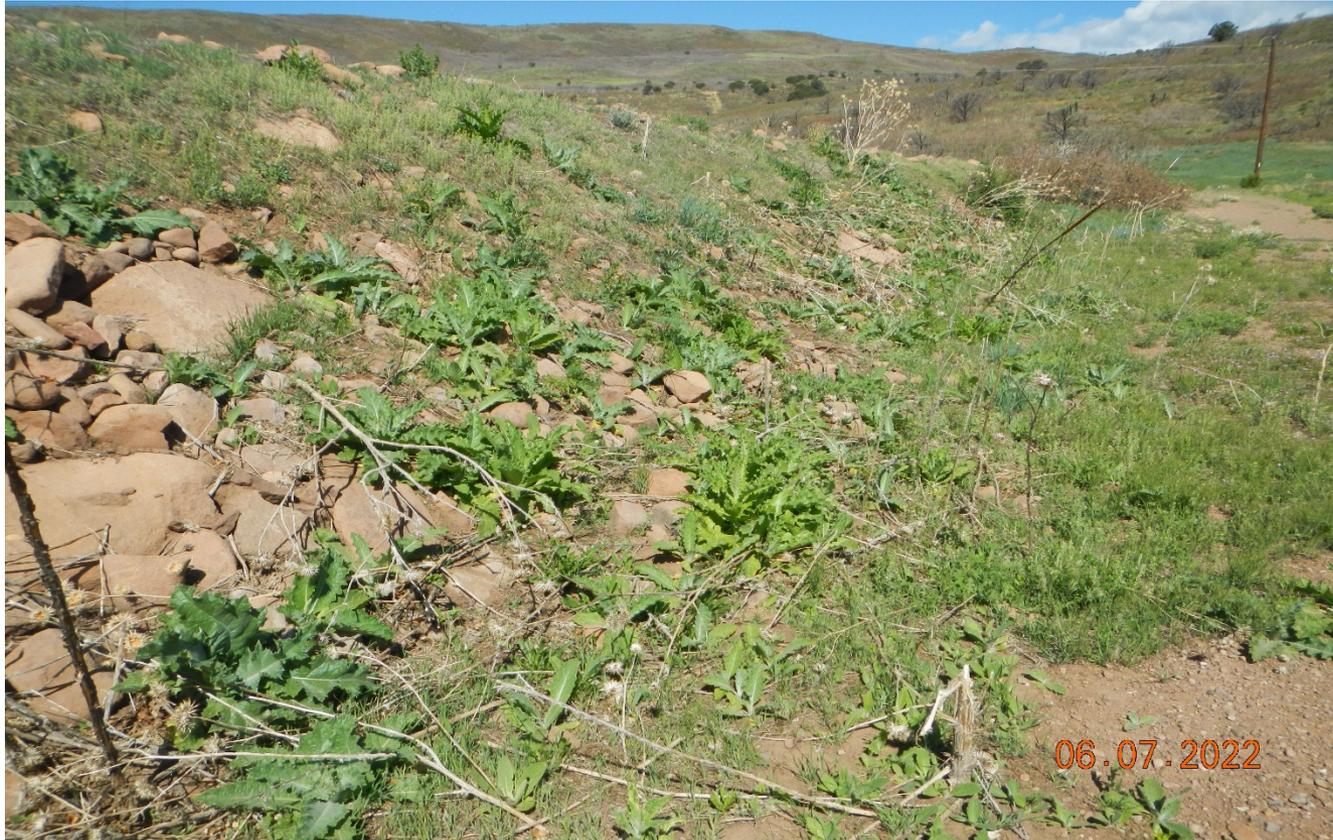
**Photo 8.** Facing northwest along the fill slope. There are numerous noxious weeds along the fill slope. Noxious weeds observed include: Common mullien, Musk thistle, Plumeless thistle, and Scotch thistle.

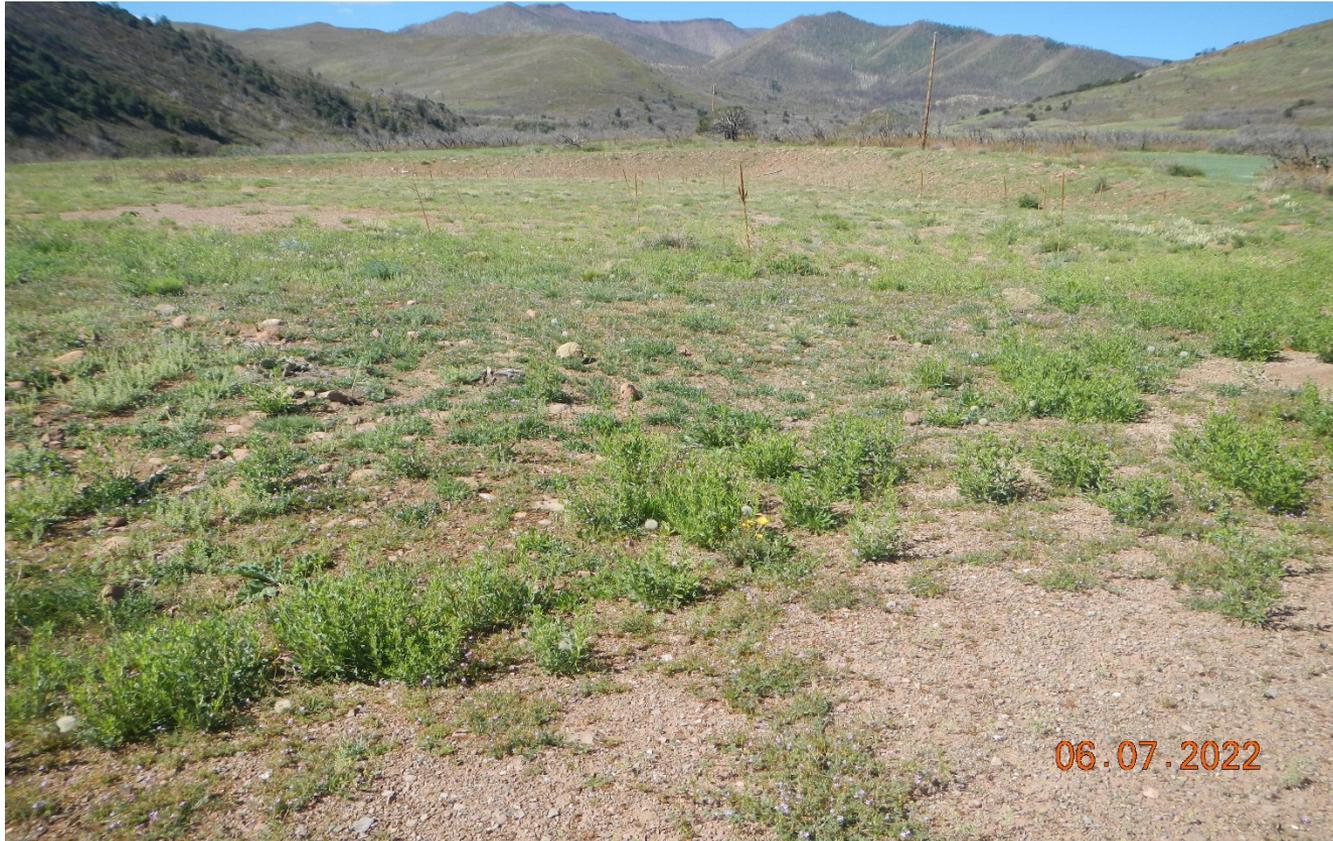
**Photo 9.** Facing west toward the location which has not been recontoured and reclaimed. The location is which is approximately 2.3 acres in size.

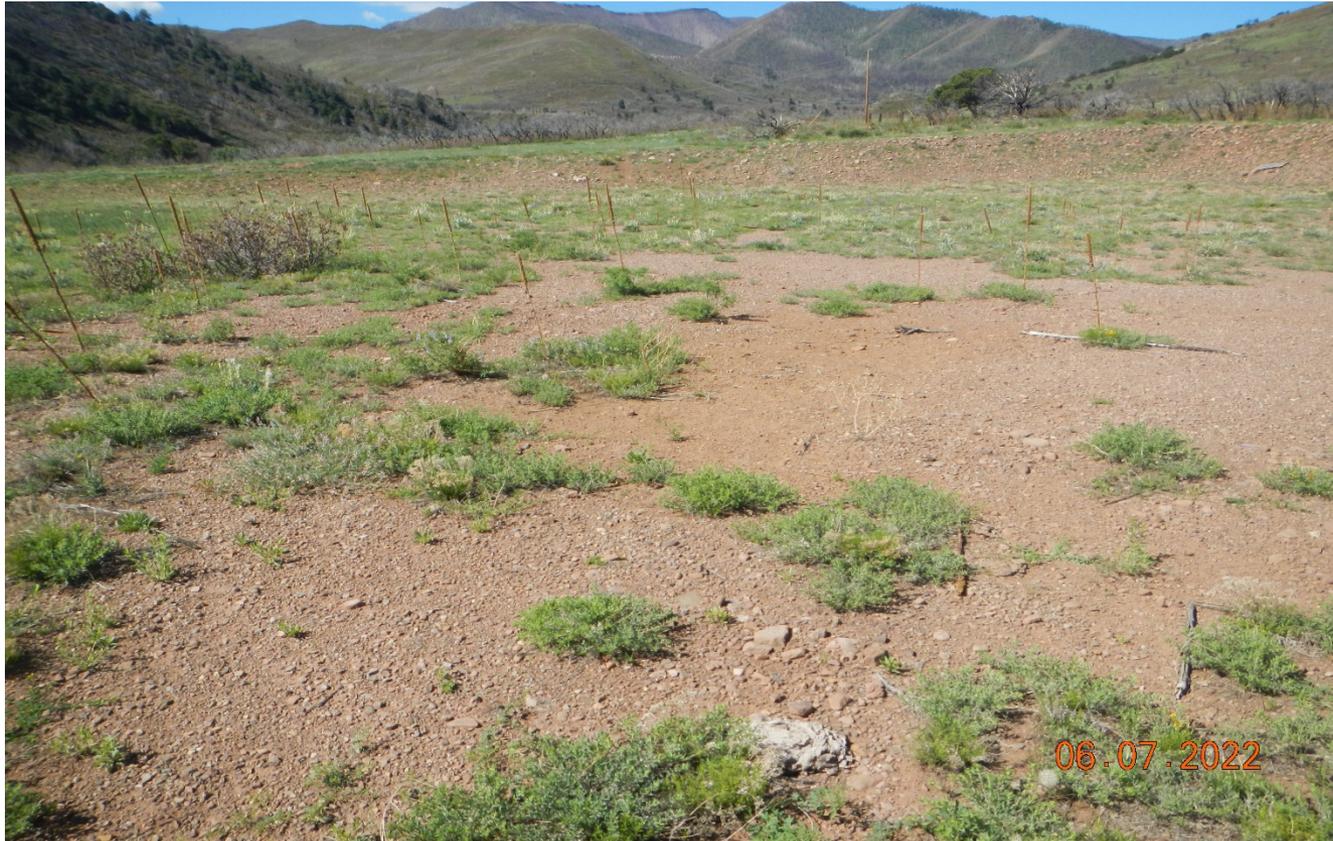
**Photo 10.** Center of the location facing west. The location is not reclaimed and soils are compacted. There are numerous weeds throughout the location.

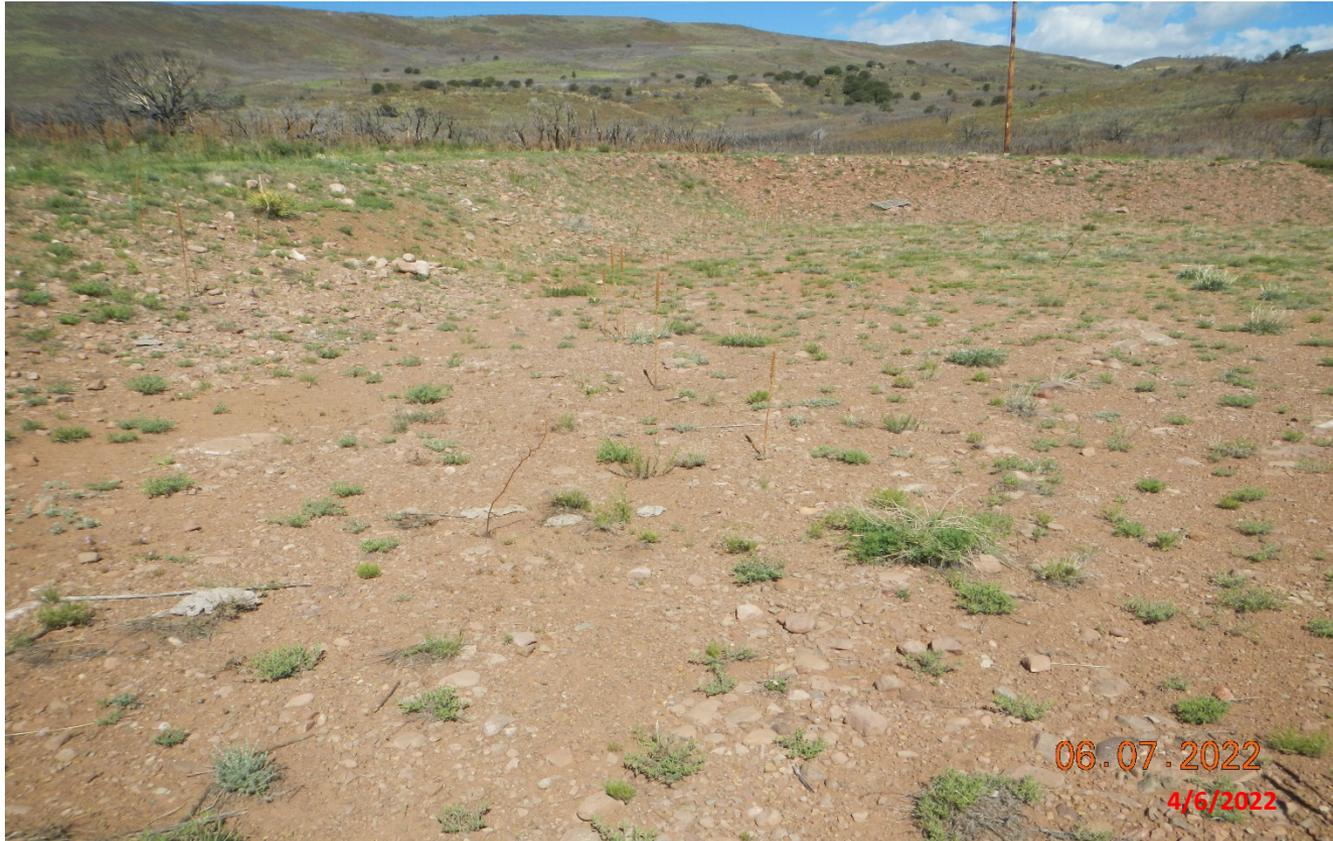
**Photo 11.** Facing northwest toward the cut slope of the location which is approximately 12 ft. in height.

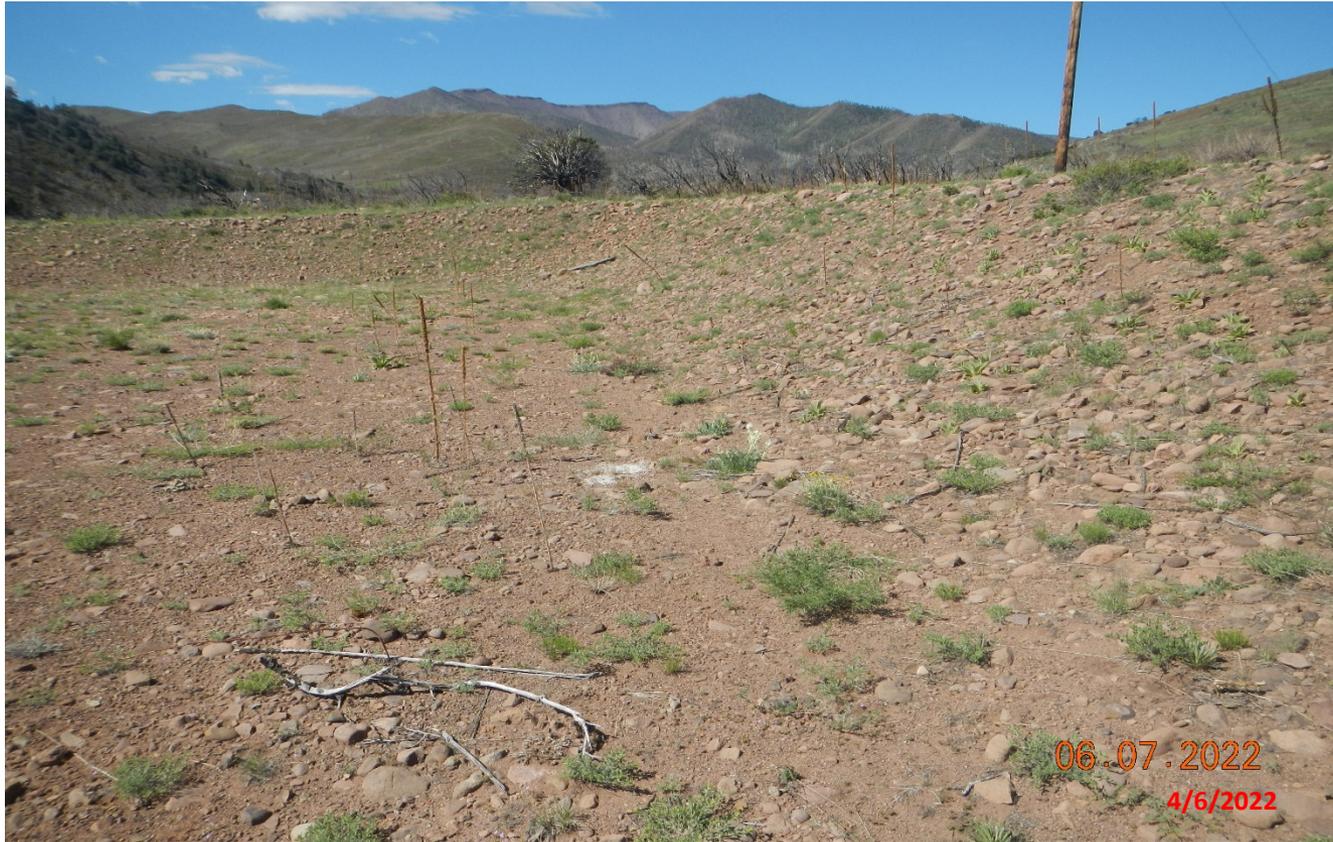
**Photo 12.** Facing southwest toward the cut slope of the location which is approximately 12 ft. in height. There are noxious weeds (Mullein) along the cut slope.

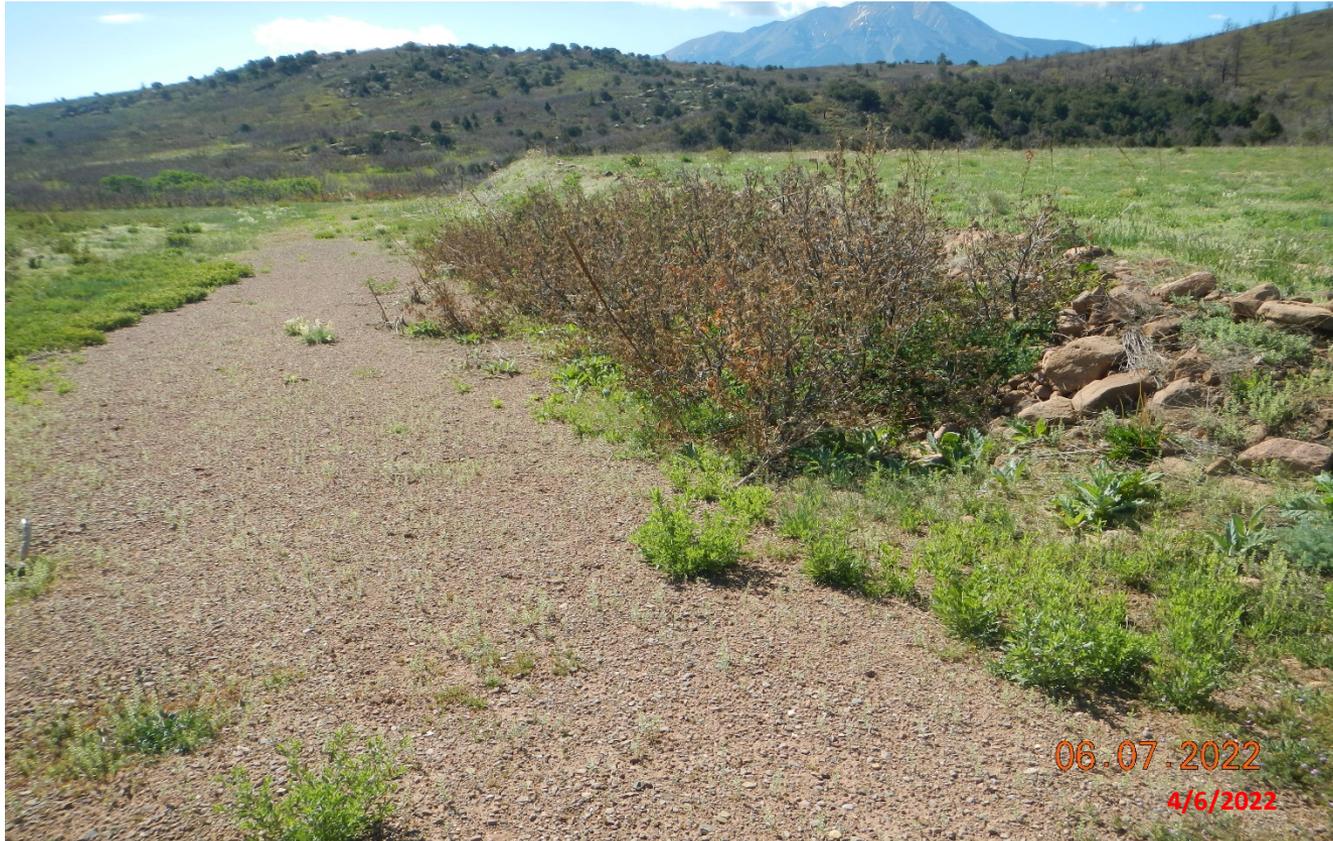
**Photo 13.** Facing south back toward the access road and the fill slope at the north side of the location.

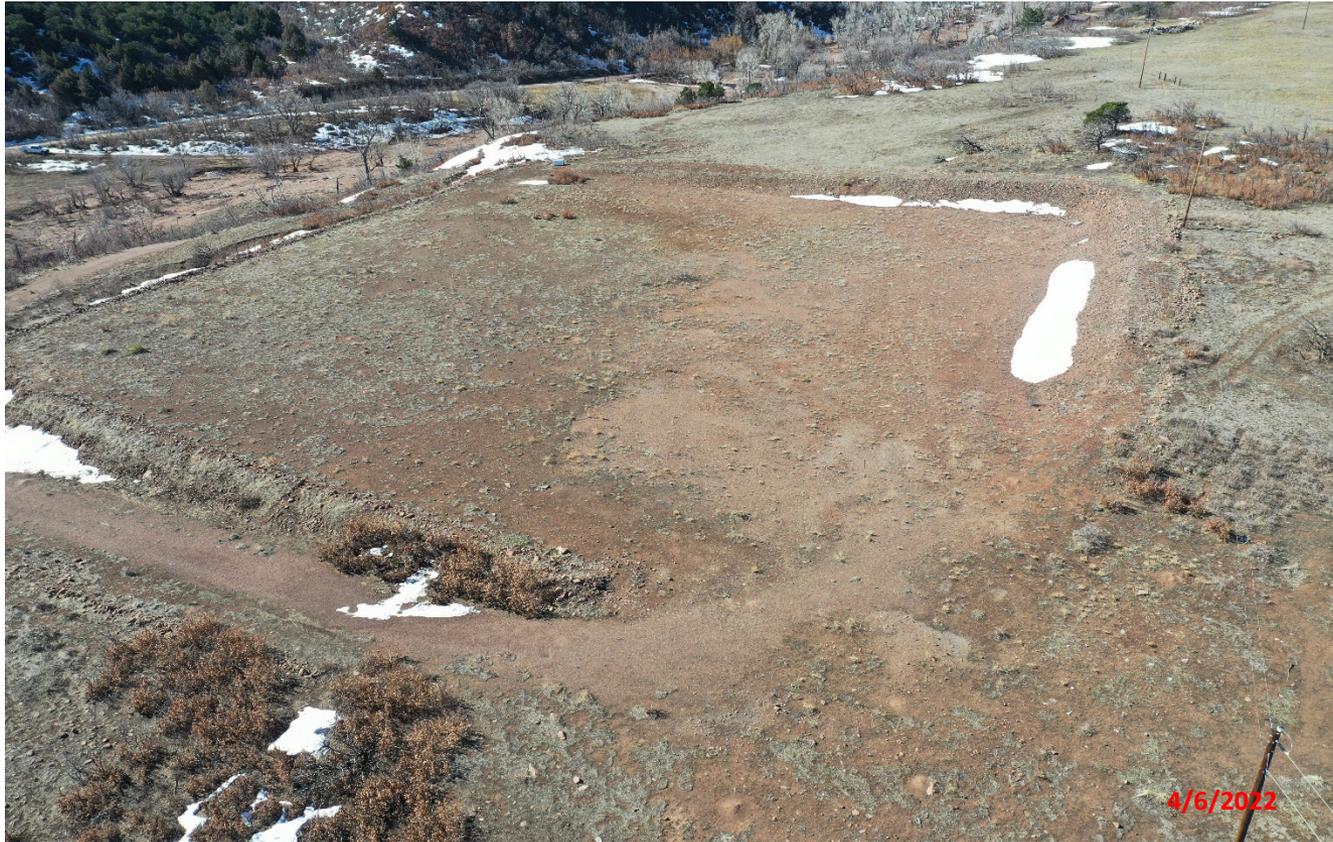
**Photo 14.** Facing south overlooking the location disturbance which is approximately 2.3 acres in size. The location has not been recontoured and reclaimed and is mostly bare of vegetation. Photo taken during previous inspection.
