Inspection Photos
Location Name: UPRR r23 PAN AM D 2
Location ID: 319939

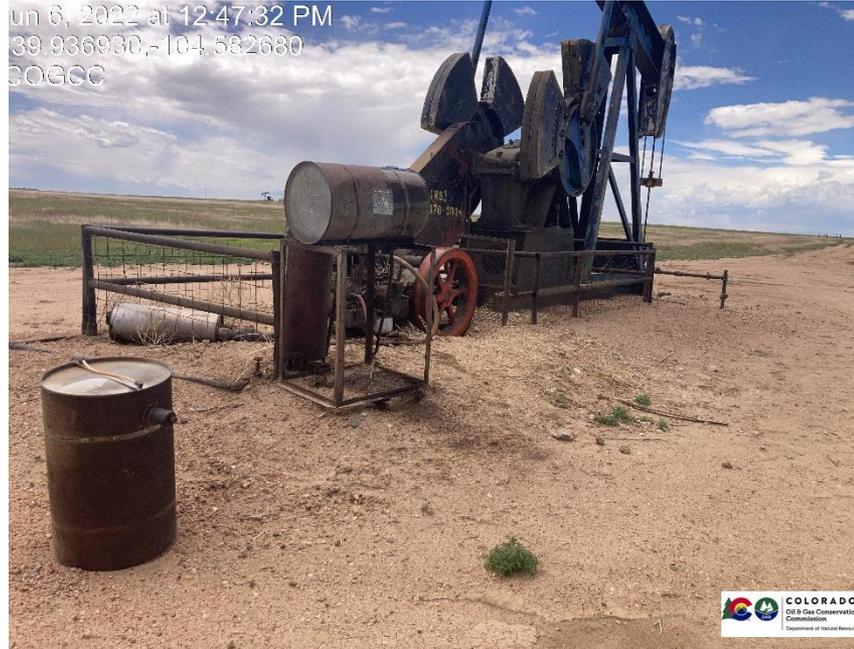
Pic 1 stained soil, mechanical issue with gas motor, trash on location, no BMP under chemical tanks

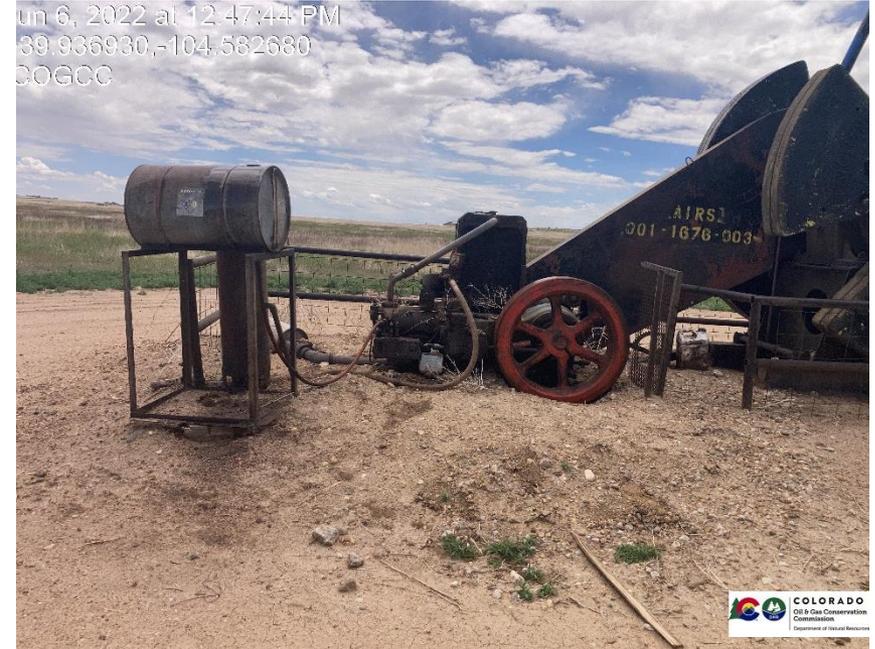
Pic 2 stained soil, mechanical issue with gas motor, trash on location, no BMP under chemical tanks

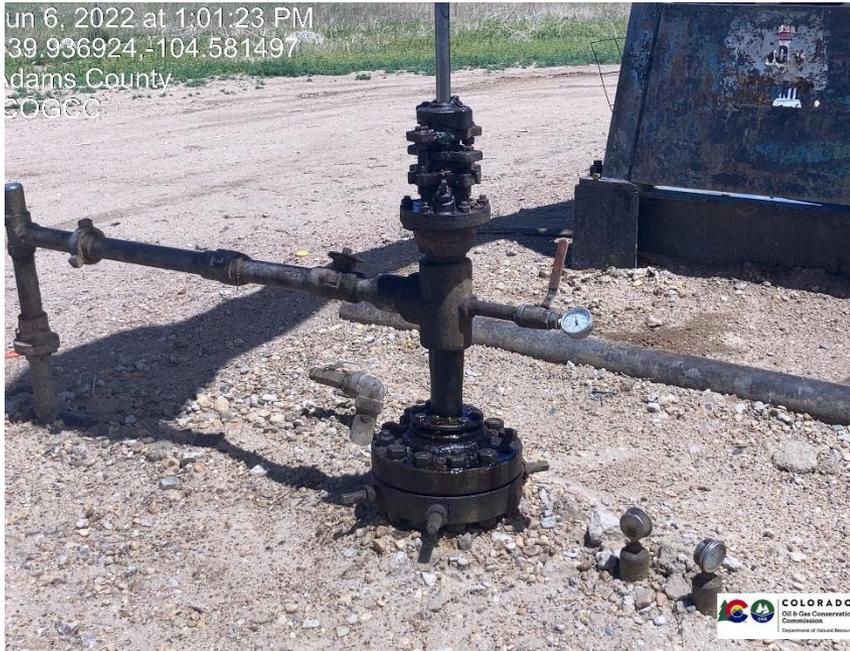
Pic 3 mechanical issue with wellhead, oil is covering wellhead

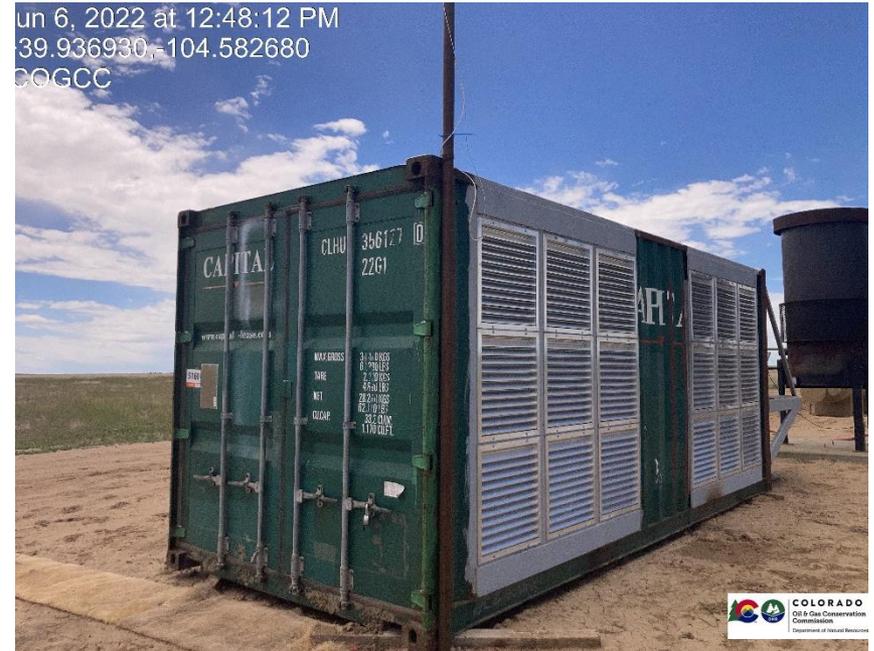
pic 4 crypto currency mining equipment

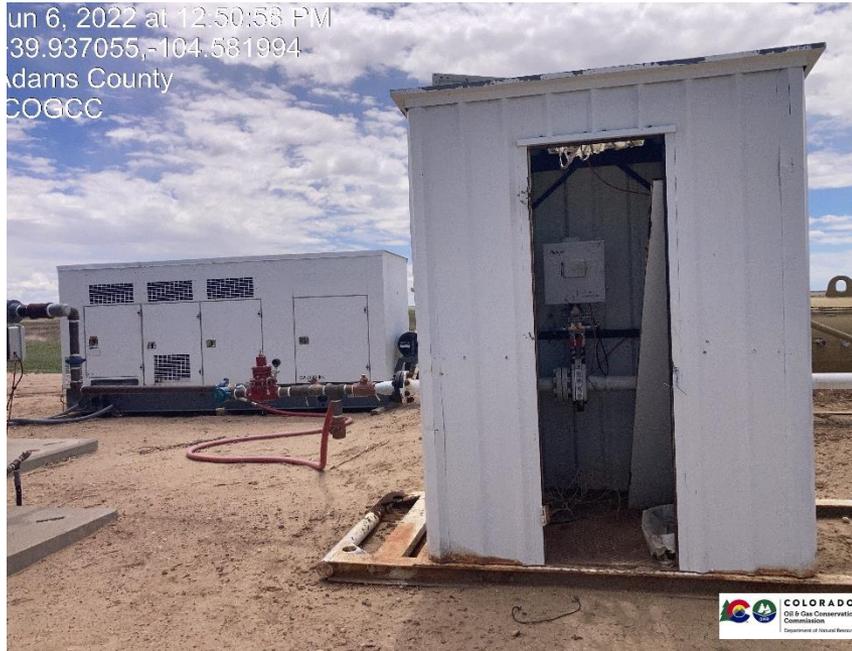
Pic 6 internal gas meter run / natural gas generator

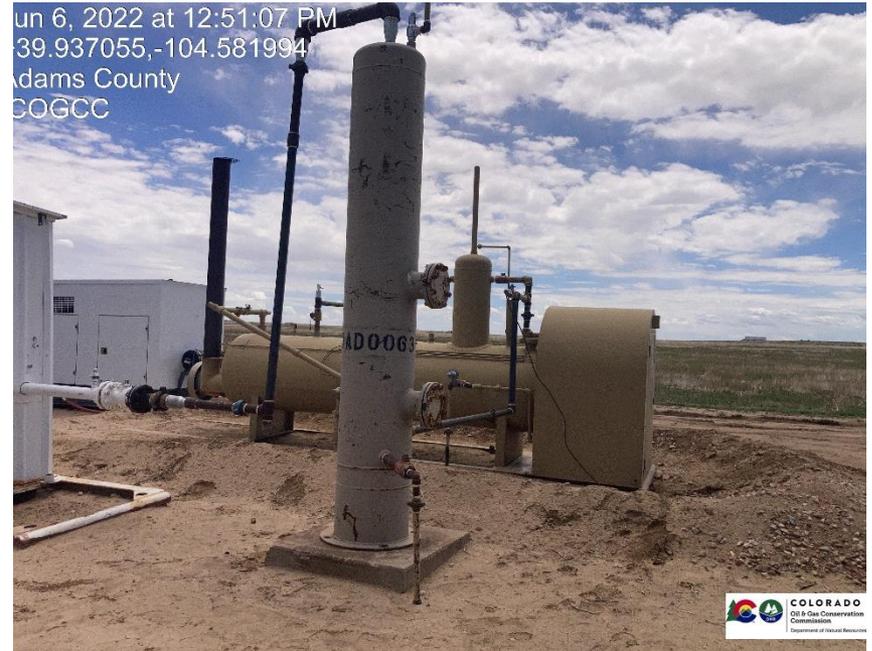
Pic 7 Vertical separator, horizontal separator
