Caerus Piceance LLC
C26NW
Location # 335163

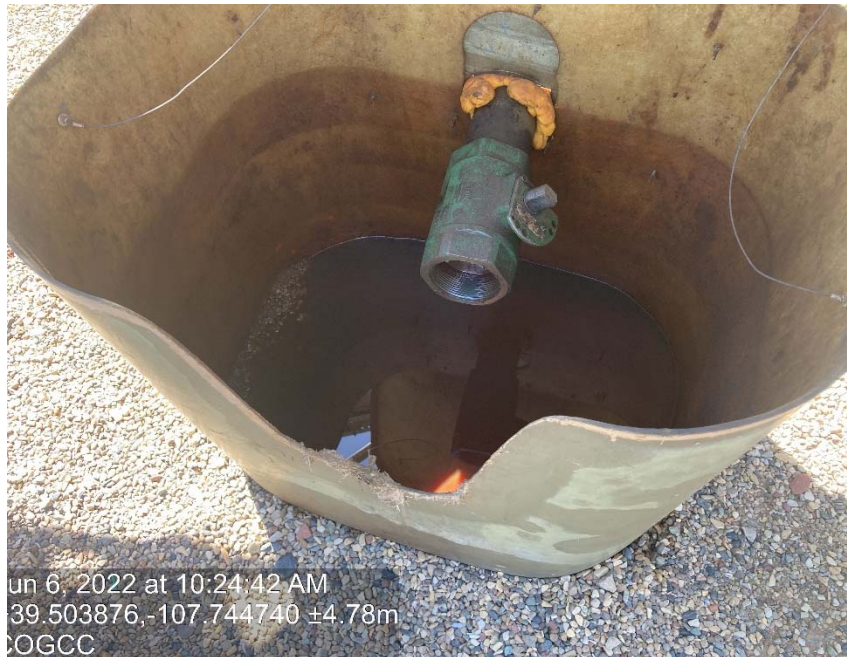
Missing caps/plugs

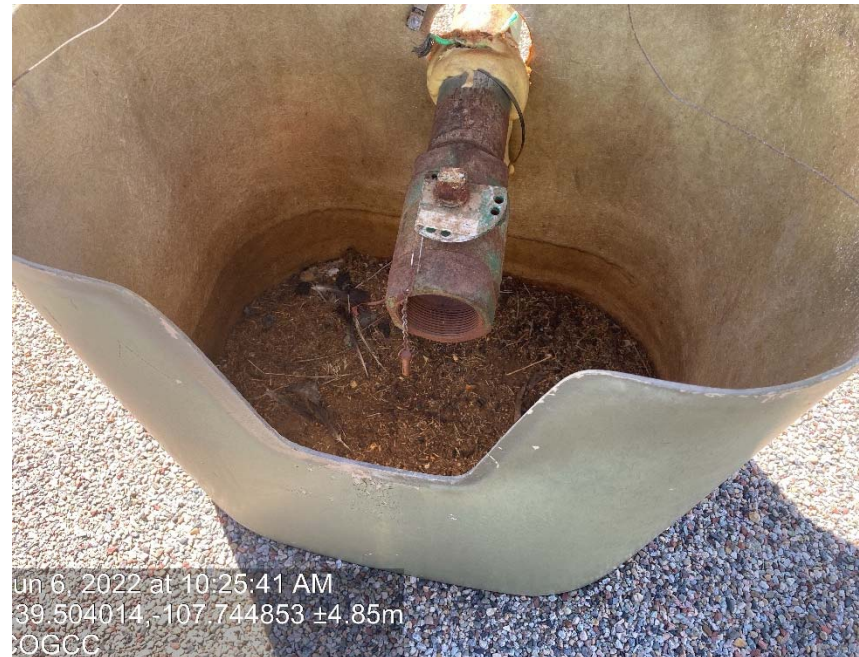
Missing caps/plugs

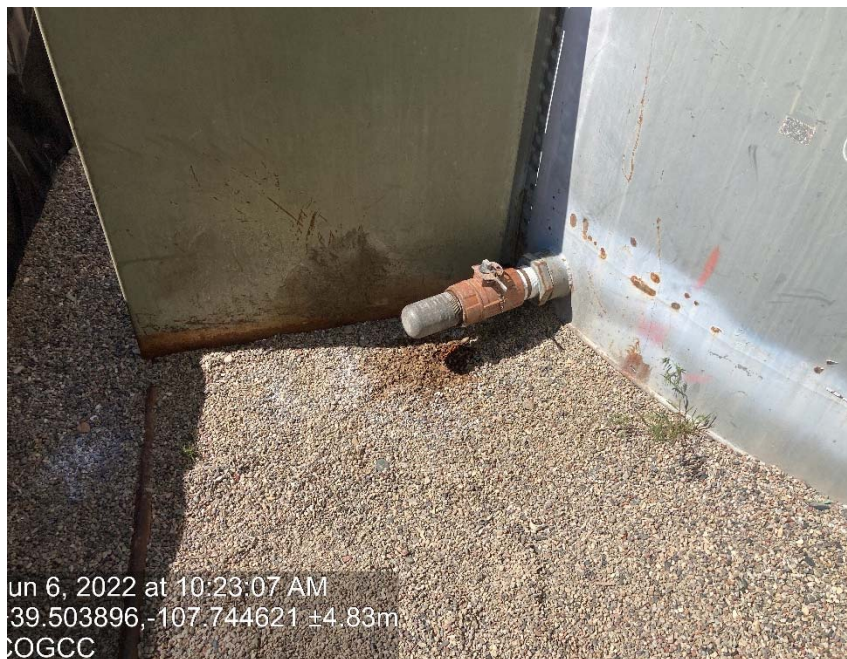
Leaking valve on tank

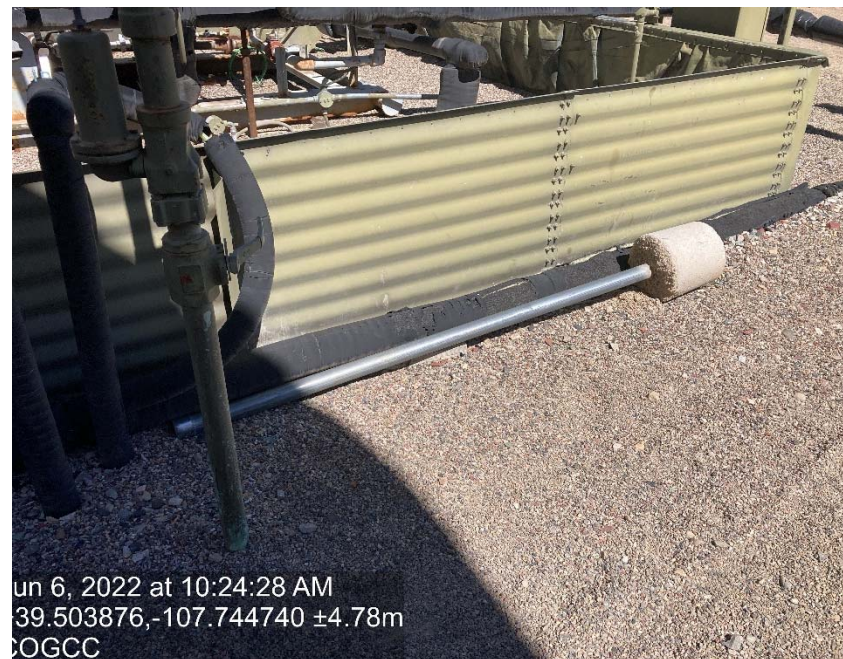
Debris

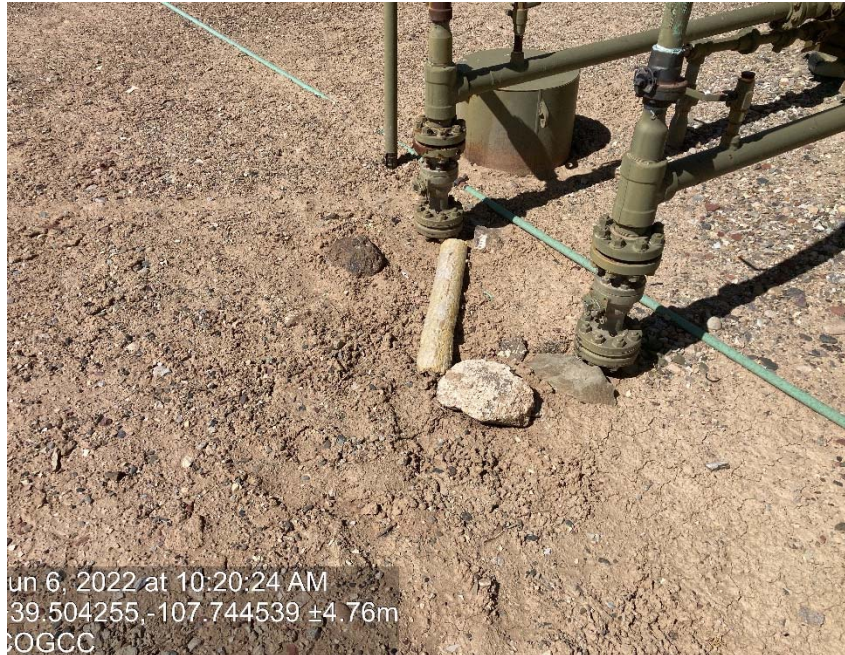
Debris

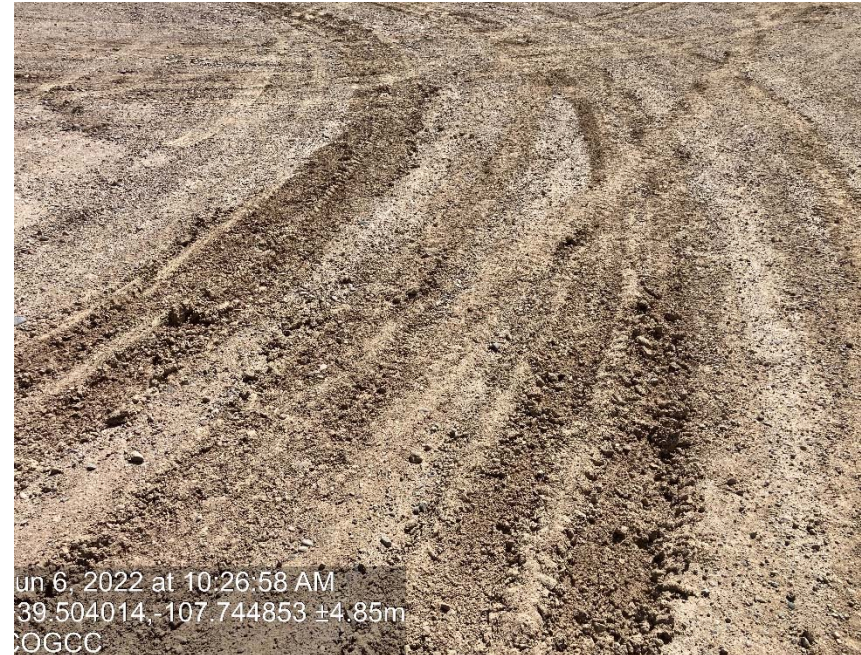
Lack of stabilization/ compaction

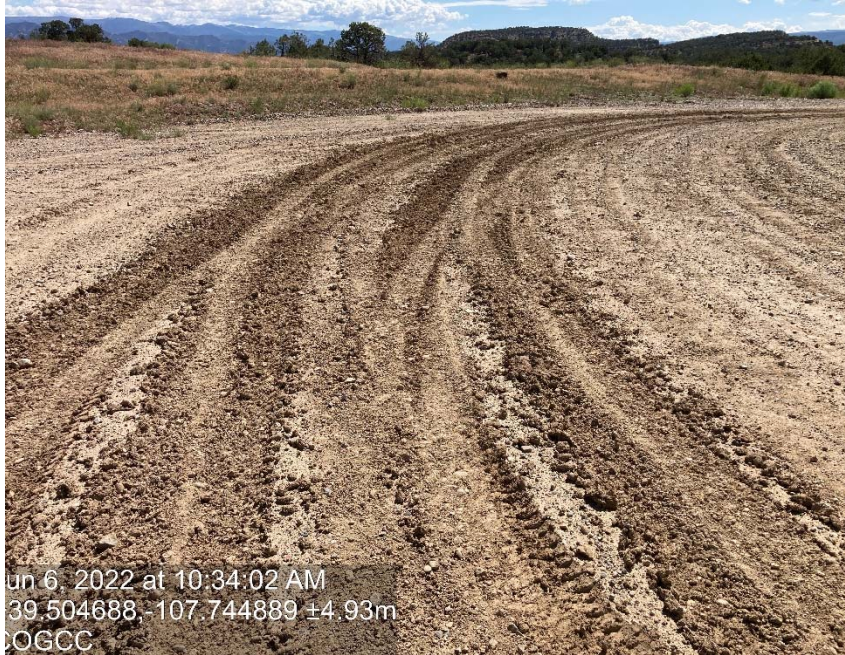
Lack of stabilization/ compaction

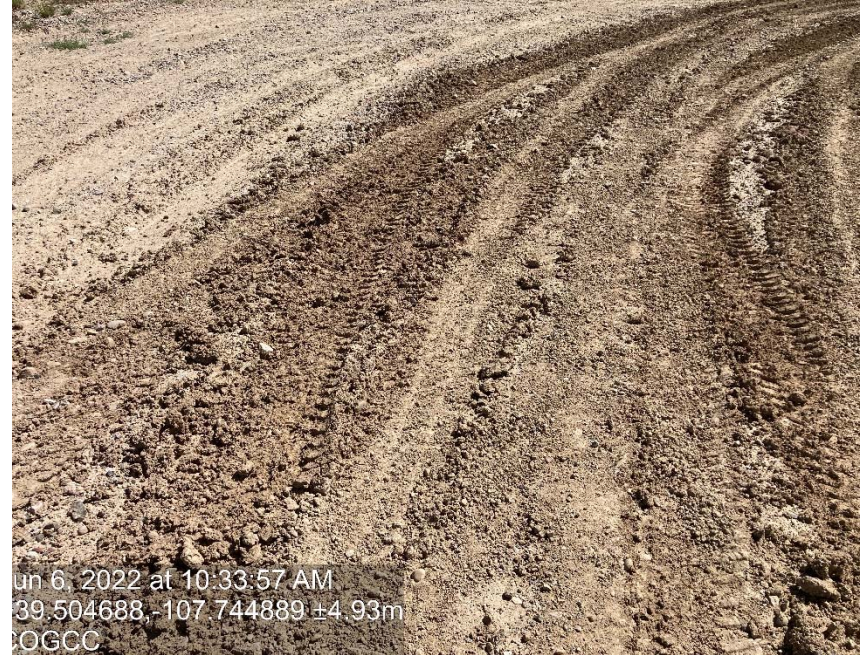
Lack of stabilization/ compaction

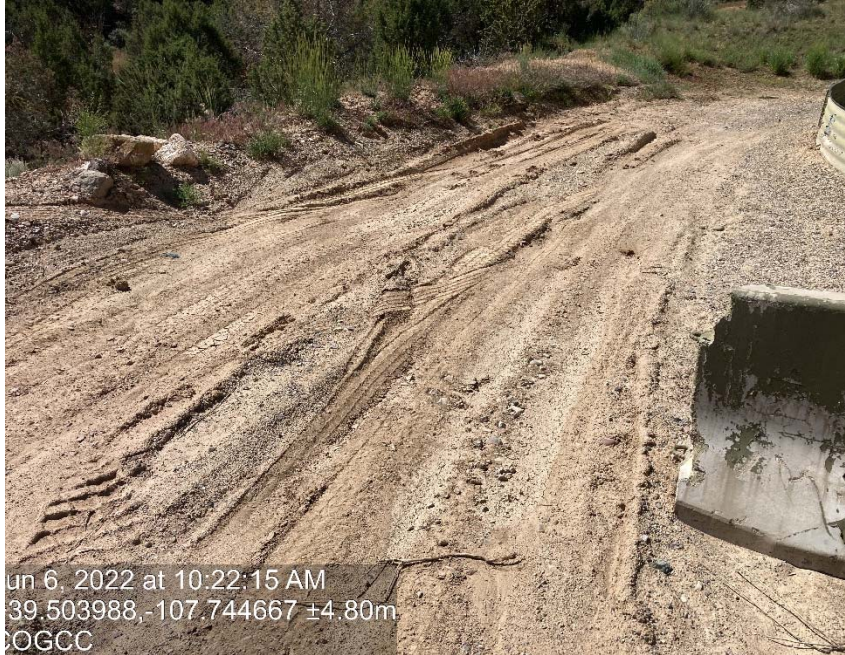
Lack of stabilization/ compaction

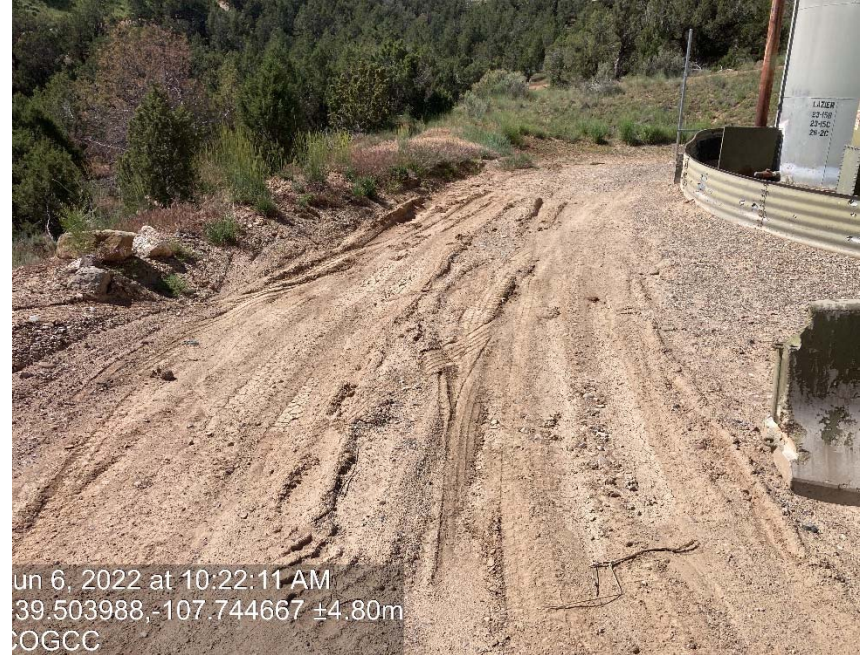
Lack of stabilization/ compaction
