Inspection Photos
Location Name: Olander #2
Location ID: 307187

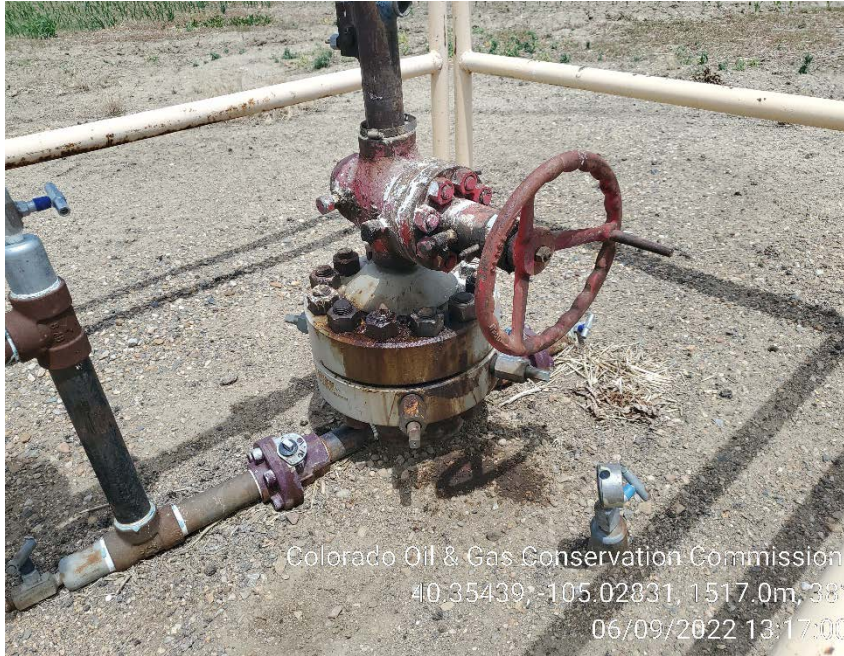
Master valve leak and stained soil

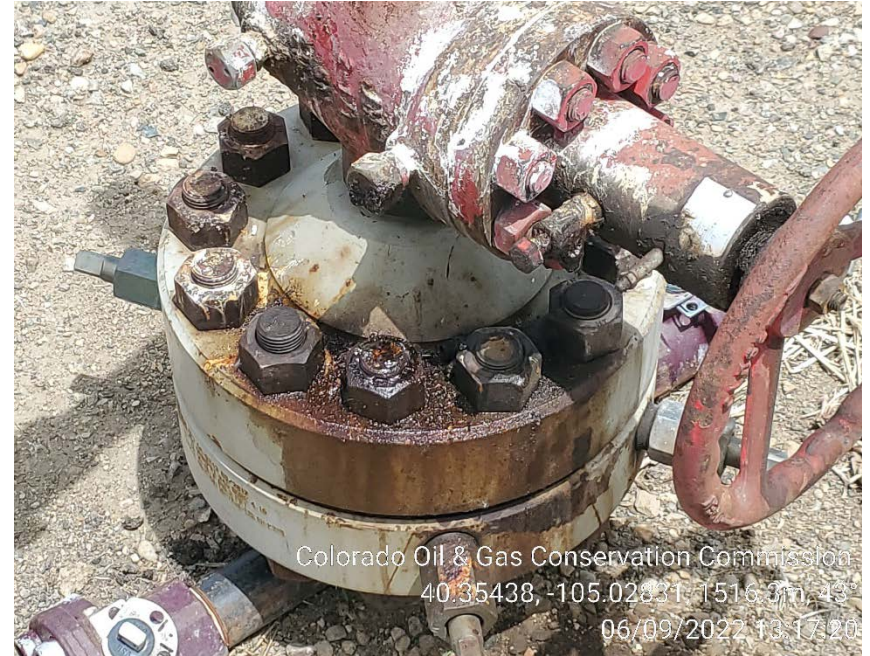
Master valve leak and stained soil
