Inspection Photos

API: 071-06037

Operator: OXY USA INC

Inspection Date: 6/16/2022

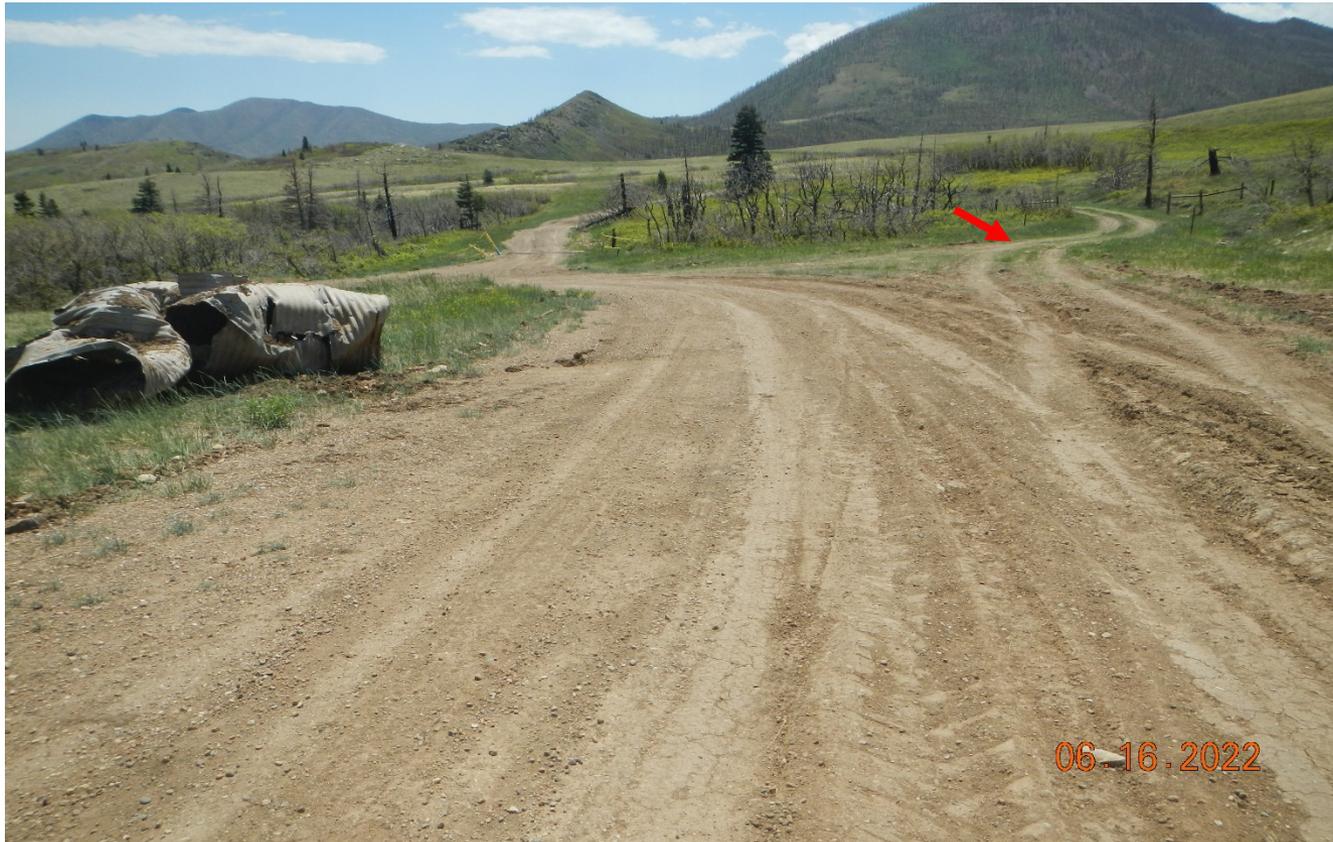
Photo 1. Facing southeast along the access road near Compressor facility. There is damaged culvert that need to be removed. Additionally vehicles are driving on the road at red arrow instead of the access road at the left due to damaged cattleguard. Vehicle must stay on original access road boundary. Additional disturbance will need to be reclaimed.

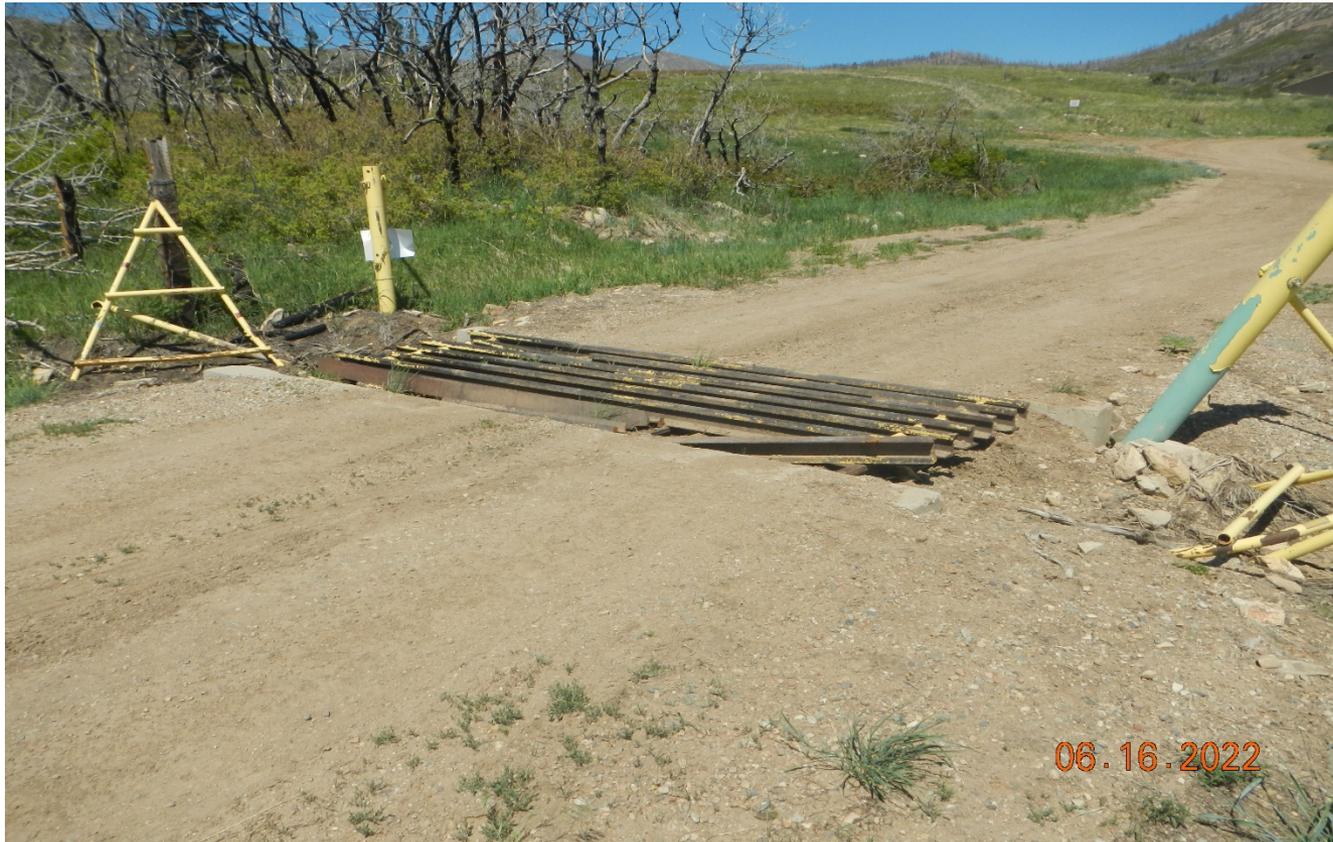
Photo 2. The cattle guard is damaged and needs to be repaired or removed.

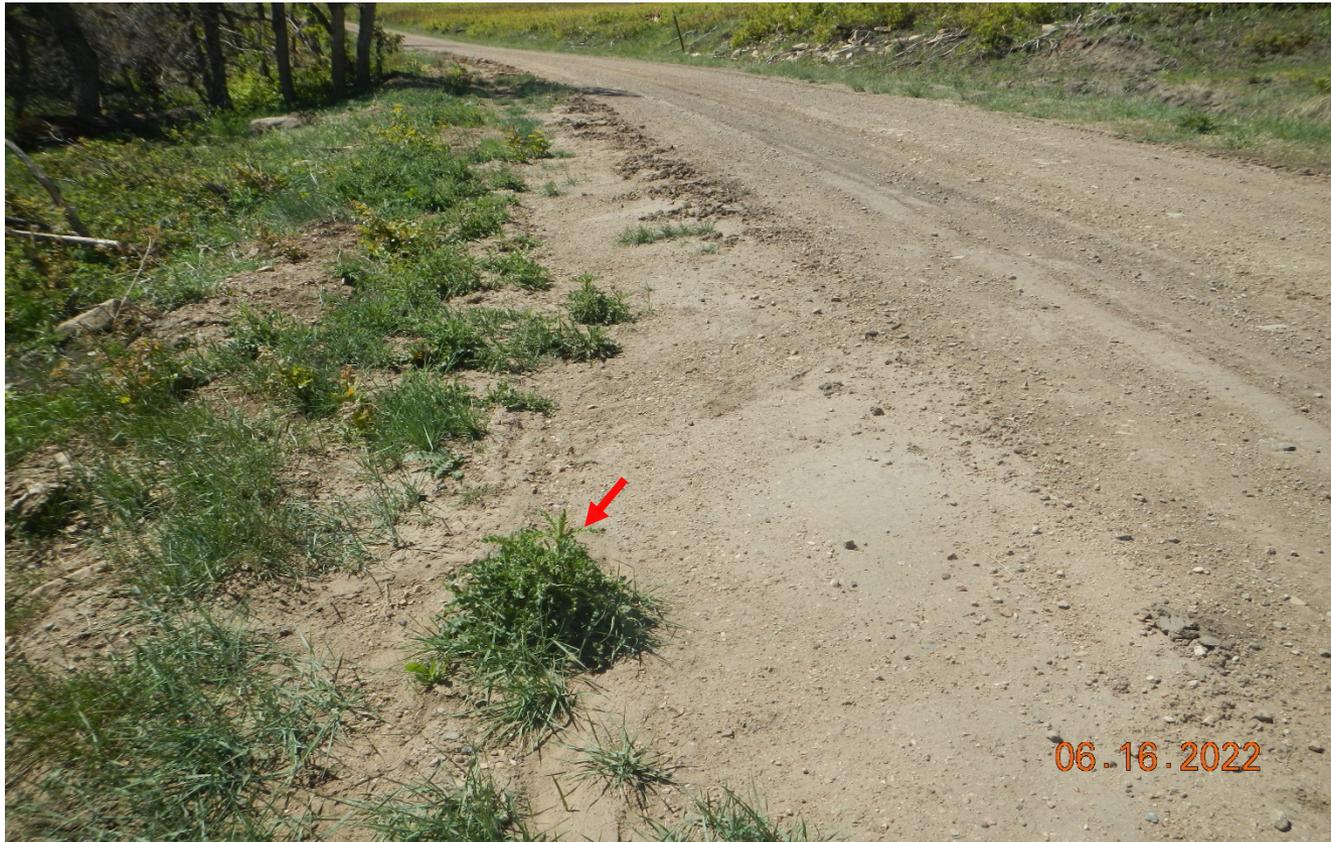
Photo 3. There are noxious weeds along the access road that need to be controlled.
Red arrow → Canada thistle

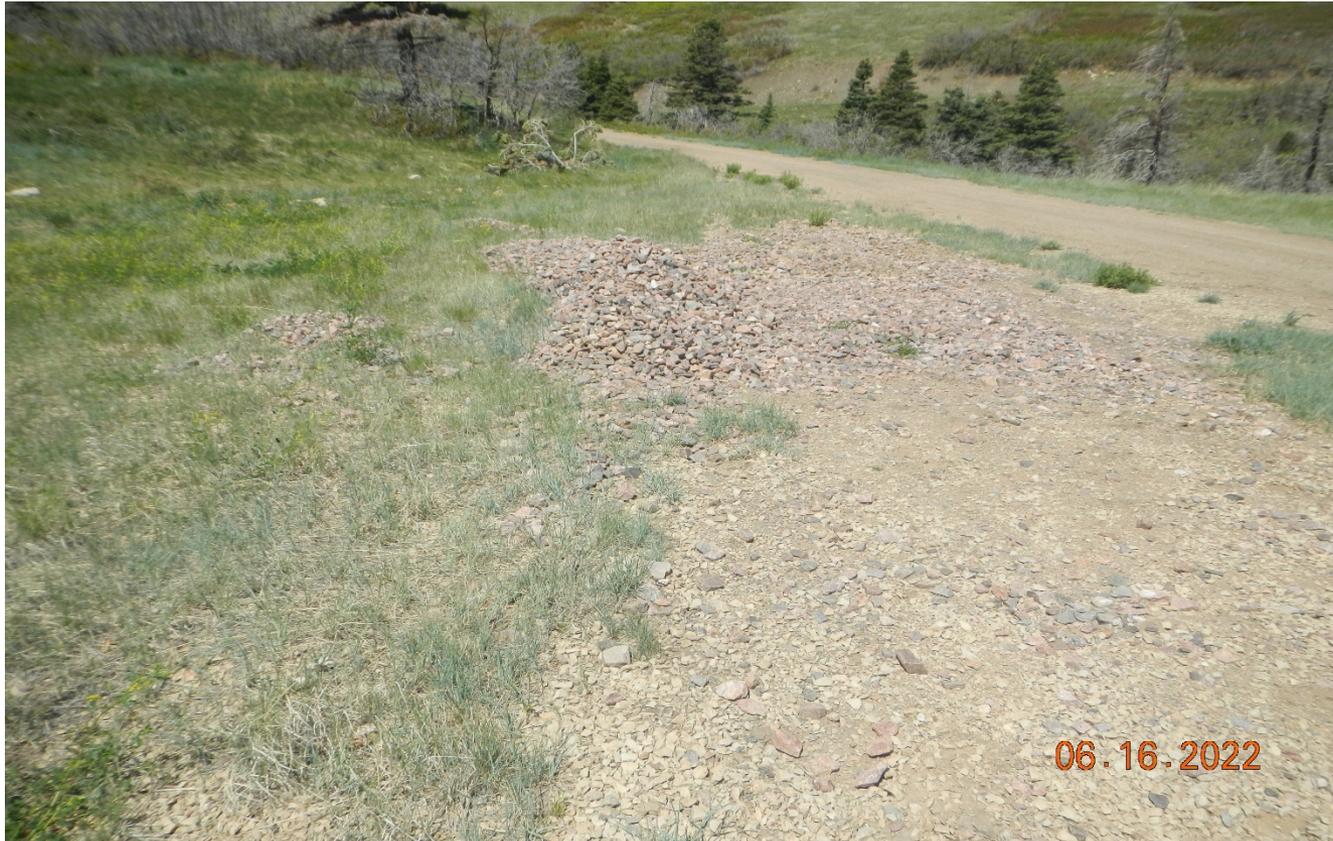
Photo 5. There is gravel debris from a pile stored on location. The leftover gravel needs to be removed.

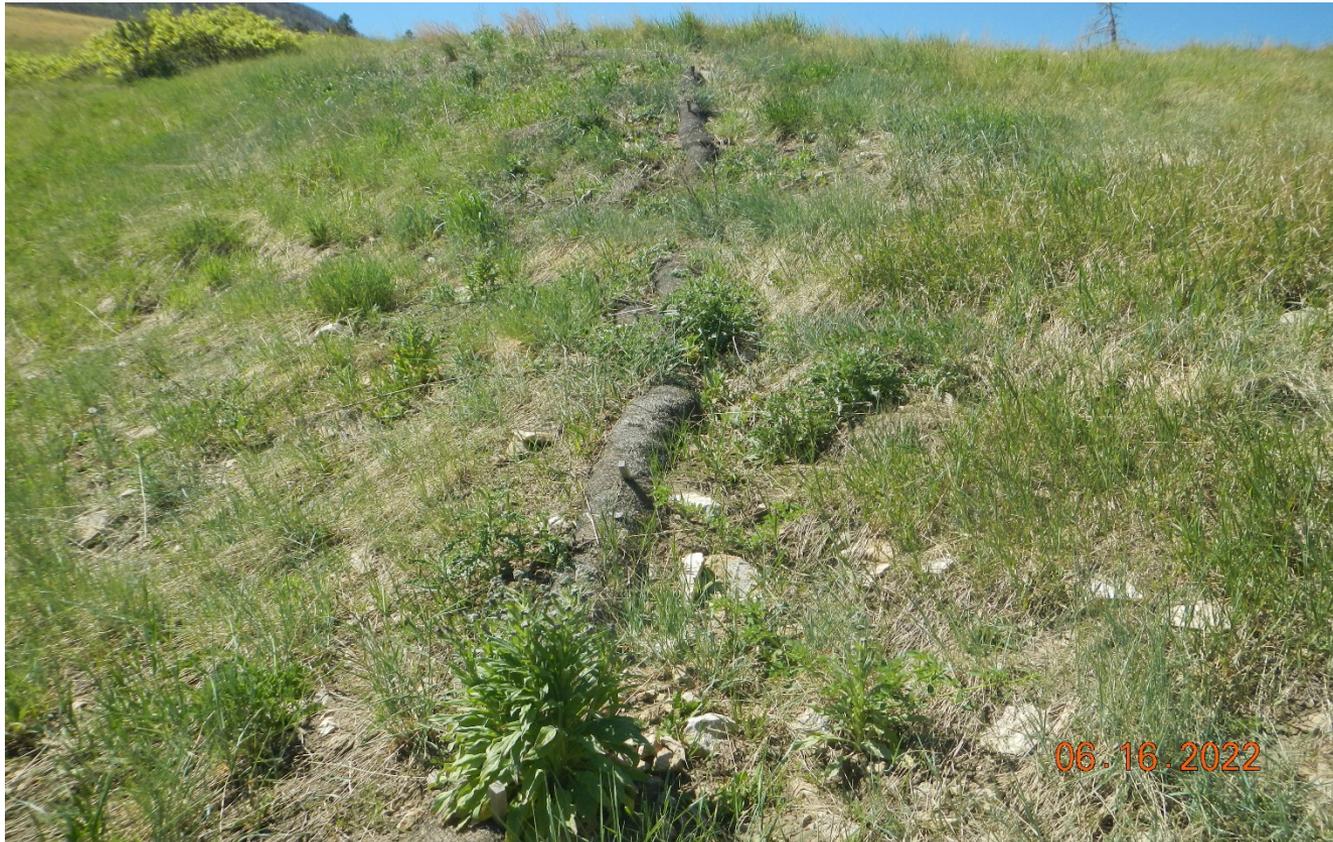
Photo 6. There are still degraded wattles on the cut slope that need to be removed. There are noxious weeds in this area that need to be controlled.
