Inspection Photos

API: 055-06041

Operator: OXY USA INC

Inspection Date: 6/16/2022

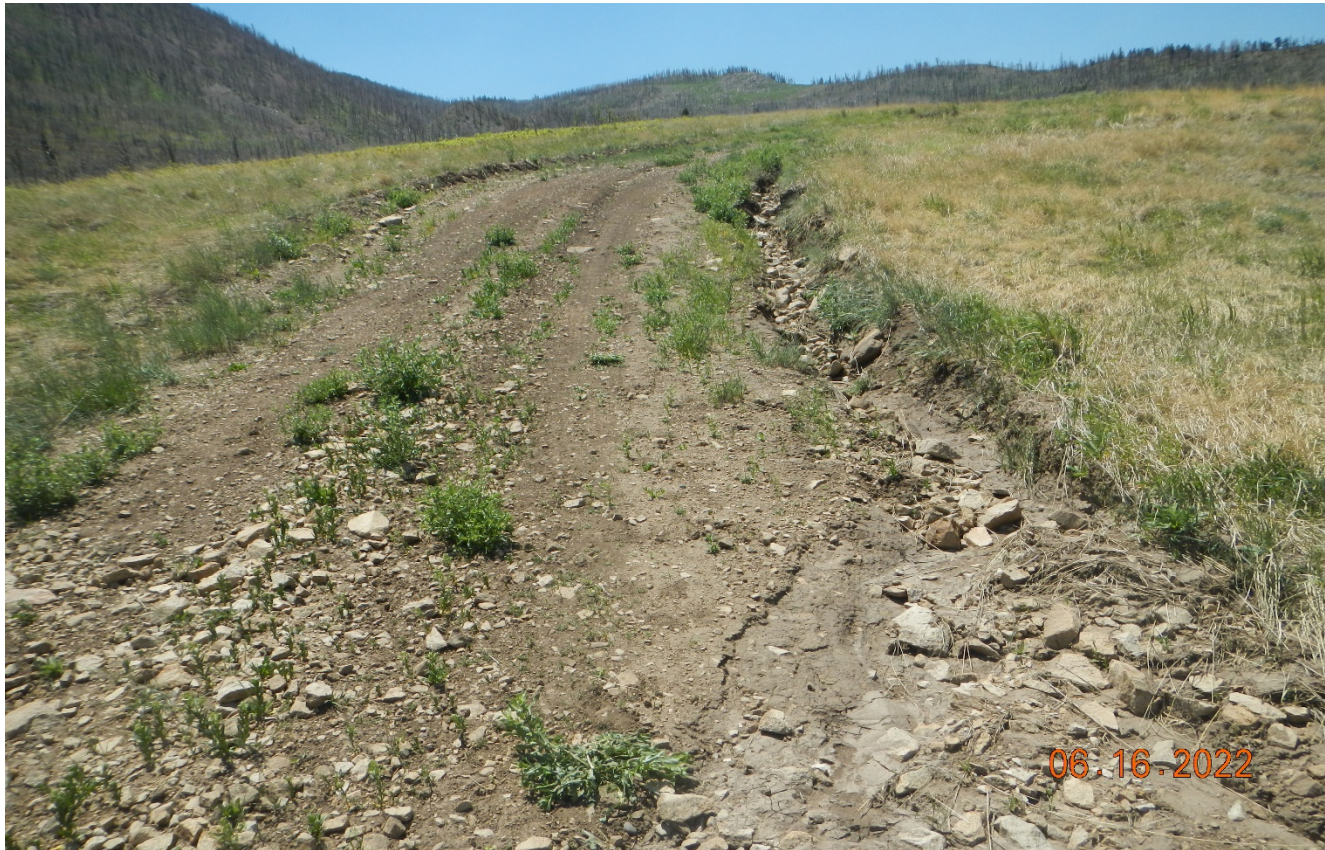
Photo 1. Facing southwest along the access road near the SMU #1-12-B . There is erosion in this area that needs to be repaired and stabilized.

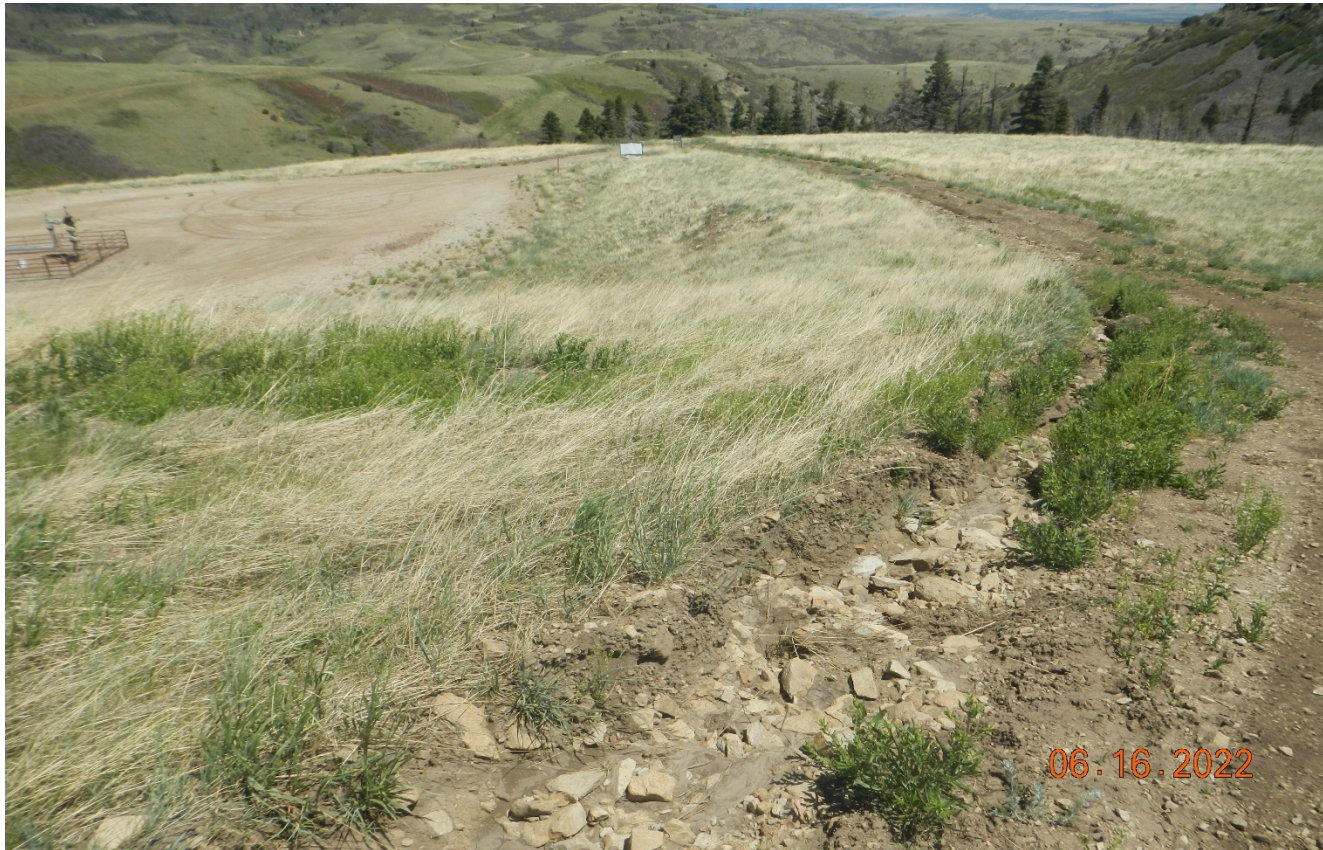
Photo 2. Facing southwest along the access road near the SMU #1-12-B . There is erosion in this area that needs to be repaired and stabilized. There is also noxious weeds in this area of the road that need to be controlled. Observed Canada thistle and Hoary crest.

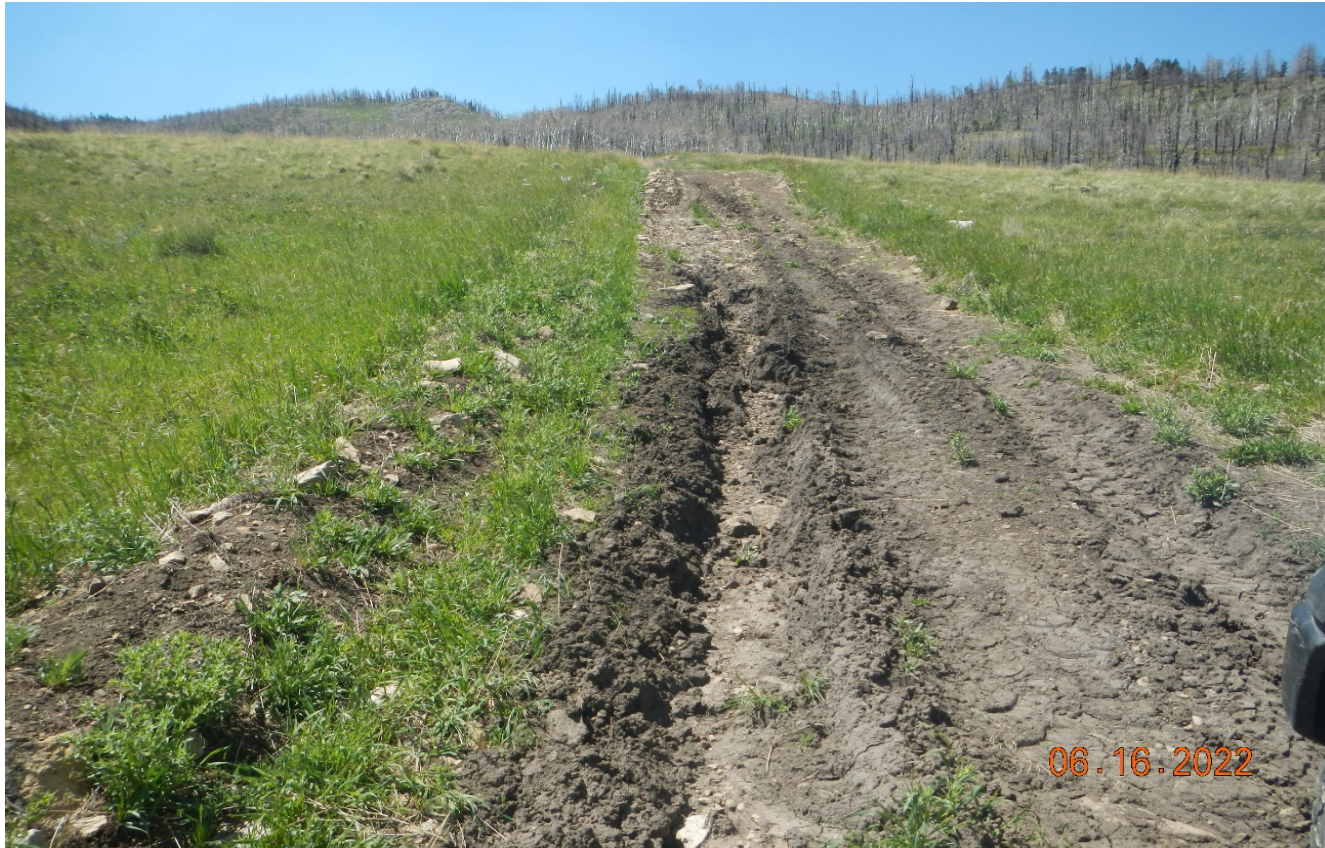
Photo 3. Facing southwest along the road. This area is rutted out and needs stabilization.

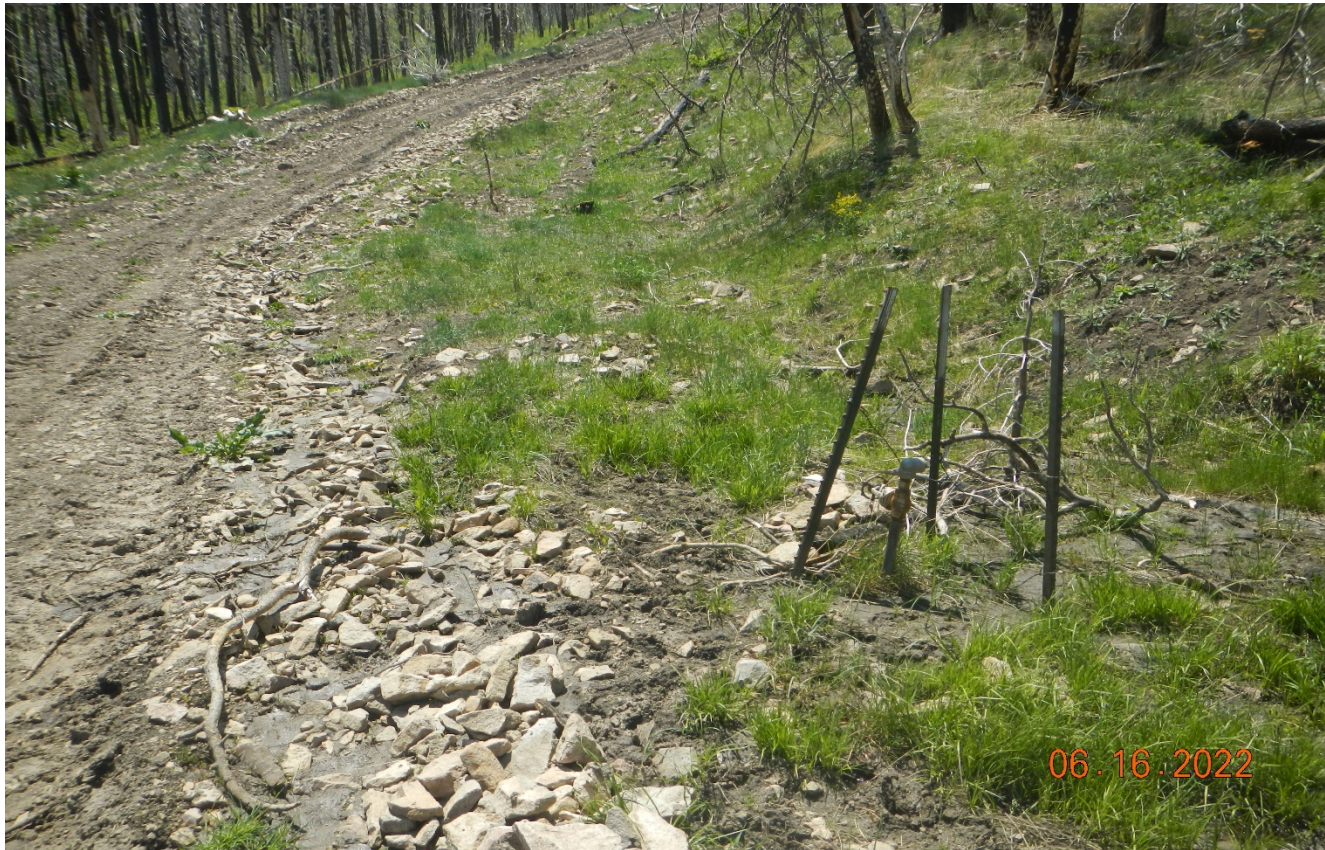
Photo 4. There is a flowline riser along the road which is Locked out. The riser needs to be identified per 1102.g.

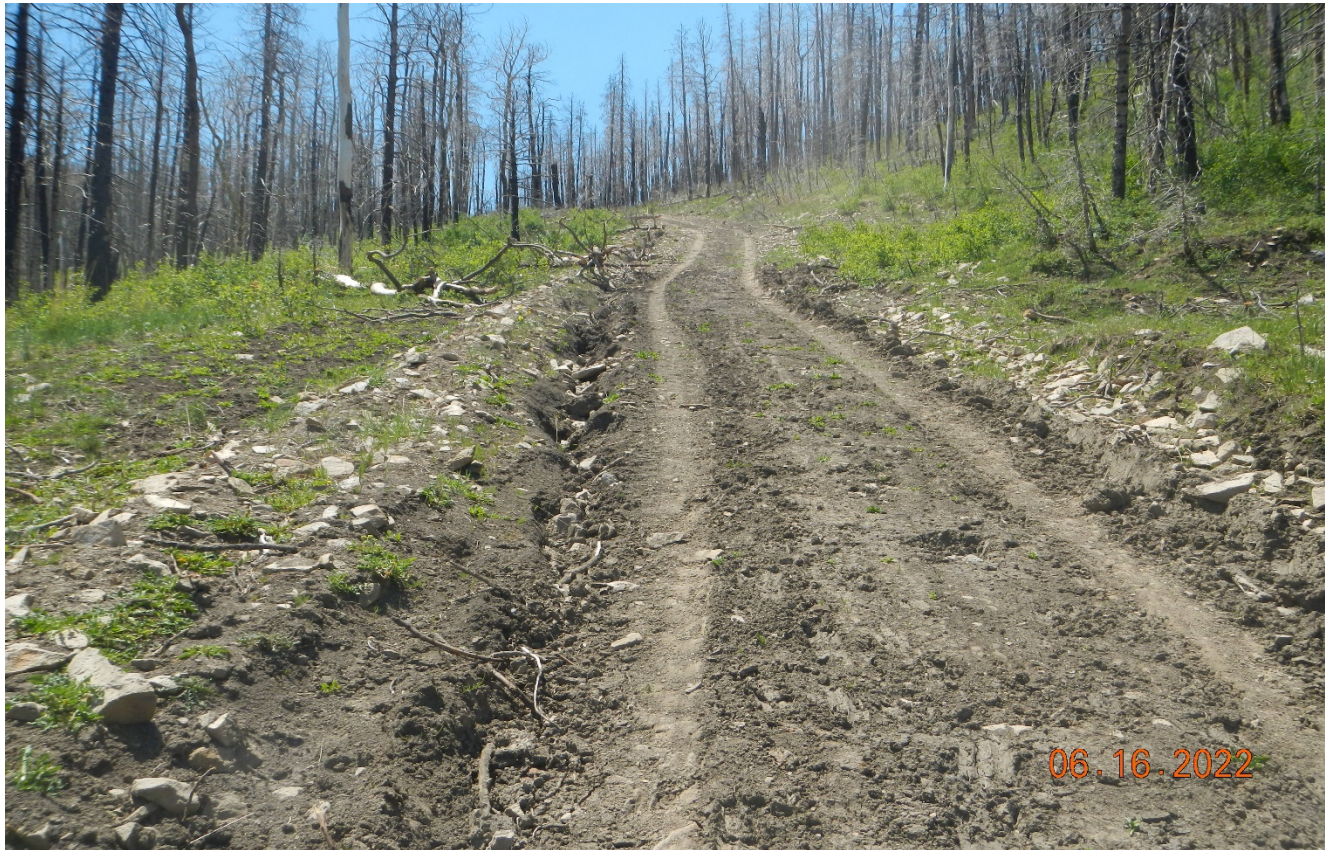
Photo 5. Facing southwest along the steep area of the road. There is erosion along this area due to stormwater not properly diverted off the road. This area needs to be repaired.

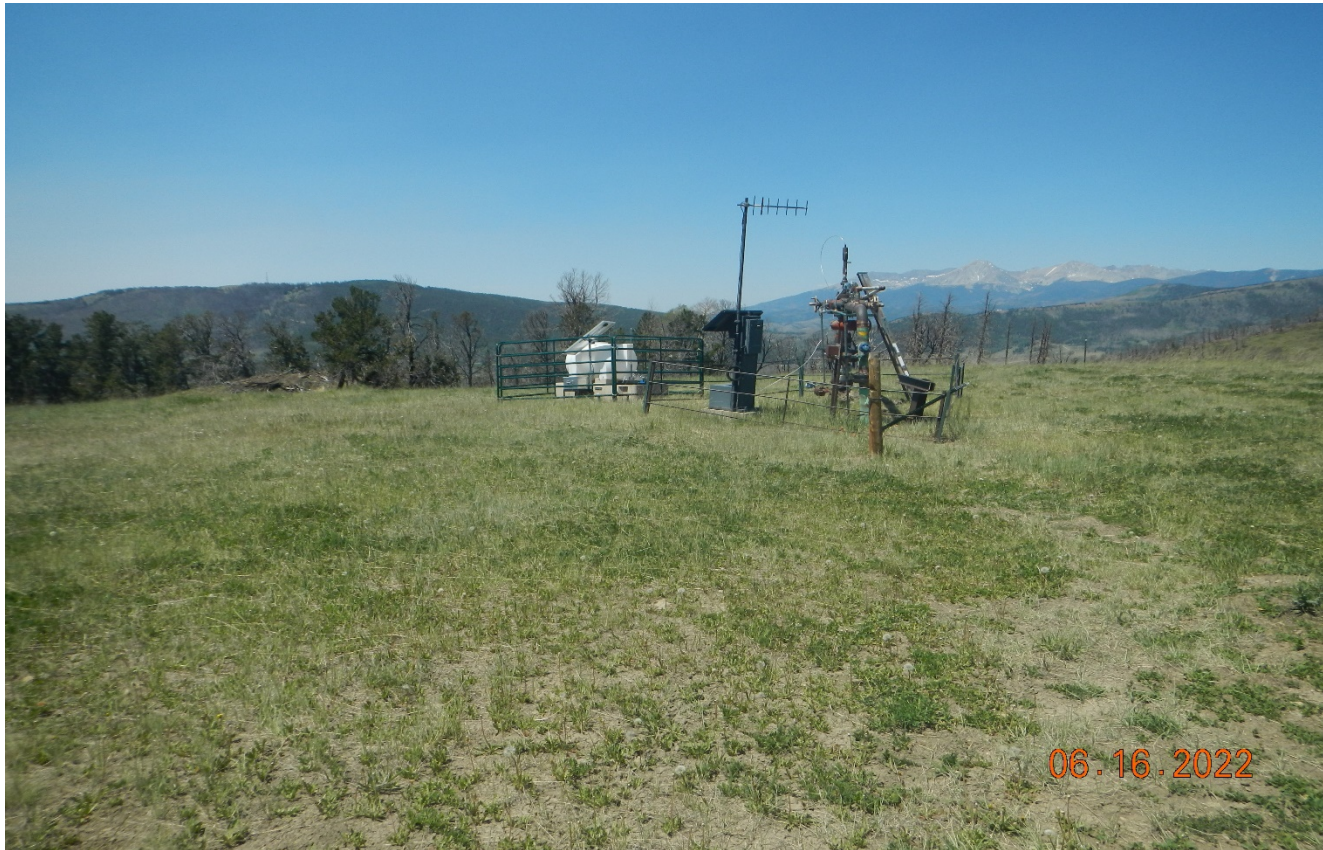
Photo 6. Facing west toward the well site. The location is fully vegetated and stabilized.

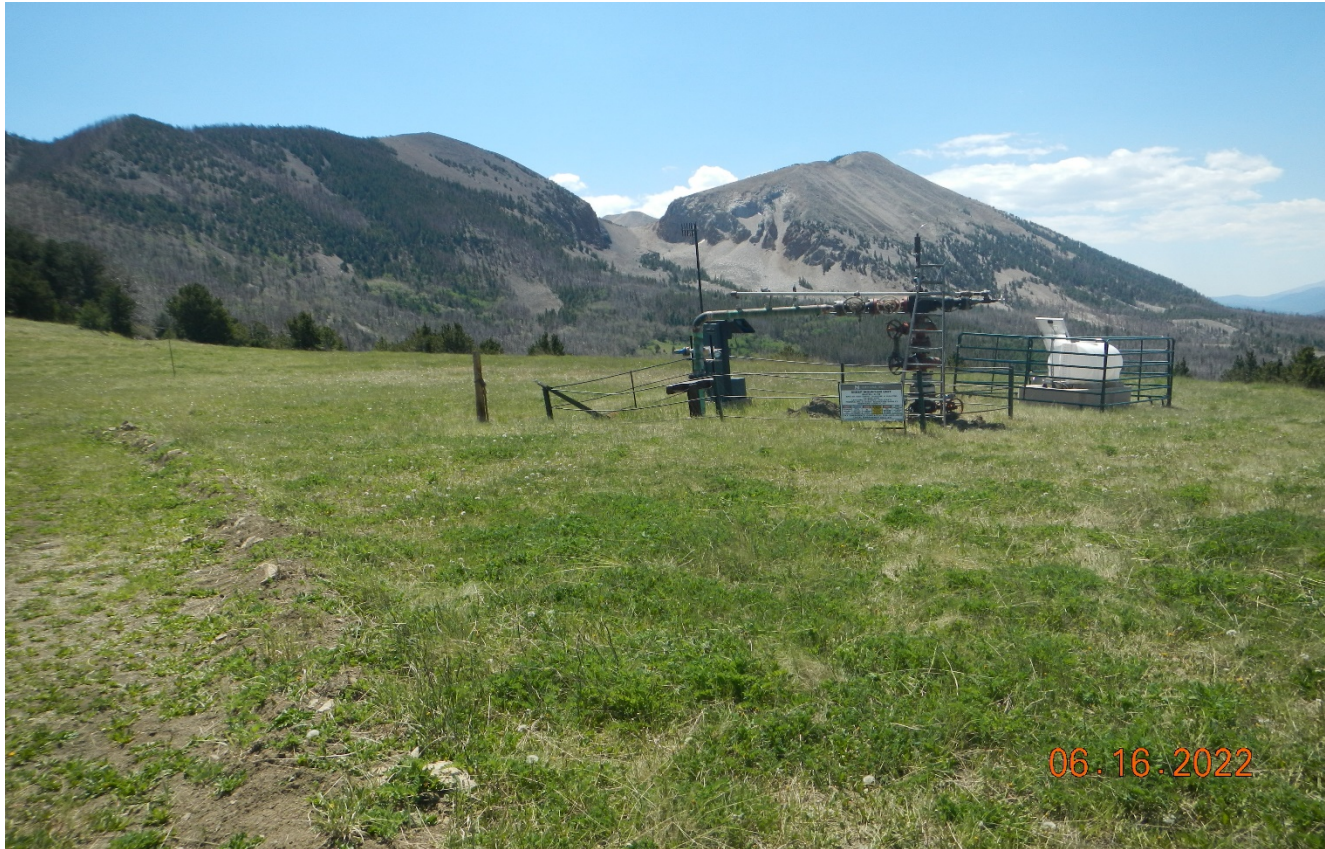
Photo 7. Facing southeast toward the well site. The location is fully vegetated and stabilized. Well sign is posted.

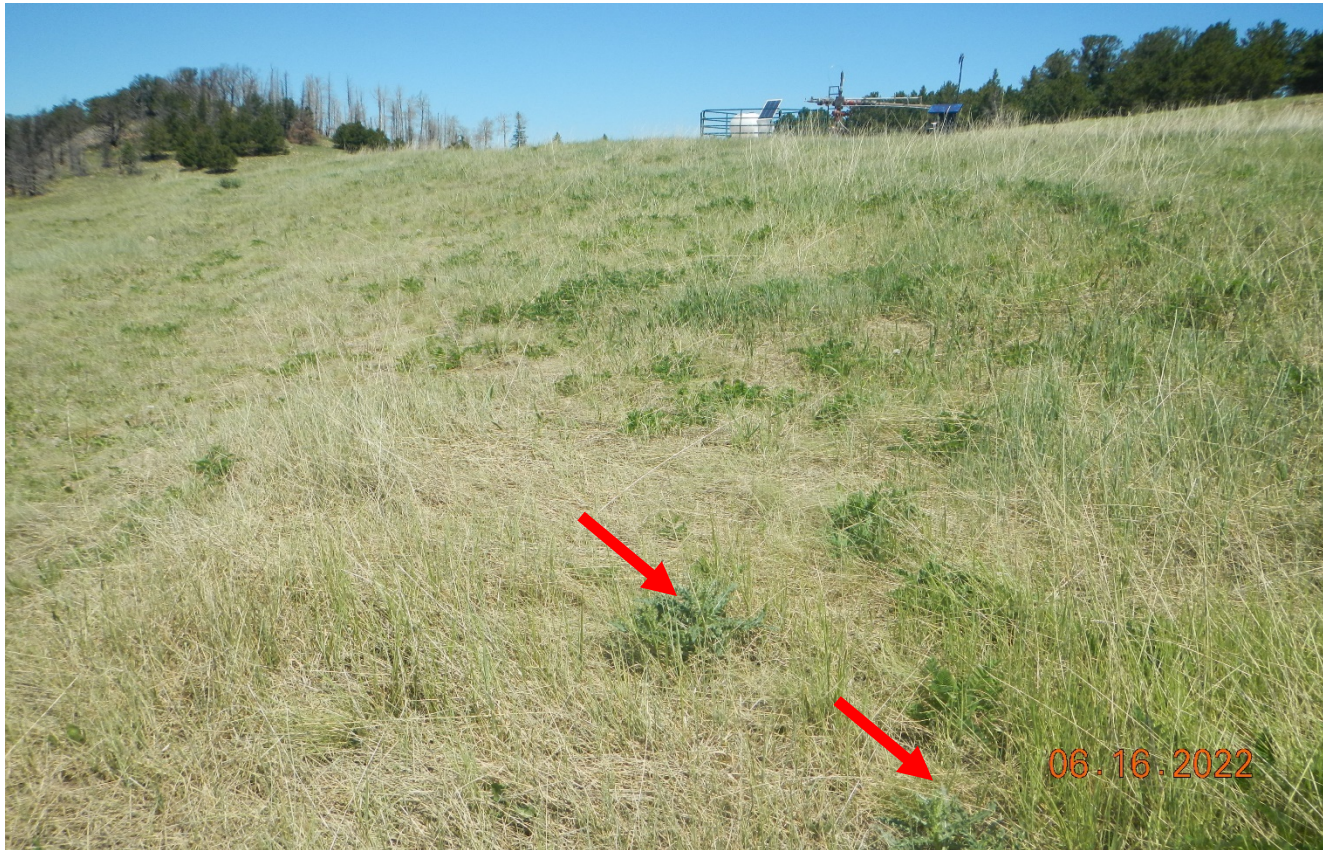
Photo 8. Facing north along the fill slope. There are noxious weeds in this area that need to be controlled. Red arrow → Canada thistle

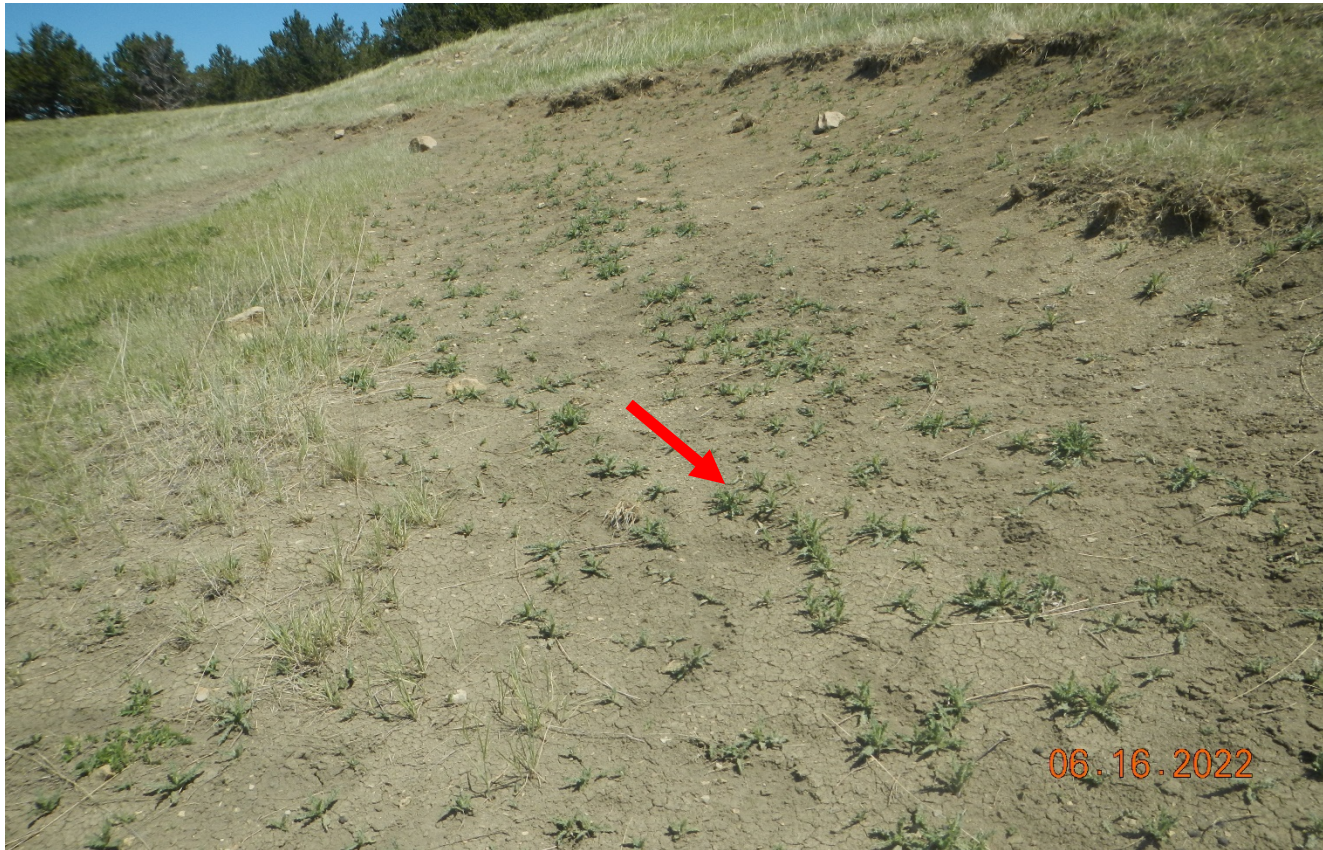
Photo 9. Facing north at the cut slope of the location. There are numerous noxious weeds in this area that need to be controlled. This area needs to be reseeded.
Red arrow → Canada thistle
