**TEP  
RWF 331-11  
Location # 335638**

**COLORADO**  
Oil & Gas Conservation  
Commission  
Department of Natural Resources

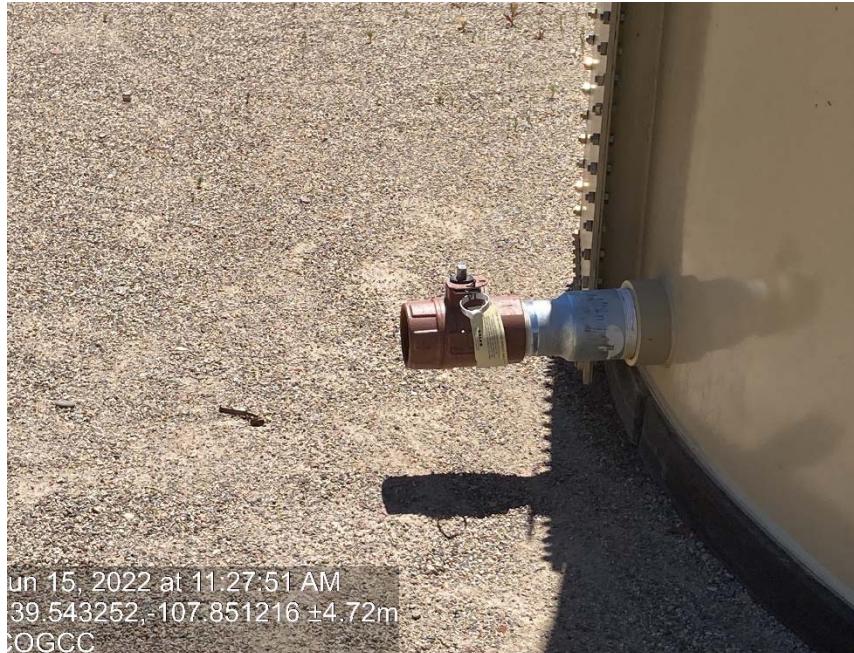
**Valves on tanks missing caps/ plugs**

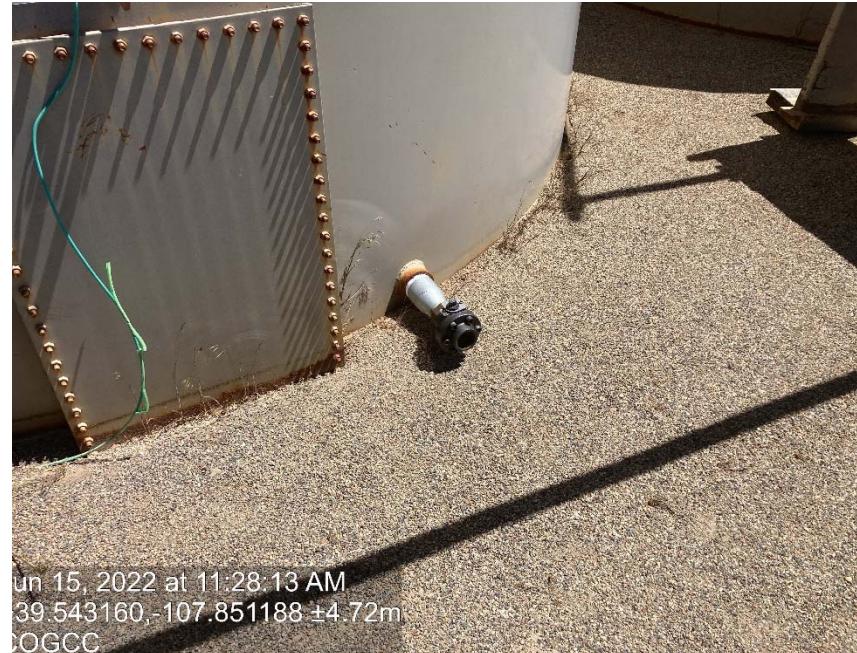
**Valves on tanks missing caps/ plugs**

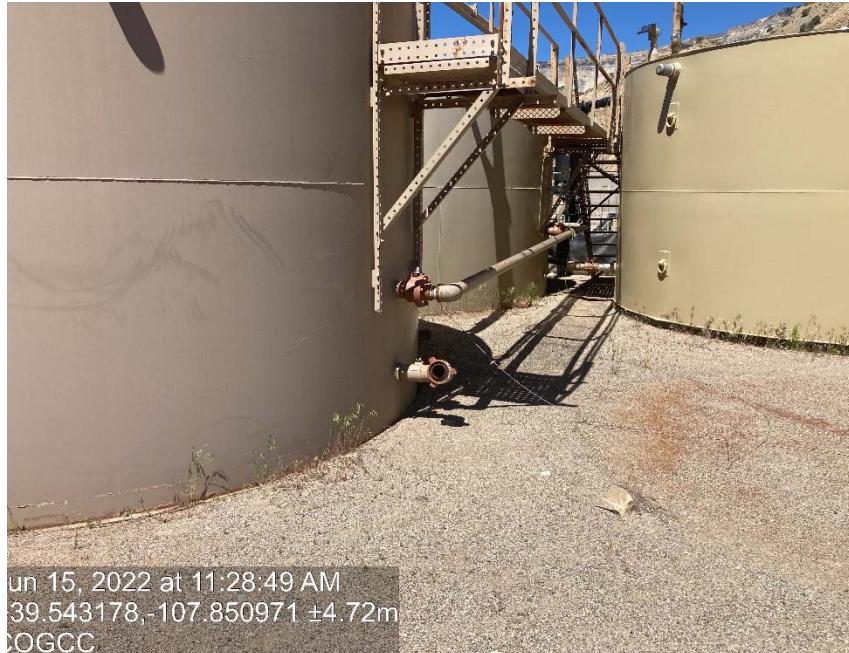
**Valves on tanks missing caps/ plugs**

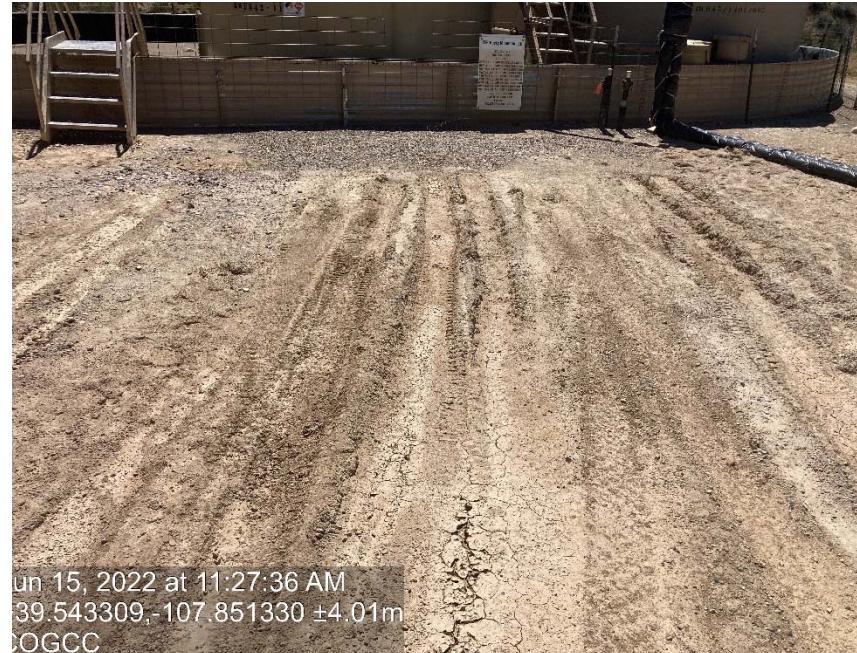
**Lack of stabilization/ compaction**

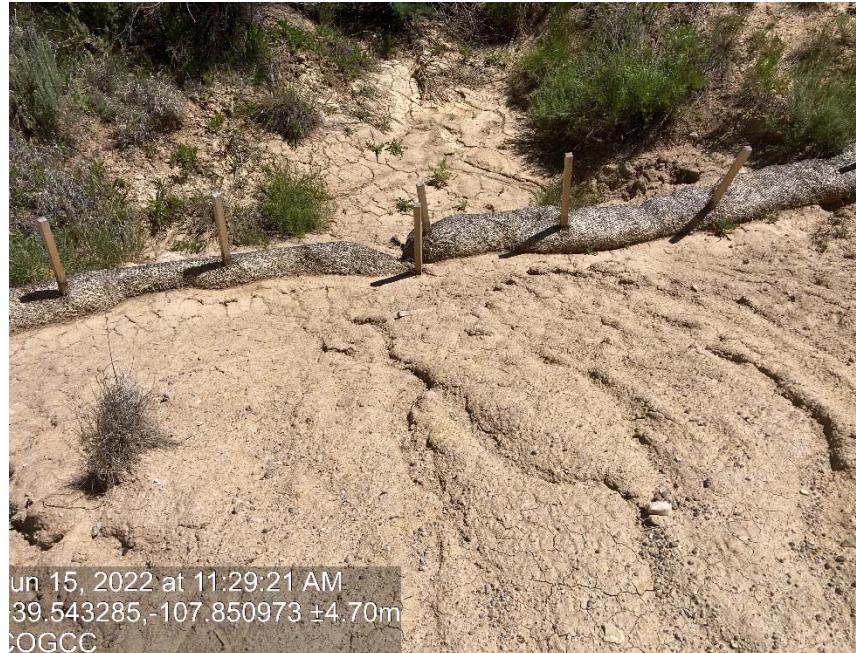
**Erosion**

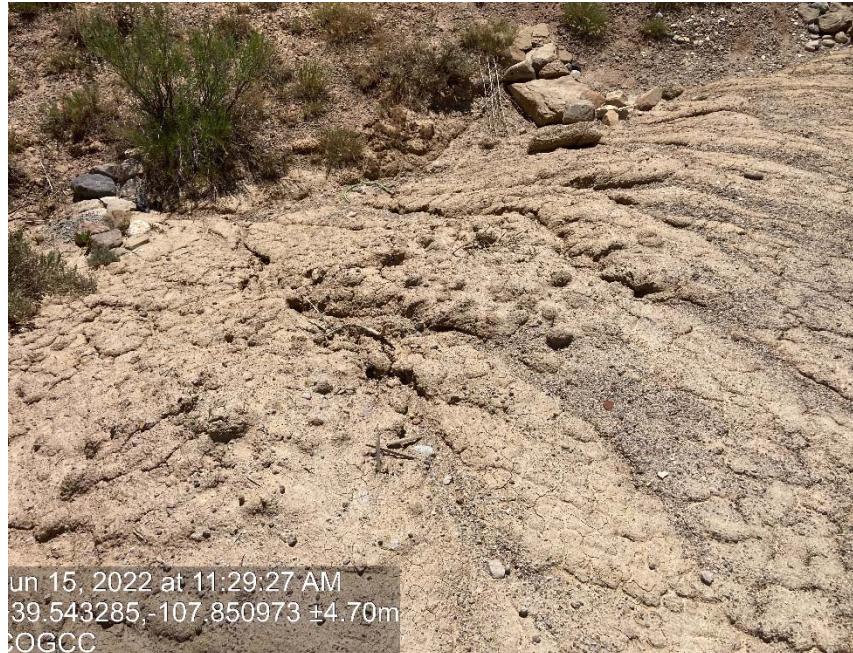
**Erosion**

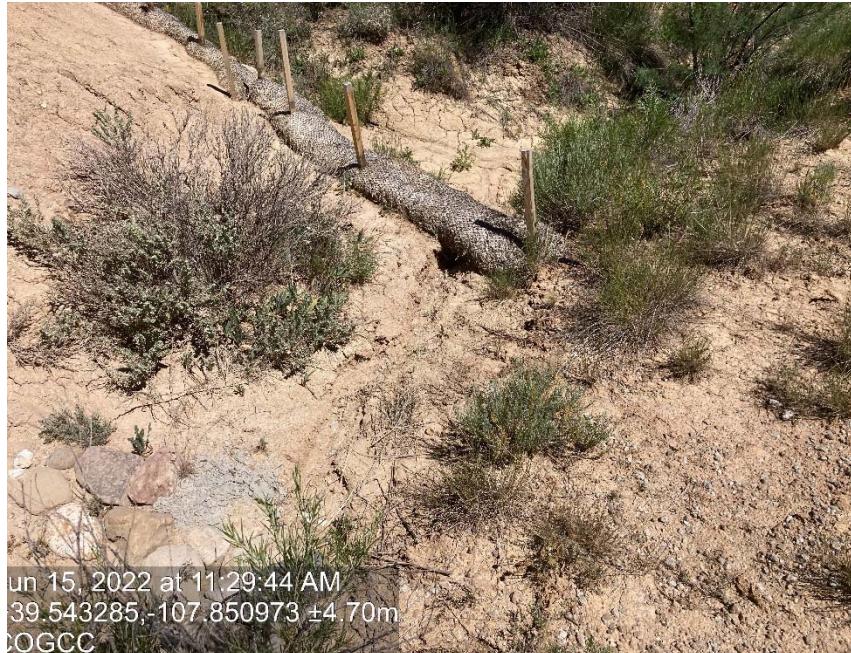
**Erosion**

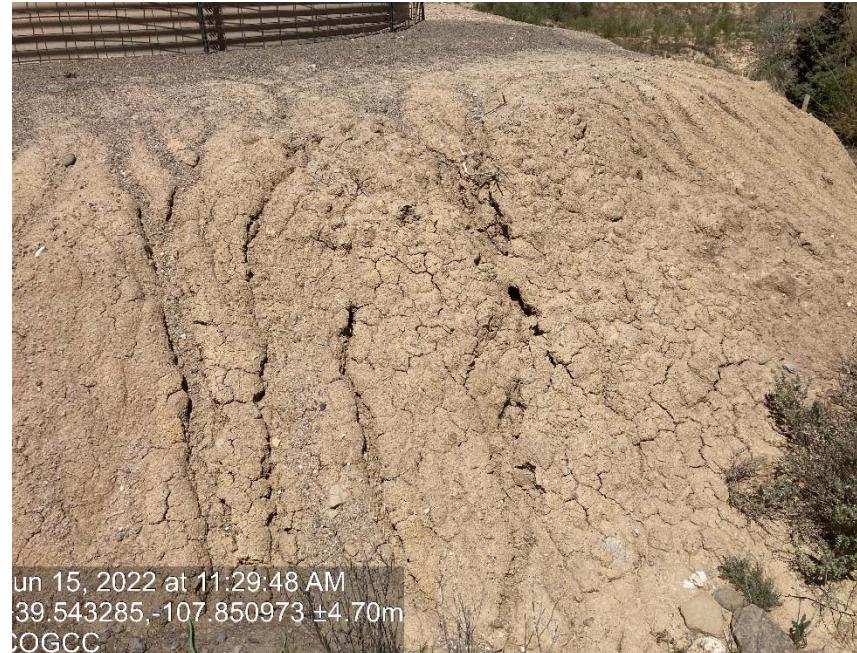
**Erosion**

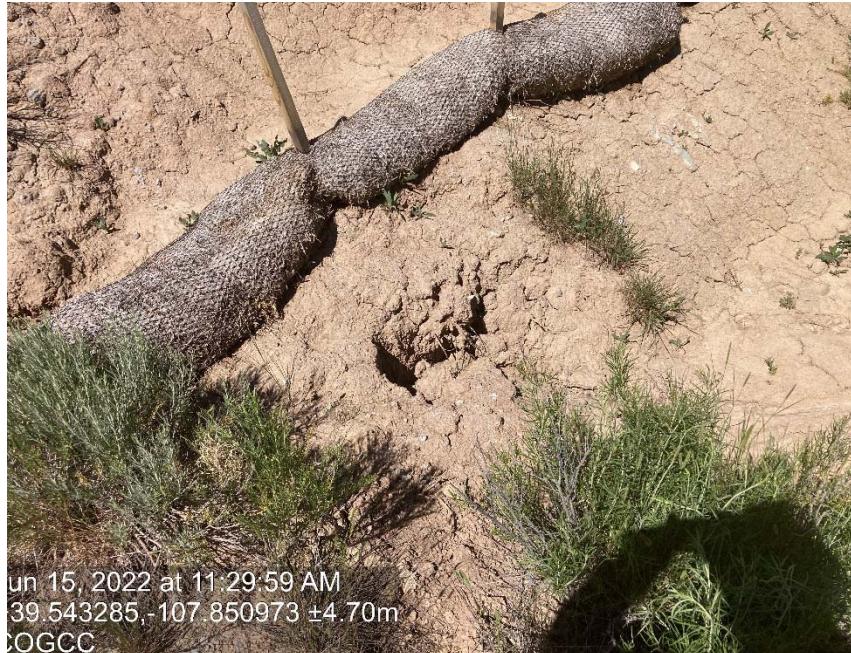
**Erosion and subsidence**

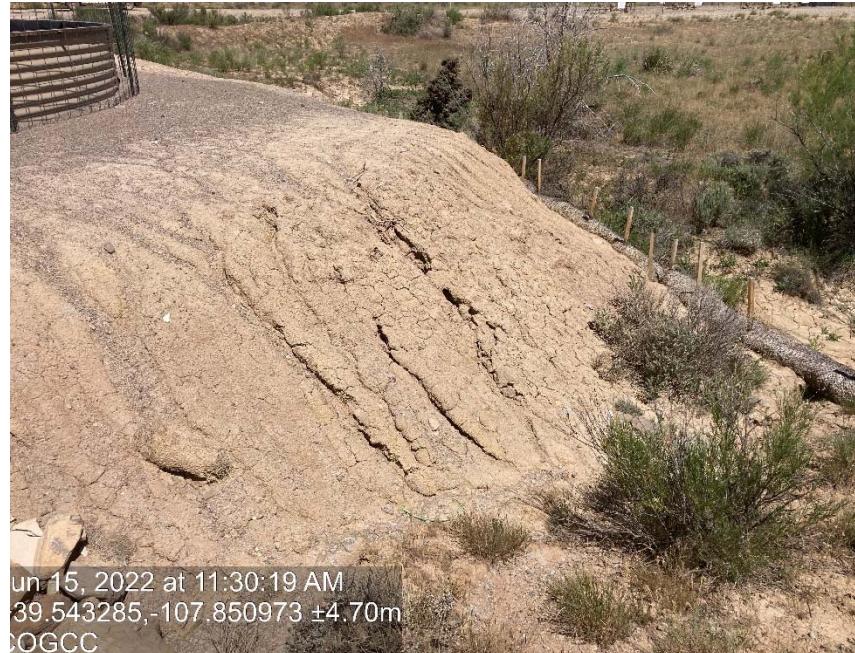
**Erosion**

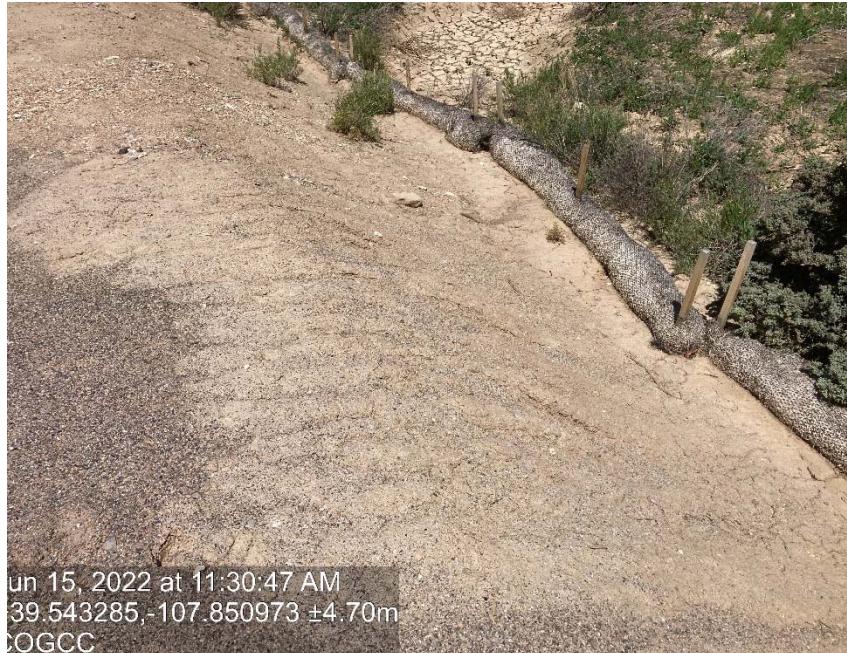
**Erosion**

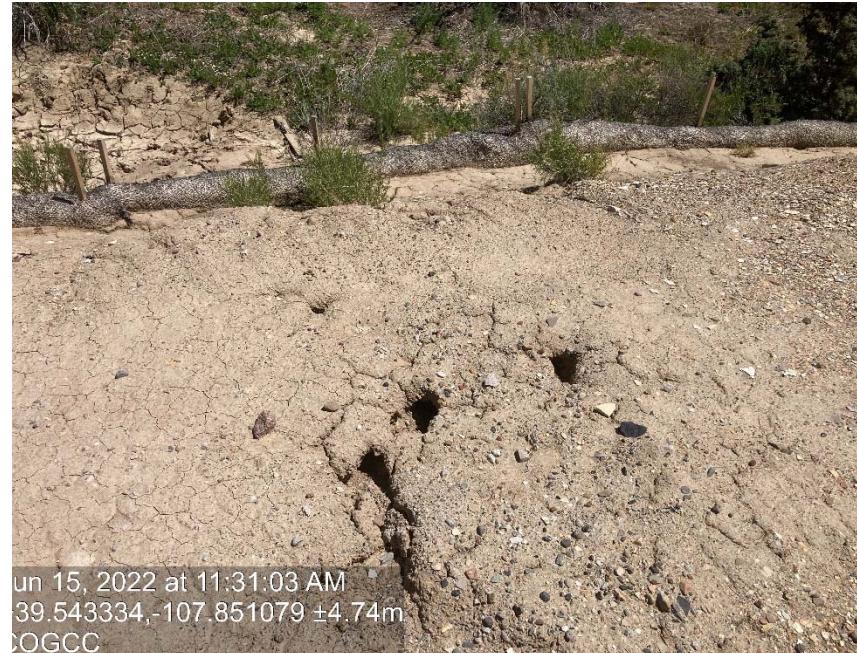
**Erosion and subsidence**

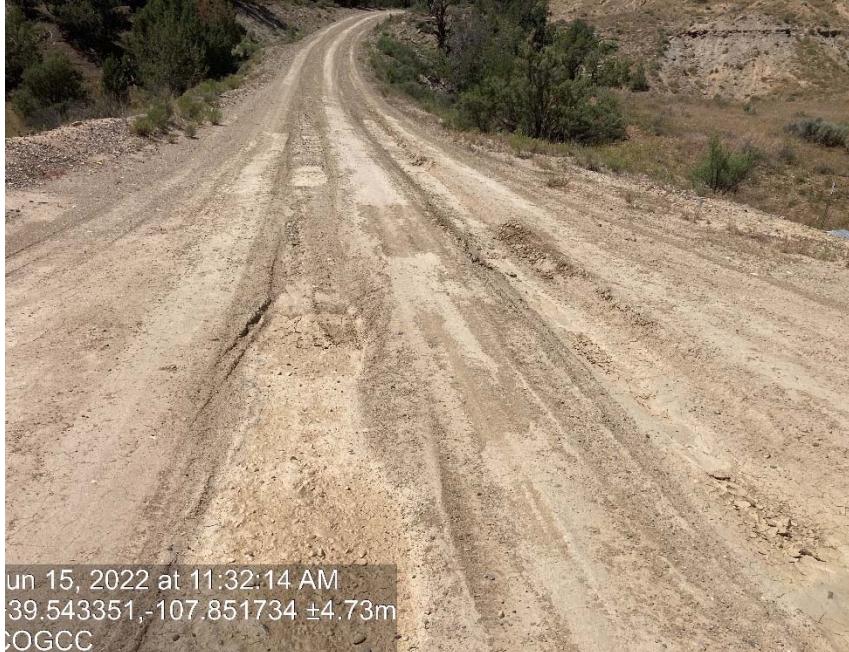
**Lack of stabilization/ compaction**

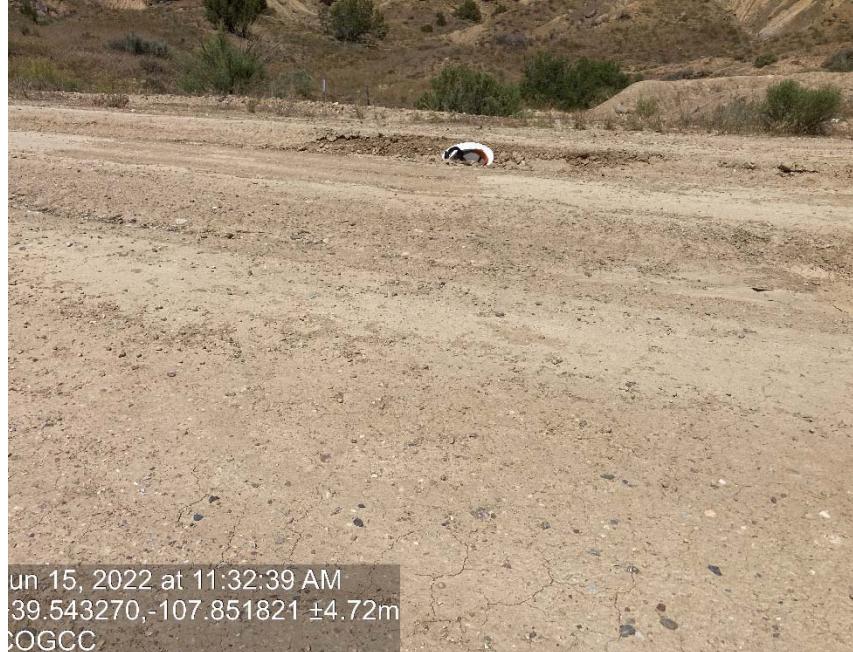
**Lack of stabilization/ compaction/ Hard hat in rutting**
