**From:** Kris Rowe <krowe@hrlcomp.com>  
**Sent:** Thursday, June 02, 2022 5:02 PM  
**To:** mco@visionenergy.biz  
**Subject:** Baldy Creek Fed 2-20 - Initial Site Invest (leaking wellhead spill)

Regarding the Baldy Creek Fed 2-20 spill, below is a quick summary of the findings;

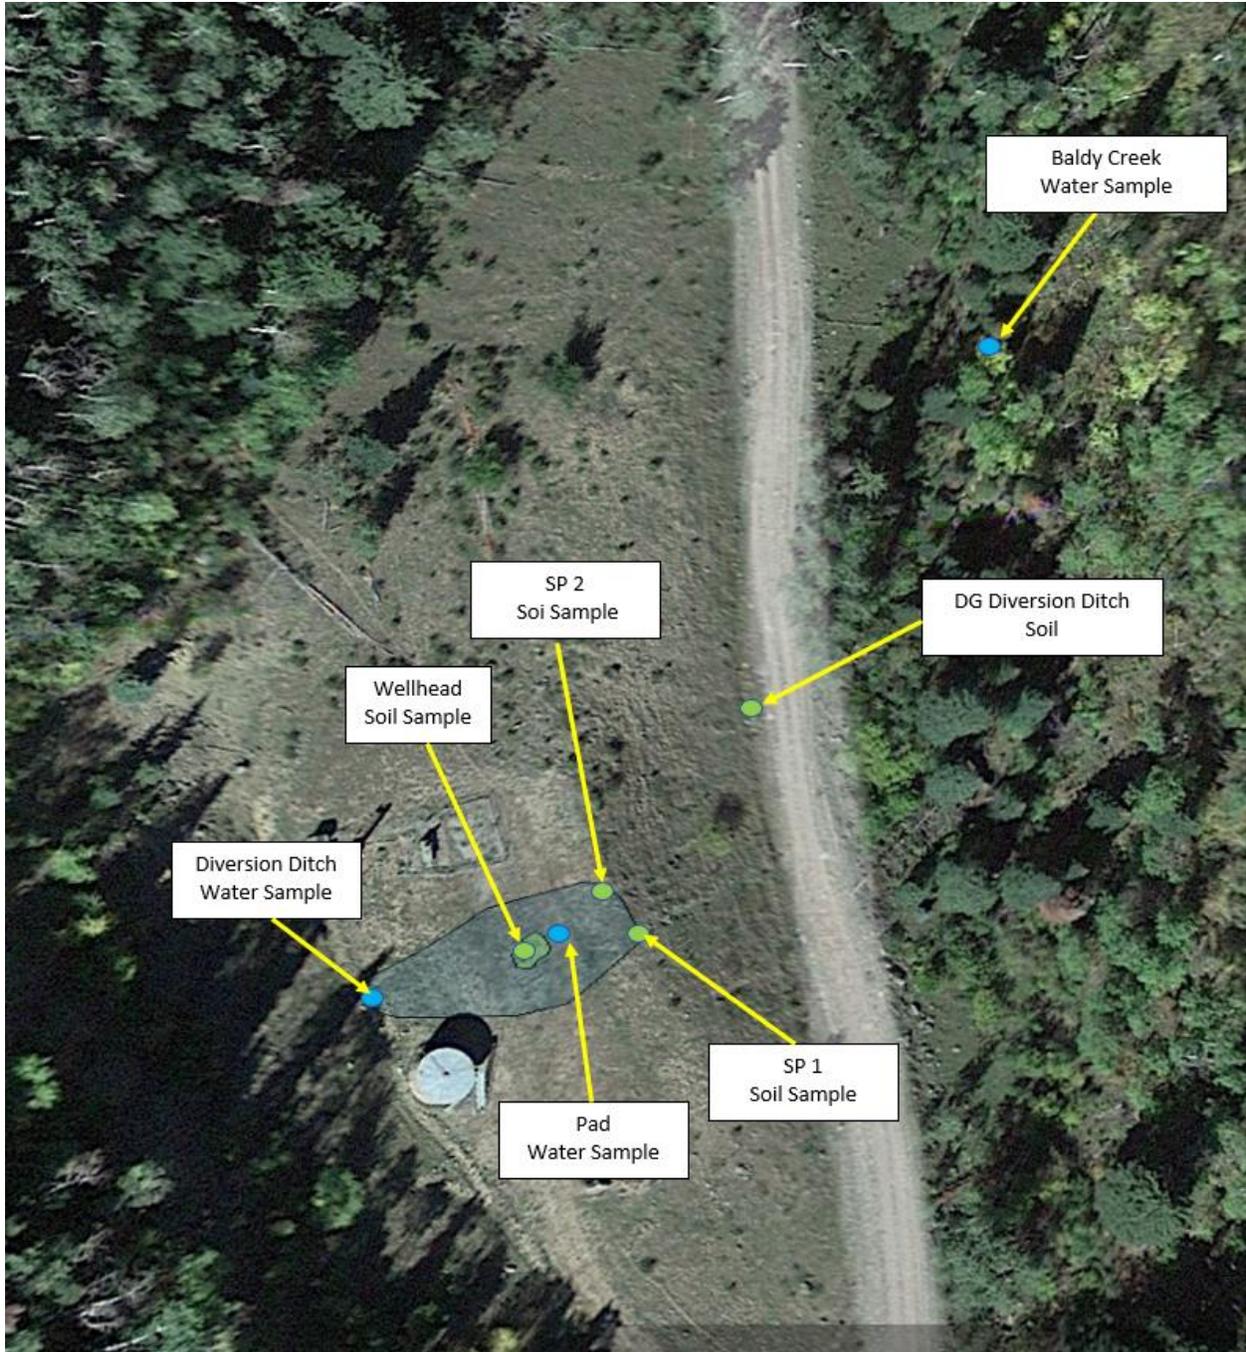
Samples were collected the pooled water directly downgradient from the staining around the wellhead, as well as at the point where the stormwater is entering the pad from the diversion ditch. Soil samples were also collected from around the wellhead, at two downgradient points within the flow path of the stormwater where it crested the pad. An additional soil sample was collected from a downgradient section within the division ditch along the access road. Although the stormwater flow was contained to the diversion ditch along the access road and could not appear to run over the road due to terrain and gradient direction, a sample was collected from the Baldy Creek at a downgradient point to ensure no impacts to the creek have occurred.

Below is a rough draft map of the sample locations and attached are photographs of the site investigation onsite that occurred today (6/2/22).
