Inspection Photos
Operator: Hilcorp Energy
API: 067-08171
Date: 6/1/2022

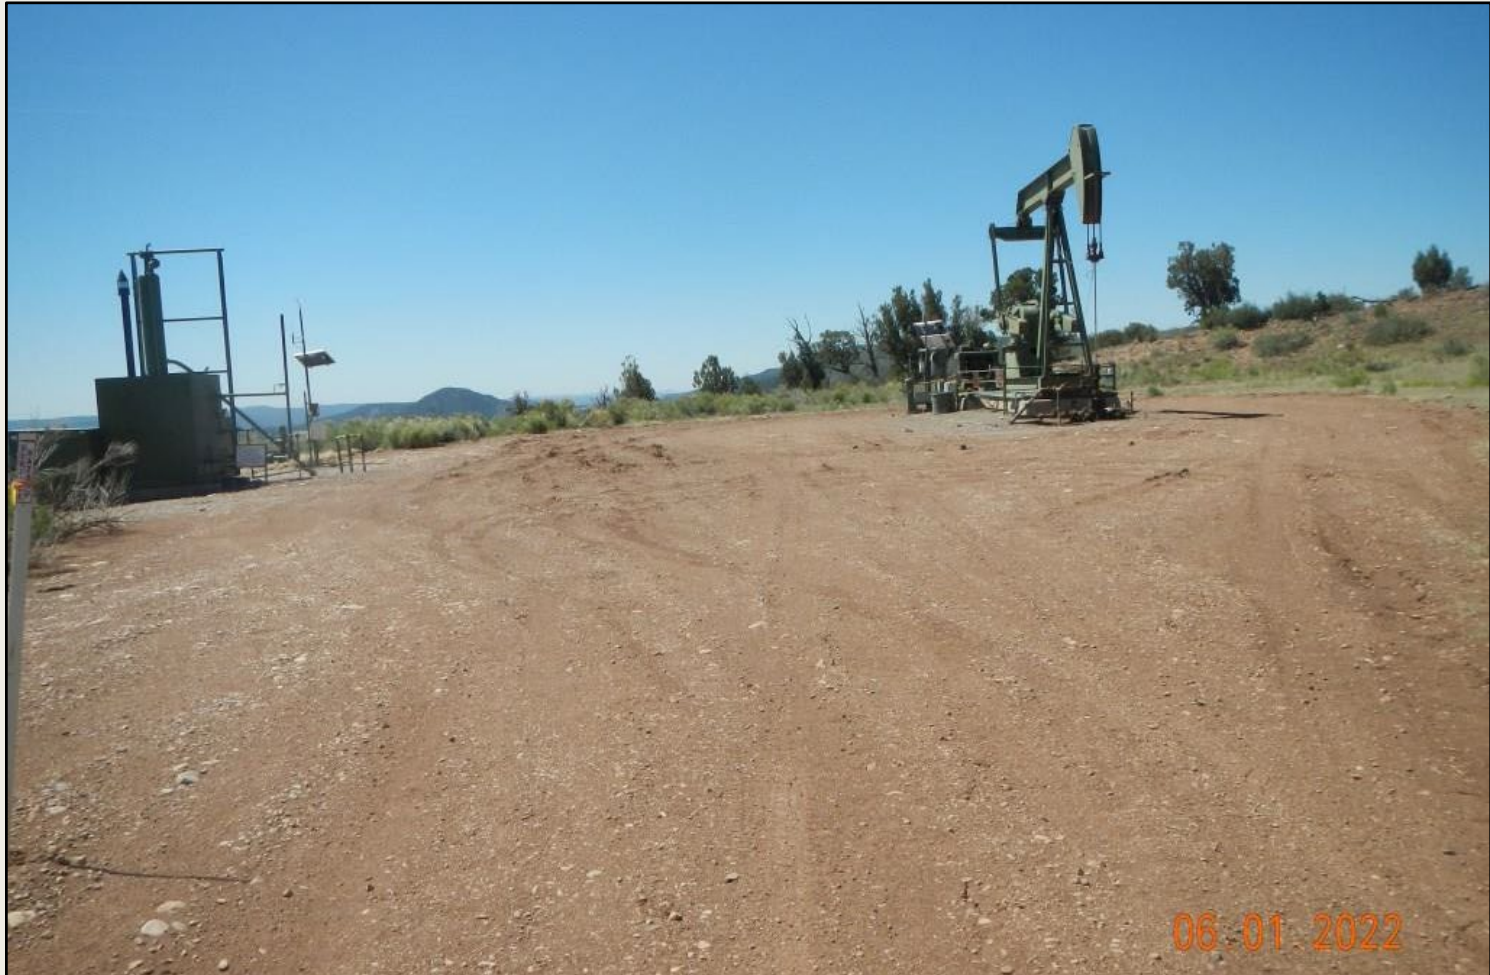
Photo 1. View of the project area from the well pad entrance facing center.

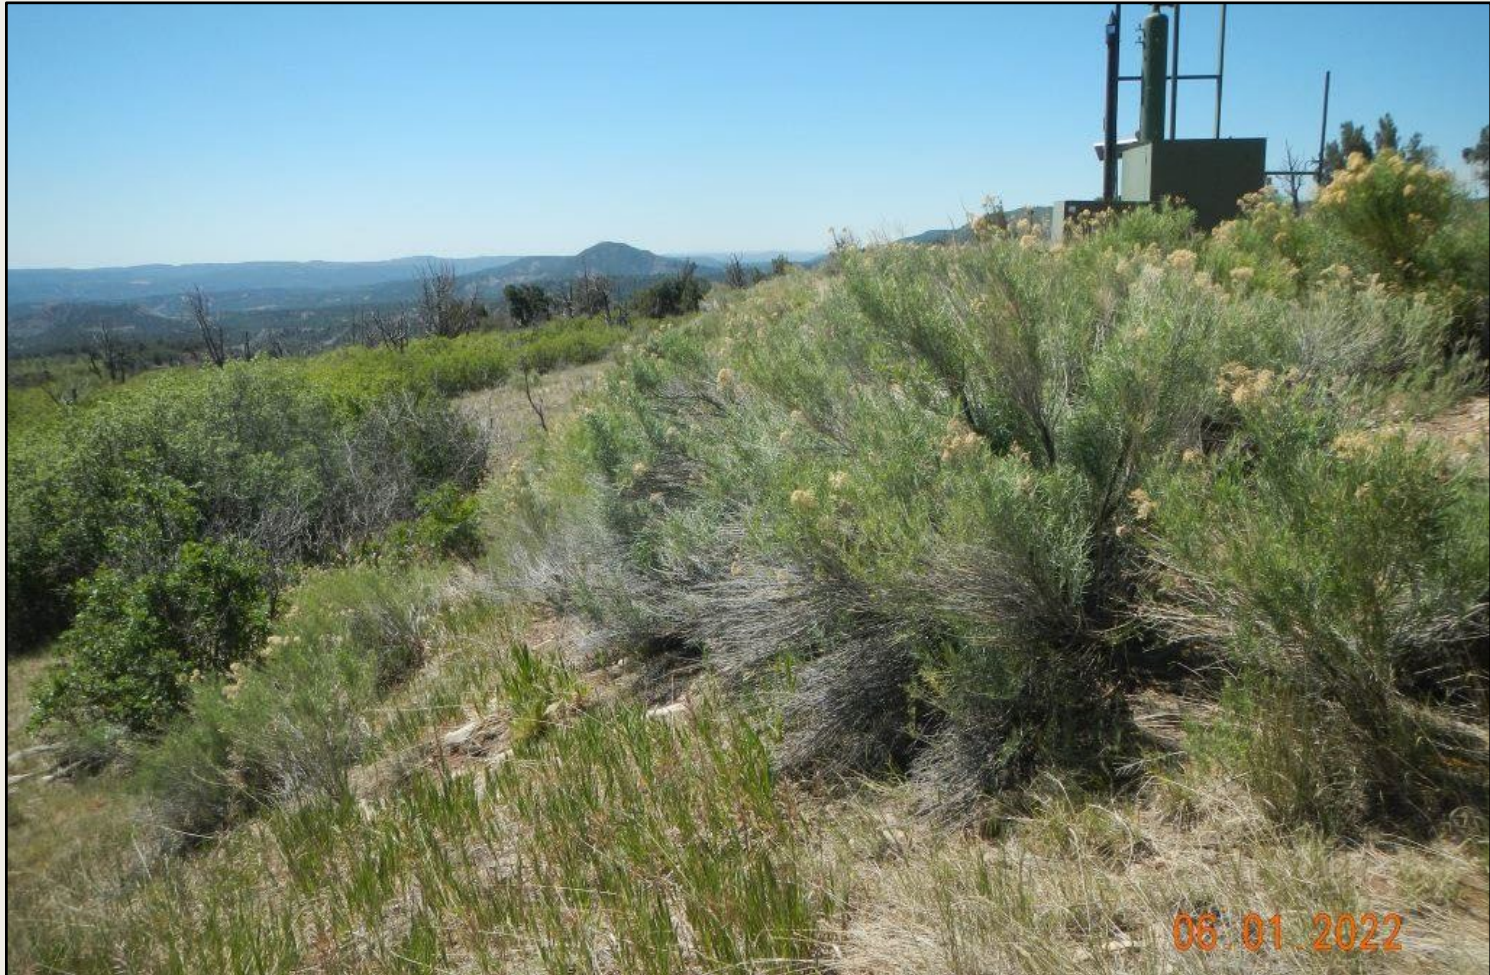
Photo 2. View of the eastern project area from the northeastern corner facing southward. Revgetation is progressing largely with western wheatgrass, smooth brome, crested wheatgrass, and rubber rabbitbrush.

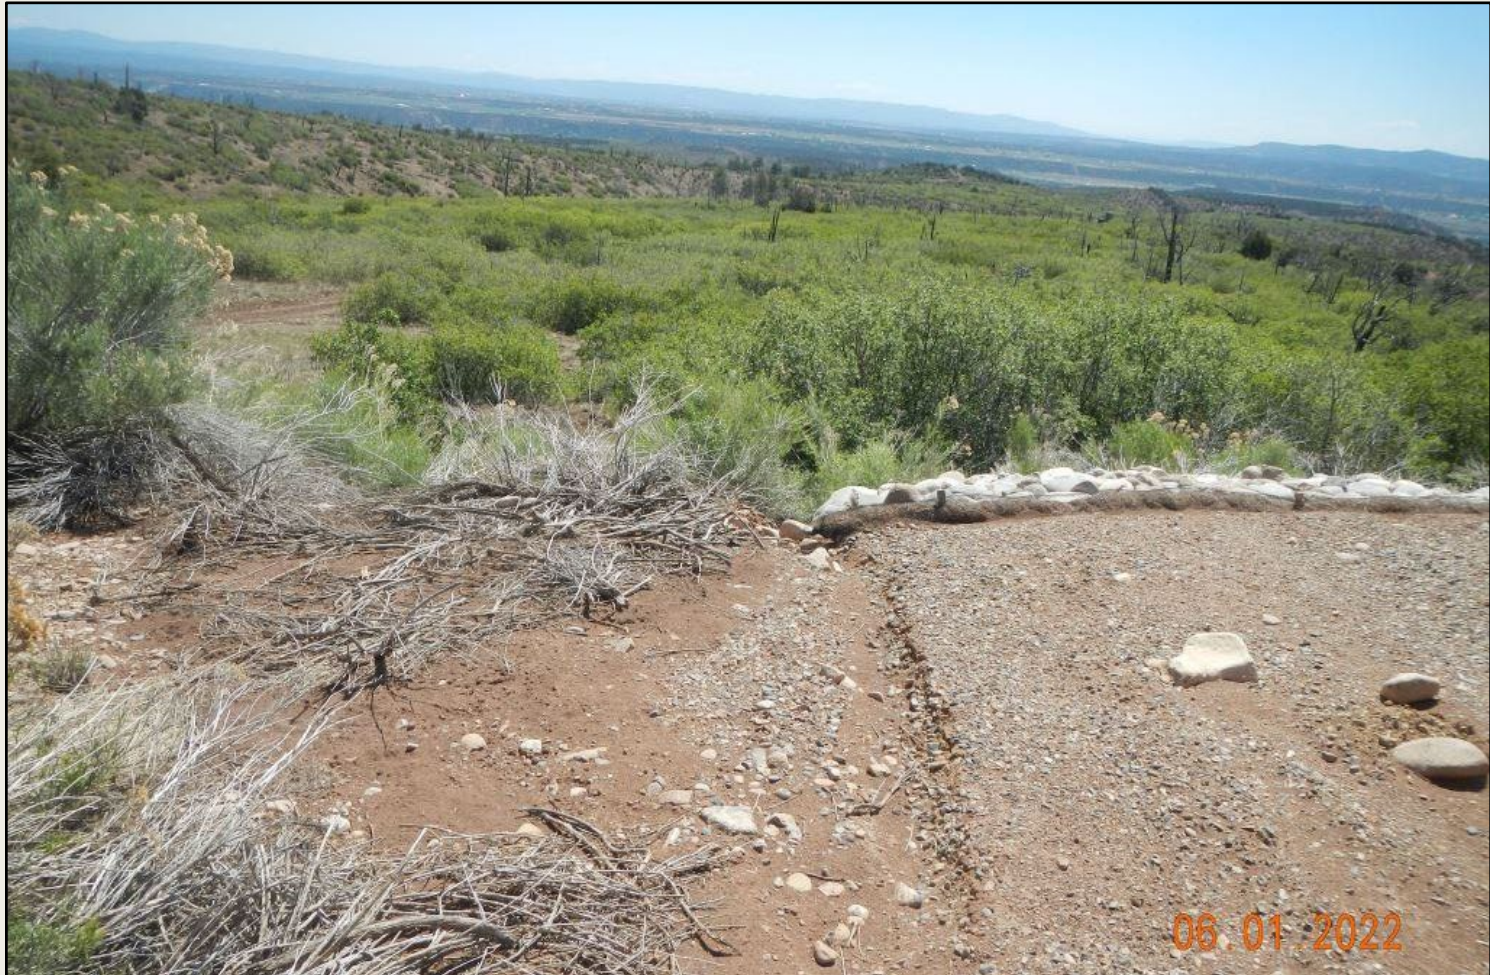
Photo 3. View of cobble BMP in the eastern project area where concentrated stormwater is flowing around the edge resulting in erosional channeling along the edge of the BMP.

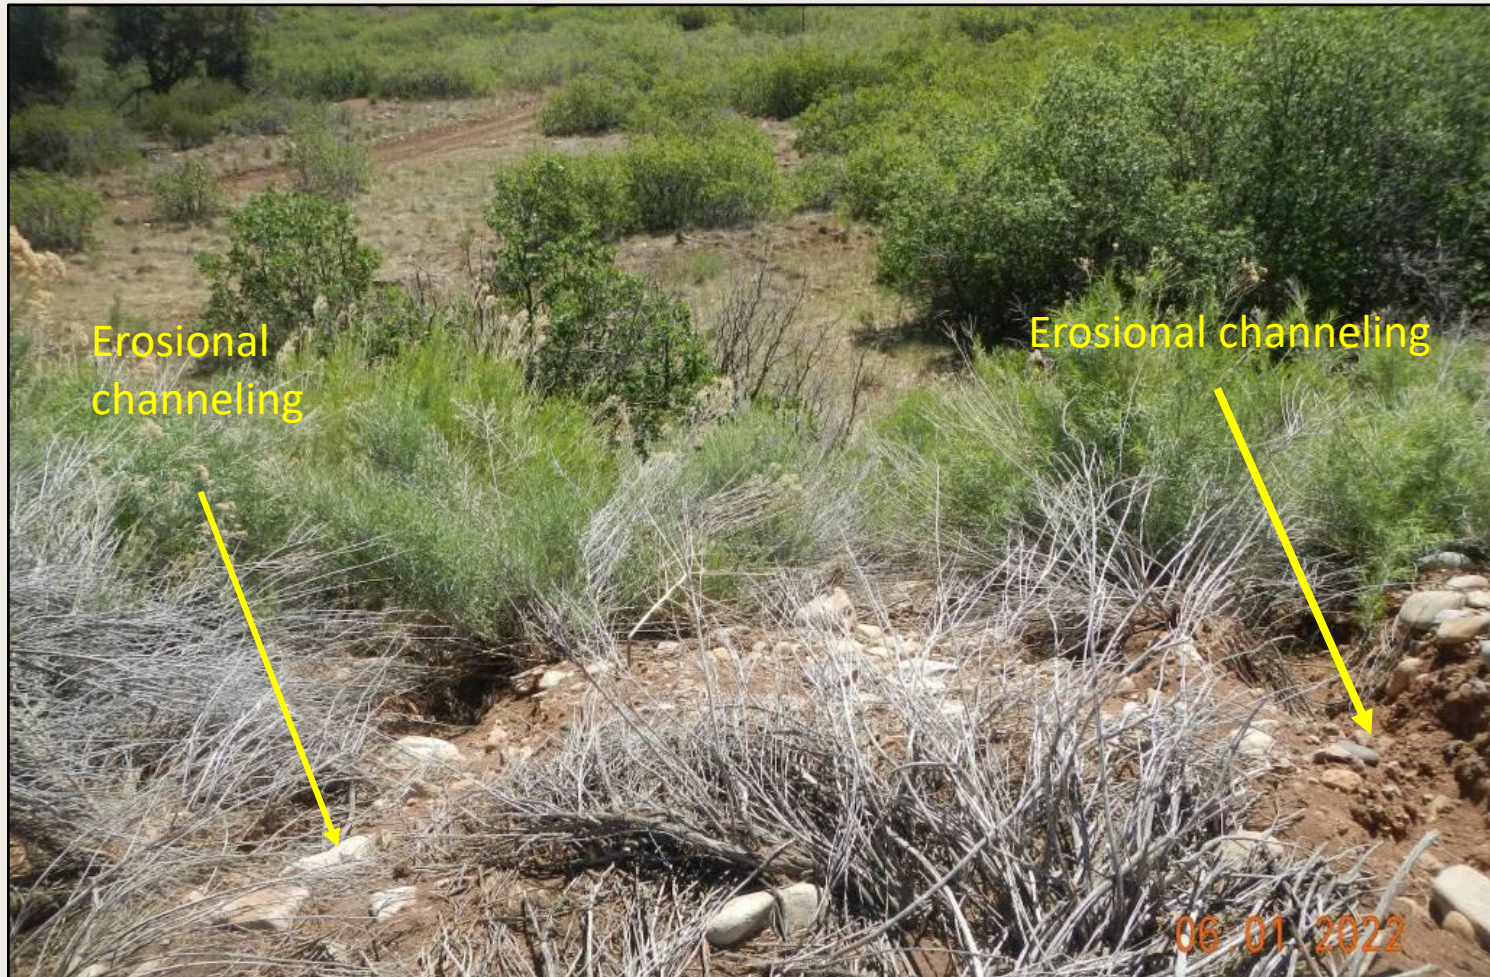
Photo 4. View of erosional channeling downslope from Photo 4, within the eastern fill slope (approx 10-12 inches wide and deep).

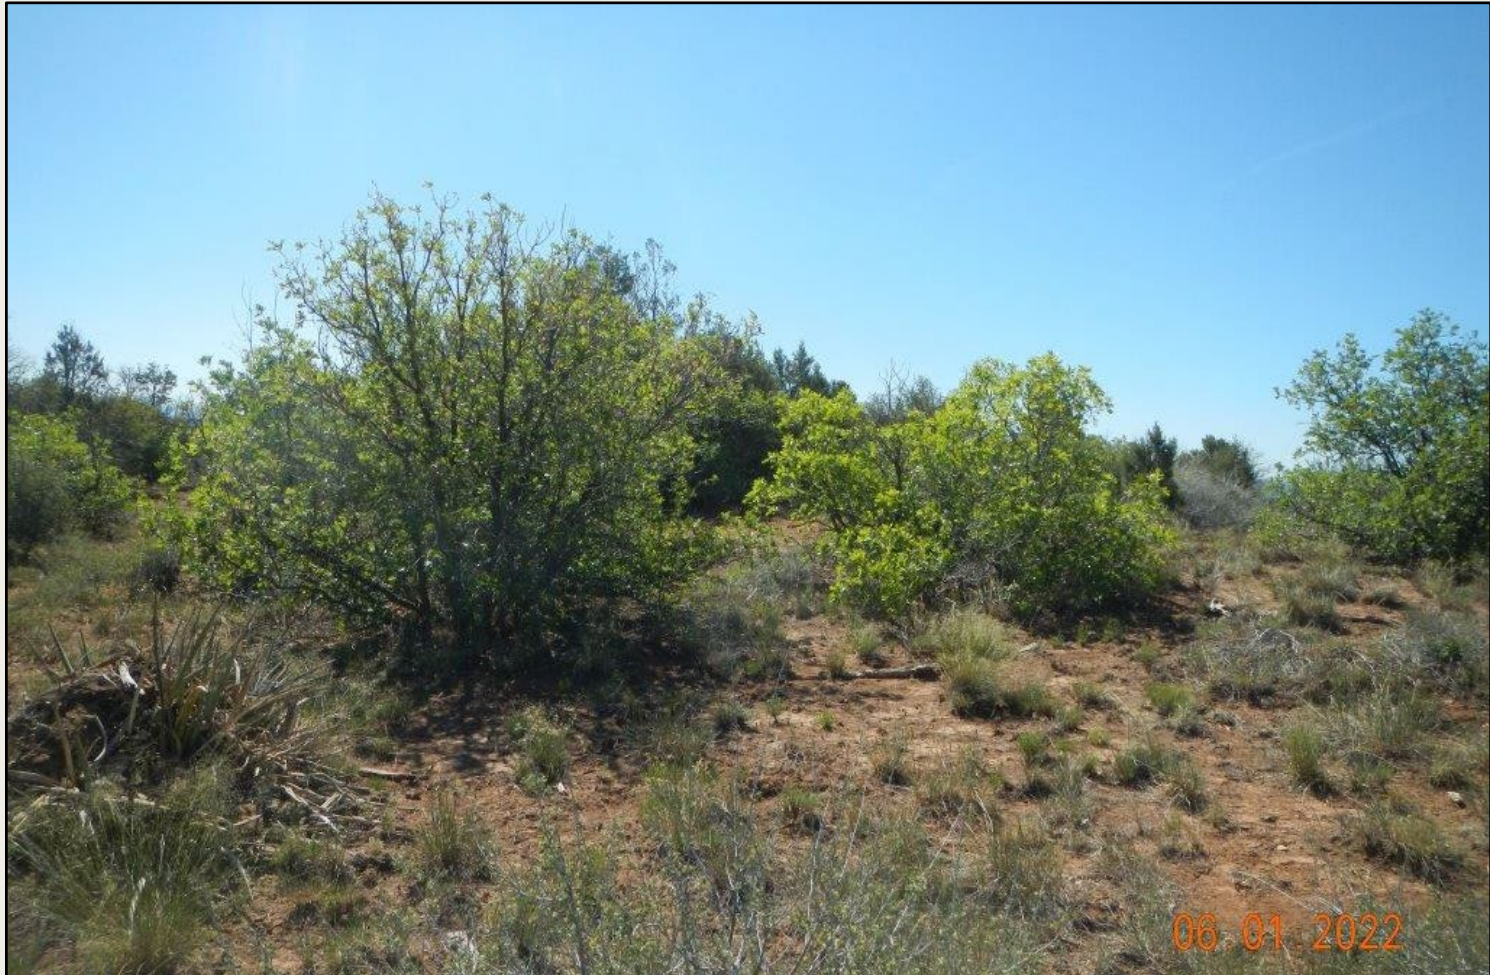
Photo 5. View of reference area comprised of gambel oak shrubland with Indian ricegrass, yucca, snakeweed, squirreltail, and *chaetopappa ericioides*.
